Geotechnical Investigation Report 788 March Road, Kanata (Ottawa), Ontario

Project Number: 18-206-2

Document ID: 18-206-2_Geotech Report_R4

Revised October 29, 2020

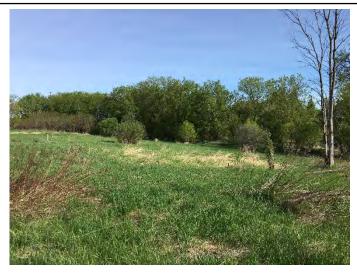
A – Upper slope, looking north from the southern boundary of the property

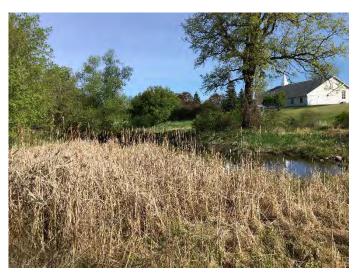
C – Toe of slope at Shirley's Brook, looking northwest

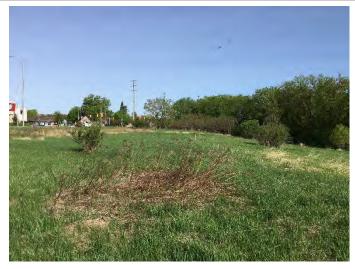
B – Upper slope, looking northwest toward intersection of March Rd and Klondike Rd

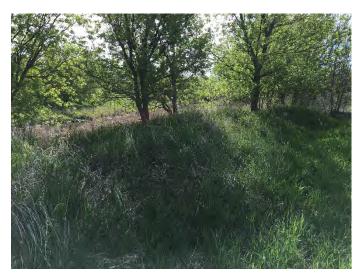
D – Fill piles located at the base of the slope in the middle of the site, looking southeast

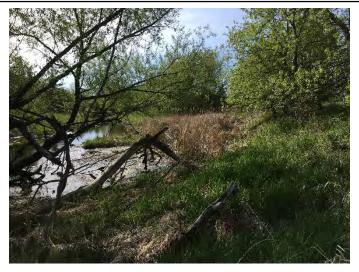
E – Edge of Shirley's Brook, looking southeast from middle of site

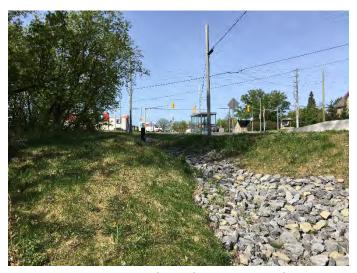
G – Drainage swale with rip rap, northern boundary of site along Klondike Road, looking southwest

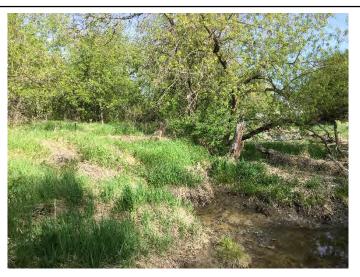
F – Edge of Shirley's Brook, looking northwest from middle of site

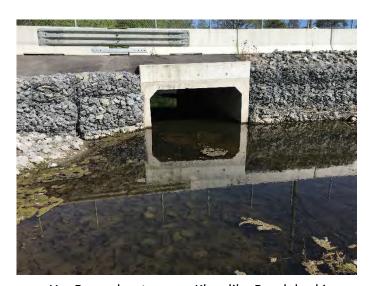
H – Box culvert across Klondike Road, looking northwest

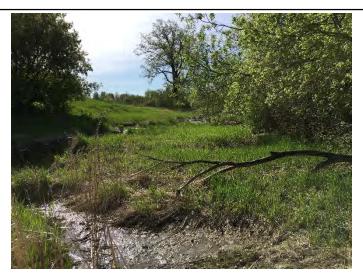
I – Shirley's Brook, looking southeast from northern boundary

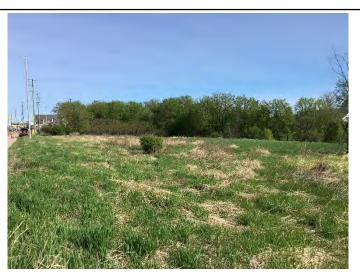
J – View of site, from southern boundary looking north

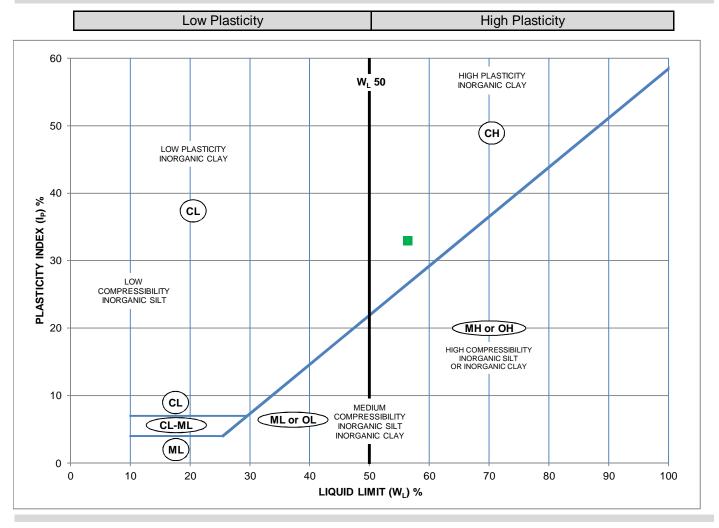
Hole No.: B18-01-3 Depth: 1.5 m to 2.1 m Lab Sample No: S-18-0560

Symbol	Borehole	Sample	Depth	Description
•	B18-01-3	-	1.5 m to 2.1 m	Clay and Silt

Liquid Limit (%)	Plastic Limit	Plasticity Index (%)
56.5	23.6	32.9

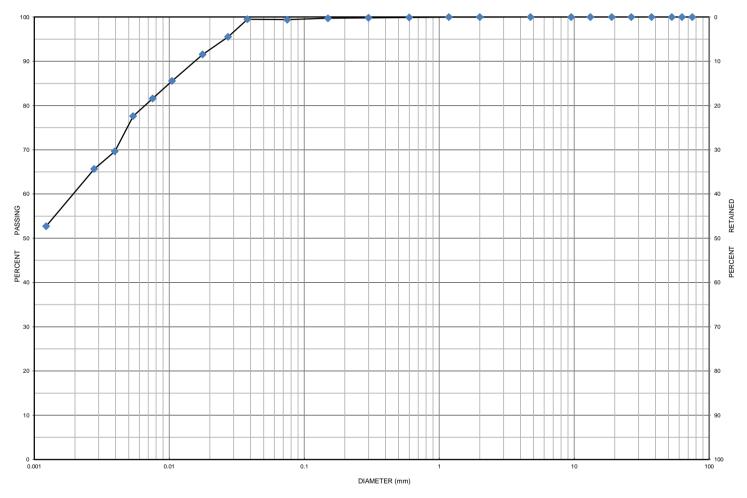
Location: BH18-01-3 **Depth:** 1.5 m to 2.1 m **Lab Sample No:** S-18-0560

Location	Depth		Gravel	Sa	nd	Silt	Clay	Moisture
BH18-01-3	1.5 m to 2.1 n	n	0	1		99		31.4
Description	Clas	sification	D ₆₀		D ₃₀	D ₁₀	Cu	C _c
Clay and Silt	C	H-MH	0.0019		-	-	-	-

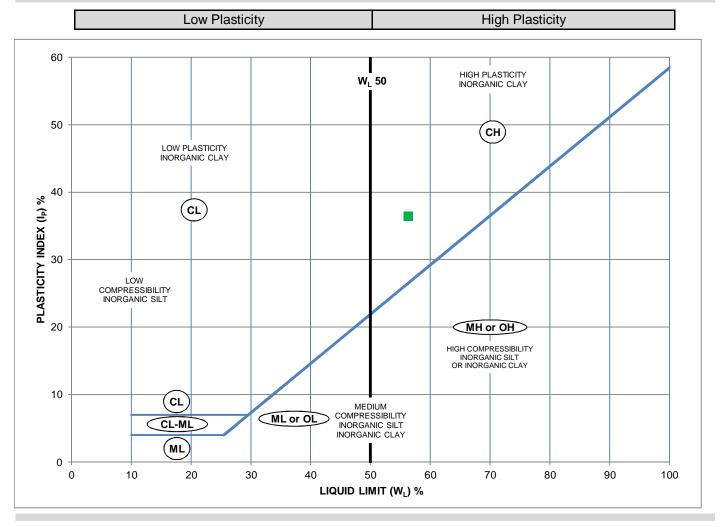
Hole No.: B18-03-7 Depth: 4.6 m to 5.2 m Lab Sample No: S-18-0561

Symbol	Borehole	Sample	Depth	Description
•	B18-03-7	-	4.6 m to 5.2 m	Clay and Silt

Liquid Limit (%)	Plastic Limit	Plasticity Index (%)
56.4	20.0	36.4

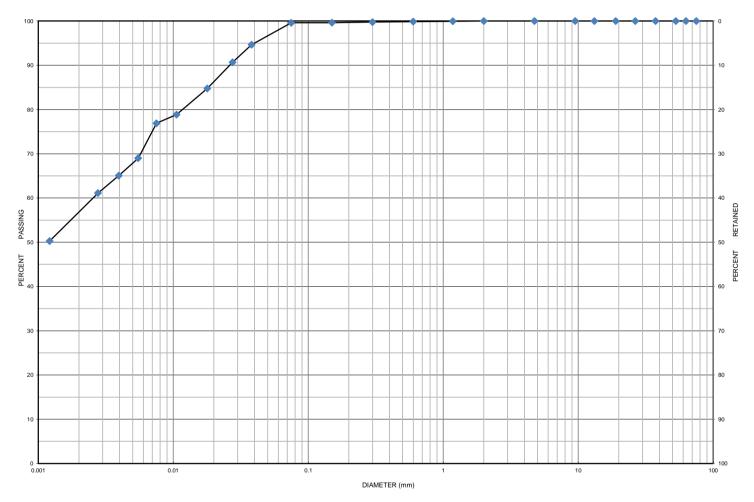
Location: BH18-03-7 **Depth:** 4.6 m to 5.2 m **Lab Sample No:** S-18-0561

Location		Depth		Gravel	;	Sand		Silt Clay		Moisture	
BH18-03-7	4.6	4.6 m to 5.2 m		0	0		100		47.6		
Description		Classification		D ₆₀		D ₃₀		D ₁₀		Cu	C _c
Clay and Silt	CH-MH 0.0027 -			=		-	-

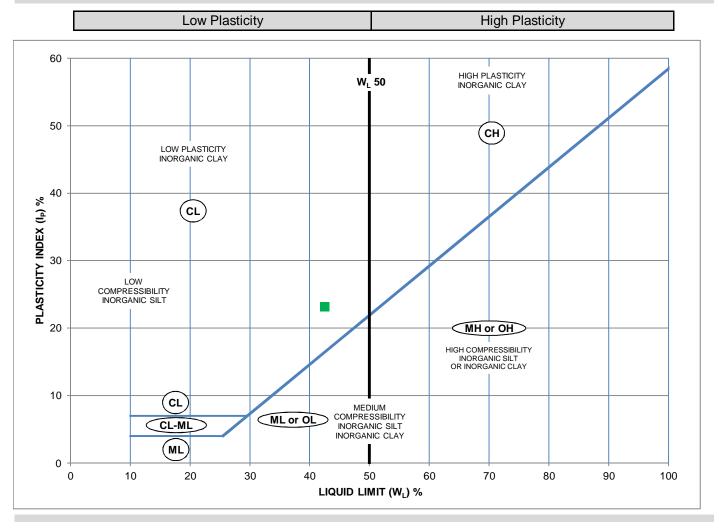
Hole No.: B18-04-8 Depth: 5.5 m to 5.9 m Lab Sample No: S-18-0562

Symbol	Borehole	Sample	Depth	Description
•	B18-04-8	-	5.5 m to 5.9 m	Clay and Silt

Liquid Limit (%)	Plastic Limit	Plasticity Index (%)
42.6	19.4	23.1

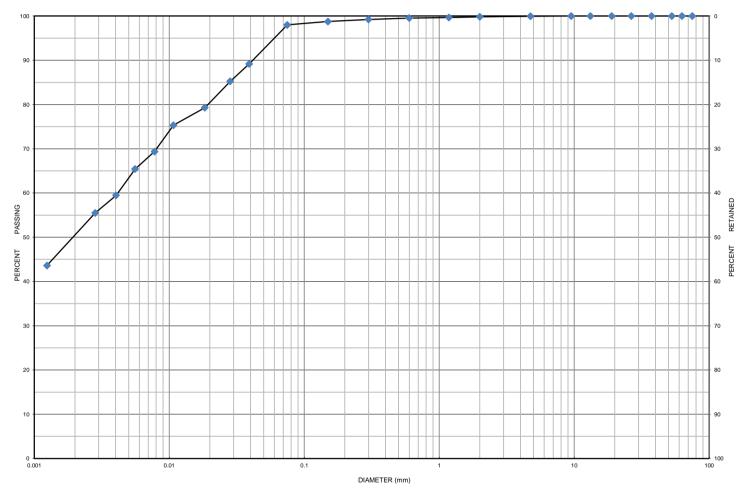
Location: BH18-04-8 **Depth:** 5.5 m to 5.9 m **Lab Sample No:** S-18-0562

Location	Depth	Gravel	Sand		Silt	Clay	Moisture
BH18-04-8	5.5 m to 5.9 m	0	2	2			46.8
Description	Classification	D ₆₀	ı	O ₃₀	D ₁₀	Cu	C _c
Clay and Silt	CL-ML	0.004	2	-	=	-	-

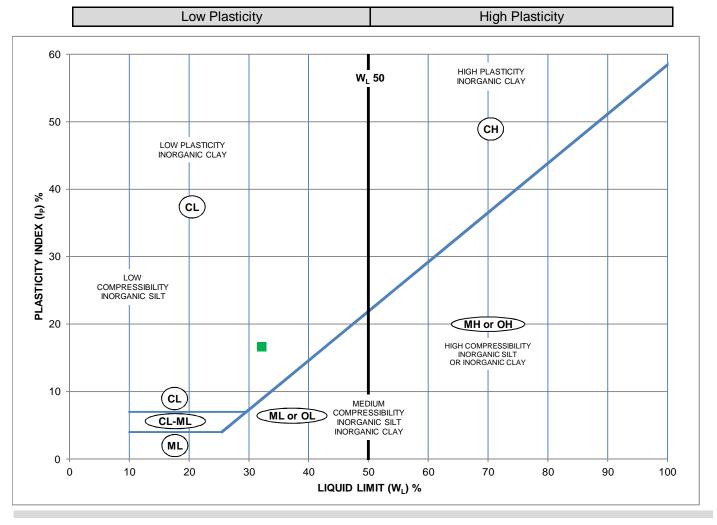
Hole No.: *BH18-05-8* **Depth**: **Lab Sample No**: *S-18-0563*

Symbol	Borehole	Sample	Depth	Description
•	BH18-05-8	-	-	Clayey Silt

Liquid Limit (%)	Plastic Limit	Plasticity Index (%)
32.2	15.6	16.6

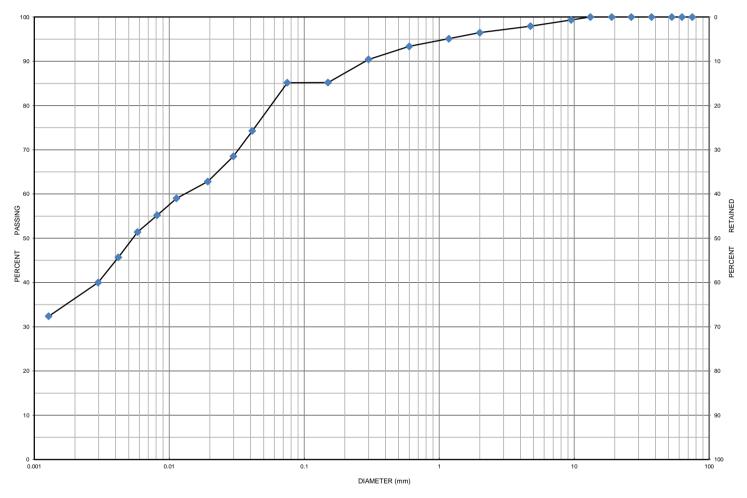
Location: BH18-05-8 **Depth:** 5.3 m to 5.9 m **Lab Sample No:** S-18-0563

Location		Depth	Gravel	;	Sand	Silt		Clay	Moisture
BH18-05-8		5.3 m to 5.9 m	2		13	85	5		30.6
Description		Classification	D ₆₀		D ₃₀	D ₁₀		Cu	C _c
Clayey Silt some Sand trace Gra	vel	ML	0.014		-	=		-	-

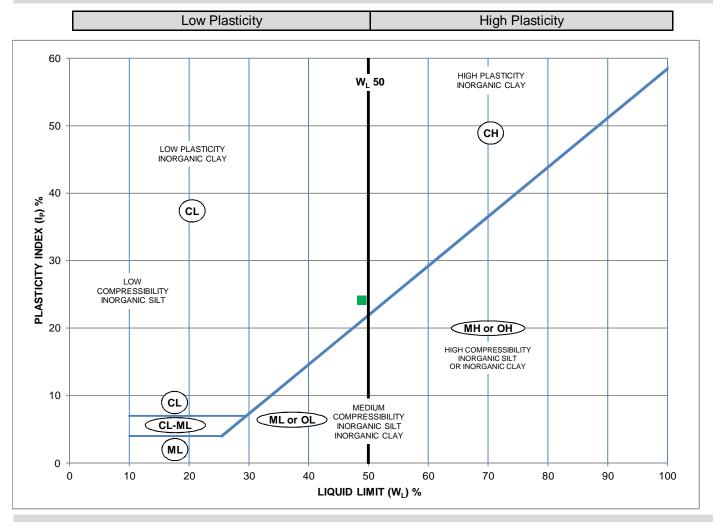
Hole No.: B18-08-5 Depth: 3 m to 3.7 m Lab Sample No: S-18-0564

Symbol	Borehole	Sample	Depth	Description
•	B18-08-5	-	3 m to 3.7 m	Clay and Silt

Liquid Limit (%)	Plastic Limit	Plasticity Index (%)
48.9	24.9	24.1

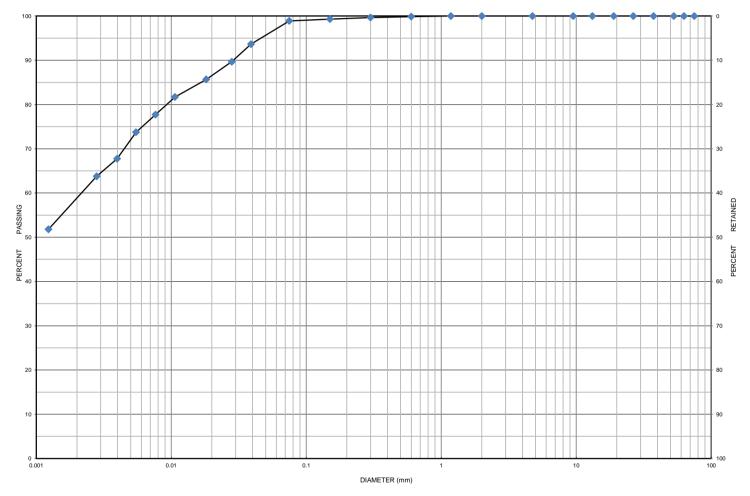
Location: BH18-08-5 **Depth:** 3 m to 3.7 m **Lab Sample No:** S-18-0564

Location	Depth	Gravel	Sand	Silt	Clay	Moisture
BH18-08-5	3 m to 3.7 m	0	1	9	9	44.6
Description	Classification	D ₆₀	D ₃	D ₁₀	Cu	C _c
Clay and Silt	CL-ML	0.0022		-	-	-

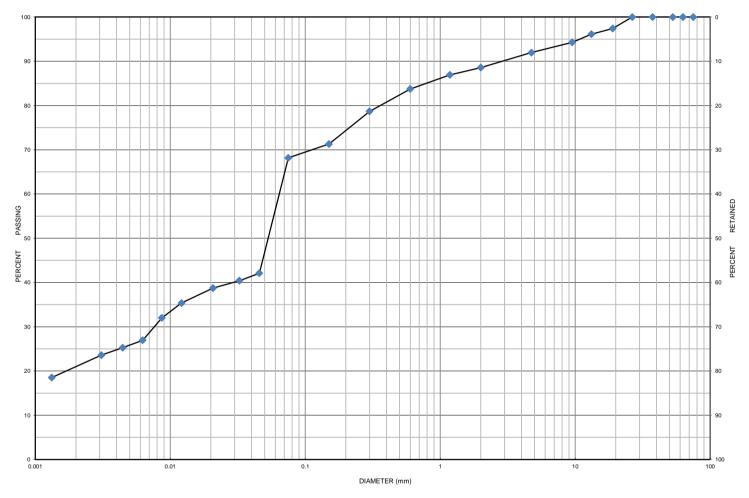
Location: BH18-08-7 **Depth:** 4.7 m to 5.3 m **Lab Sample No:** S-18-0565

Location	Sample No.		Depth		Gravel		Sand		Silt		Clay	Moisture
BH18-08-7		4	4.7 m to 5.3 m	8			24		68			22.2
	Description Classification				D ₆₀		D ₃₀		D ₁₀		Cu	C _c
Clayey Sandy Silt trace Gravel ML				0.064		0.007	7	-		-	-

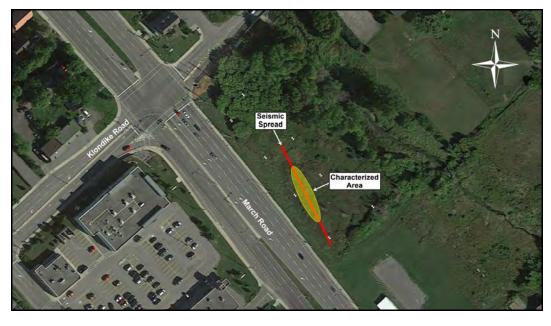
Figure 2: Location of the seismic spread (source: Google Earth™)

The surveys were carried out, on June 8th, by Mr. Alexis Marchand and Mrs. Chloé Gingras, trainee. Figure 1 shows the regional location of the site and Figure 2 illustrates the location of the seismic spreads. Both figures are presented in the Appendix.

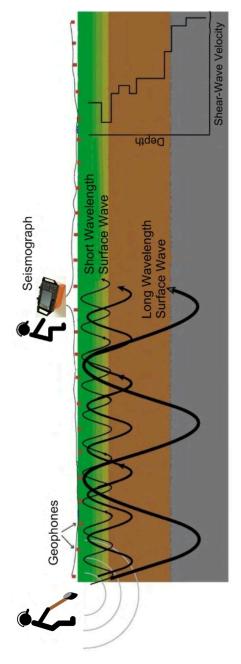
Figure 3: MASW Operating Principle

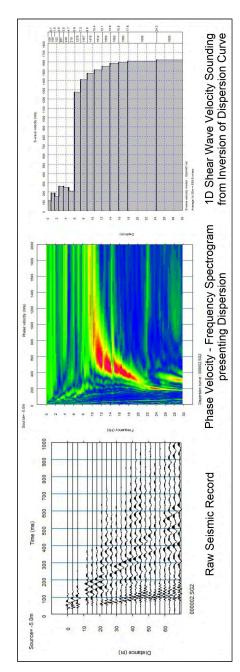
Figure 4: Example of a MASW/ESPAC record, Phase Velocity - Frequency curve and resulting 1D Shear Wave Velocity Model

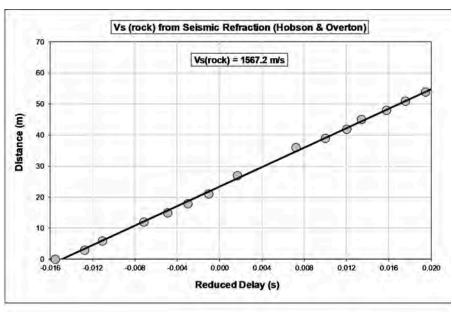
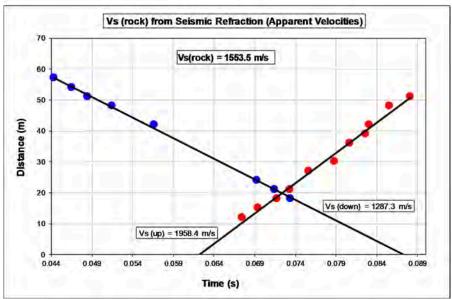
Figure 5: Rock V_S from Seismic Refraction

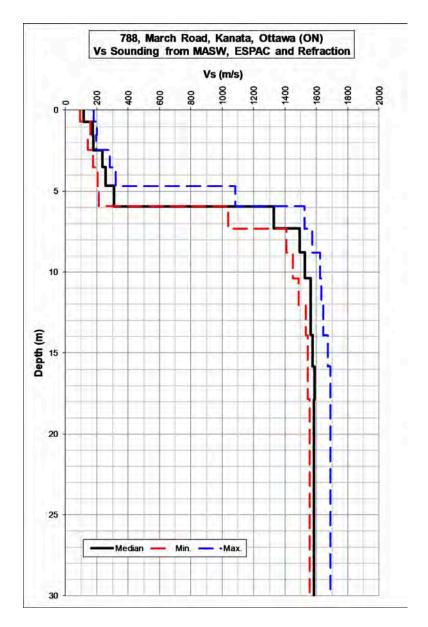
Figure 6: MASW Shear-Wave Velocities Sounding

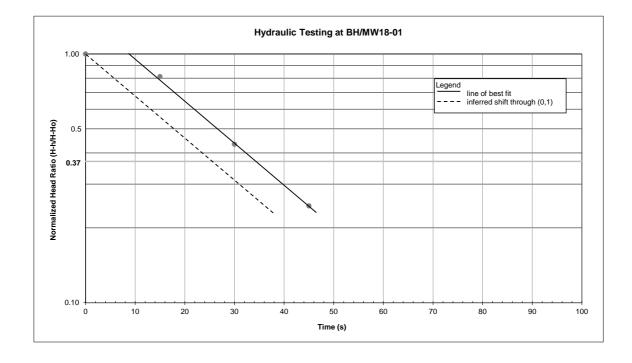
$$K = \frac{r_c^2 \ln \left(\frac{L}{R}\right)}{2 L T_o}$$

K =	1.4E-05	m/s	
R (borehole rad	dius)	0.05	m
L (interval length	th)	3.60	m
$r_{\text{\tiny C}}$ (radius of we	II casing)	0.025	m
T_{O} (T = 63% re	covery)	26	s

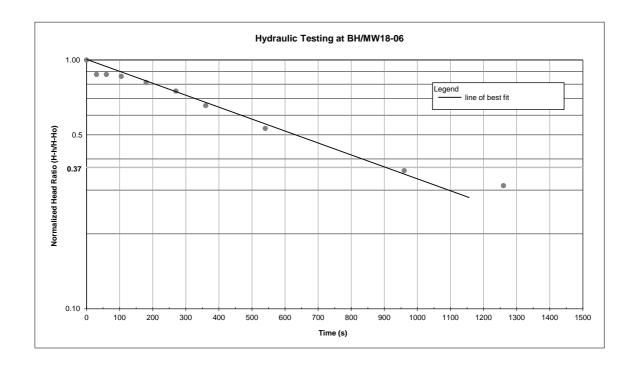
BH/MW18-06

$$K = \frac{r_c^2 \ln \left(\frac{L}{R}\right)}{2 L T_o}$$

K = 3.7E-07	m/s
R (borehole radius)	0.10 m
L (interval length)	3.30 m
r _c (radius of well casing)	0.025 m
T_O (T = 63% recovery)	900 s
