# SEPTIC IMPACT ASSESSMENT (REV.2) 5646-5650 MANOTICK MAIN STREET

Project No.: CCO-22-2383

Hawkins Properties  
650a Eagleson Road  
Ottawa, ON

McIntosh Perry Consulting Engineers Ltd.  
115 Walgreen Road  
Carp, ON K0A 1L0

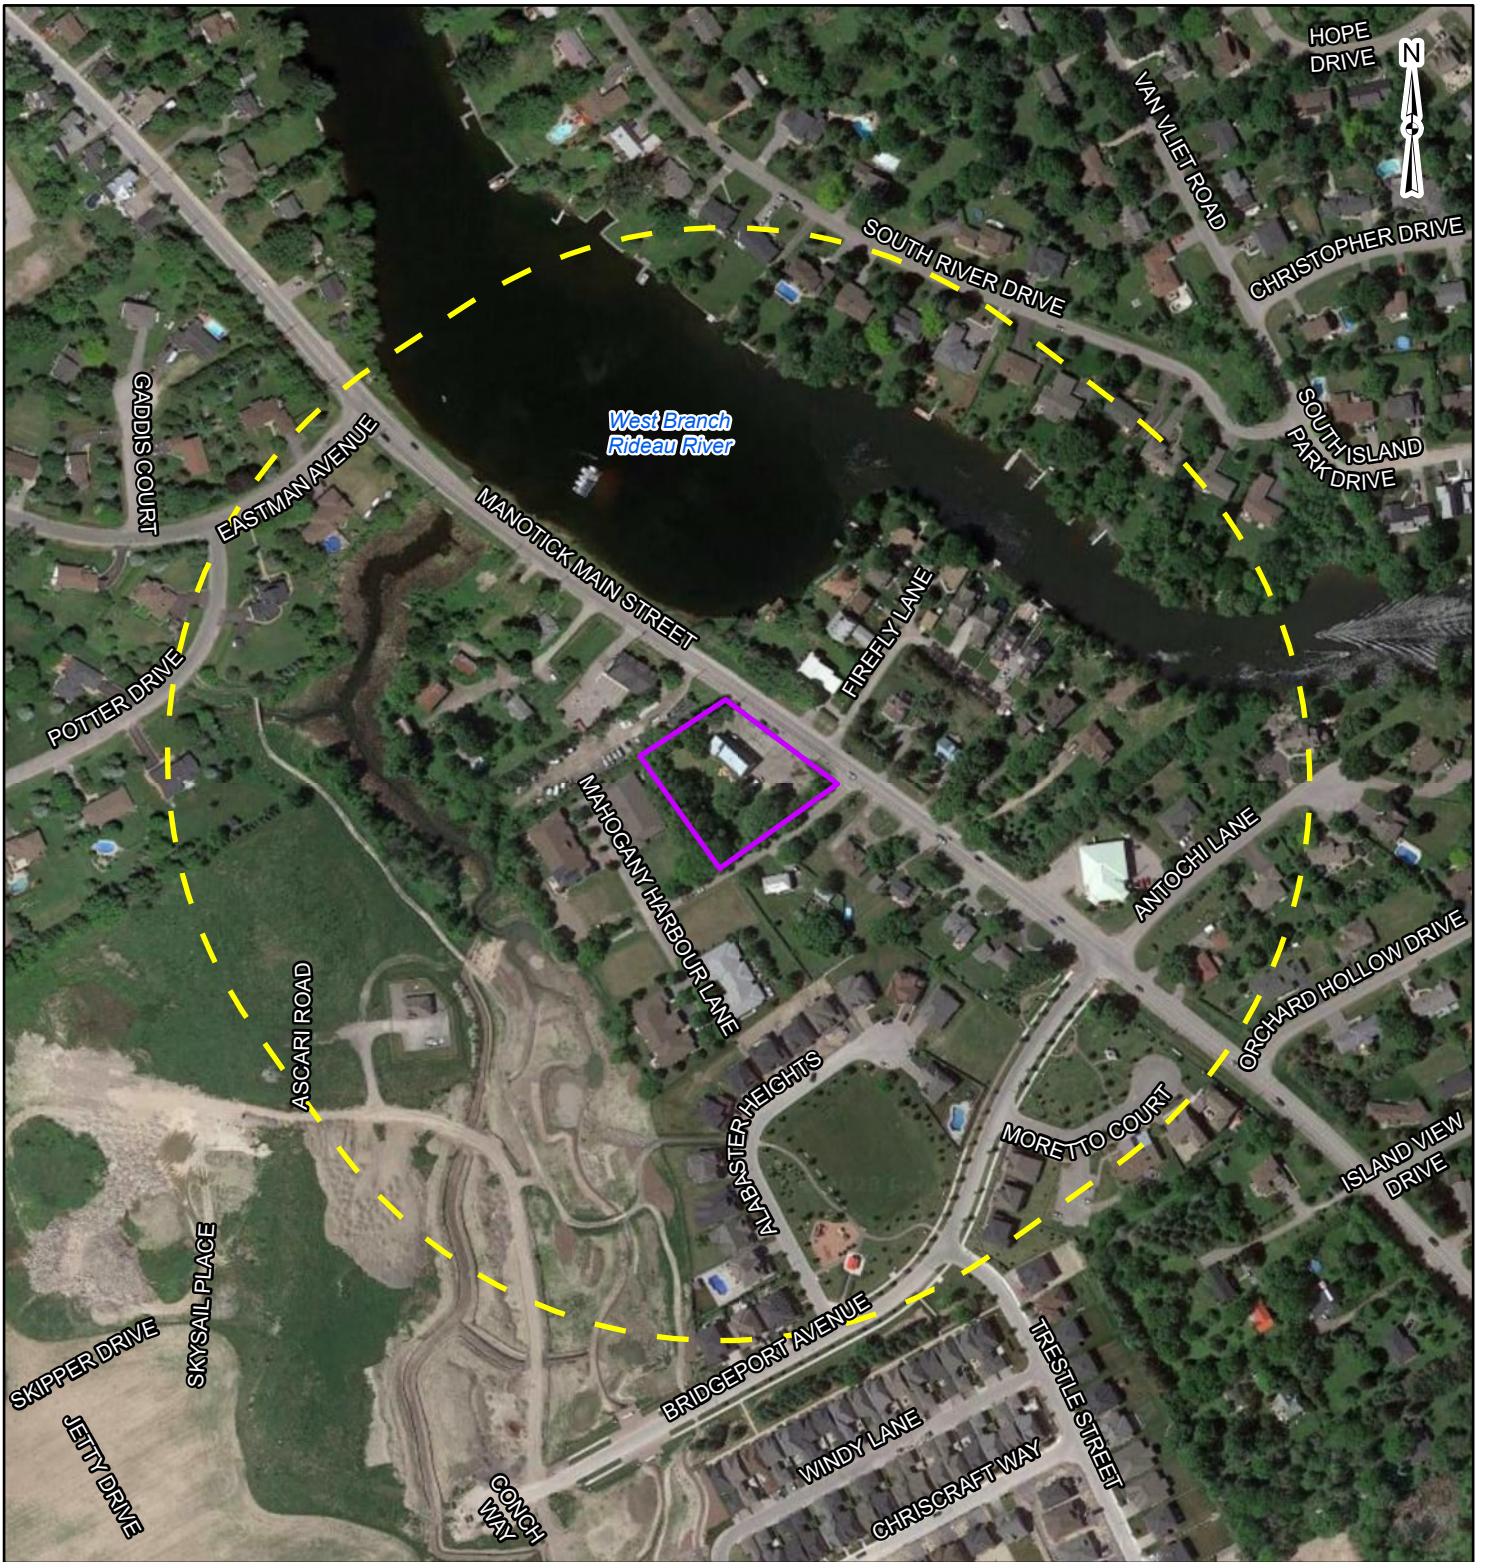
- Site Boundary
- 250m Buffer

CLIENT:	HAWKINS PROPERTIES		
PROJECT:	SEPTIC IMPACT ASSESSMENT 5646-5650 MANOTICK MAIN STREET		
TITLE:	STUDY AREA AND SURROUNDING LAND USE		
<b>McINTOSH PERRY</b> <small>115 Walgreen Road, RR3, Carp, ON K0A1L0          Tel: 613-836-2184 Fax: 613-836-3742          www.mcintoshperry.com</small>	PROJECT NO:	CCO-22-2383	FIGURE:
	Date	Jun., 14, 2023	<b>2</b>
	GIS	AH	
	Checked By	KC

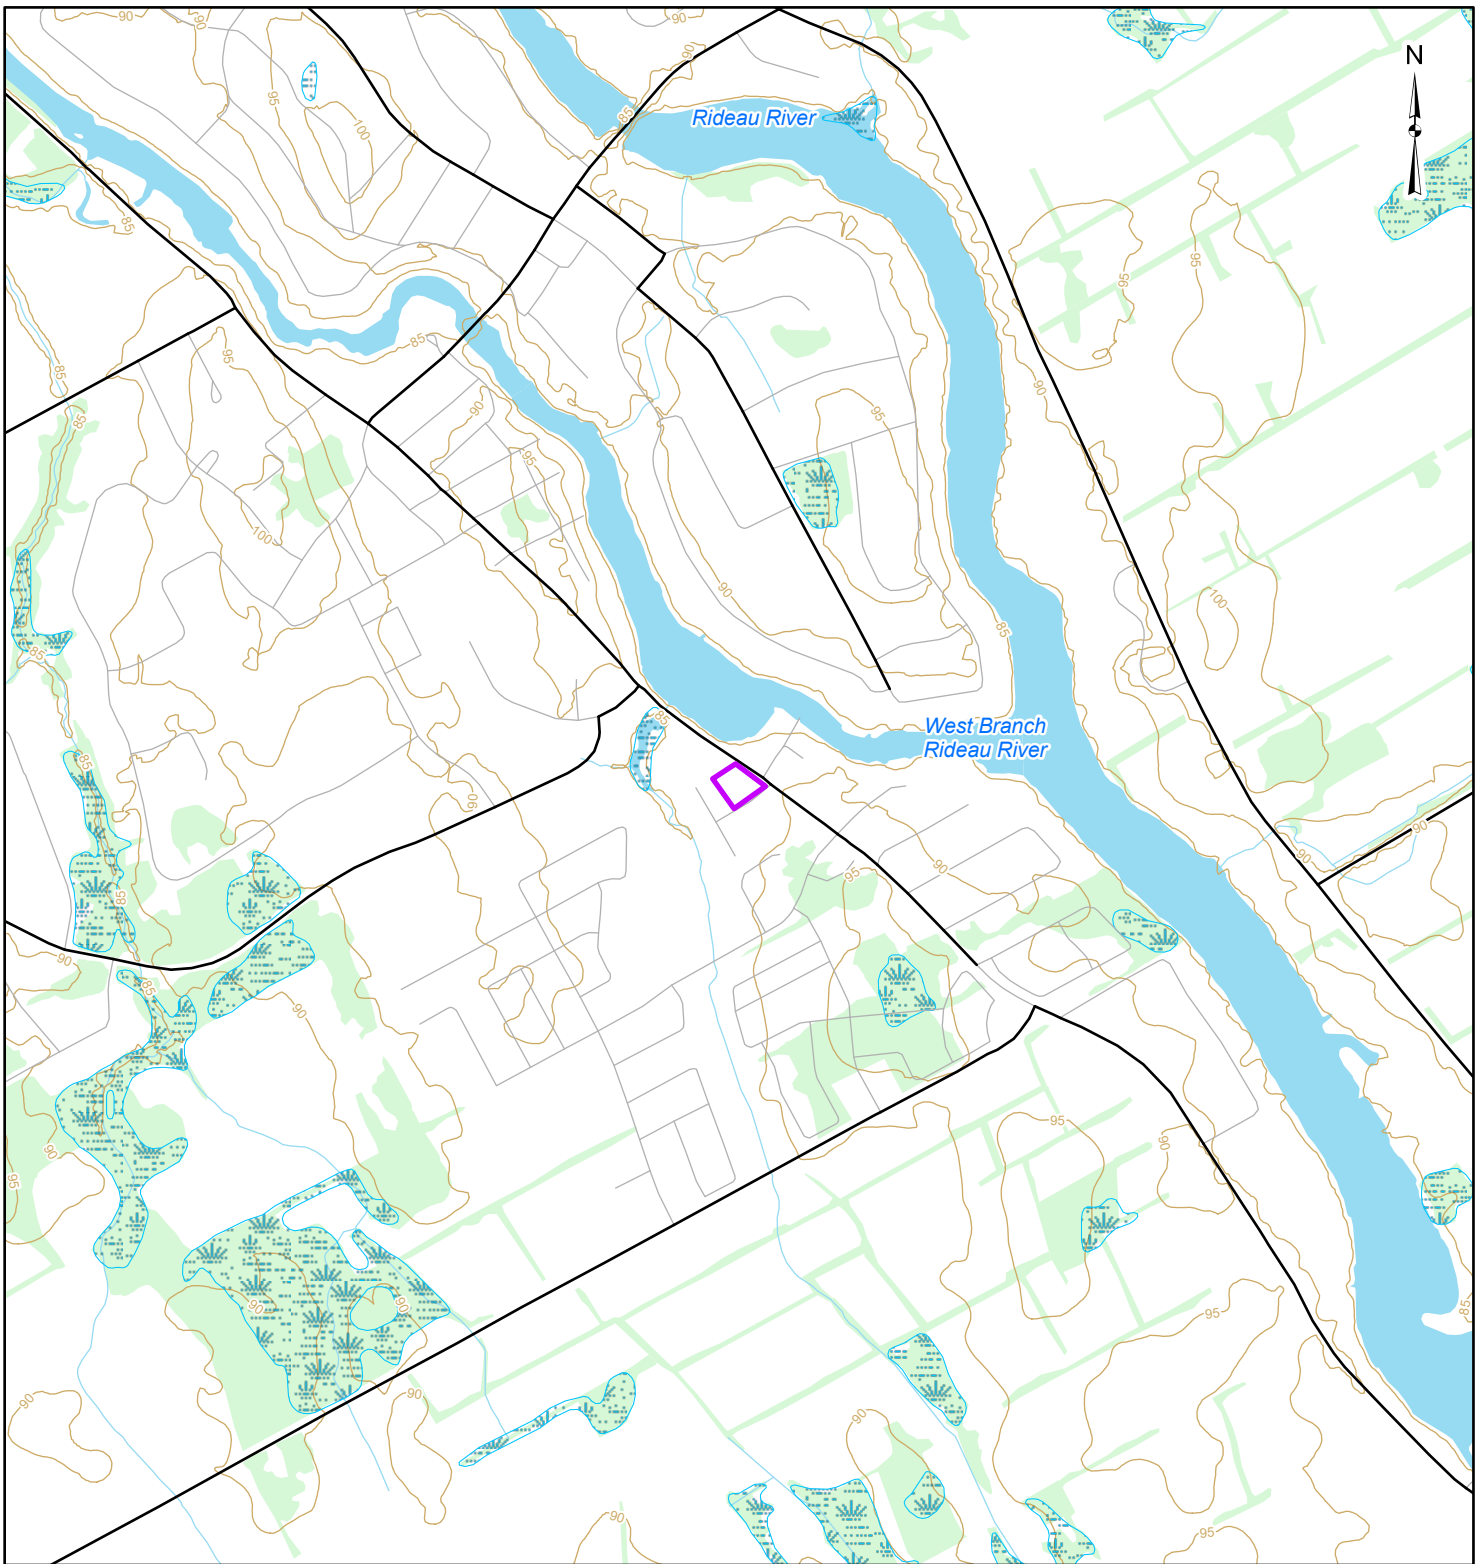
- Site Boundary
- Contour (masl)
- Local Road
- Major Road
- Watercourse
- Waterbody
- Unevaluated Wetland
- Wooded Area

<b>CLIENT:</b>	<b>HAWKINS PROPERTIES</b>		
<b>PROJECT:</b>	<b>SEPTIC IMPACT ASSESSMENT</b>		
	<b>5646-5650 MANOTICK MAIN STREET</b>		
<b>TITLE:</b>	<b>DRAINAGE AND TOPOGRAPHY</b>		
	<b>PROJECT NO:</b> CCO-22-2383	<b>FIGURE:</b>	<b>3</b>
Date	Jun., 14, 2023		
GIS	AH		
Checked By	KC

The Site occurs within the Rideau Falls – Rideau River watershed. The closest water body to the Site is the Mahogany Harbour, part of the West Branch Rideau River, located approximately 40 metres (m) north, at its closest point. On-site infiltration of water is interpreted to occur in areas of permeable ground surface. Surface drainage at the Site appears to be largely controlled by sheet flow runoff to the northeast ditches/stormwater catchbasins along Manotick Main Street with a small part of the southwestern edge of the Site currently draining to the southwest along the tree line.

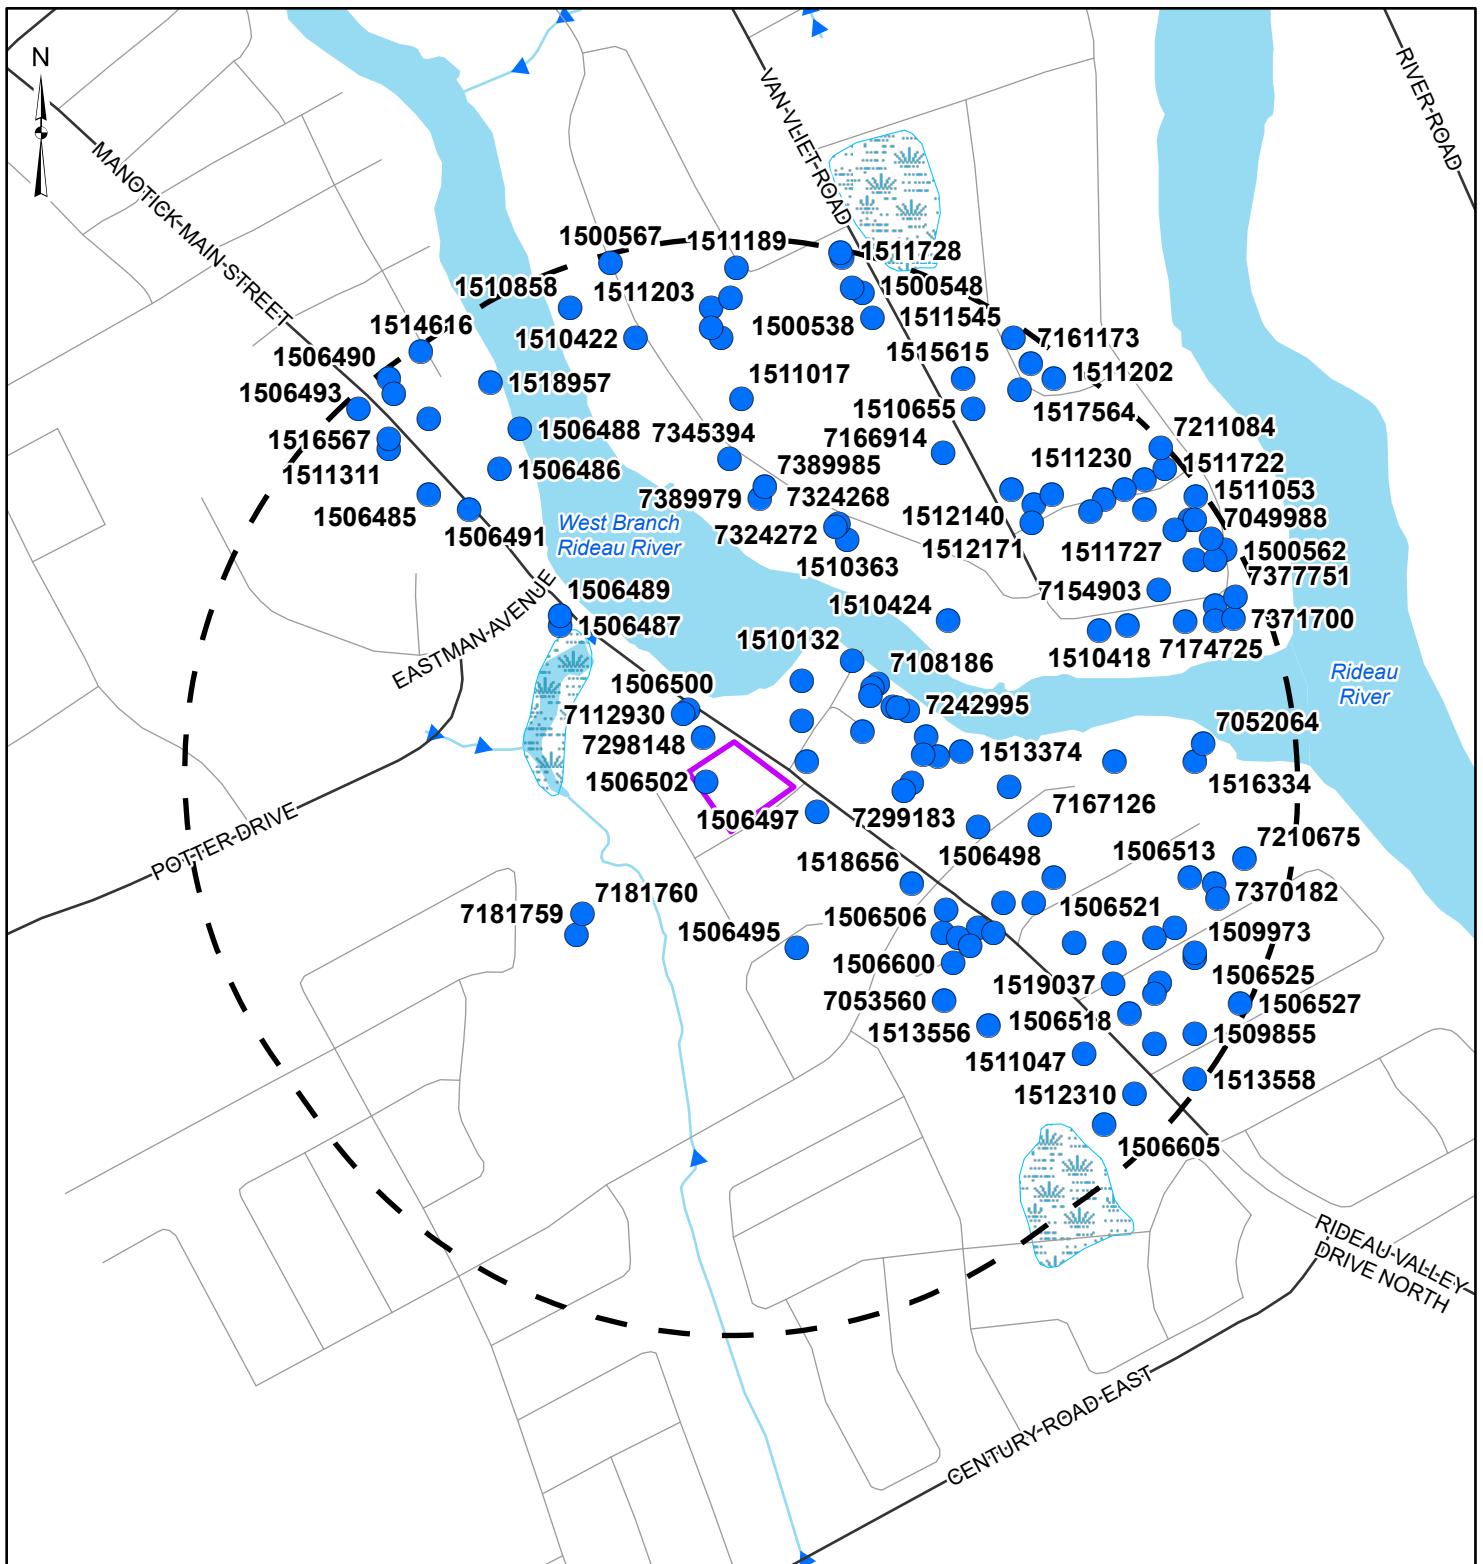
- MECP Well Location \
- Site Boundary
- 500m Buffer
- Local Road
- Major Road
- ~ Watercourse
- Waterbody
- Unevaluated Wetland

CLIENT:		<b>HAWKINS PROPERTIES</b>	
PROJECT:		<b>SEPTIC IMPACT ASSESSMENT 5646-5650 MANOTICK MAIN STREET</b>	
TITLE:		<b>MECP WELL RECORD SUMMARY</b>	
PROJECT NO: CCO-22-2383		FIGURE:	
Date	Jun., 14, 2023	<b>4</b>	
GIS	AH		
Checked By	KC

MP conducted a review of MECP WWIS records within 500 m of the Site. Out the of the 131 wells found within the study area, one (1) was listed as commercial, two (2) were listed as livestock, two (2) were listed as test holes/monitoring, 11 were undefined, and 115 were listed for domestic water supply usage and shown in Figure 4. The MECP Water Well Information System Records are summarized in Table 2-1 below.

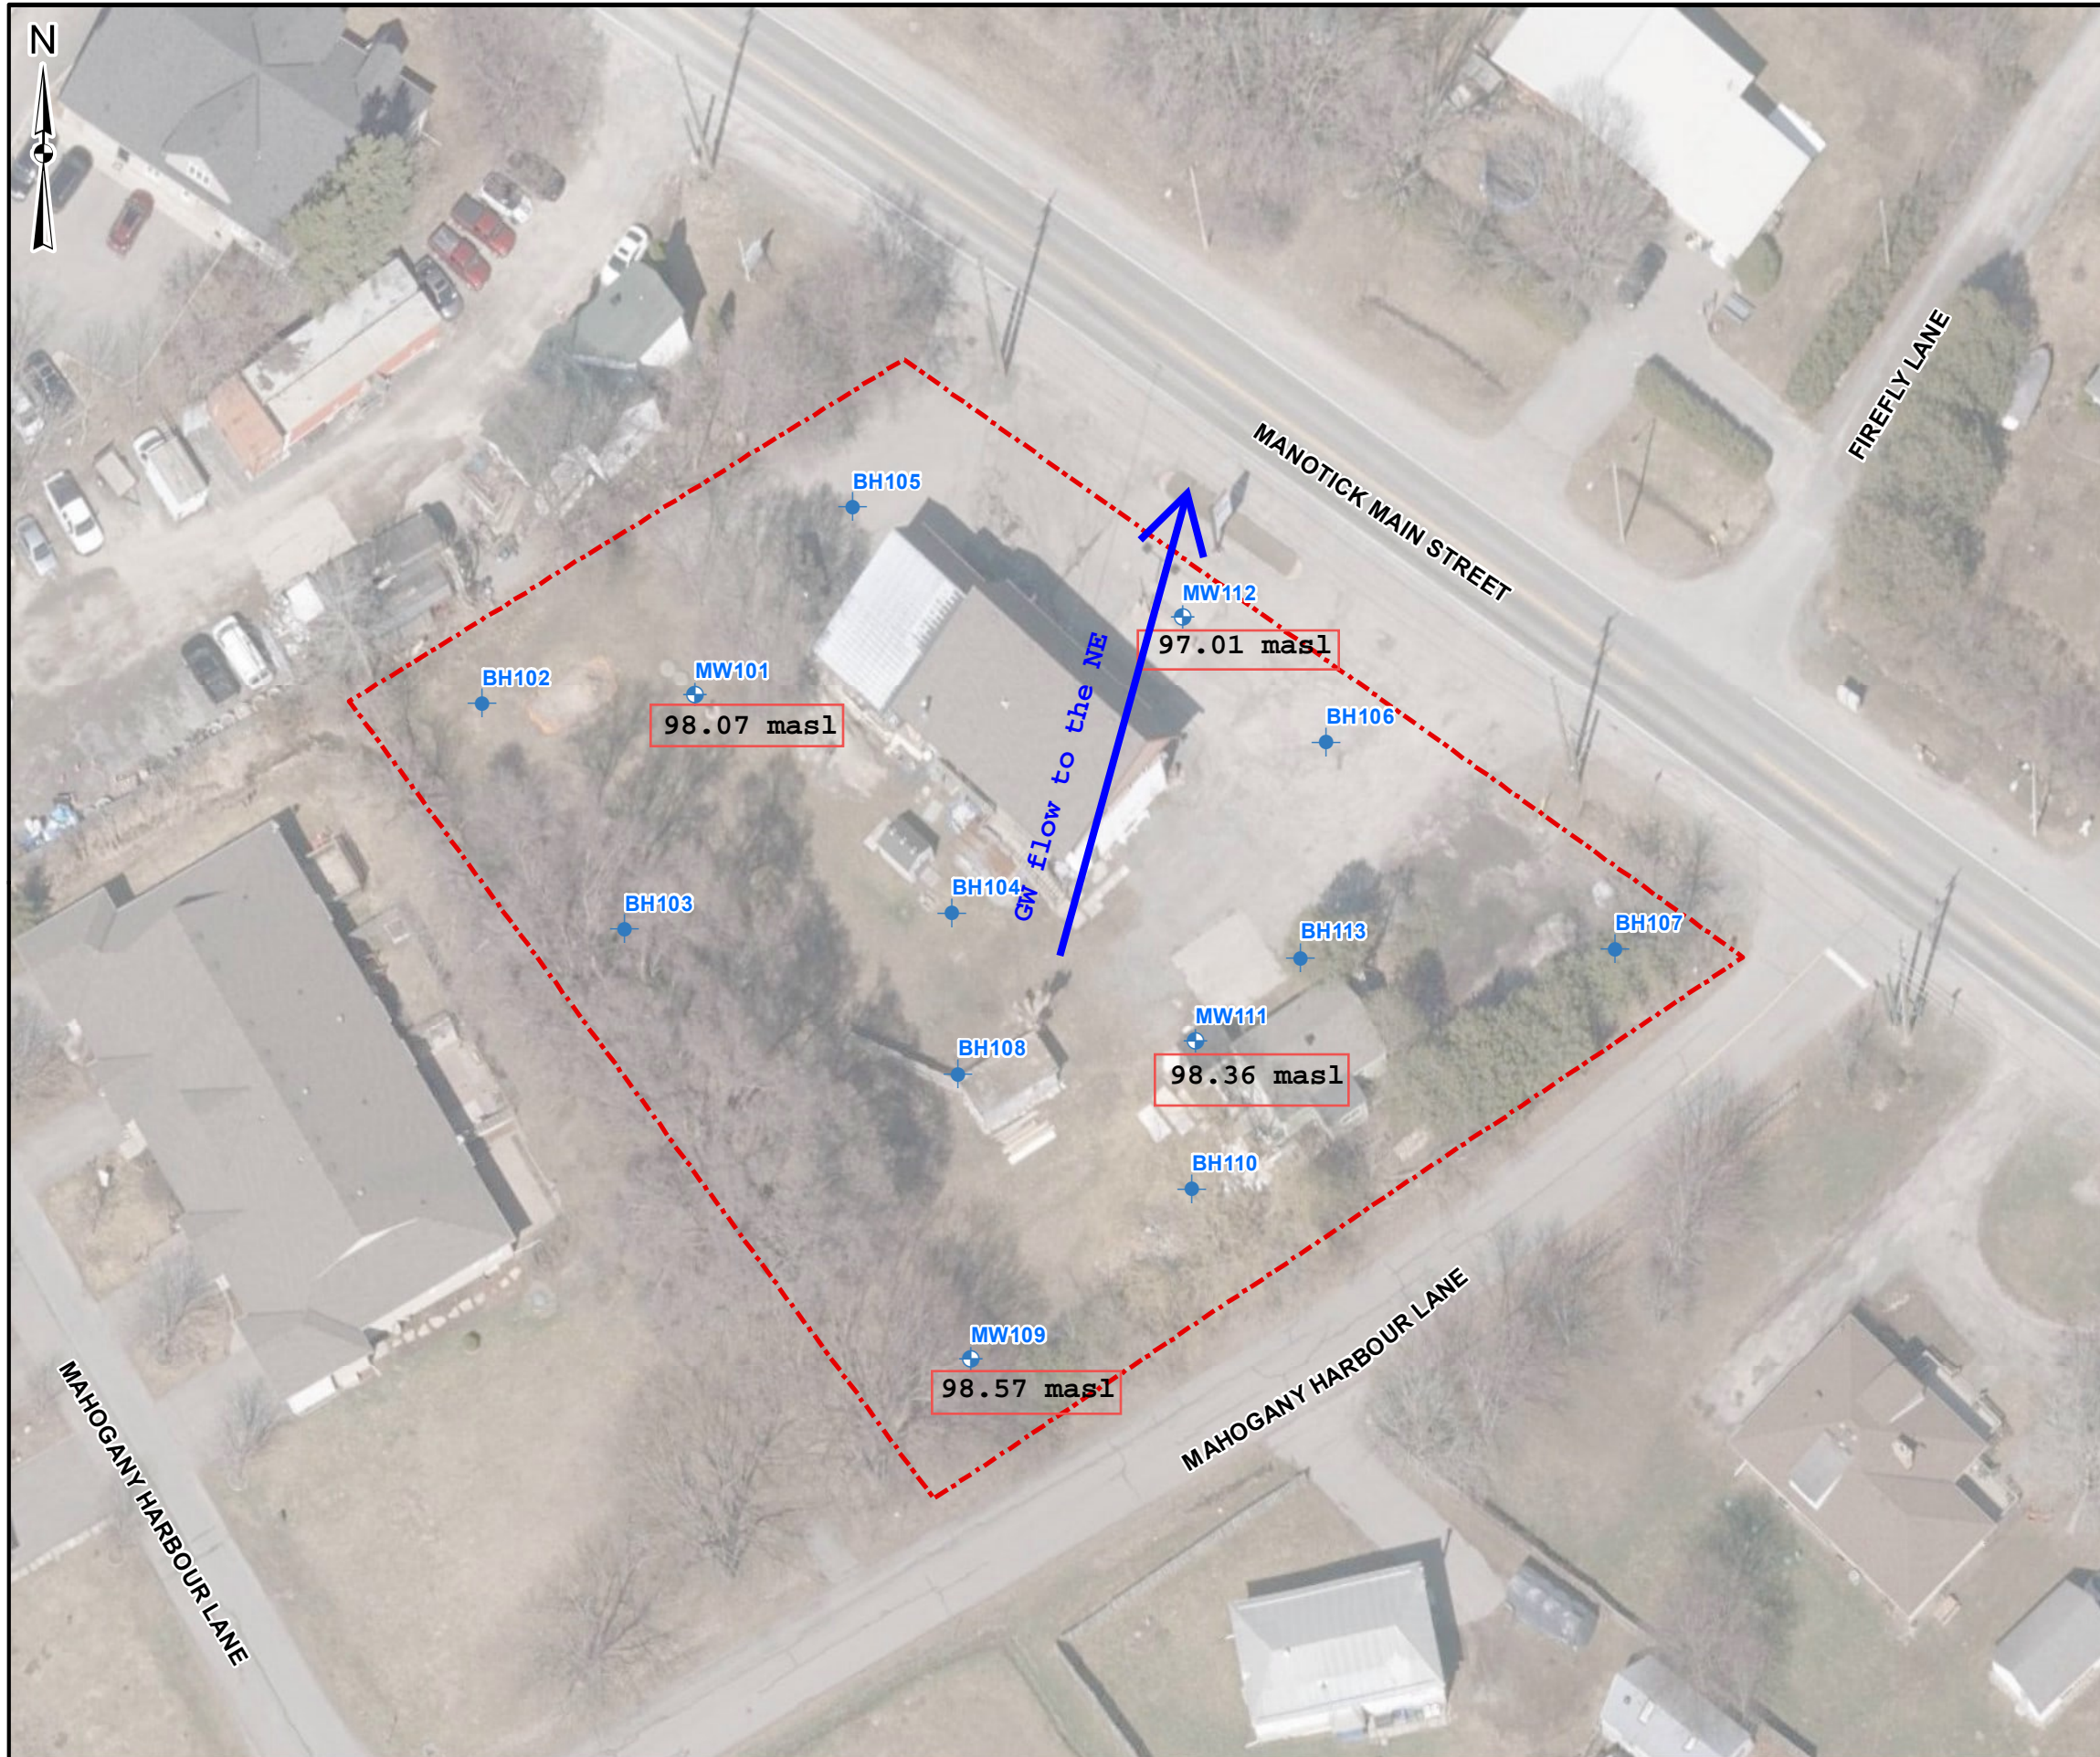
**LEGEND**  
 [Red dashed line] PROPERTY BOUNDARY  
 [Blue dot with crosshair] BOREHOLE  
 [Blue circle with crosshair] MONITORING WELL

**NOTE:** Figure edited from Geotechnical Investigation Report completed by Terrapex Environmental Ltd., December 2022

As part of a geotechnical investigation conducted by Terrapex, boreholes were advanced via drilling at various locations throughout the Site to assess its geology and subsurface conditions, including properties of the on-site overburden. In total, 13 boreholes were advanced.

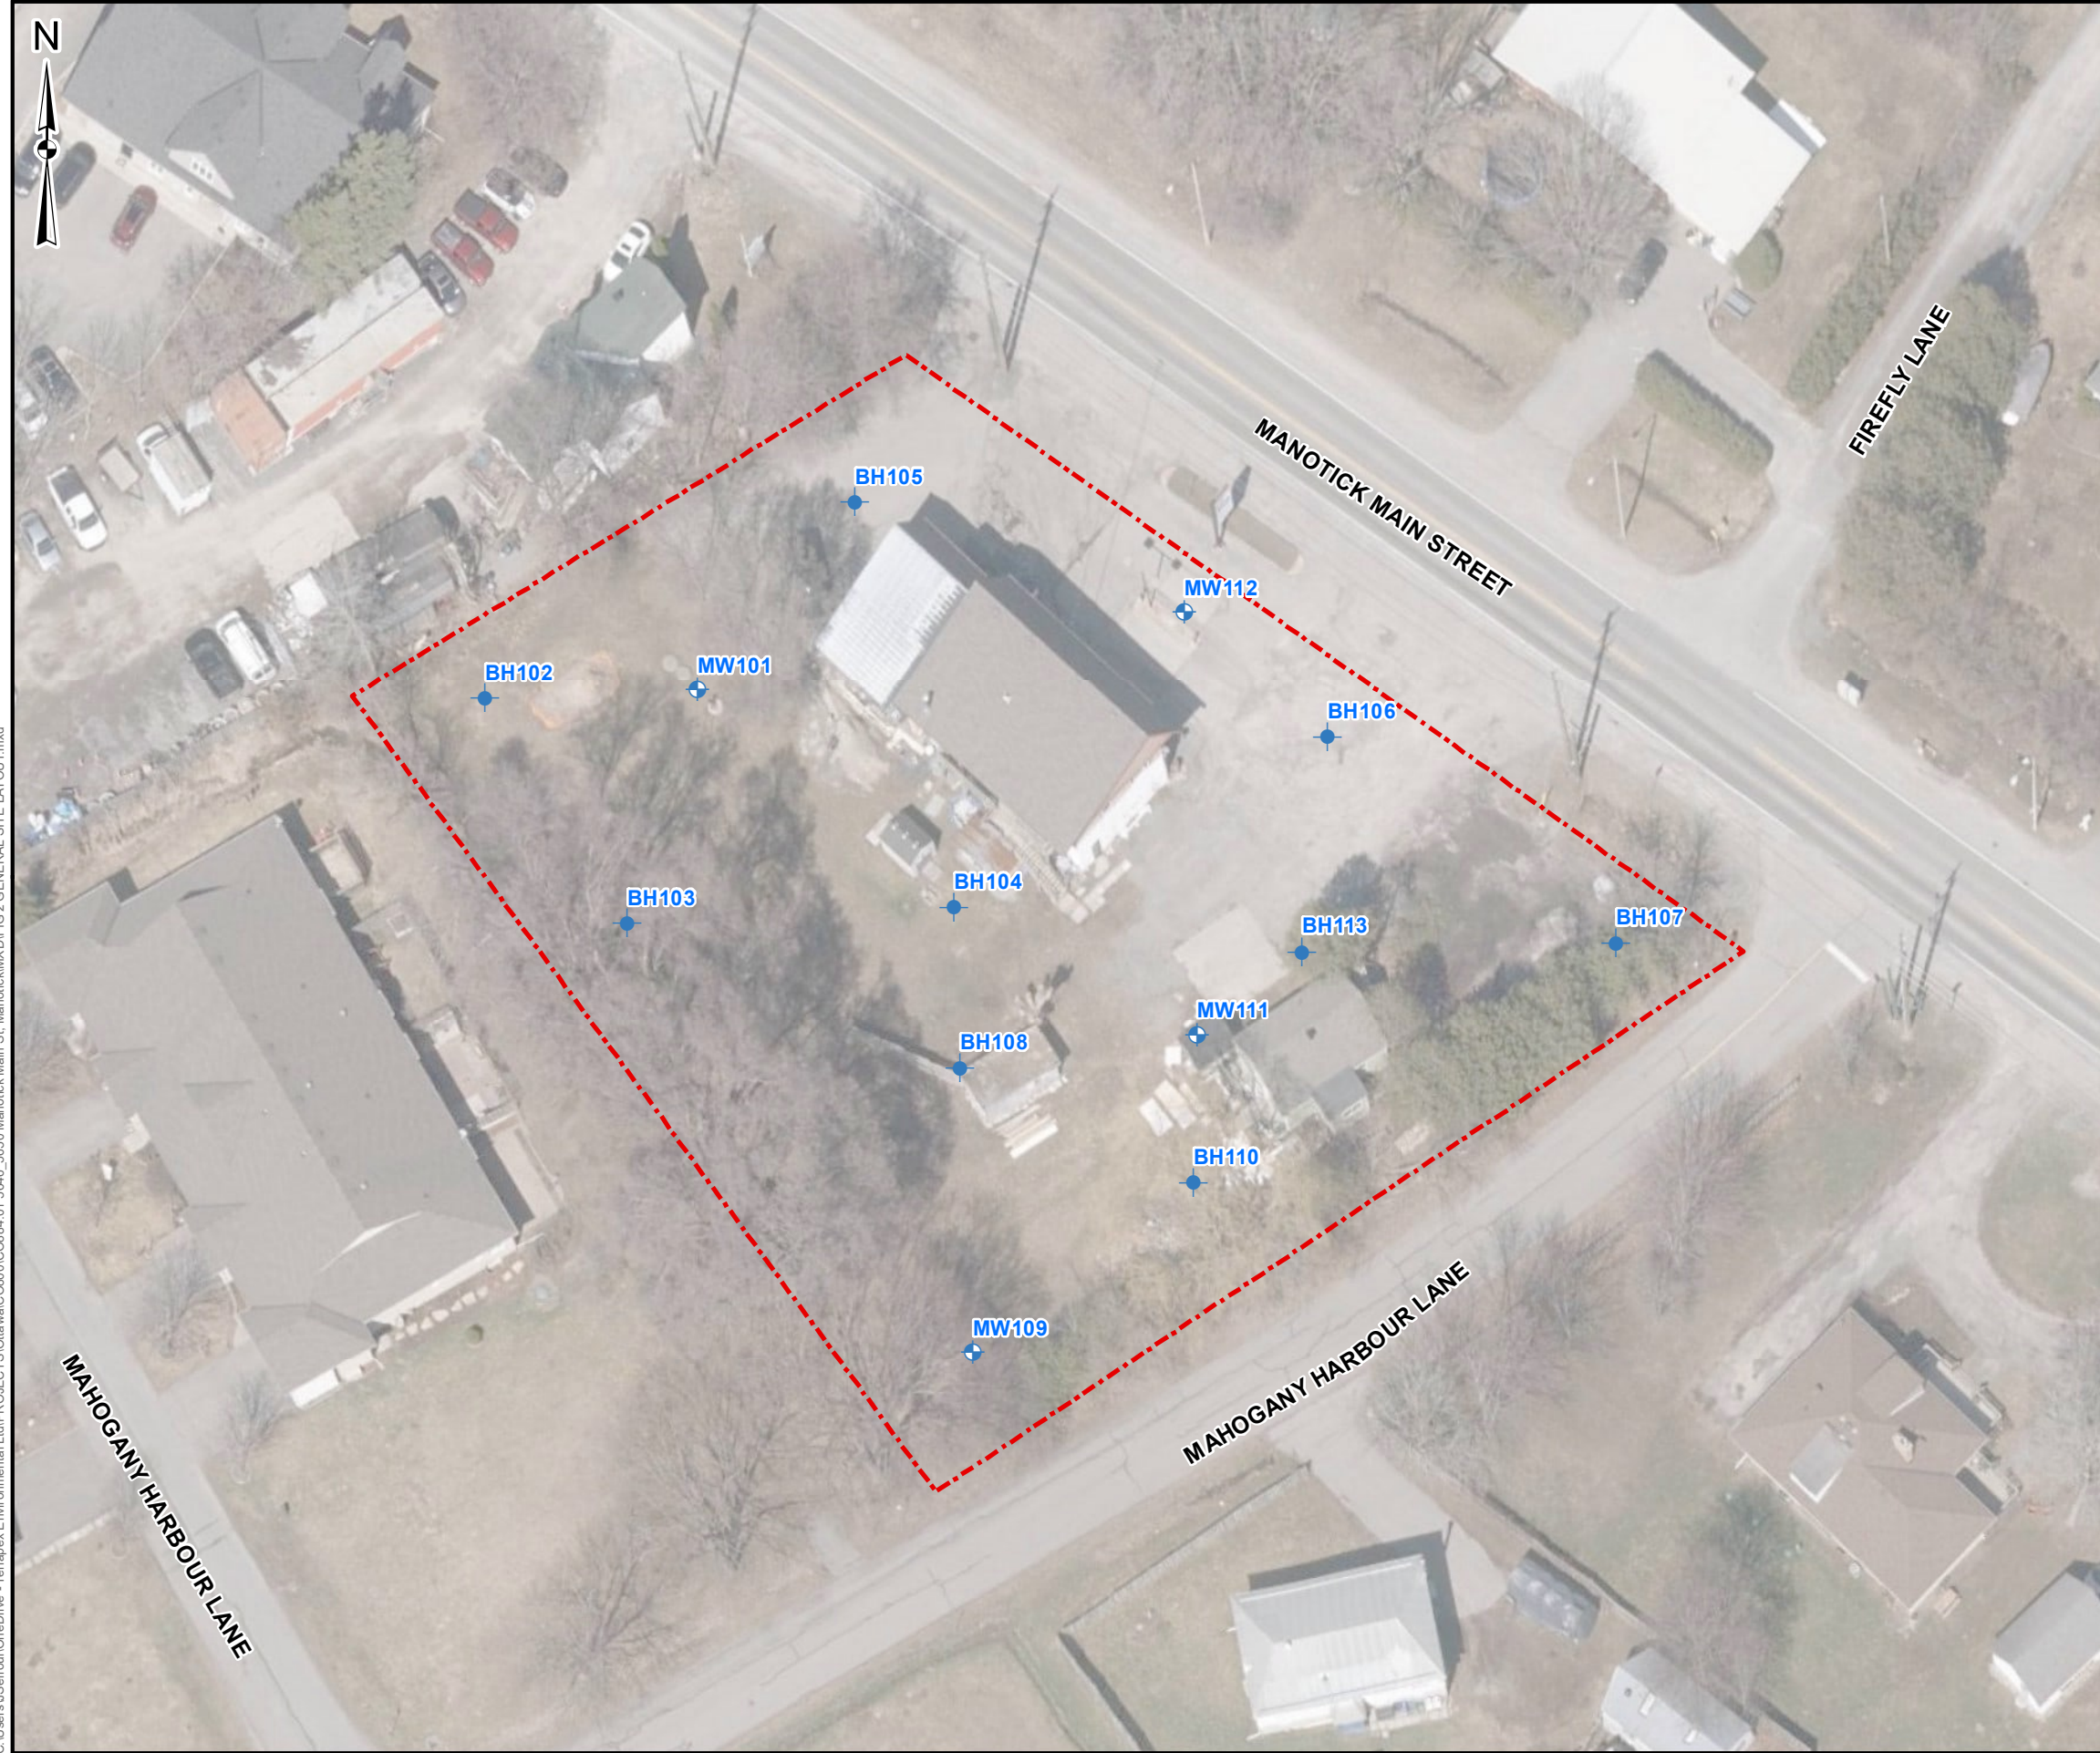
C:\Users\JSerrouil\OneDrive - Terrapex Environmental Ltd\PROJECTS\Ottawa\CO884.01\_5646\_5650 Manotick Main St, Manotick\MXD\FIG 2 GENERAL SITE LAYOUT.mxd

The locations of the boreholes are shown on Figure 2 in Appendix B. The borehole log sheets are enclosed in Appendix C of this report.

We understand that it is proposed to demolish the existing buildings at the Site and redevelop the Site with two single storey drive through restaurant buildings located at the northwest and southwest corners of the Site with the remainder of the Site being developed with driveways, parking lots and other soft and hard landscaping features. The locations of the proposed buildings are shown on Figure 2, in Appendix B of this report.

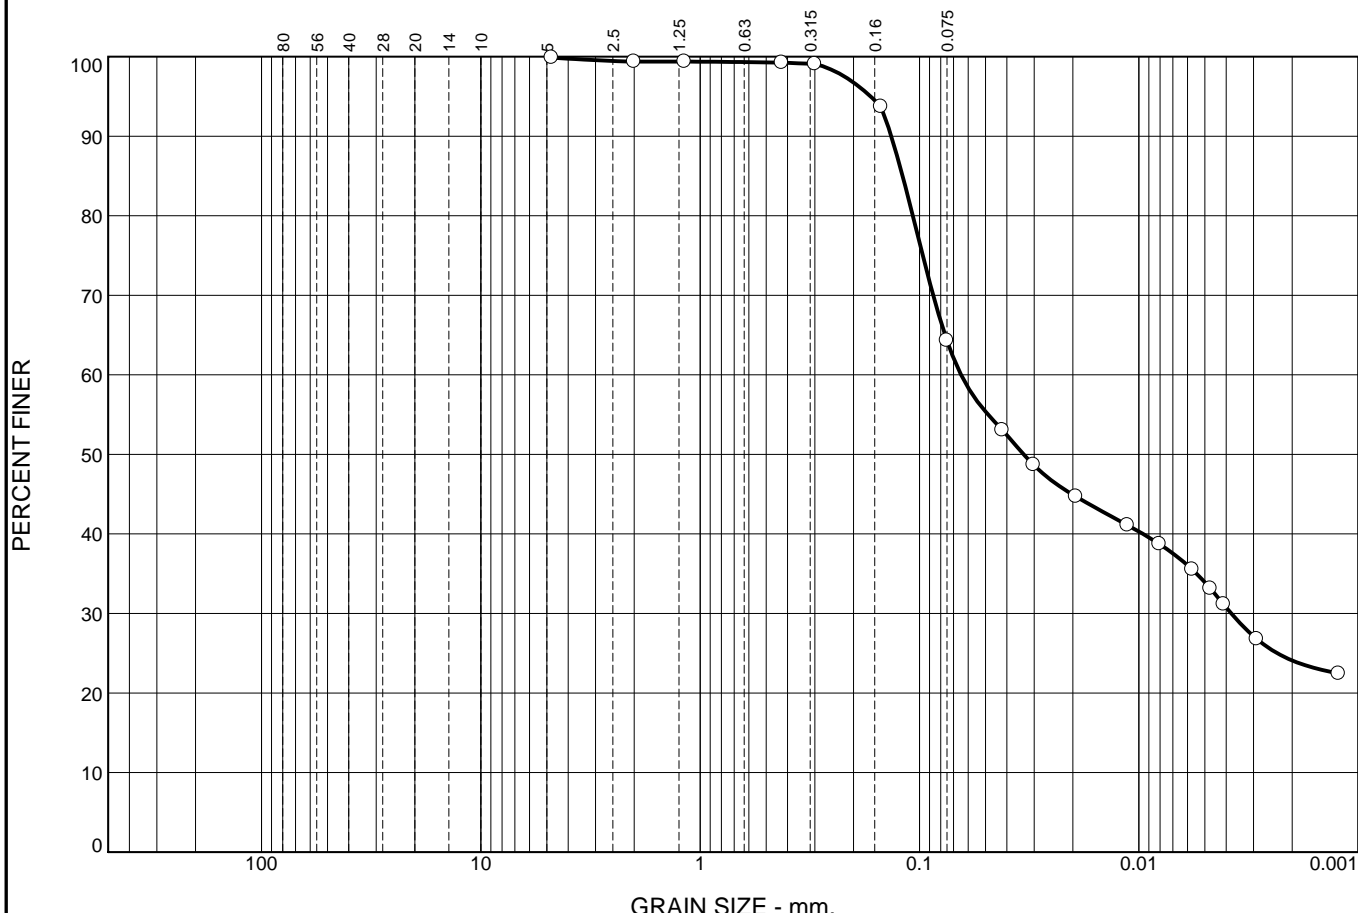
Figure 1

% +75mm	% Gravel		% Sand		% Fines	
				Coarse	Fine	Silt	Clay
<input type="radio"/>				0.2	34.9	40.2	24.1

LL	PL	D85	D60	D50	D30	D15	D10	Cc	Cu
<input checked="" type="checkbox"/>	51	19	0.1194	0.0646	0.0335	0.0038

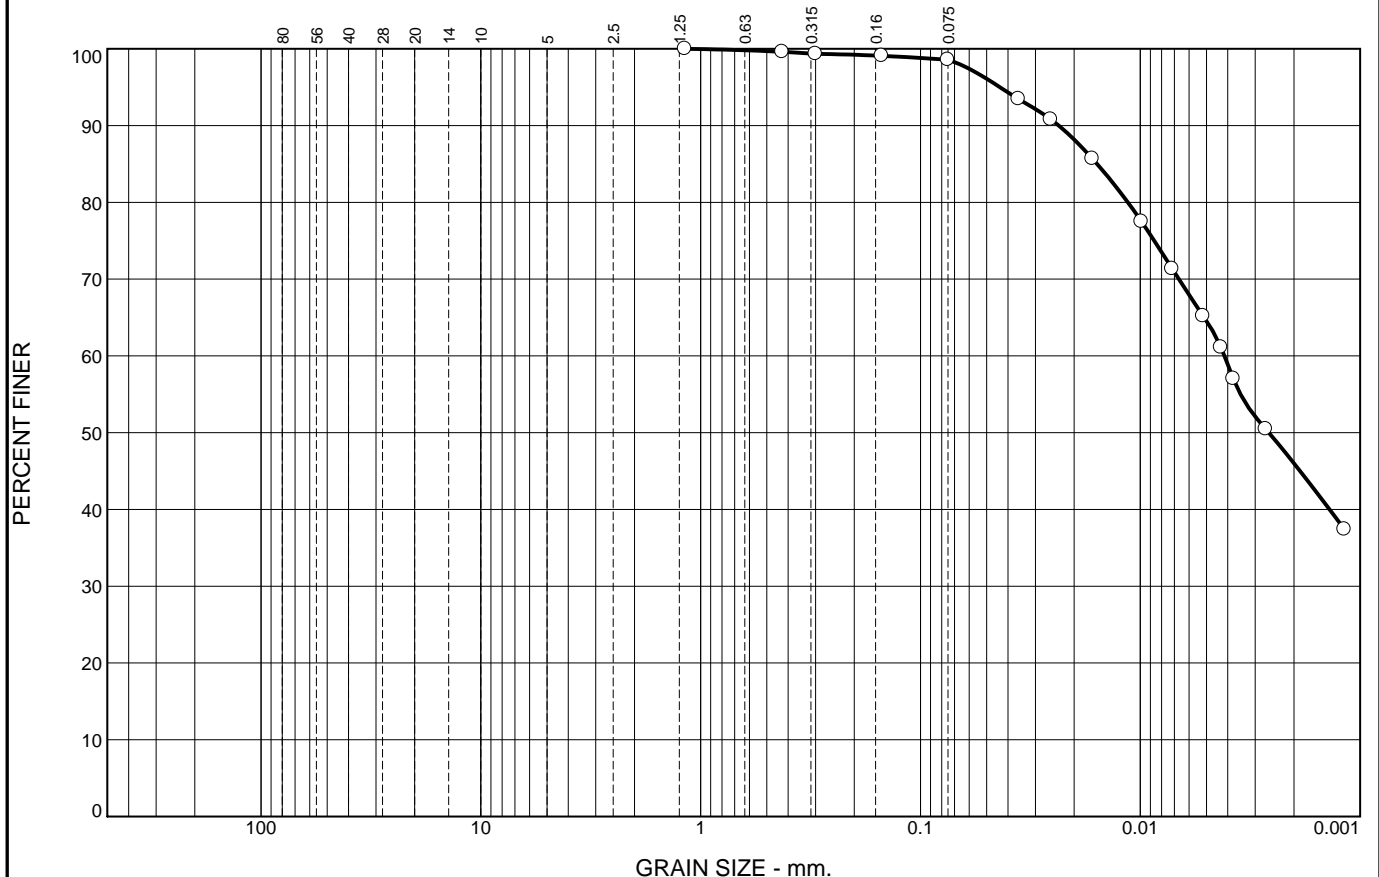
% +75mm	% Gravel	% Sand		% Fines	
			Coarse	Fine	Silt	Clay
○	0.0	0.0	0.4	1.0	52.6	46.0

⊗	LL	PL	D <sub>85</sub>	D <sub>60</sub>	D <sub>50</sub>	D <sub>30</sub>	D <sub>15</sub>	D <sub>10</sub>	C <sub>c</sub>	C <sub>u</sub>
○	39	18	0.0157	0.0041	0.0026

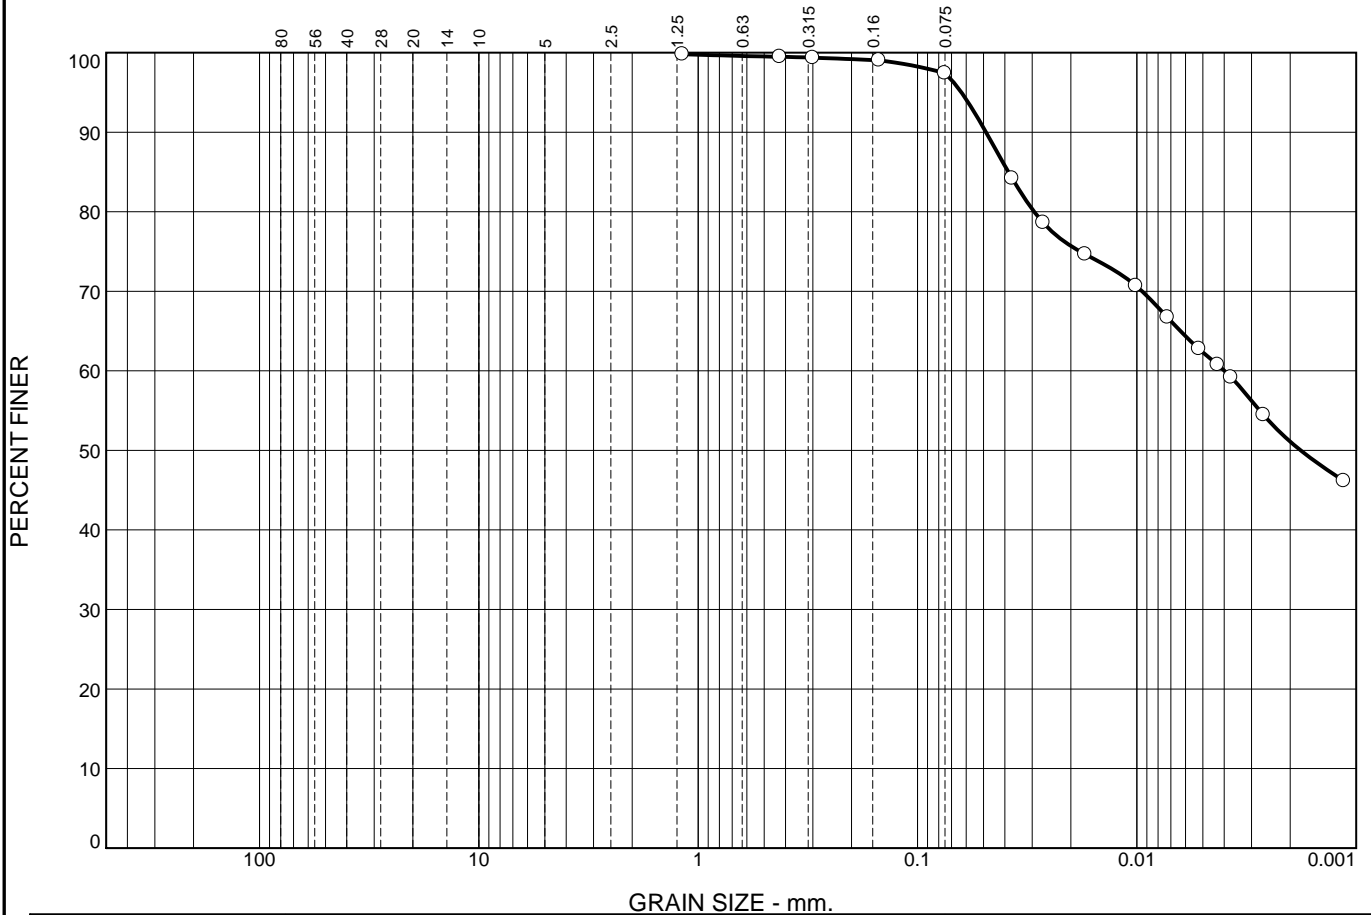
Figure 3

% +75mm	% Gravel		% Sand		% Fines				
		Coarse	Fine	Silt	Clay					
<input type="radio"/>				2.1	46.3	51.1				
<input checked="" type="checkbox"/>	LL	PL	D85	D60	D50	D30	D15	D10	Cc	Cu
<input type="radio"/>	31	11	0.0385	0.0040	0.0018

Material Description	USCS	AASHTO
<input type="radio"/> CLAY AND SILT, trace sand

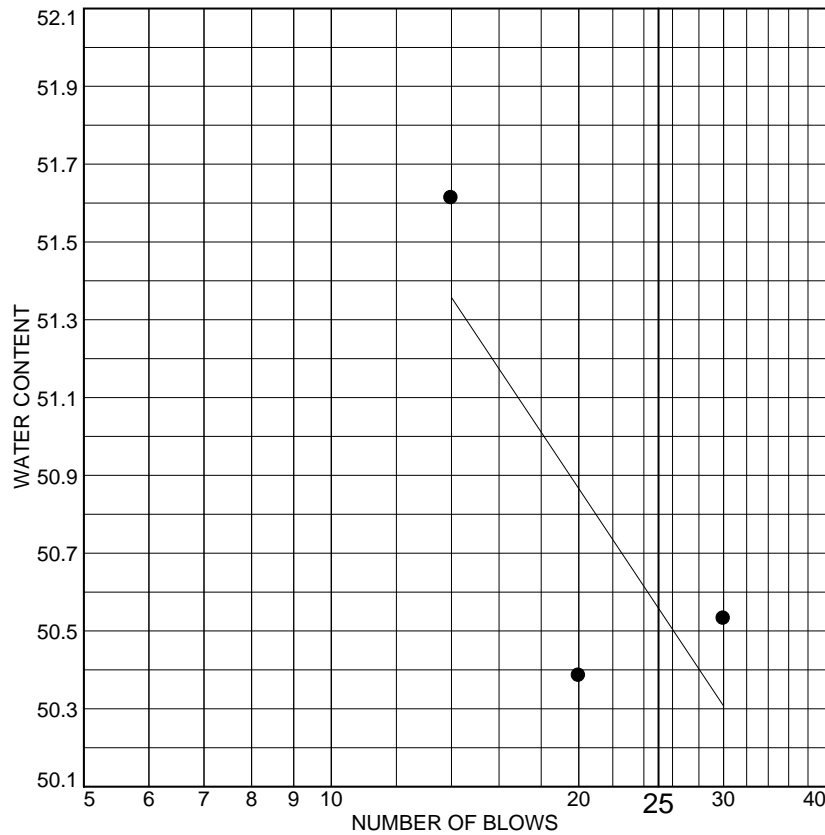
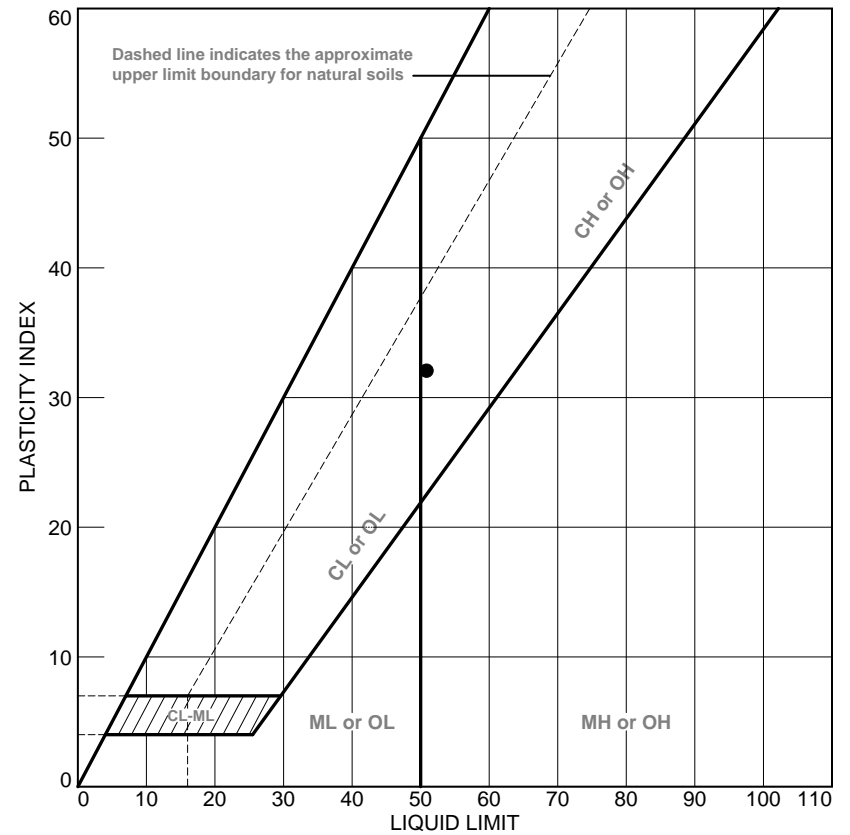
SOURCE	SAMPLE #	DEPTH/ELEV.	DATE SAMPLED	USCS	MATERIAL DESCRIPTION	NM %	LL	PI
●	BH 101-SS3			CH	sandy, SILT AND CLAY		51	32

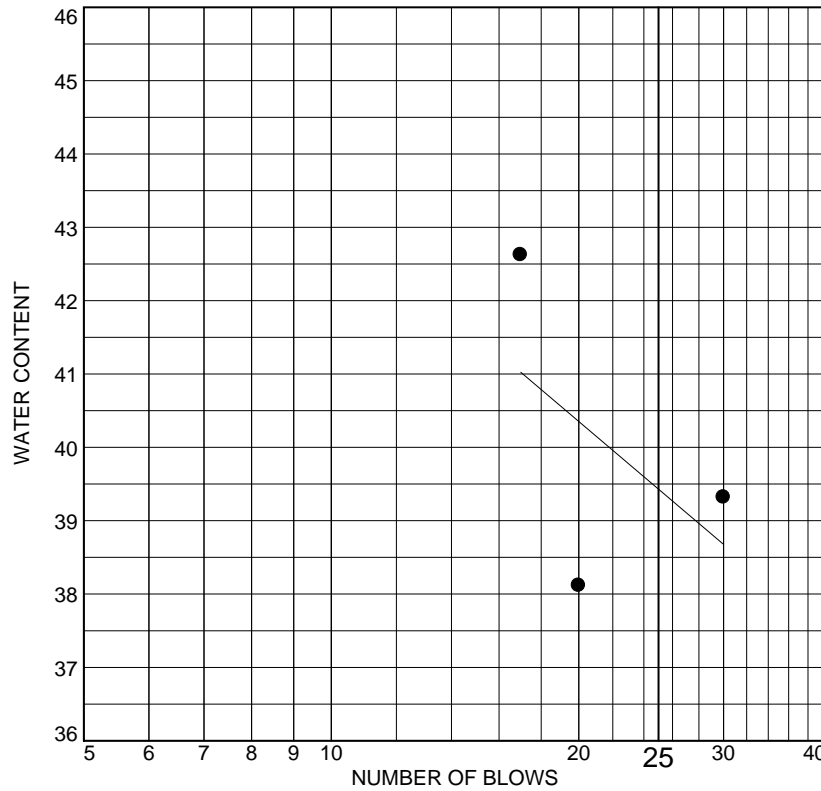
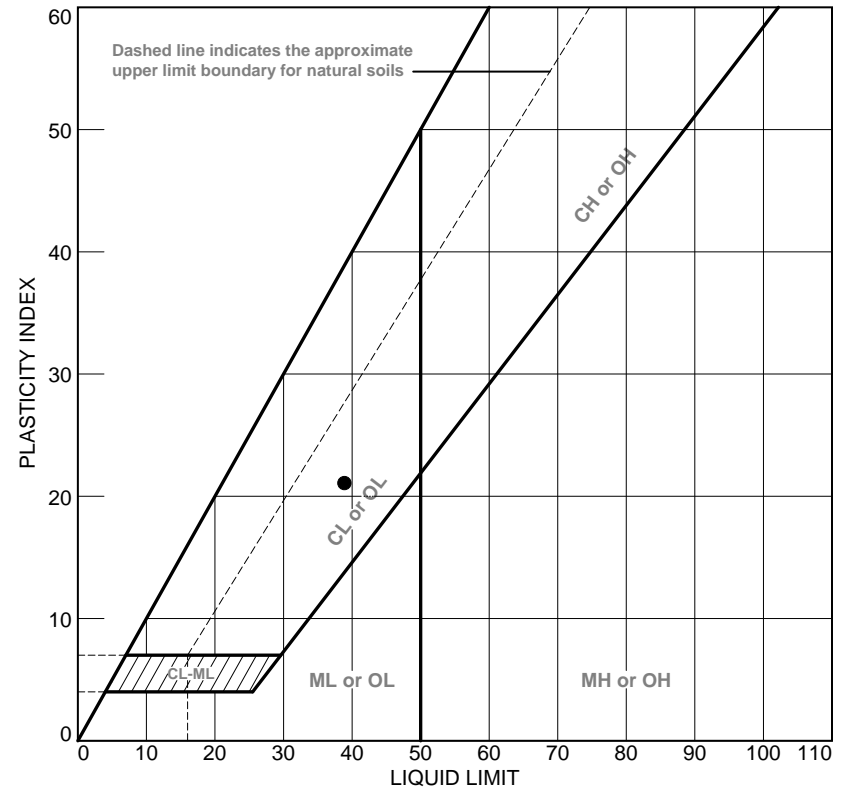
SOURCE	SAMPLE #	DEPTH/ELEV.	DATE SAMPLED	USCS	MATERIAL DESCRIPTION	NM %	LL	PI
●	BH 101-SS6			CL	SILT AND CLAY, trace sand		39	21
