Tree Conservation Report

5646/5650 Manotick Main St.
Manotick, ON K4M 1B3

May 4, 2023
Updated, Sept 21, 2023
Updated Dec 18, 2023
Updated Feb 21, 2024
Updated June 27, 2024

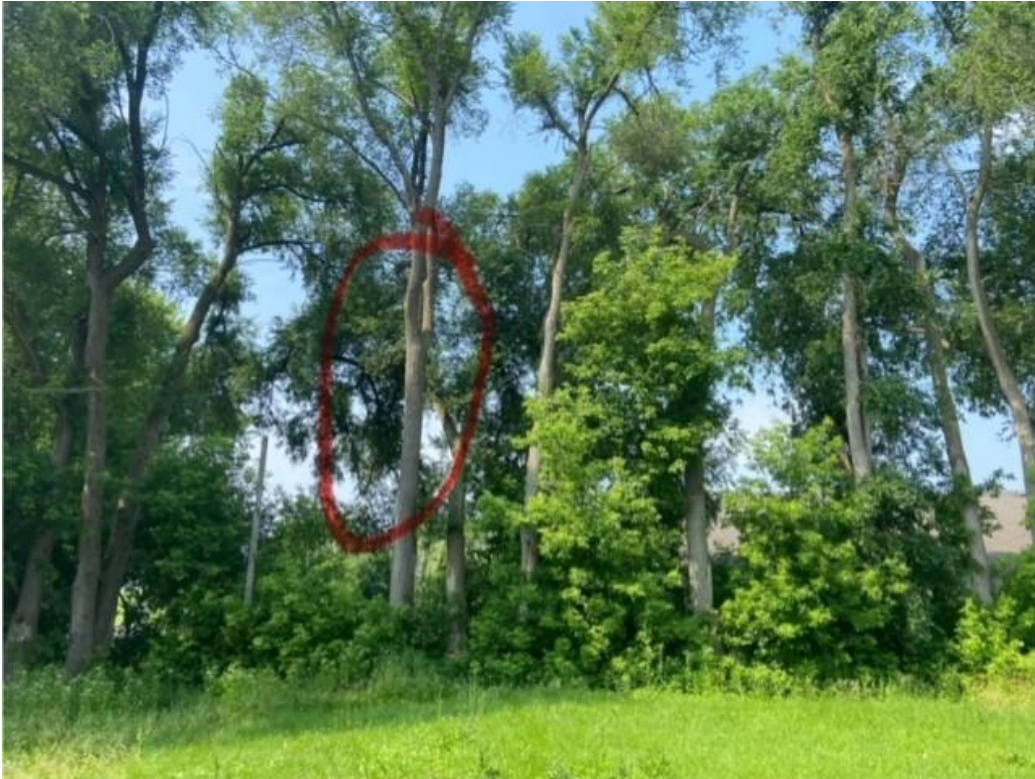
69cm DBH American Elm to be removed.

- All other trees on the property, including one elm from tree cluster 9 which is located to the north side of the standing clothesline pole DBH 69cm. See photos on page 5.

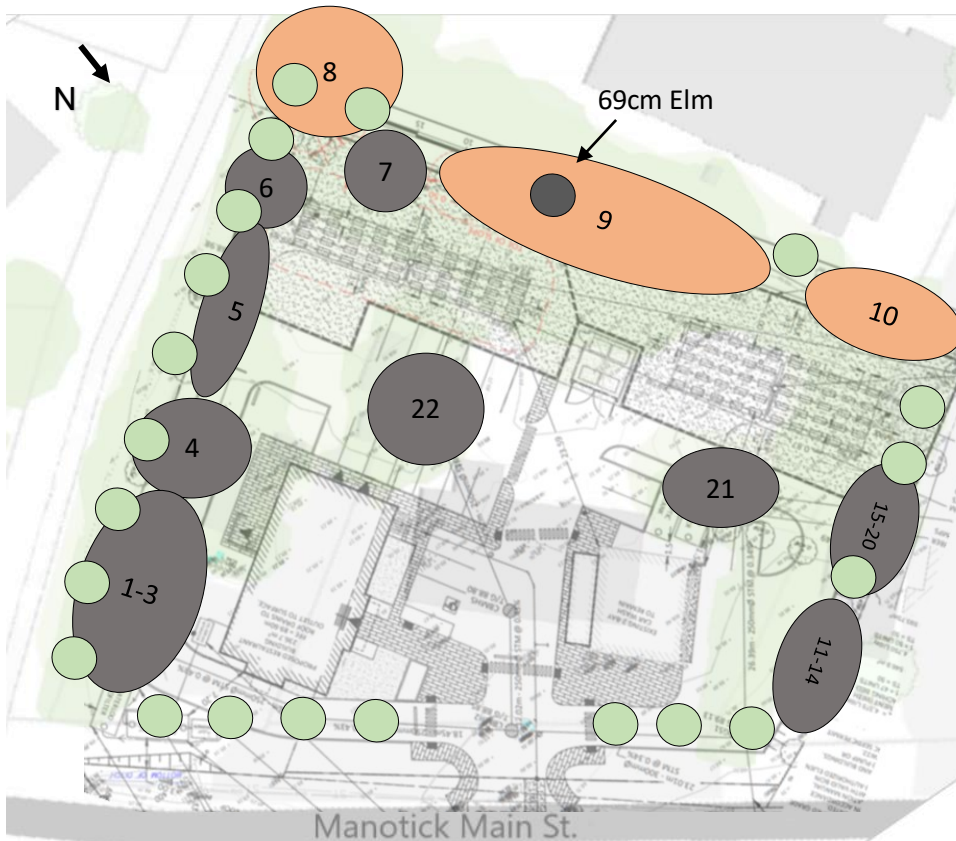
Map #2: Overlay of development plans onto area map.

Trees to be planted*
-   Trees or clusters of trees to be removed
-

Trees or clusters of trees to be protected and retained.

*See landscaping plan for exact planting locations

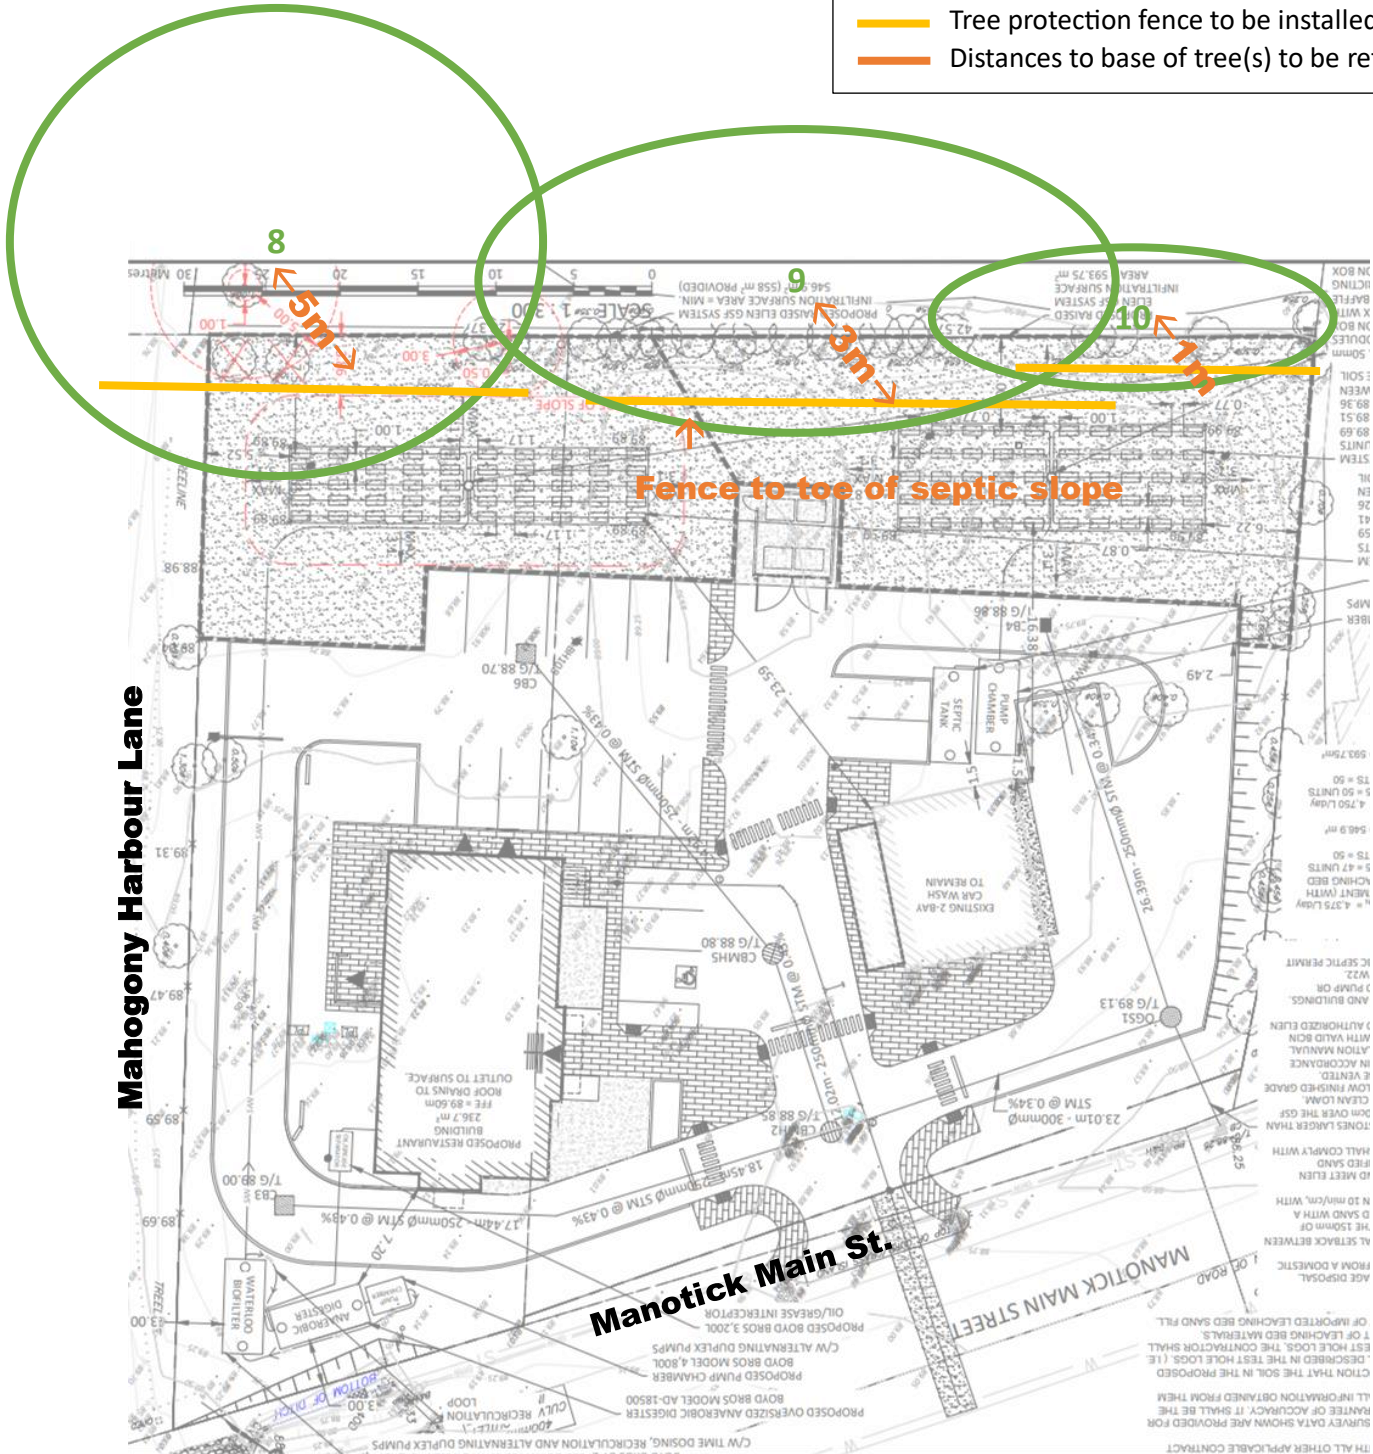
Tree Protection Plan for 5646/5650 Manotick Main St.

- CRZ of trees to be retained (approximate)
- Tree protection fence to be installed
- Distances to base of tree(s) to be retained

This Tree Protection Plan is required to mitigate any potential damage to the roots of the trees during construction. A site plan with an illustration of this tree protection plan is on page 8. Please note that the tree protection plan site plan is not to scale and measurements should be taken before installing the tree protection fence.

- A temporary fence 1.2m high should be erected at the distances determined in this report which will allow no more than 20% of the CRZ of the retained to be impacted by the construction. Tree protection fences are in yellow on the site plan and include a fence in the following positions.

- No closer than 3m from the retained elm trees in cluster #9 (One tree to be removed)
 - No closer than 5m from Tree #8
 - No closer than 1m from the immature mixed stand (cluster #10) in the NW corner

- Any Excavation in the vicinity of tree #8 any distance closer than 8m from the tree and deeper than 30cm should be **done with an air spade**, tree roots should be carefully cut with a clean saw and protected during work. This includes not leaving the roots exposed for prolonged periods and backfilling in the root area with clean soil.
