# Phase I Environmental Site Assessment

917 Merivale Road Ottawa, Ontario

LRL File No.: 230543 September 12, 2023

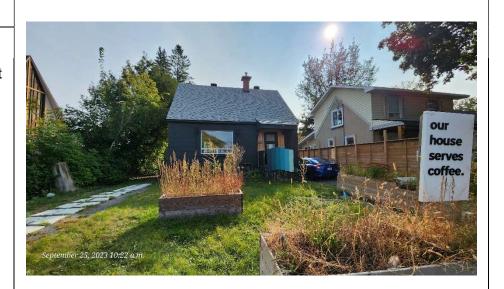
## Photograph No. 2

From east facing west across the eastern extent of the Site.

Generally referred to as the 'back yard' at the rear of the building.

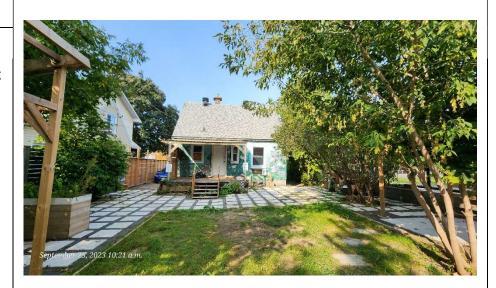
## Photograph No. 3

Typical conditions of the main floor of the building, as encountered at the time of the Site visit.

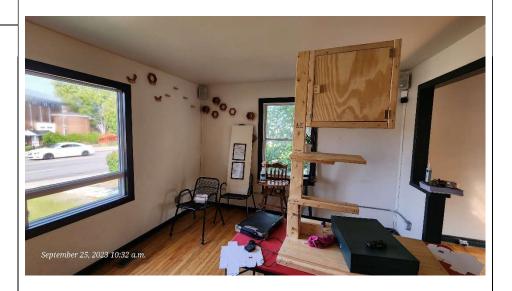
## Photograph No. 4

Typical conditions of the main floor of the building, as encountered at the time of the Site visit.

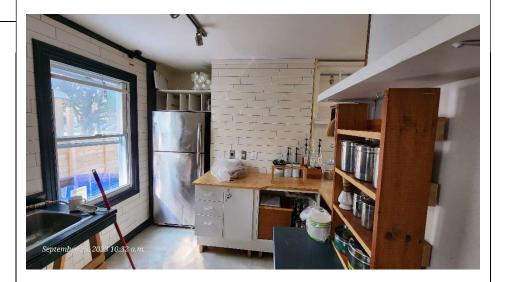
## Photograph No. 5

Second level of building on Site – general conditions encountered.

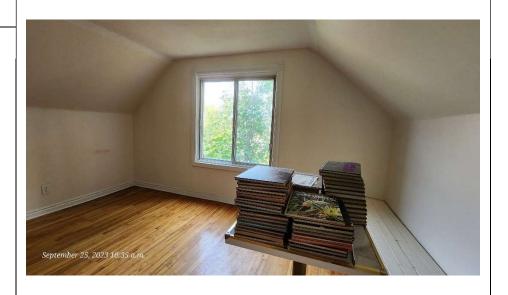
## Photograph No. 6

Second level of building on Site – general conditions encountered.

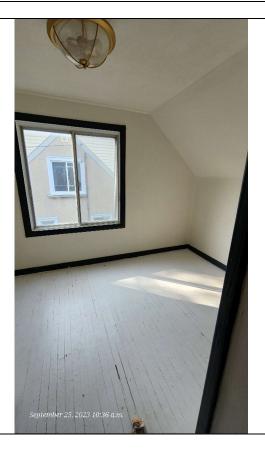
## Photograph No. 7

Typical conditions of the basement at the time of the Site visit.

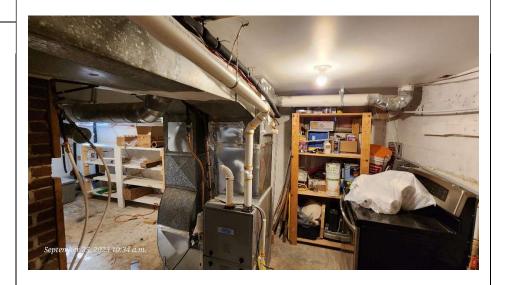
## Photograph No. 8

Typical conditions of the basement encountered at the time of the Site visit.

Natural gas furnace visible in the background.

Heating Systems:	Natural gas forced air.				
Cooling Systems:	Central air cooling system.				
Floor drains:	Not observed, however a sanitary clean-out port was encountered in the basement, as well as a metal plate cover concealing a cut-out of the cement slab floor. The purpose of the cover is unknown, however may be a former sump-pit location.				
Sumps:	Not observed.				
Paint booth:	Not observed.				
Staining or corrosion (other than water):	Not observed.				
Mechanical equipment:	Not observed other than a natural gas fired furnace.				
Interior finishing	Hardwood flooring throughout main floor and second level, with drywall ceiling and walls. Brick and mortar as well as ceramic tile finishes were also present in limited areas of the main floor. A vinyl composite floor material covered a portion of the former kitchen area. The basement level had similar finishes encountered, include drywall ceiling and walls, with a vinyl composite floor. Poured cement falls, and flooring was encountered in the unfinished portion of the basement.
