**Phase One Environmental Site  
Assessment  
1055 Klondike Road  
Ottawa, Ontario**

October 2, 2018  
Project: 64153.85

**Re: Phase One Environmental Site Assessment  
1055 Klondike, Ottawa, Ontario**

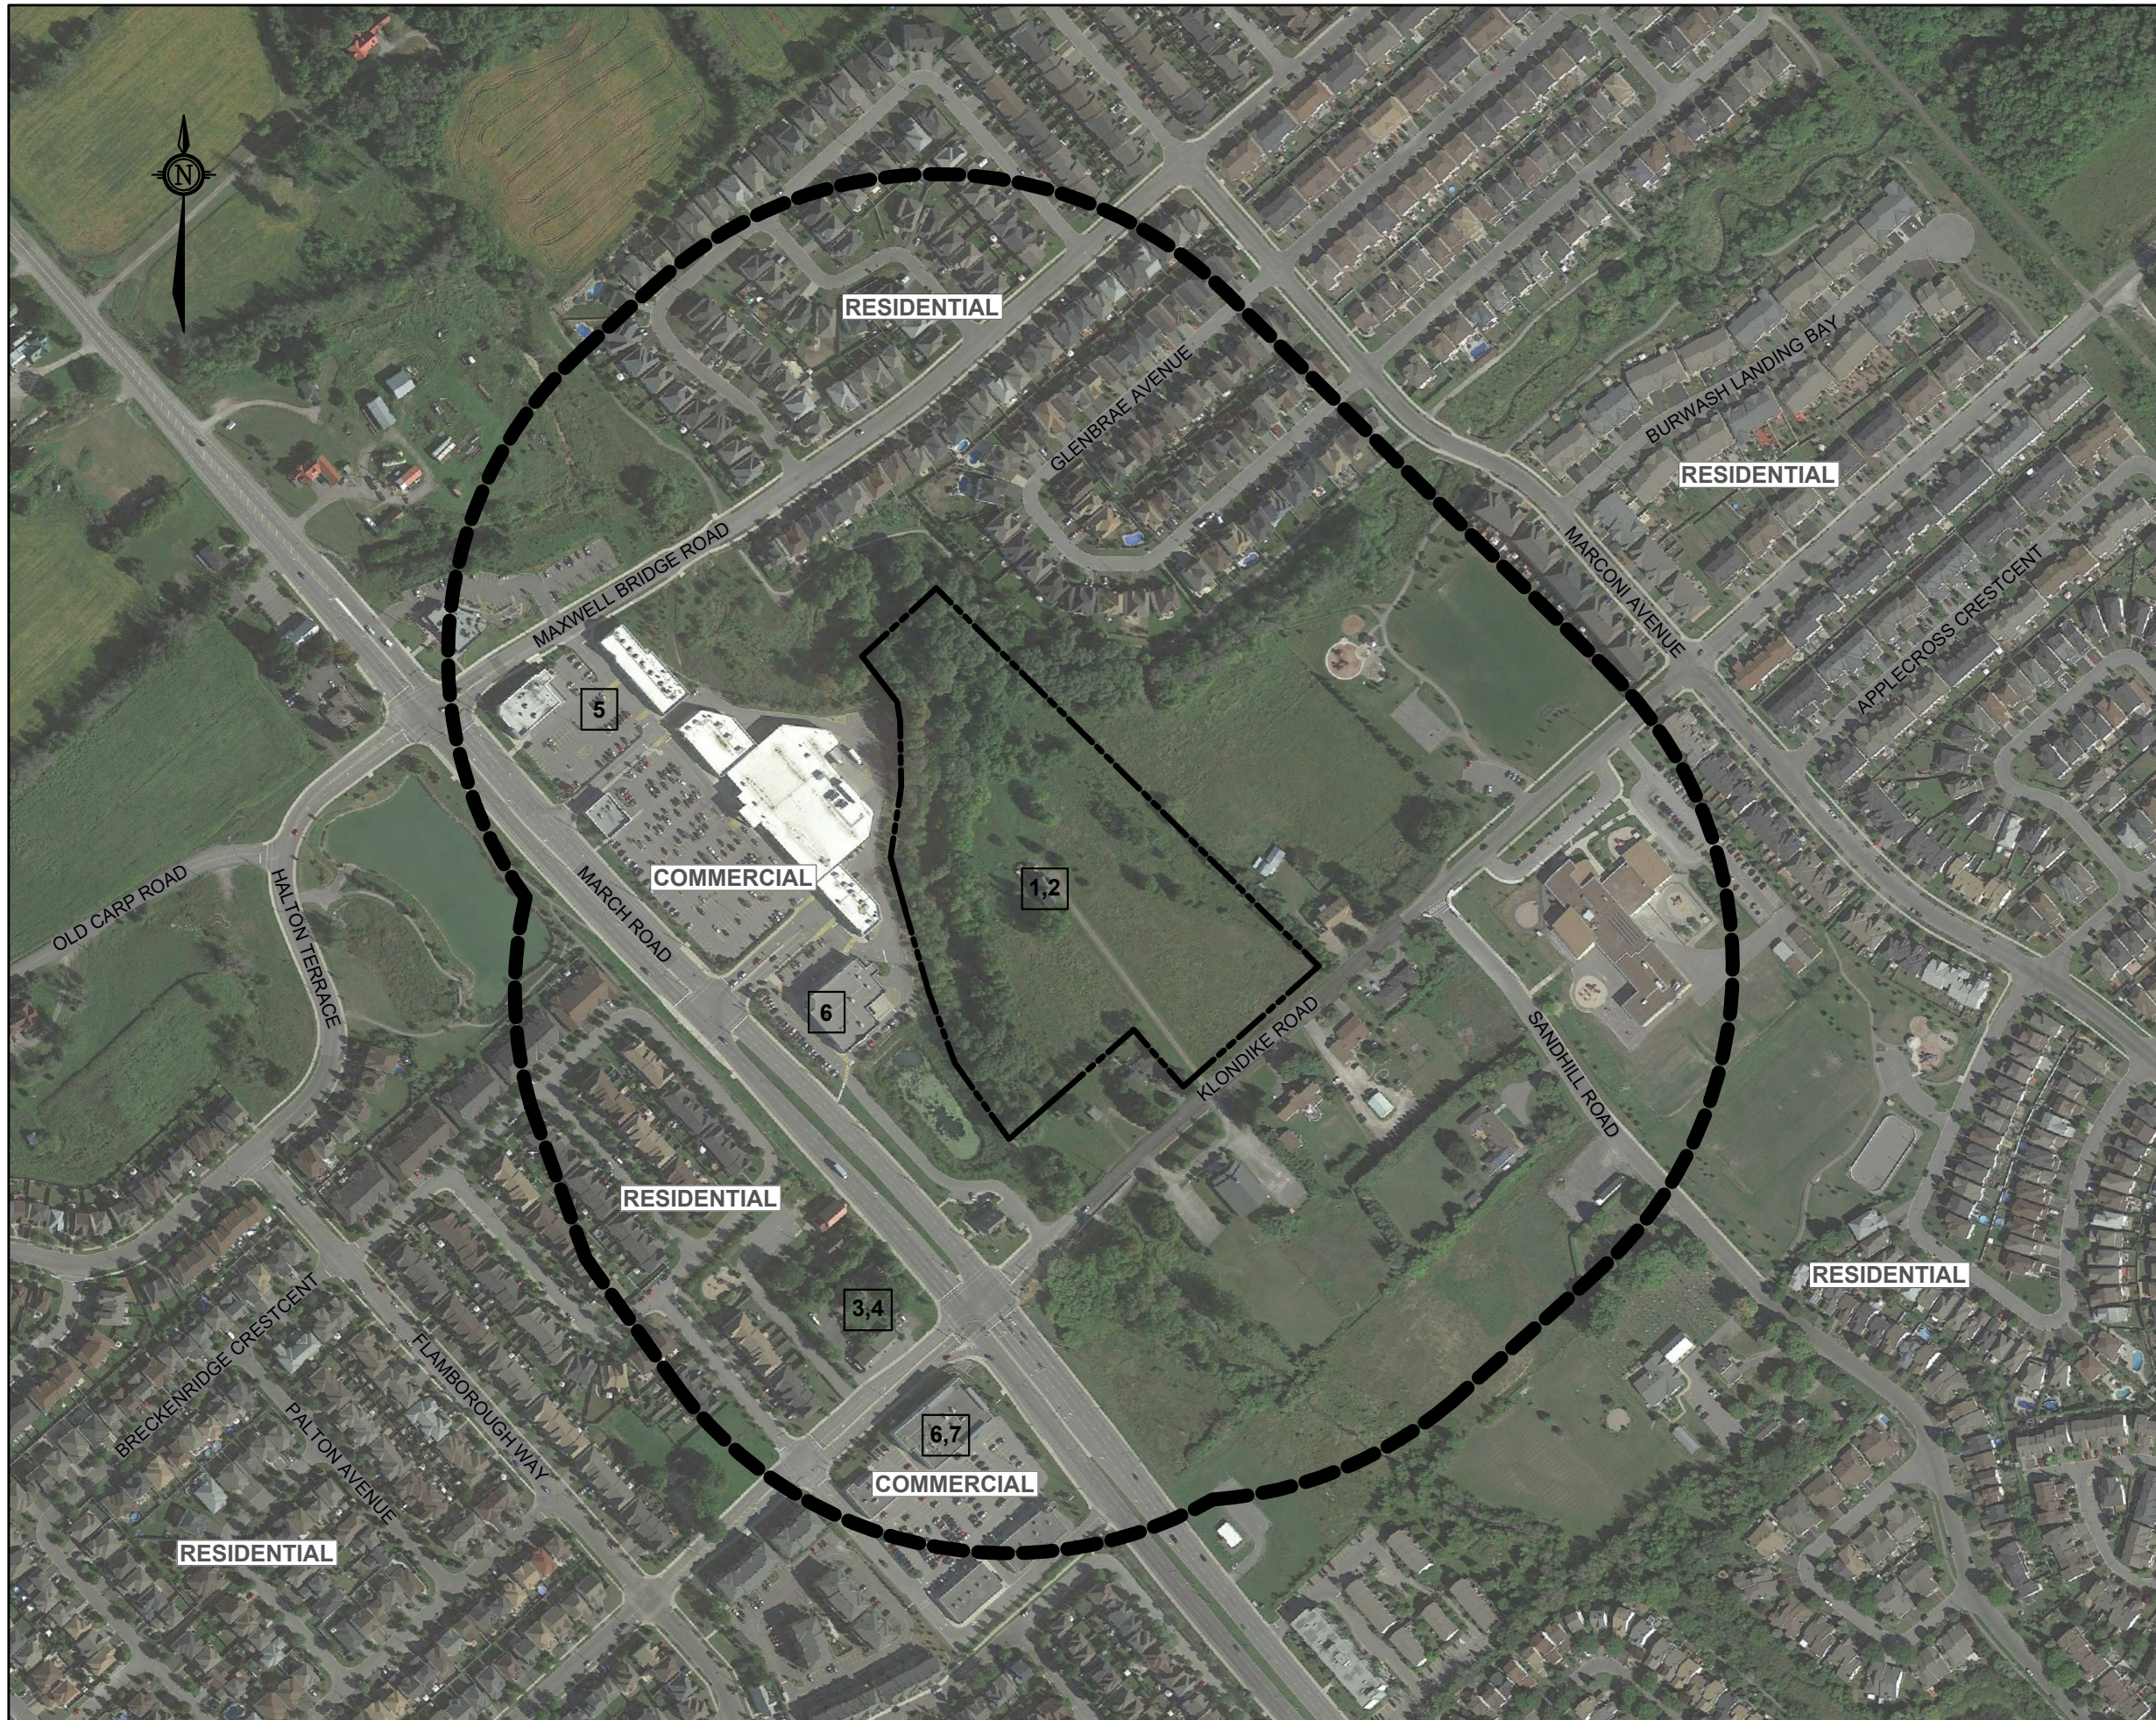
Date OCTOBER 2018	Rev. 0	<b>FIGURE 2</b>
----------------------	-----------	-----------------

The required details of the Phase One Conceptual Site Model are presented on Figure 2 and 3, as noted in the following table:
