**Geotechnical Investigation  
And Slope Stability Assessment  
Proposed Commercial Development  
225 Maple Creek Court  
Ottawa, Ontario**

May 10, 2024  
Project: 100227.103

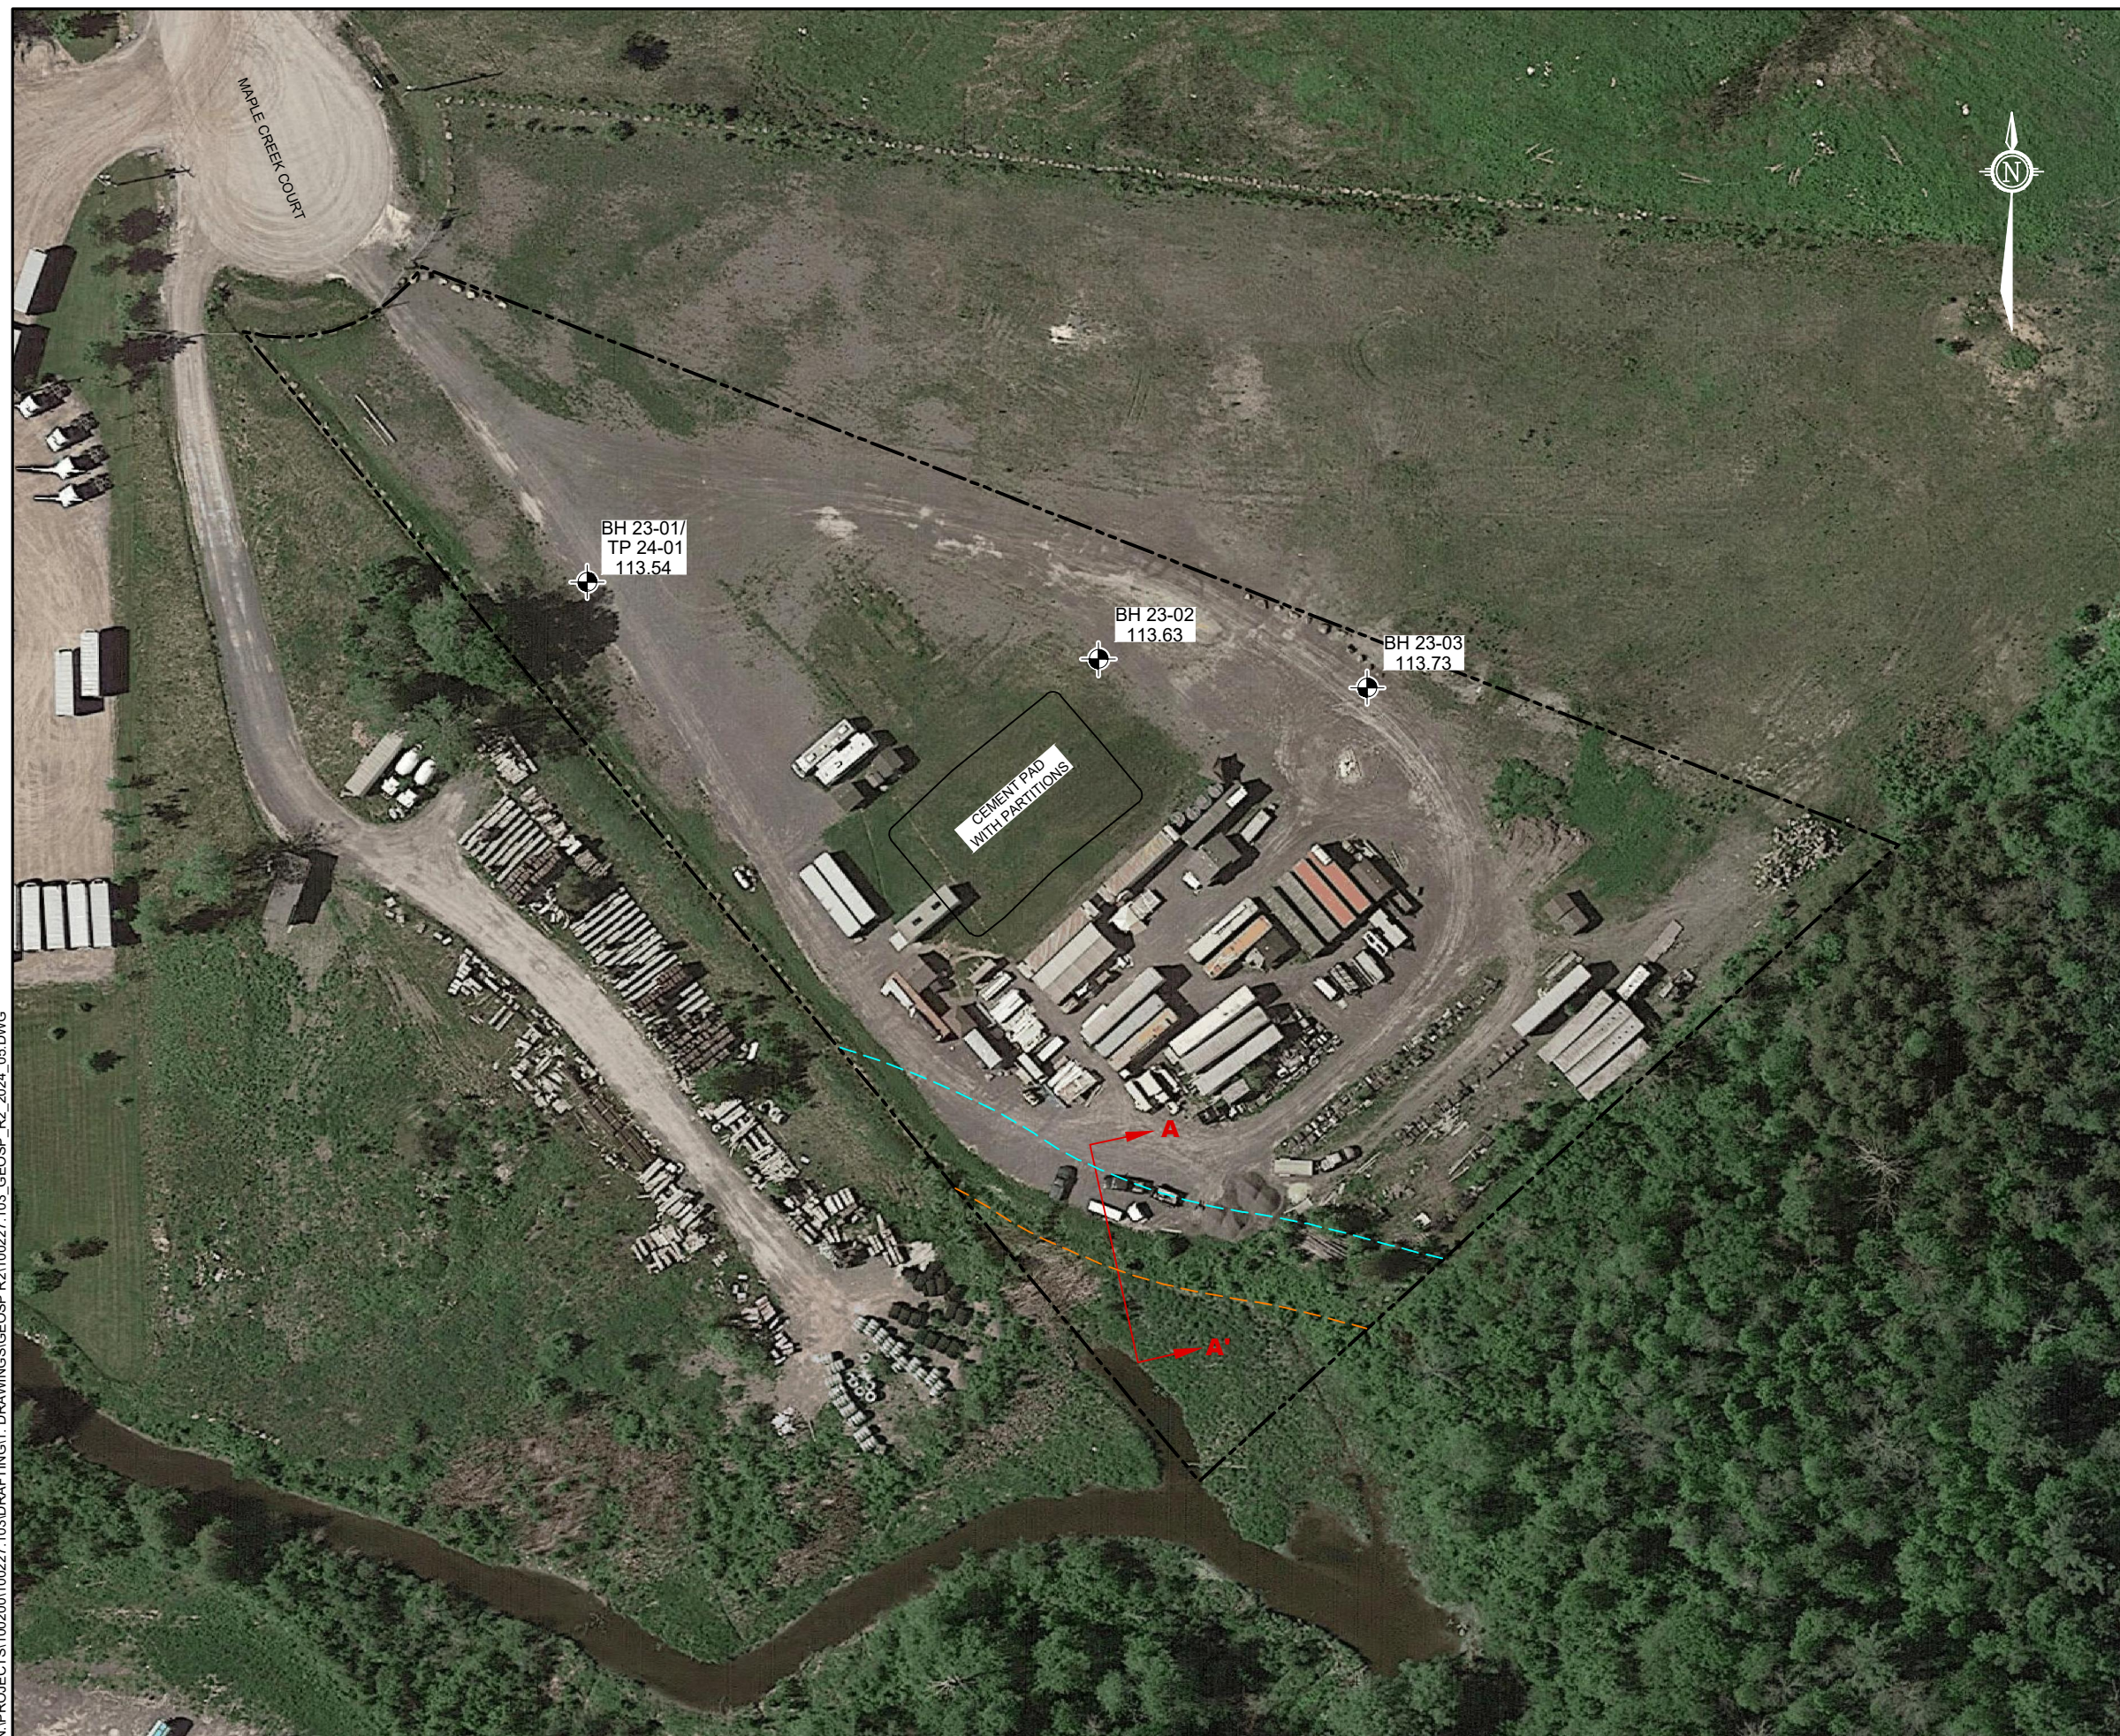
Figure 1 – Site Plan

BH #	←	BOREHOLE ID
TP #	←	TEST PIT ID
XX.XX	←	GROUND SURFACE ELEVATION, IN METRES GEODETIC DATUM
BH #/ TP #	←	MULTIPLE TEST HOLES ADVANCED ADJACENT TO EACH OTHER
		<b>BOREHOLE LOCATION</b> (current investigation by GEMTEC)
		APPROXIMATE SITE BOUNDARY
		APPROXIMATE CEMENT PAD BOUNDARY
		APPROXIMATE LIMIT OF HAZARD LANDS
		APPROXIMATE SLOPE CREST LOCATION
		APPROXIMATE CROSS SECTION LOCATION

Based on the above information, the Limit of Hazard Lands for the slope adjacent to Huntley Creek will be about **13 metres**, as measured from the crest of the slope shown on Figure 1.

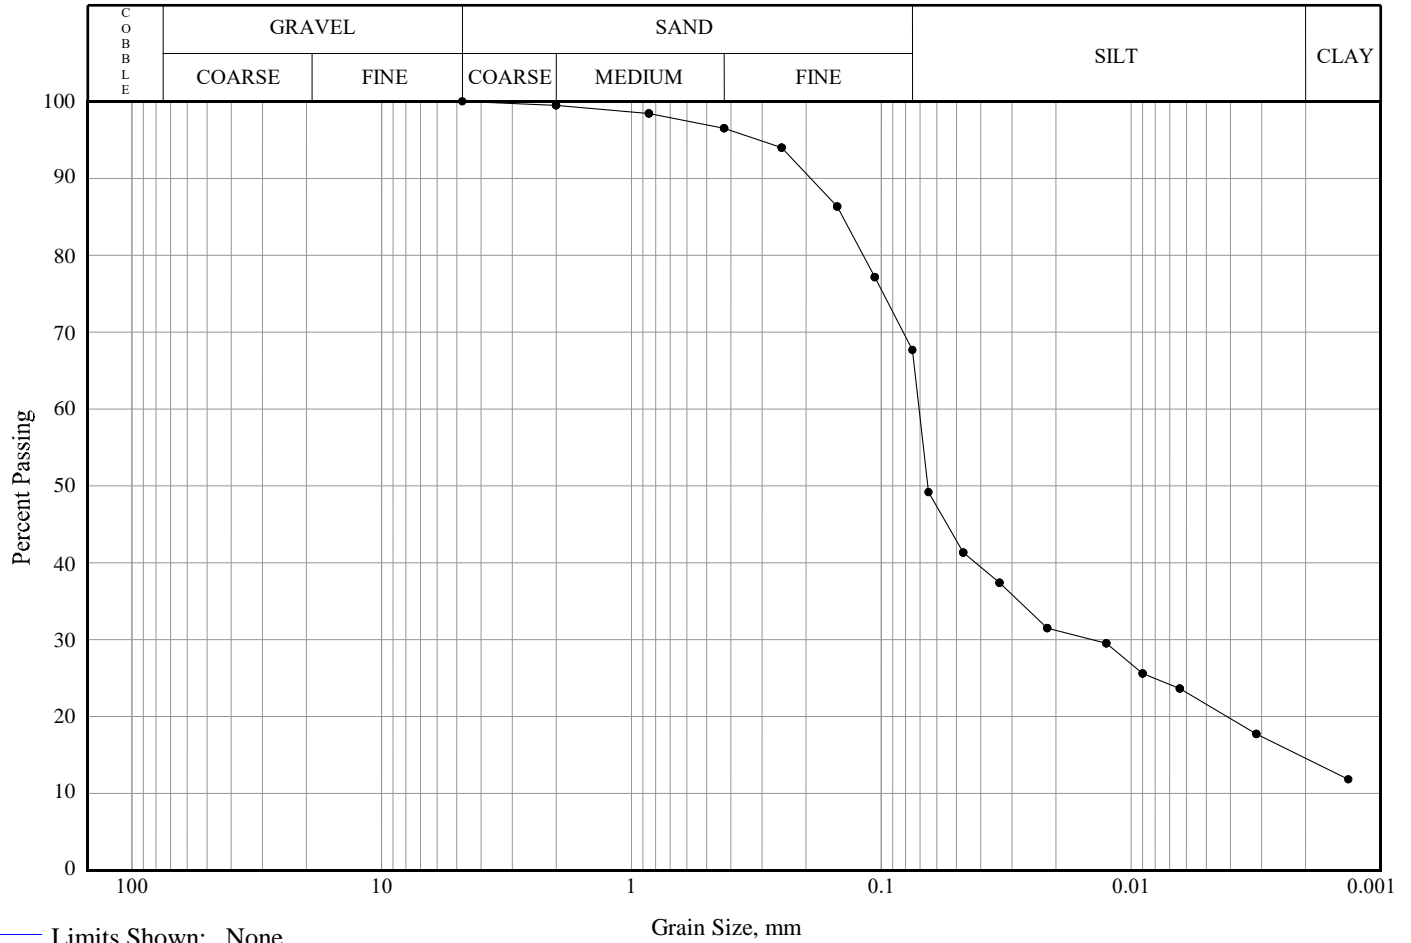
Line Symbol	Sample	Borehole/ Test Pit	Sample Number	Depth	% Cob.+ Gravel	% Sand	% Silt	% Clay
—●—	WEATHERED CRUST	TP24-01	3	0.8-1.6	0.0	32.4	53.1	14.5

Line Symbol	CanFEM Classification	USCS Symbol	D <sub>10</sub>	D <sub>15</sub>	D <sub>30</sub>	D <sub>50</sub>	D <sub>60</sub>	D <sub>85</sub>	% 5-75µm
—●—	Sandy silt , some clay	CL	---	0.002	0.01	0.07	0.07	0.14	53.1

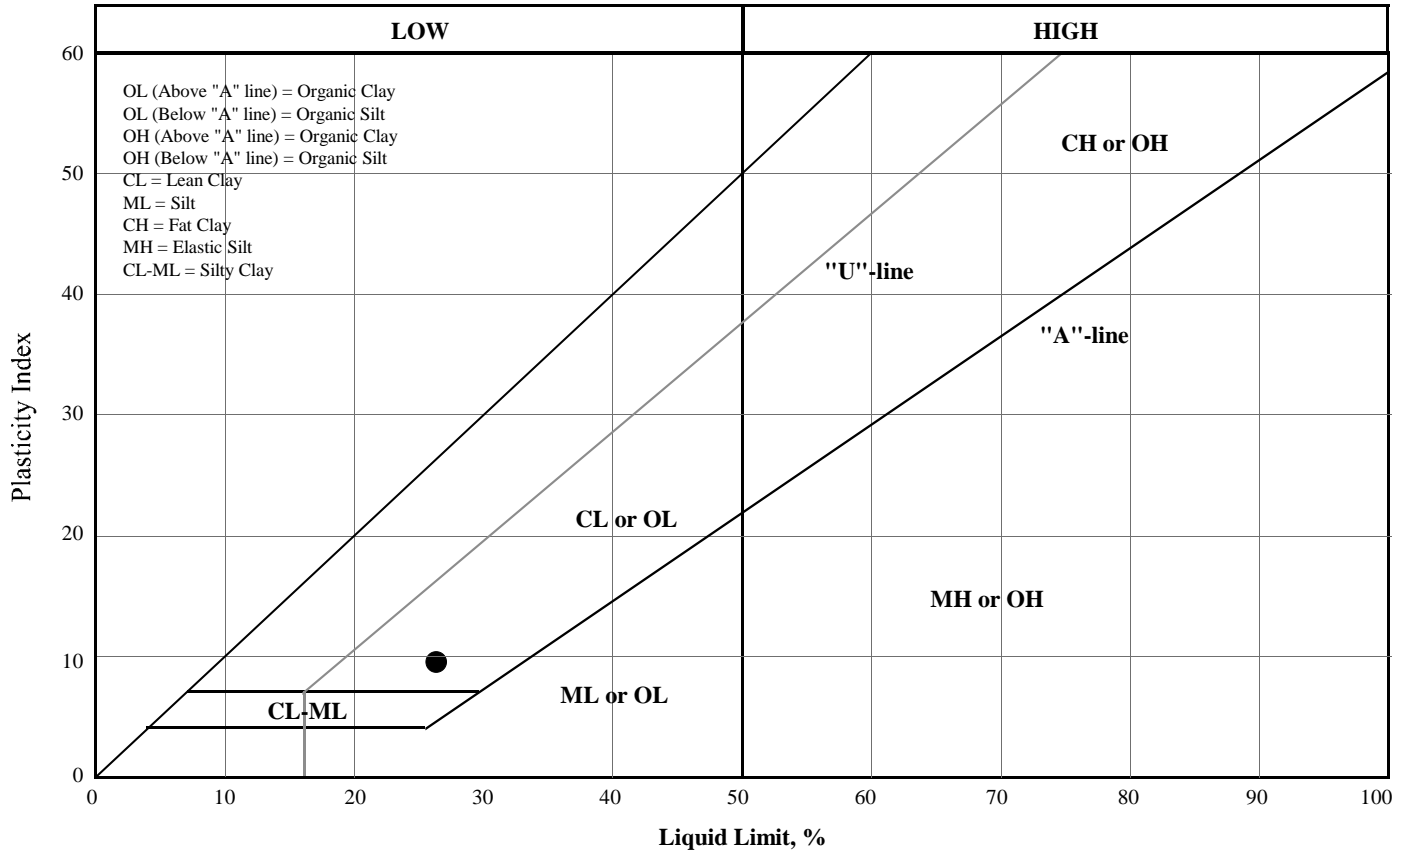
Symbol	Borehole /Test Pit	Sample Number	Depth	Liquid Limit	Plastic Limit	Plasticity Index	Non-Plastic	Moisture Content, %
●	24-01	3	0.8-1.6	26.3	16.8	9.5	N/A	28.8

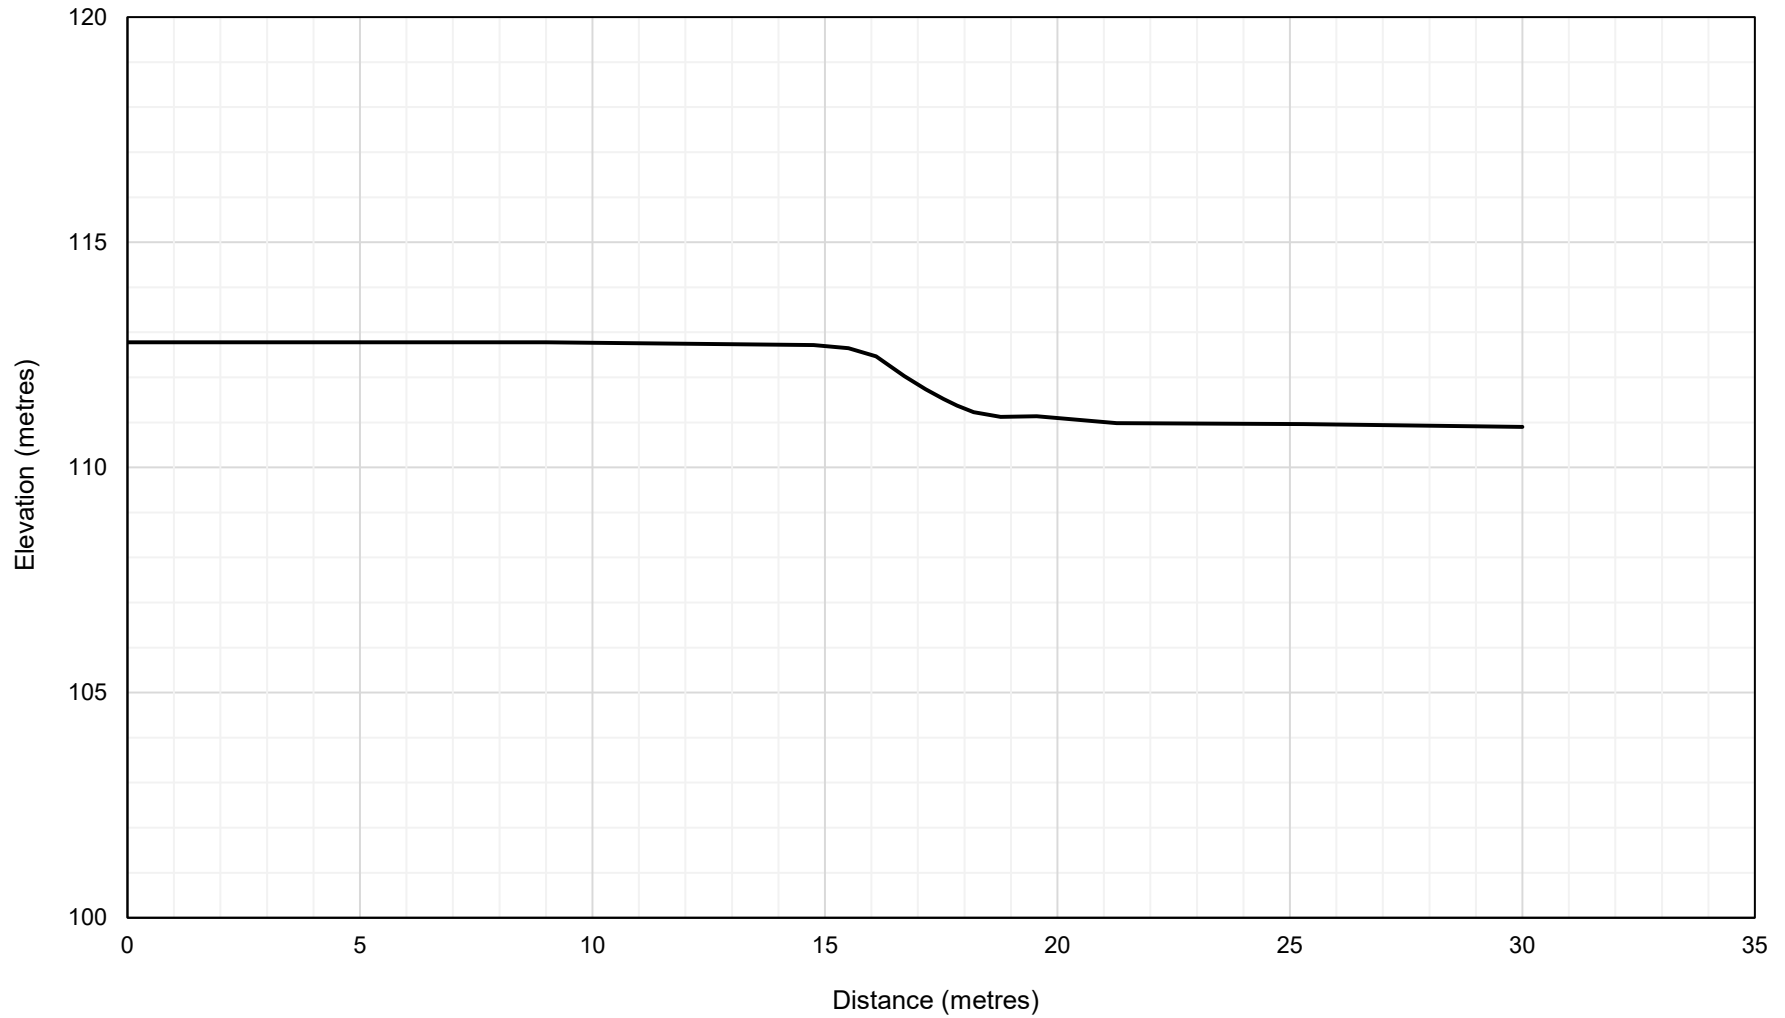
**FIGURE D1**

**Slope Section A-A'**  
**Proposed Commercial Development, 225 Maple Creek Court**  
**Ottawa, Ontario**

The slope stability analyses were carried out at Section A-A’ using SLIDE 2018, a commercial two-dimensional limit equilibrium slope stability program by RocScience Inc. The slope stability analyses were carried out using soil parameters, groundwater conditions, and a cross section profile that attempt to model the slopes in question but do not exactly represent the actual conditions.

- One augerhole was advanced at the crest (top) of the slope along Section A-A' and encountered about 150 millimetres of granular fill material over silty sand with organic matter. The hand augerhole was terminated at a depth of about 1.8 metres below ground surface in the silty sand. Groundwater seepage was not observed in the hand augerhole.
- A second augerhole was advanced along the midpoint of the slope along Section A-A' and encountered about 150 millimetres of topsoil over silty sand with organic matter. The hand augerhole was terminated at a depth of about 1.5 metres below ground surface in the silty sand. Groundwater seepage was observed at a depth of about 0.9 metres below ground surface, where the soils recovered from the hand augerhole were in a wet condition.

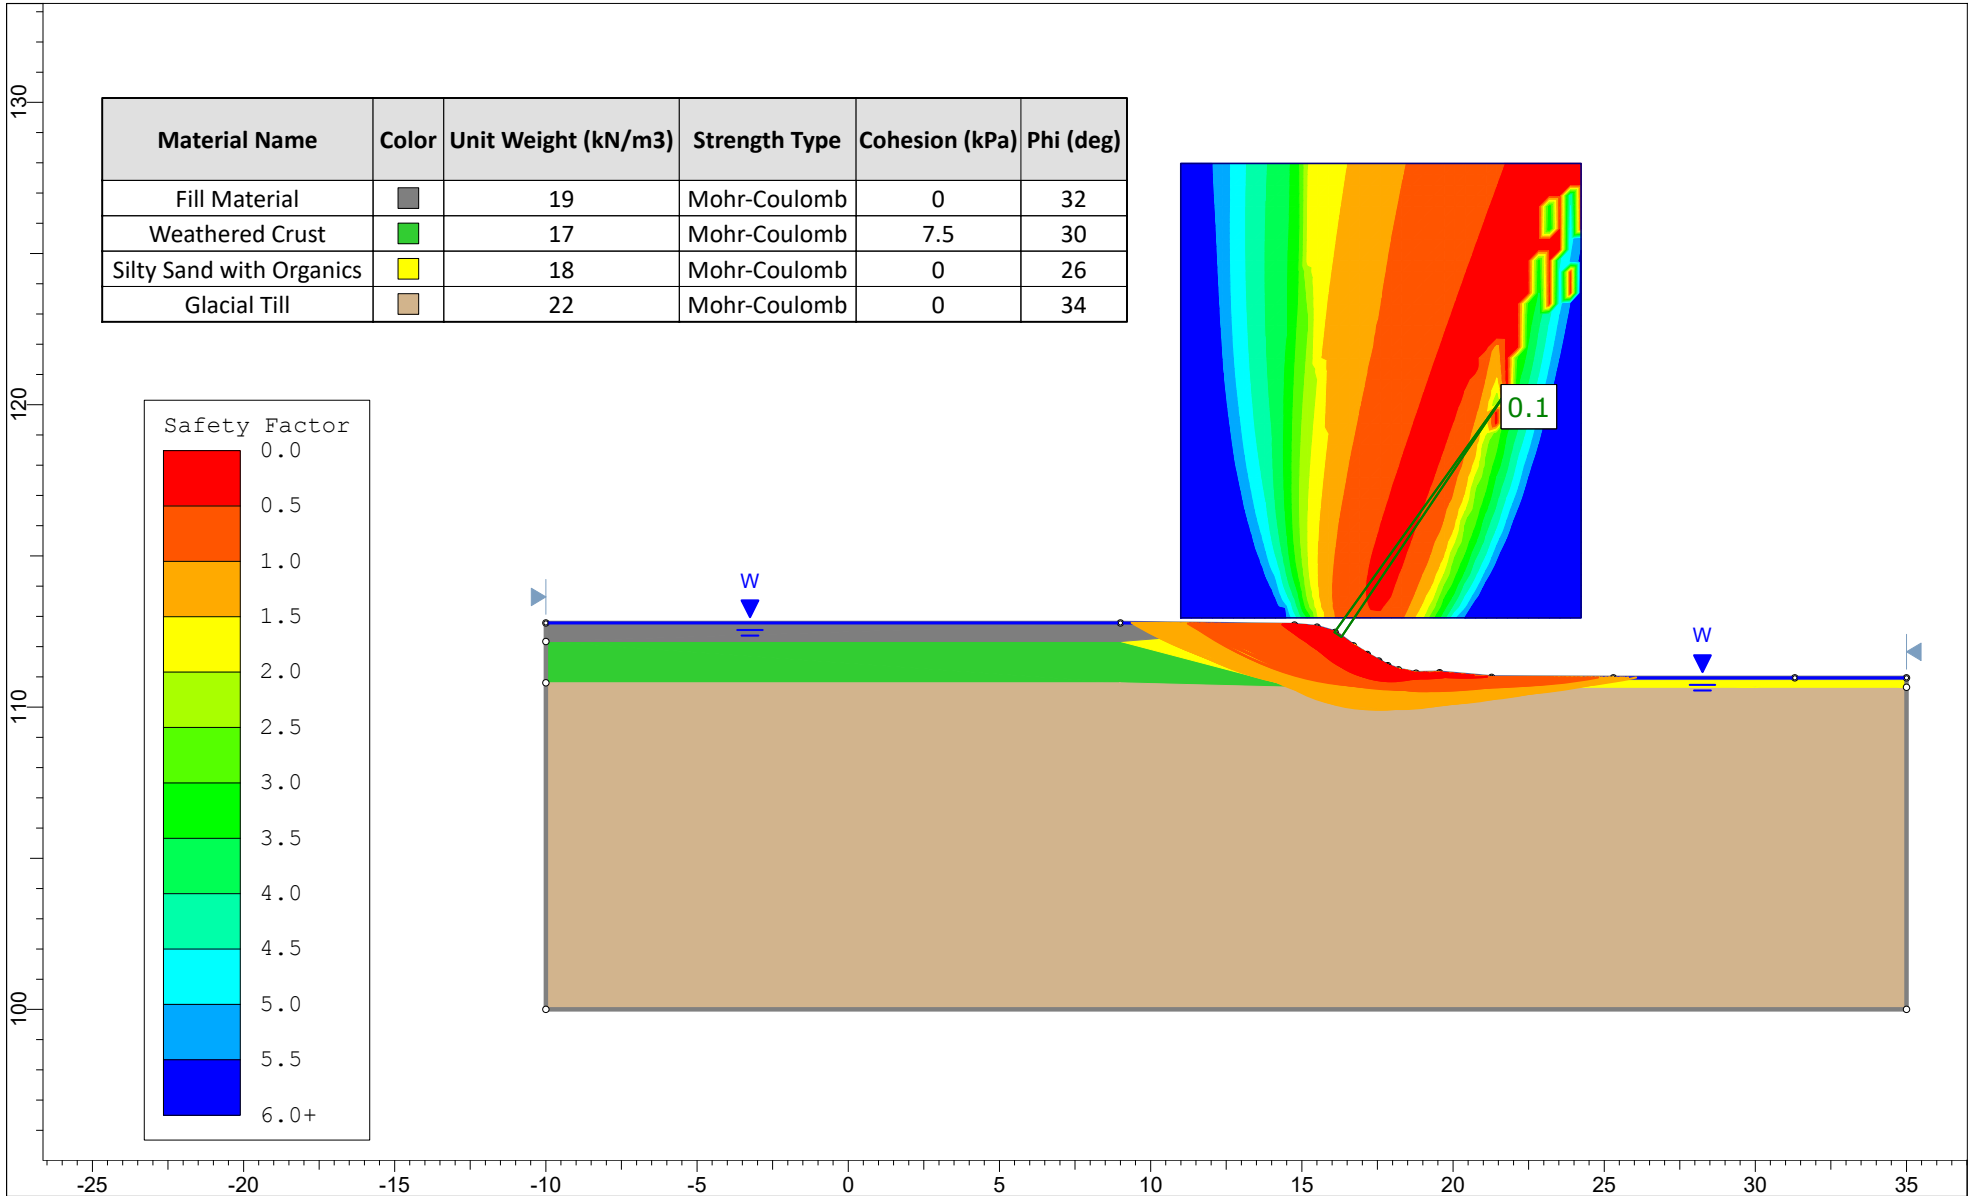
Material Name	Color	Unit Weight (kN/m3)	Strength Type	Cohesion (kPa)	Phi (deg)
Fill Material	Grey	19	Mohr-Coulomb	0	32
Weathered Crust	Green	17	Mohr-Coulomb	7.5	30
Silty Sand with Organics	Yellow	18	Mohr-Coulomb	0	26
Glacial Till	Brown	22	Mohr-Coulomb	0	34

<b>GEMTEC</b> CONSULTING ENGINEERS AND SCIENTISTS	<i>Project</i> Slope Stability Assessment, Proposed Commercial Development, 225 Maple Creek Court, Ottawa, Ontario		
	<i>Analysis Description</i> Section A-A', Static Analysis		
	<i>Drawn By</i> FZ	<i>Location</i> Ottawa, Ontario	<i>Figure Number</i> <b>D2</b>
	<i>Date</i> October 2023	<i>Project Number</i> 100227.103

The results of the slope stability analyses are provided in Appendix D. Based on the results of the analyses of the existing slope conditions, the slope along the existing creek has a minimum factor of safety of less than 1.0 in the static case, and also in the seismic case. As such, the slopes are not considered to be stable in their existing condition.

The Stable Slope Allowance, as described in the MNR procedures, encompasses the area where a factor of safety of less than 1.5 against overall rotational failure is calculated. At Sections A-A', the slope stability analyses indicate that the existing slope along the creek in its current configuration has a factor of safety against failure of less than 1.0 (refer to Figures D2 and D3 in Appendix D). Therefore, the **Stable Slope Allowance** described in the MNR procedures extends about 7 metres horizontally from the crest of the slope at Section A-A'.

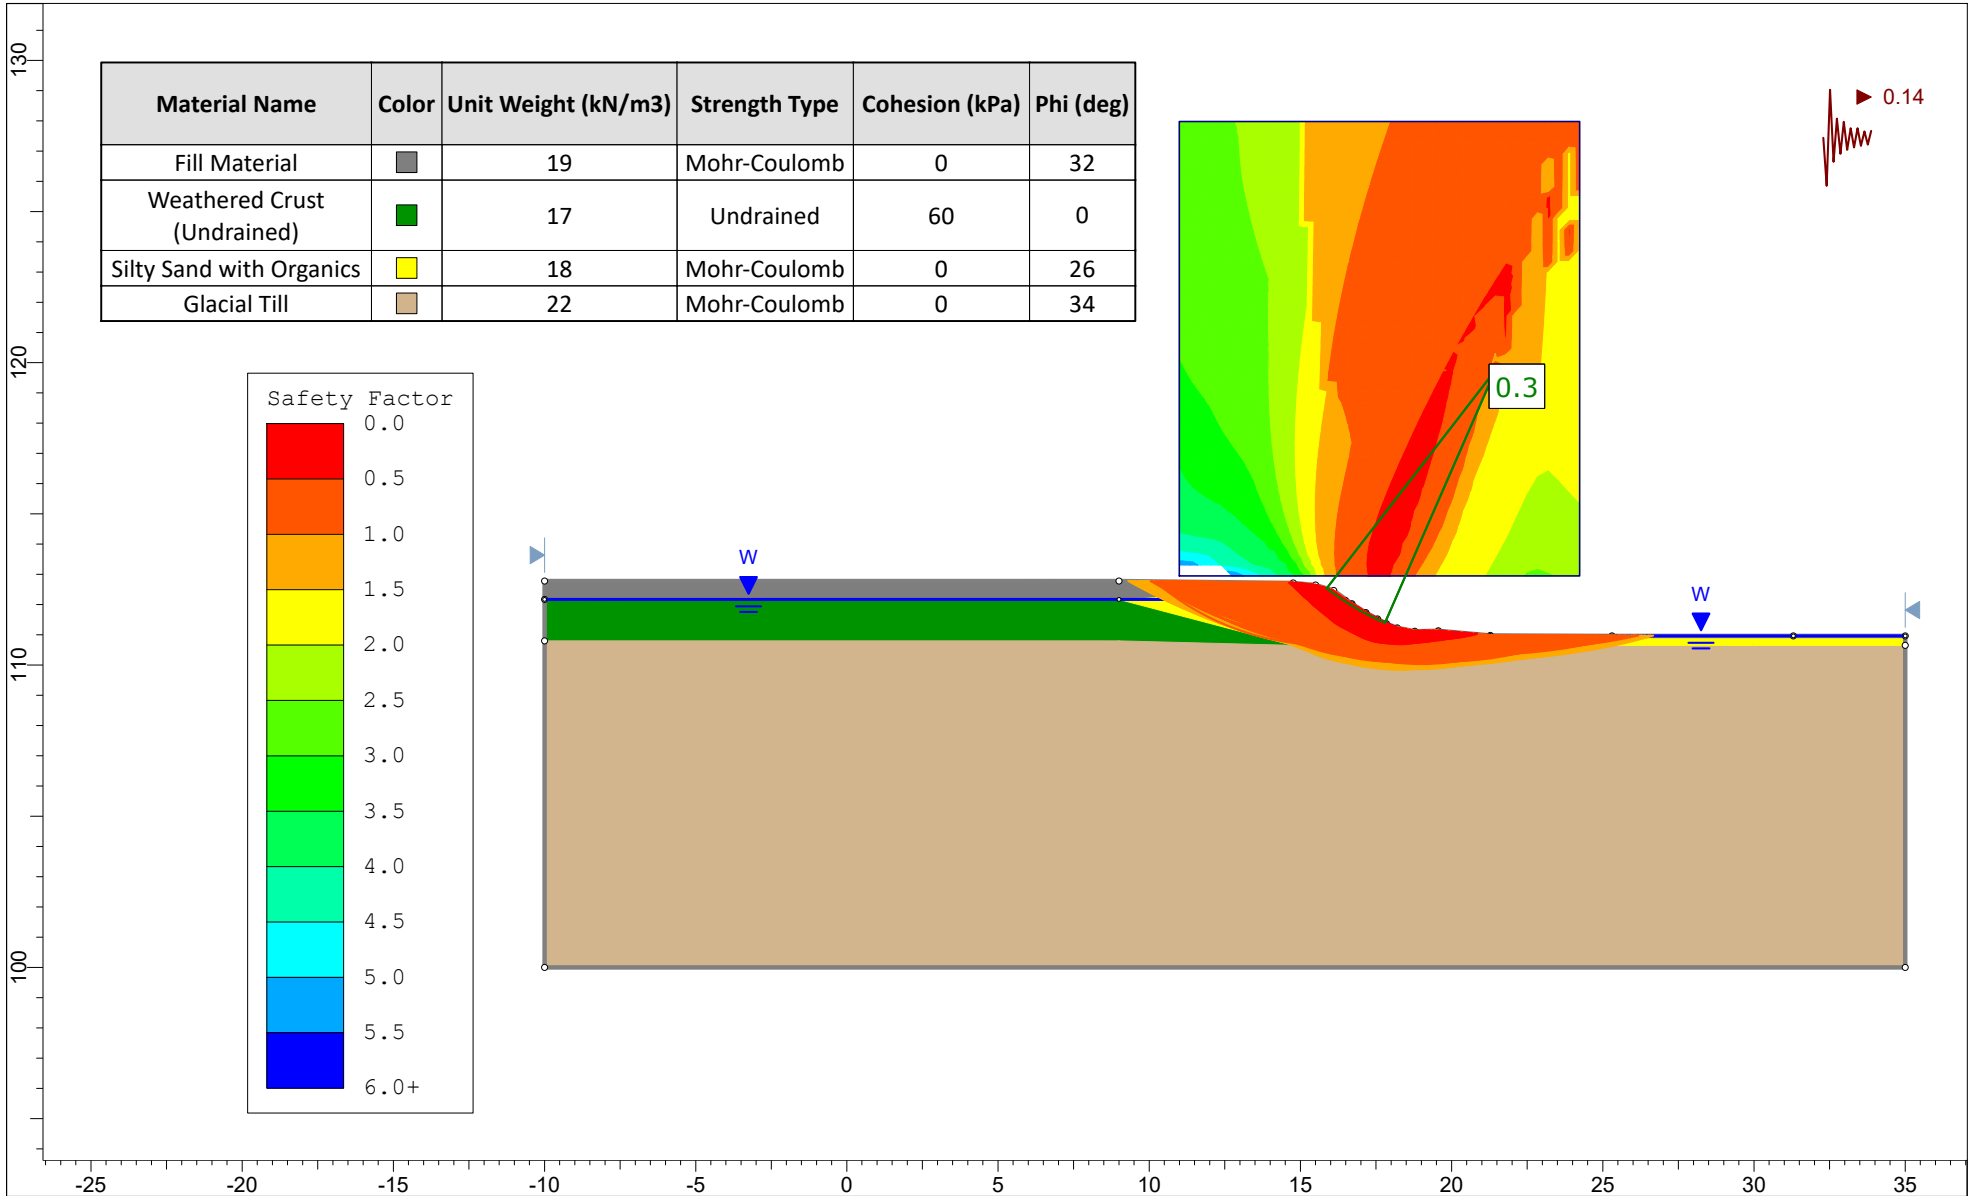
<b>GEMTEC</b> CONSULTING ENGINEERS AND SCIENTISTS	<i>Project</i> Slope Stability Assessment, Proposed Commercial Development, 225 Maple Creek Court, Ottawa, Ontario		
	<i>Analysis Description</i> Section A-A', Pseudo-static Analysis		
	<i>Drawn By</i> FZ	<i>Location</i> Ottawa, Ontario	<i>Figure Number</i> <b>D3</b>
	<i>Date</i> October 2023	<i>Project Number</i> 100227.103
