Phase I-Environmental Site Assessment

1950 Scott Street, 312 and 314 Clifton Road
Ottawa, Ontario

Prepared For
2506100 Ontario Inc.
c/o Colonnade Bridgeport

September 17, 2020
Report: PE4995-1

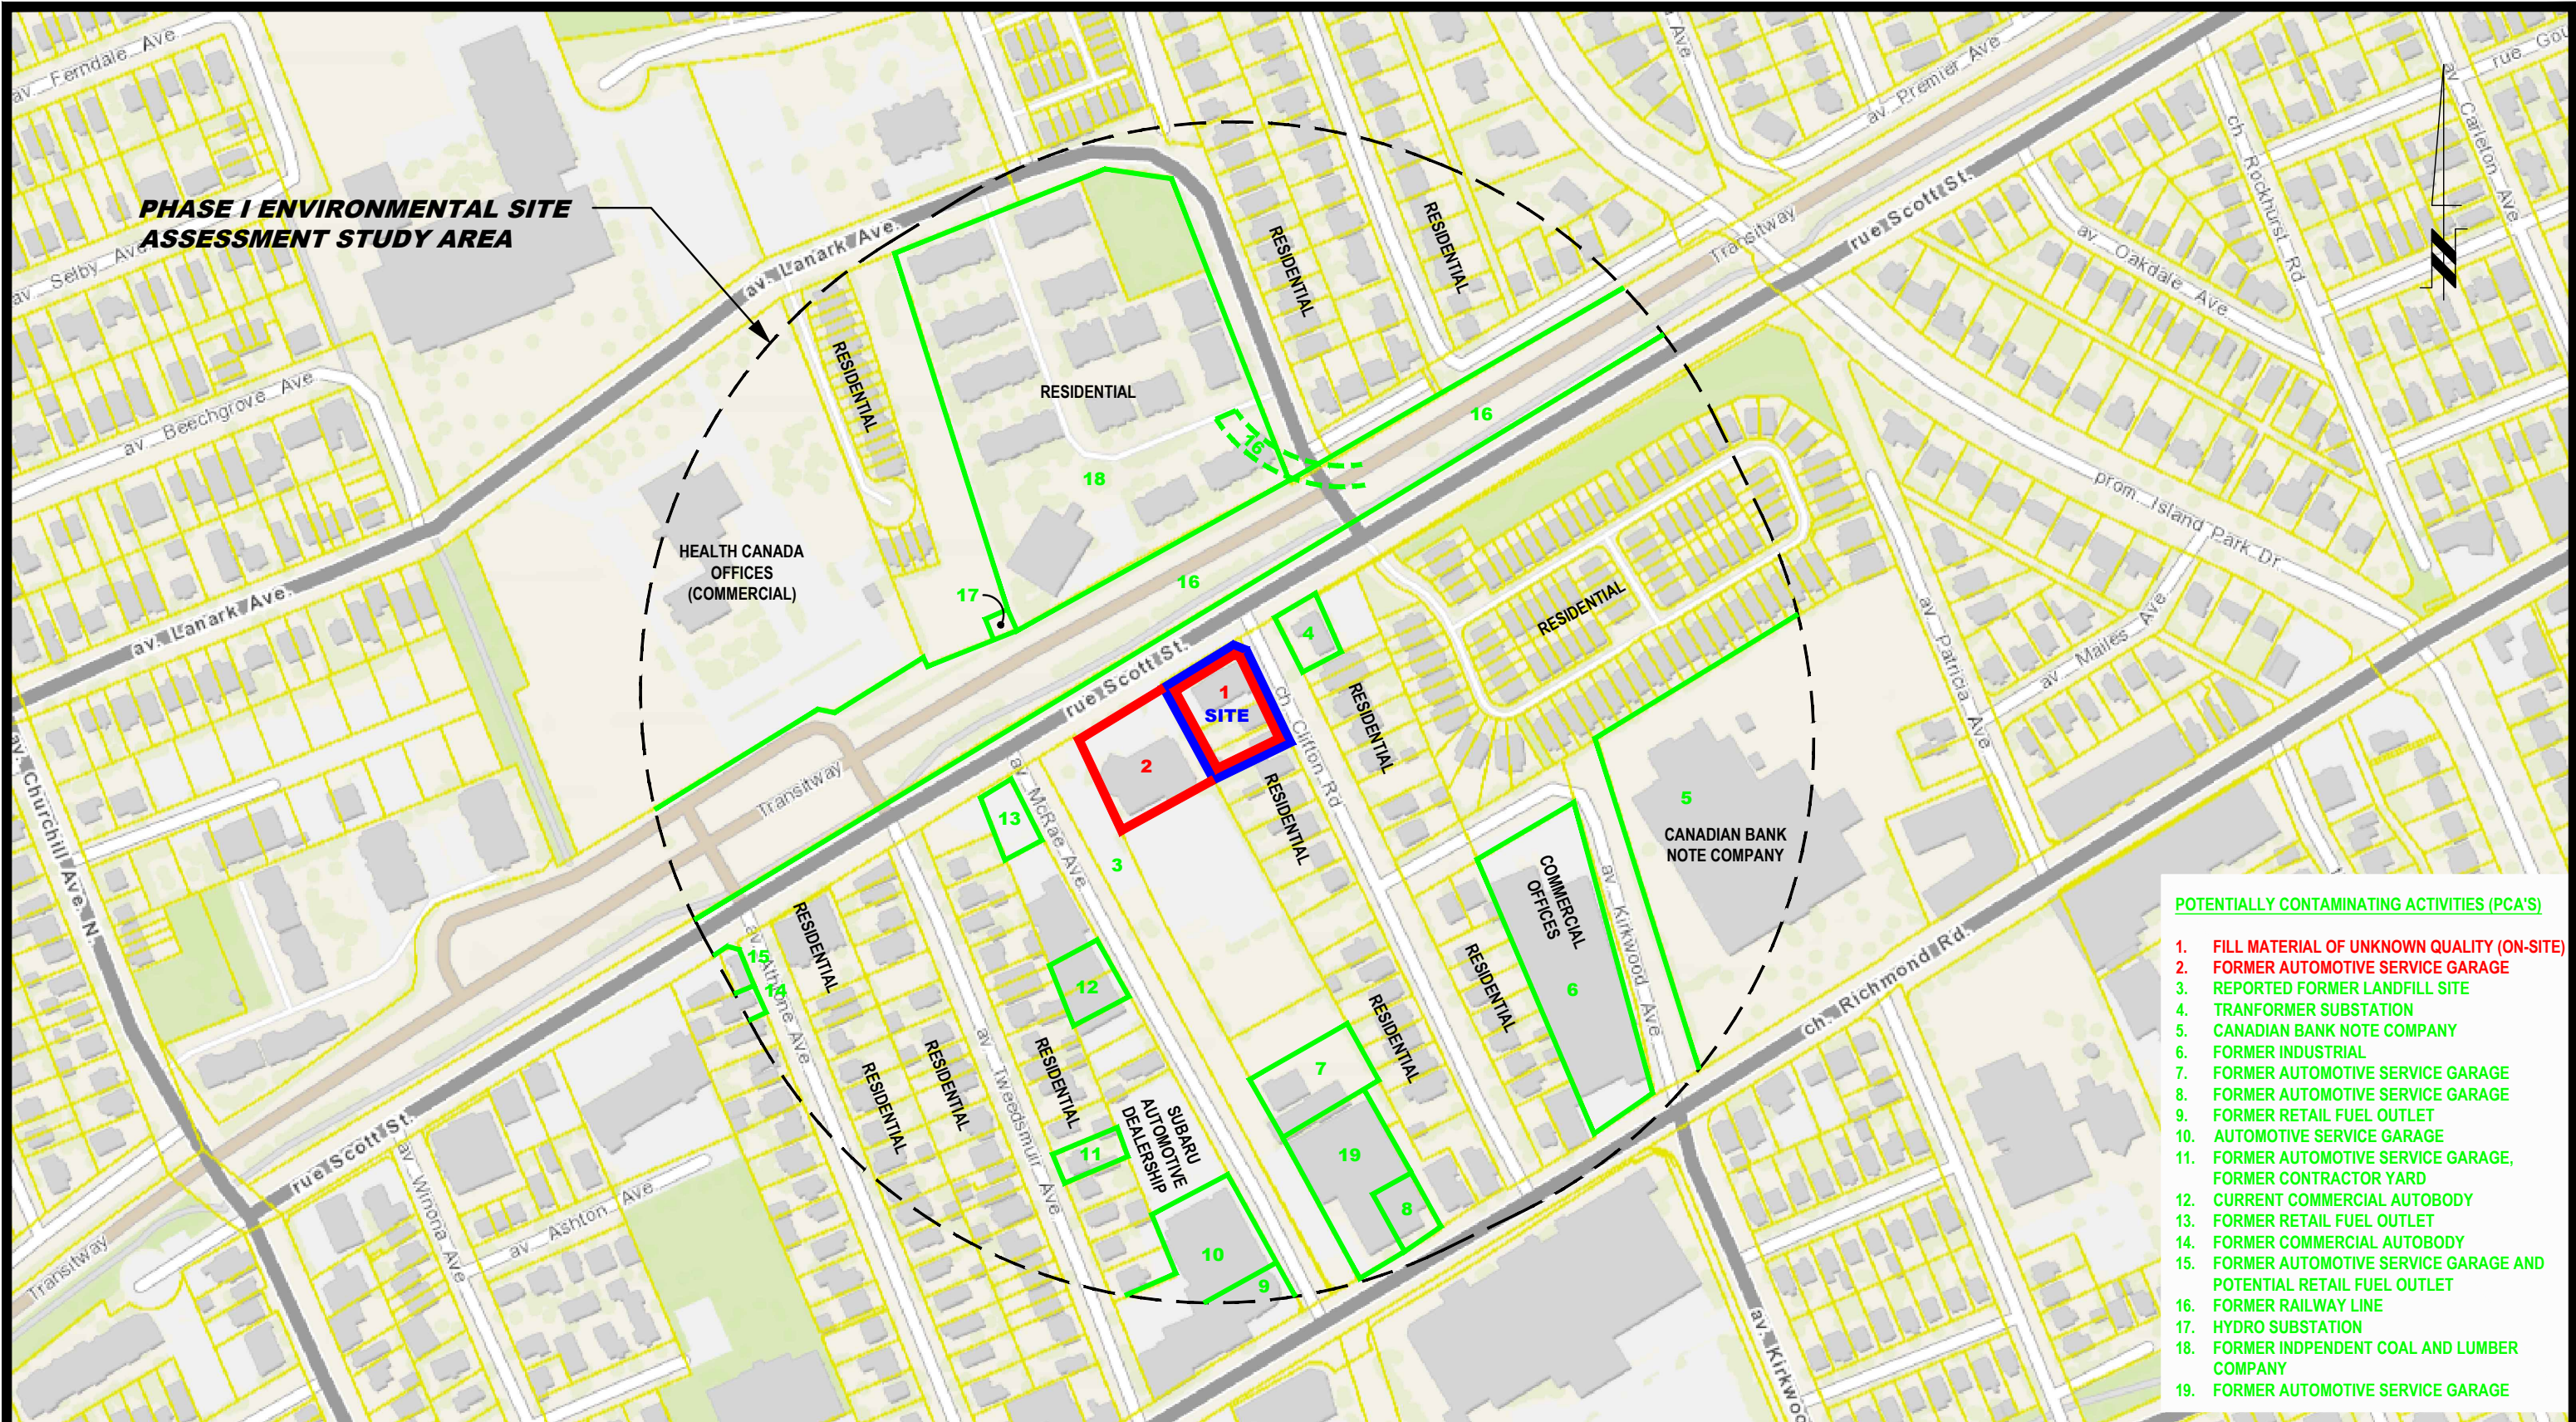
DRAWING PE4995-2 – SURROUNDING LAND USE PLAN

POTENTIALLY CONTAMINATING ACTIVITIES (PCA'S)

- 1. **FILL MATERIAL OF UNKNOWN QUALITY (ON-SITE)**
- 2. **FORMER AUTOMOTIVE SERVICE GARAGE**
- 3. **REPORTED FORMER LANDFILL SITE**
- 4. **TRANSFORMER SUBSTATION**
- 5. **CANADIAN BANK NOTE COMPANY**
- 6. **FORMER INDUSTRIAL**
- 7. **FORMER AUTOMOTIVE SERVICE GARAGE**
- 8. **FORMER AUTOMOTIVE SERVICE GARAGE**
- 9. **FORMER RETAIL FUEL OUTLET**
- 10. **AUTOMOTIVE SERVICE GARAGE**
- 11. **FORMER AUTOMOTIVE SERVICE GARAGE, FORMER CONTRACTOR YARD**
- 12. **CURRENT COMMERCIAL AUTOBODY**
- 13. **FORMER RETAIL FUEL OUTLET**
- 14. **FORMER COMMERCIAL AUTOBODY**
- 15. **FORMER AUTOMOTIVE SERVICE GARAGE AND POTENTIAL RETAIL FUEL OUTLET**
- 16. **FORMER RAILWAY LINE**
- 17. **HYDRO SUBSTATION**
- 18. **FORMER INDEPENDENT COAL AND LUMBER COMPANY**
- 19. **FORMER AUTOMOTIVE SERVICE GARAGE**

The remaining off-site PCAs noted above are not considered to represent areas of potential environmental concern (APECs) on the Phase I Property based on their separation distances and/or cross or down gradient orientations with respect to the subject site. The locations of the aforementioned PCAs, are depicted on Drawing PE4995-2 - Surrounding Land Use Plan.

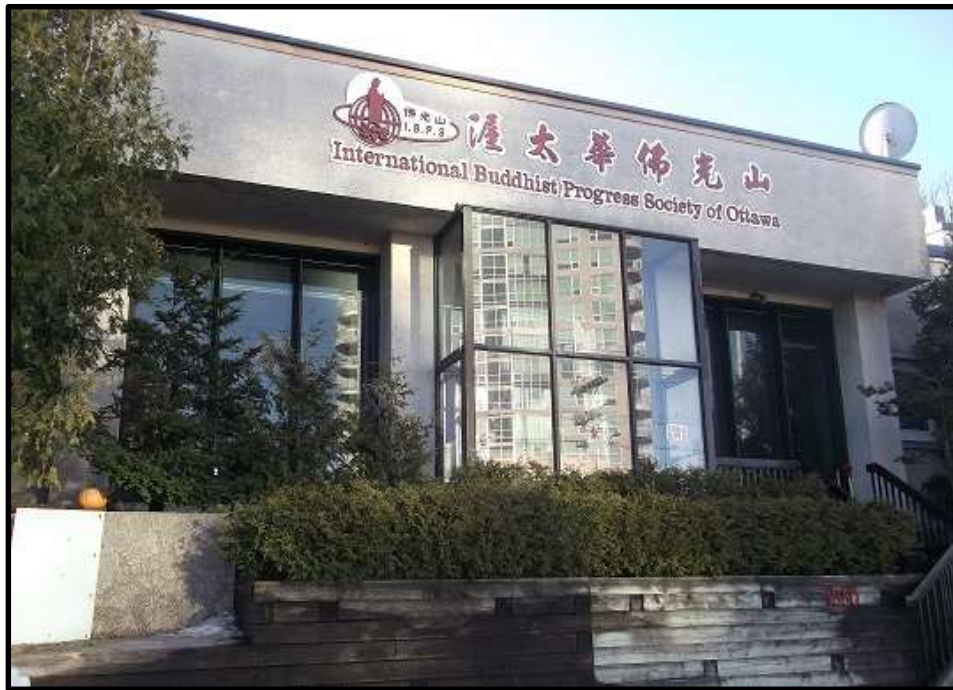
Photograph 1: North face of subject building at 1950 Scott Street, facing southeast.

The parcel of the Phase I Property addressed 1950 Scott Street, is occupied by the International Buddhist Progress Society of Ottawa. The building structure has one storey with a basement level and is constructed with a poured concrete foundation and concrete walls. The exterior is finished with parging and a flat, tar and gravel style roof. The building, constructed as early as 1953, is currently heated with electricity.

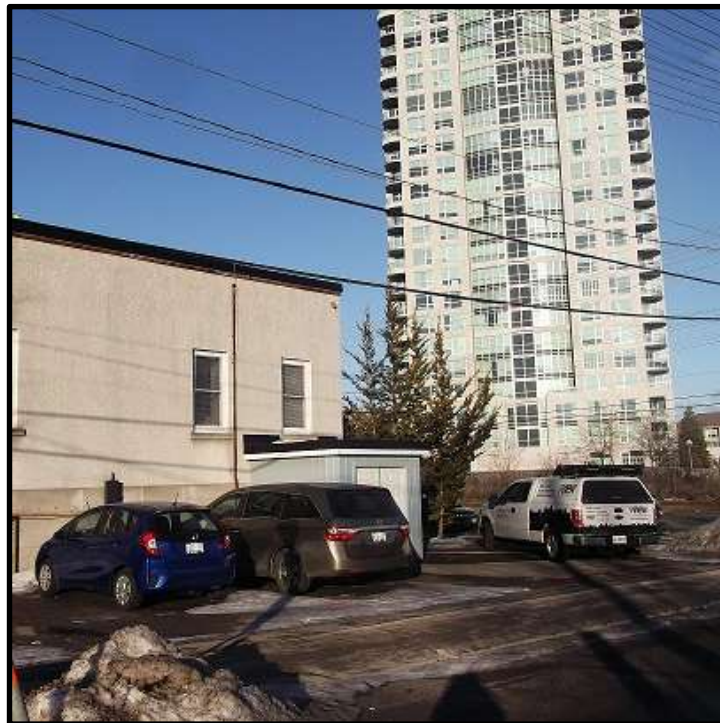
Photograph 2: East face of subject building addressed 1950 Scott Street, facing northwest. Photograph also depicts residential property to the north, across Scott Street.

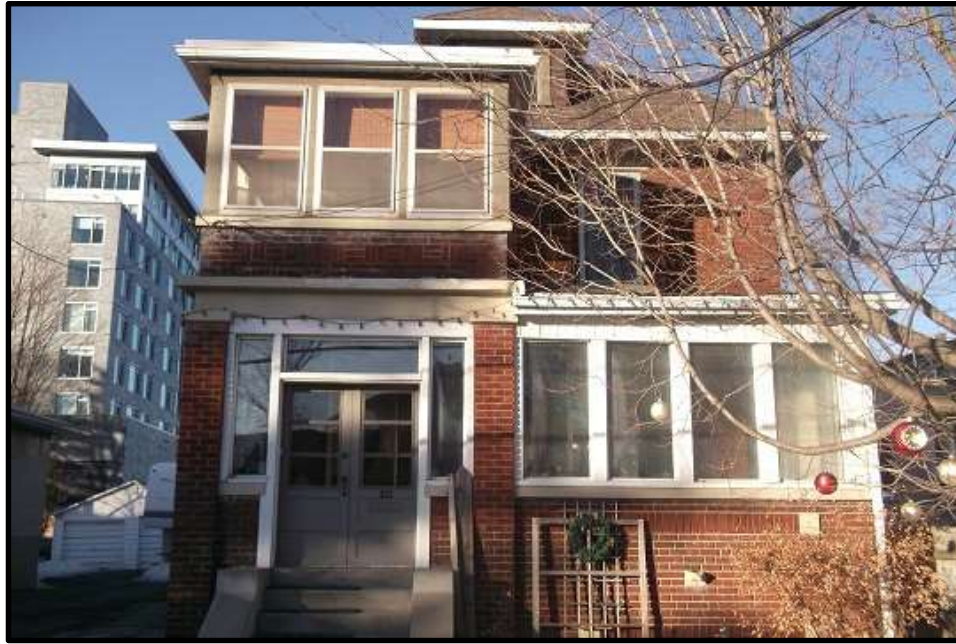
Photograph 3: East face of subject building at 312 Clifton Road, facing west.

A residential dwelling, private garage and two (2) storage sheds occupy the property addressed 312 Clifton Road. The dwelling is constructed with a stone and mortar foundation and is finished on the exterior with brick and a peaked roof covered with asphaltic shingles. The dwelling is currently heated with natural gas-fired equipment. The private garage is a wood frame structure with a poured slab-on-grade foundation, finished on the exterior with vinyl siding and parging with a peaked roof covered with asphaltic shingles. The storage sheds are temporary metal frame structures. The dwelling and private garage are considered to have been constructed as early as 1928.

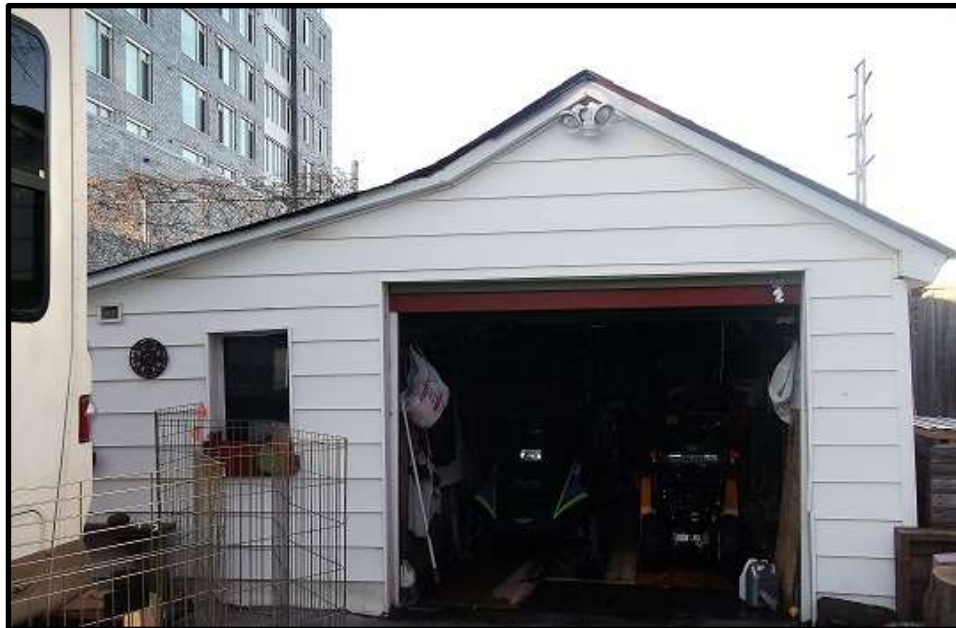
Photograph 4: View of private garage at 312 Clifton Road, facing west. Photograph also illustrates newly constructed residential building (2015) immediately southwest of the Phase I Property.
