**ENVIRONMENTAL IMPACT STATEMENT
and
TREE CONSERVATION REPORT**

PROPOSED MIXED USE DEVELOPMENT

**WEST of PALLADIUM DRIVE
KANATA WEST
CITY of OTTAWA**

January, 2014

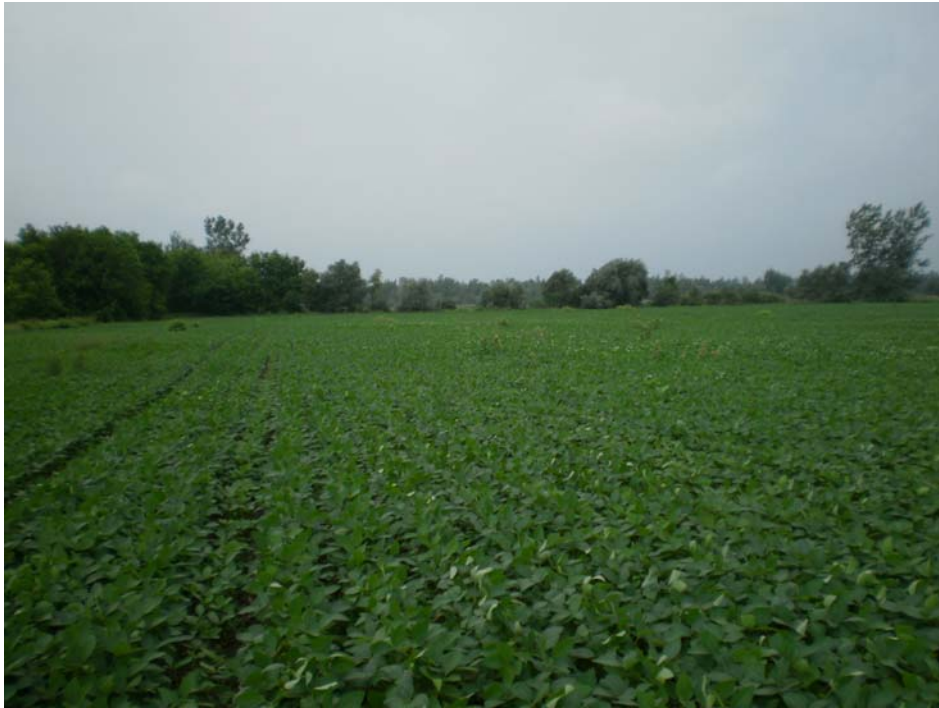
Photo 1 – Soybean fields dominate the north portion of the site. This is the north - central field with view looking west to intermittent deciduous hedgerow (July 10th, 2013)

Outside of the Feedmill Creek corridor, the site is dominated by open agricultural lands, with deciduous hedgerows separating the fields and on the site peripheries (Photo 1). Cultural meadow, thicket and woodland habitats are in the west portion of the site, which is now out of agricultural production (Map 1). All of the lands outside of the Feedmill Creek corridor and the deciduous hedgerows are in agricultural use on 1976 aerial photography.

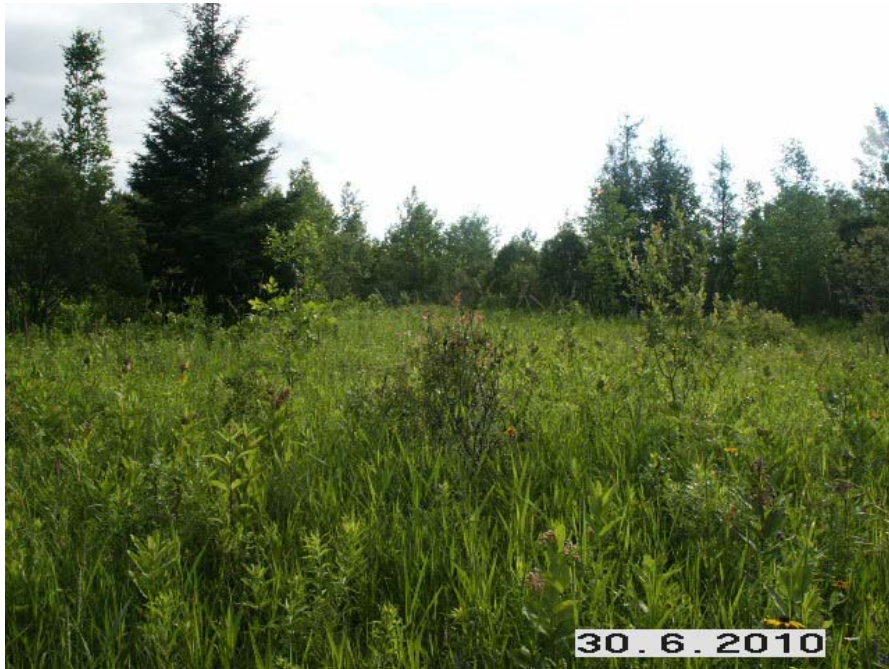
Photo 2 –Cultural meadow habitat in the central-west portion of the site

The majority of the site outside of the Feedmill Creek corridor was cultivated in corn in the south and soybean in the north in 2009 - 2013. Cultural meadow vegetation adjacent to the cultivated fields includes reed canary grass, common dandelion, St. John's wort, Canada goldenrod, tall goldenrod, late goldenrod, common milkweed, narrow-leaved meadowsweet, wild parsnip, ox-eye daisy, June meadow grass and common buckthorn, slender willow and red-osier dogwood shrubs (Photo 2).

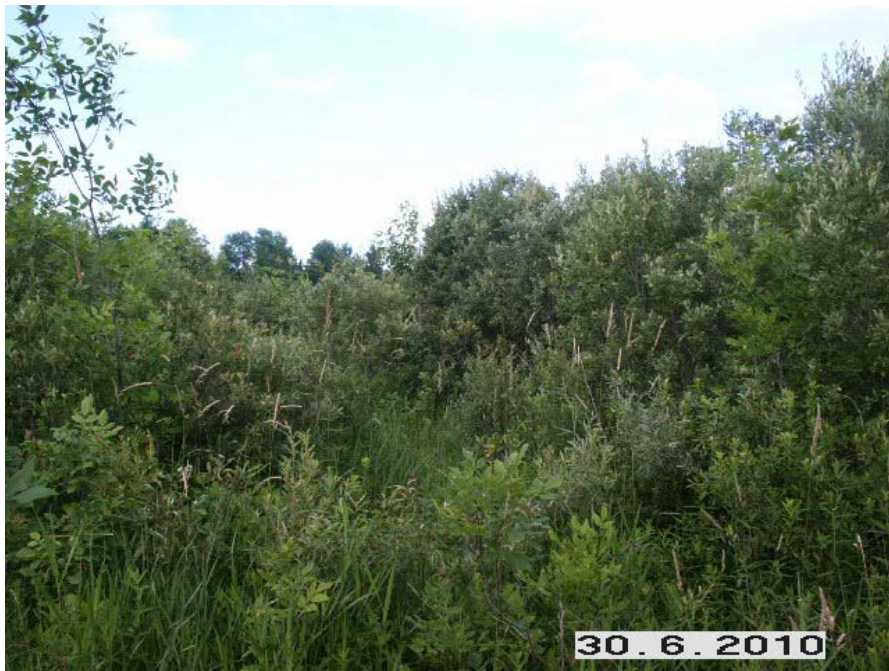
Photo 3 – Cultural thicket habitat in the southwest portion of the site

Cultural thickets in the west portion of the site are dominated by common buckthorn, glossy buckthorn, red-osier dogwood, Bebb's willow, slender willow, pussy willow and red raspberry. Glossy buckthorn is dominant in the central part of the thicket habitat. Scattered regenerating stems of balsam poplar, trembling aspen, red ash, white elm, white cedar and tamarack are up to 20cm dbh. Canada and tall goldenrod are abundant ground cover in the cultural thicket, along with common dandelion, wormseed mustard, tufted vetch, brown-eyed susan, timothy, Philadelphia fleabane, daisy fleabane, bird's-foot trefoil, red clover, tall buttercup, ox-eye daisy, common yarrow, white-sweet clover, joe-pye-weed, blue vervain, yellow avens, purple loosestrife, orchard grass, awnless brome grass, wild grape, helleborine, Virginia creeper, common milkweed, blue violet and wild madder (Photo 3).

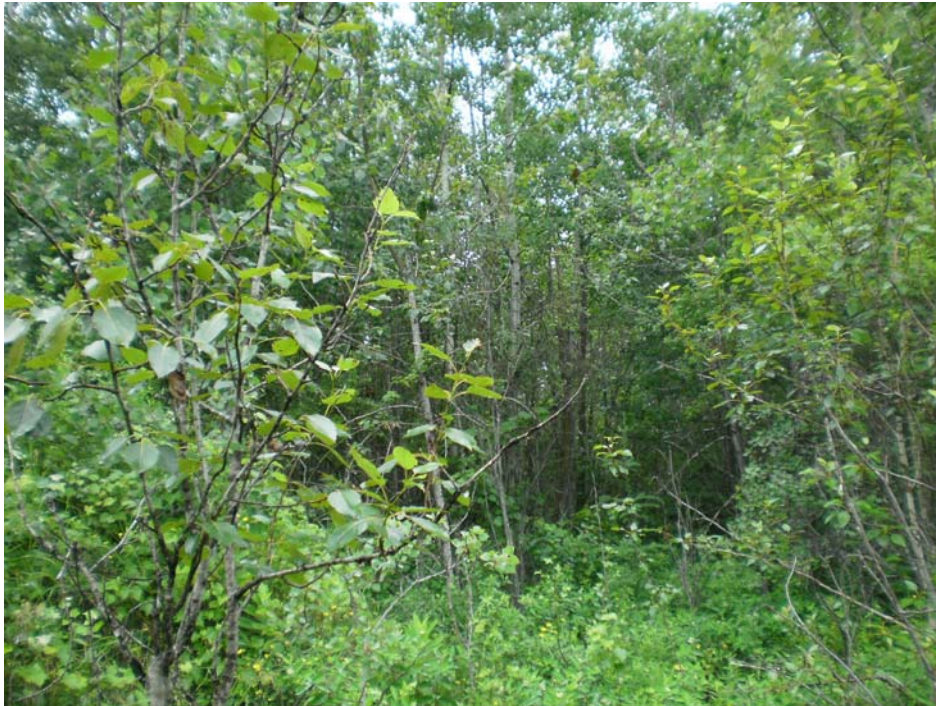
Photo 4 – Cultural woodland in the northwest portion of the site (July 10th, 2013)

Cultural woodlands are also in the northwest portion of the site (Photo 4). Poplars (trembling aspen, balsam poplar and eastern cottonwood) up to 27cm dbh are very common on this former agricultural land. Bebb's willow, pussy willow, nannyberry, grey dogwood and common buckthorn shrubs are well represented along with regenerating poplar, white spruce, white cedar and white poplar stems. Ground flora includes white-sweet clover, blueweed, black-eyed susan, bladder campion, bird's-foot trefoil, Canada goldenrod, ox-eyed daisy, tufted vetch, wild carrot, daisy fleabane, scouring rush, common milkweed, and flowering dogbane. Wild grape growth is on some of the trees and shrubs.

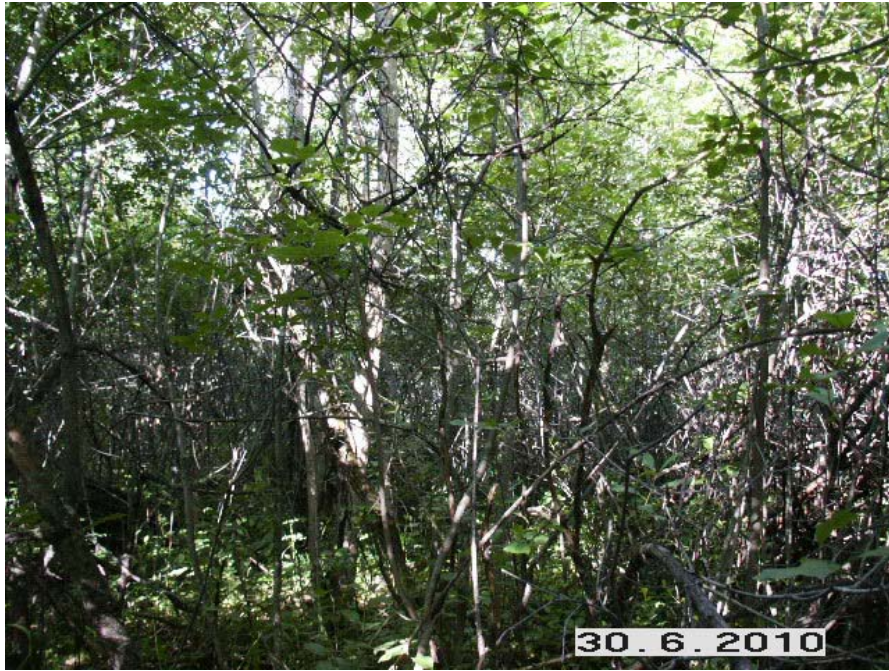
Photo 5 – Young poplar deciduous forest with thick buckthorn in understory

This community, in the central-west portion of the site, occurs where the poplar coverage is greater than 60 percent adjacent to the cultural thickets dominated by buckthorn to the east and north and willow thickets to the south (Photo 5, vegetation community 5 on Map 1). Glossy buckthorn continues to be dominant in the understory, with regenerating red ash stems in many areas. Balsam poplar, trembling aspen and white birch are the common tree species, with pockets of dense white cedar up to 22cm dbh. Most deciduous trees are less than 20cm dbh, with a few poplars up to 32cm dbh. Many of the young tree trunks and limbs are broken in this scrub-like vegetation unit, with wind throw and ice storm damage appearing extensive. Wild grape coverage is extensive on many trees and shrubs. Canada goldenrod, tall goldenrod, poison ivy, wild grape, common dandelion, field horsetail, daisy fleabane, white snakeroot, Virginia creeper, enchanter's nightshade, tall meadow-rue, blue violet, tall buttercup, common burdock and sensitive fern are representative of the ground flora generally dominated by non-native and/or invasive species.

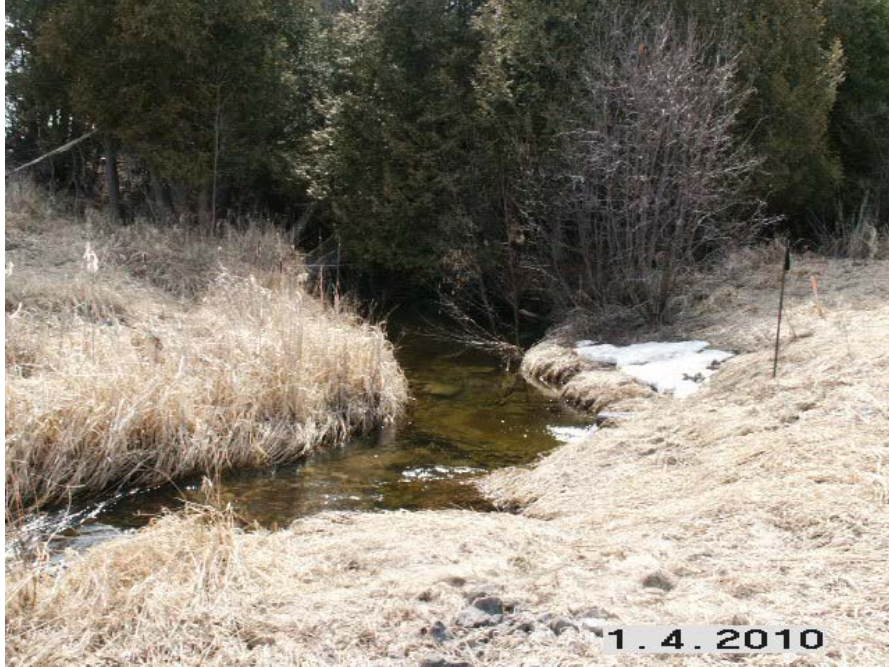
Photo 8 – Feedmill Creek emerging from the mixed forest just west of Palladium Drive. View looking southwest

In the southwest portion of the site Feedmill Creek meanders along the periphery of and through a mixed forest (Photo 8). A breeched beaver dam was through the creek in the south-central portion of the west part of the site. This likely accounted for standing water observed to the north of Feedmill Creek in this area on 2005 and 2008 aerial photography. The lack of a dam should assist in maintaining a cool water thermal regime for Feedmill Creek. In addition to stream shading, the good canopy cover in most this reach will provide a source of woody debris, bank erosion protection, surface water filtering and a cool microclimate (Robinson, 2004).

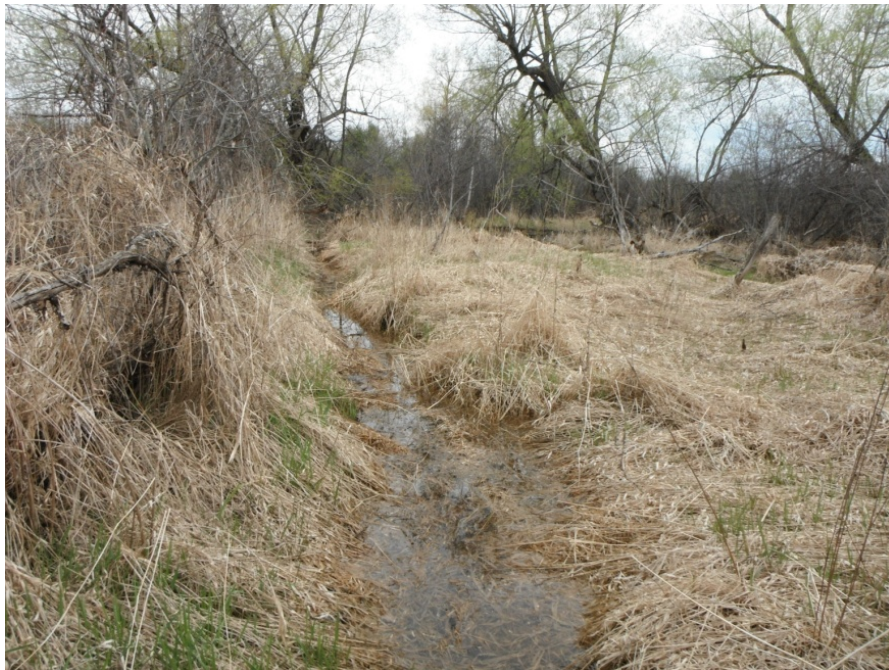
Photo 10 - Station D3 along the same southwest tributary just upstream of the confluence with Feedmill Creek (April 30th, 2012)

Three stations were sampled along the tributary with an electrofisher and dip nets. Electroshocking was completed for a station length of 35 metres at 50-100 volts, and 1.5-1.7 amps. The water temperature was 11.8° C, with an air temperature of 16.0° C at 14:30. The conductivity was 875 µs, with a pH of 7.47 and total dissolved solids of 450 ppm. The downstream sampling station included a pool. The average wetted widths and depths were 1.8 metres and 13 cm, respectively (Photos 9 and 10). The area fished was 37 m² and the shock time was 27 seconds. No fish were captured or observed using either the electrofisher or a total of ninety- three dips at the three sampling stations.

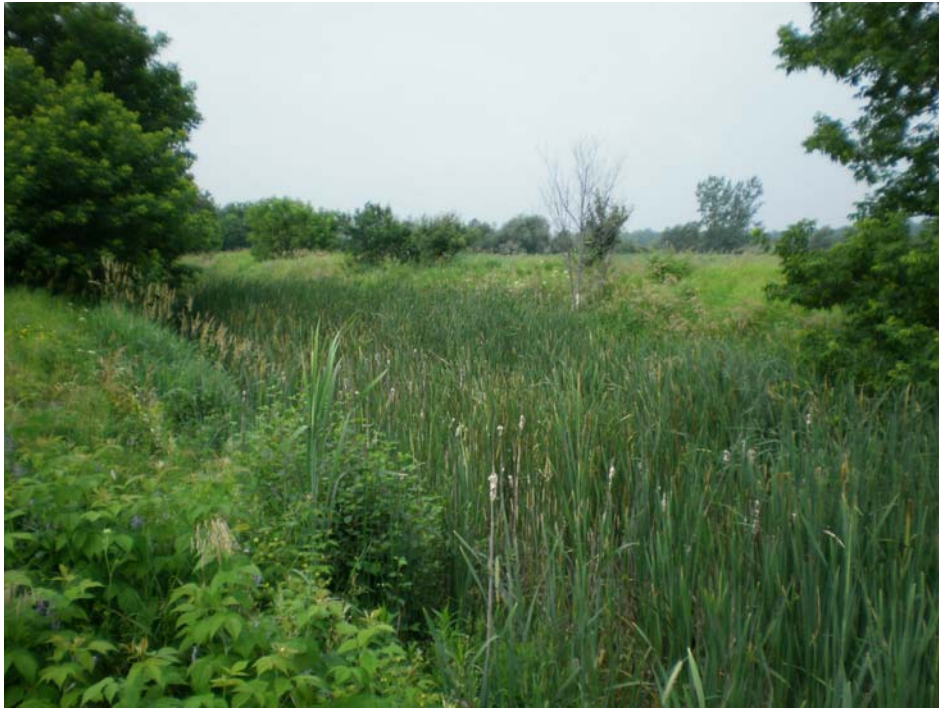
*Photo 11 – West-east channel in the north-central portion of the site.
View looking west (July 10th, 2013)*

A west to east channel in the north portion of the site parallels the north site boundary and enters Feedmill Creek via a roadside swale on the west side of Huntmar Drive. Broad-leaved cattails were well established in most reaches of the channel with hard-stemmed bulrush, water plantain, purple loosestrife, path rush, wool grass, European reed and bittersweet nightshade also present (Photo 11). Water depths on July 10th, 2013 were up to 30cm. The slopes were well vegetated with reed canary grass, bird's-foot trefoil, brome grass, tufted vetch, blueweed, wild carrot, common burdock, orchard grass, colt's-foot, wild grape, boneset, narrow-leaved goldenrod, joe-pye-weed and speckled alder and slender willow shrubs. North-side agricultural channels flow from the north into the west-east channel. These channels were generally dry on July 10th, 2013 with pockets of water up to 9cm (Photo 12).

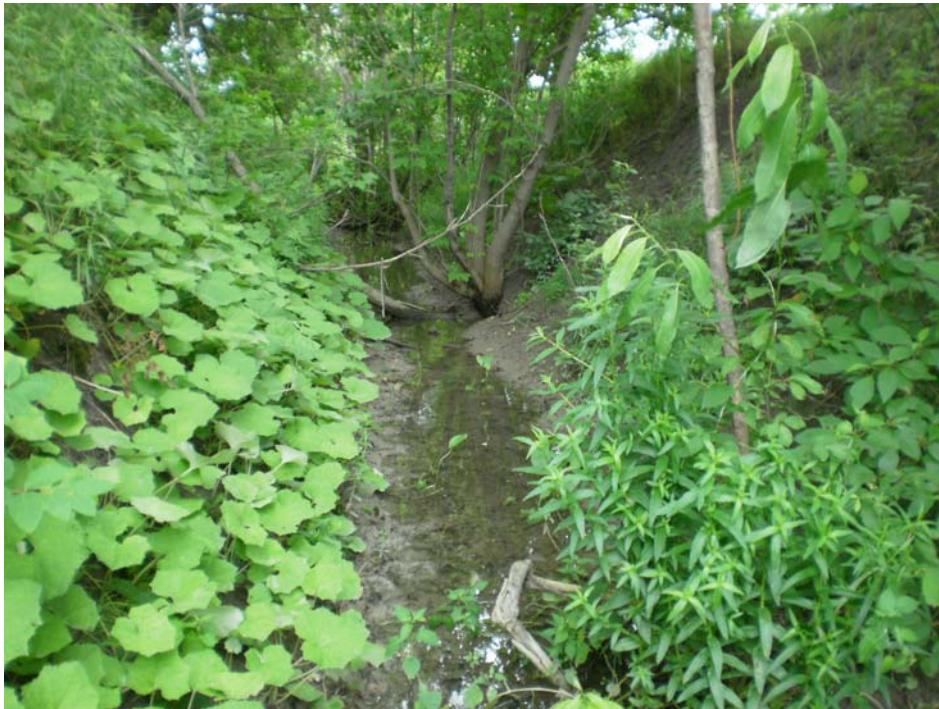
Photo 12 – North-south channel joining the west-east channel in the north-central portion of the site. View looking north (July 10th, 2013)

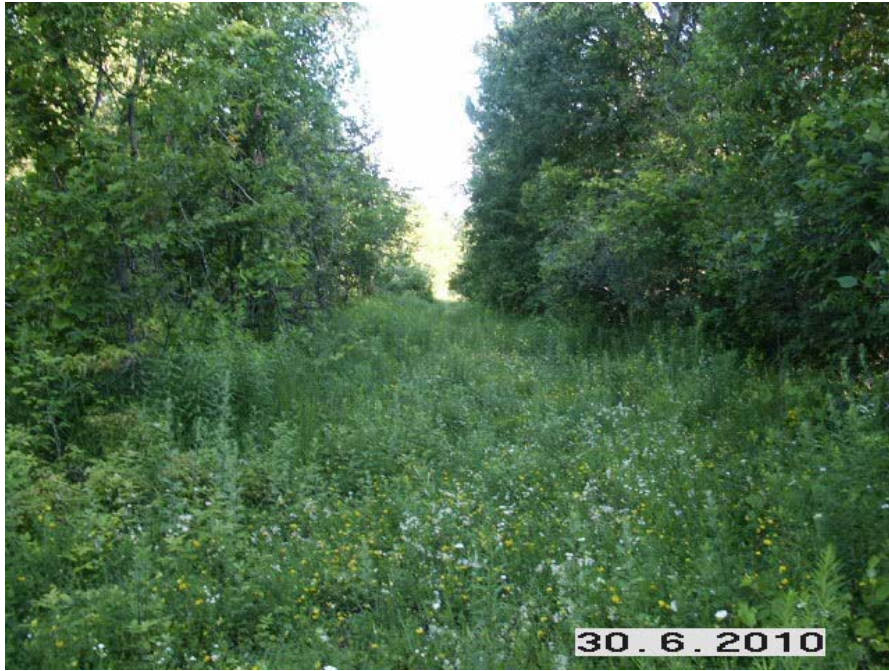
*Photo 13 – Old access lane along central and north portion of west edge of site.
View looking north, with west edge of site on right*

The oldest of the on-site trees would be in the range of 60 – 70 years old, although the vast majority are much younger. Although the site is in the urban area, the adjacent lands to the west are in the rural area. Of the three criteria that must be met for identifying significant woodlands in the rural portion of the City of Ottawa, the east edge of the adjacent forest does not contain forest interior habitat or mature stands of trees 80 years of age or older. Lands further to the west that could not be observed from the west edge of the site were not surveyed due to access concerns and may meet the rural criteria for significant woodlands. However, as described below the adjacent woodlands will be protected and no impacts are anticipated on any significant woodlands that may be present off-site in the woodlands. An access trail is along the west edge of the site, providing a break in the young forest cover (Photo 13).

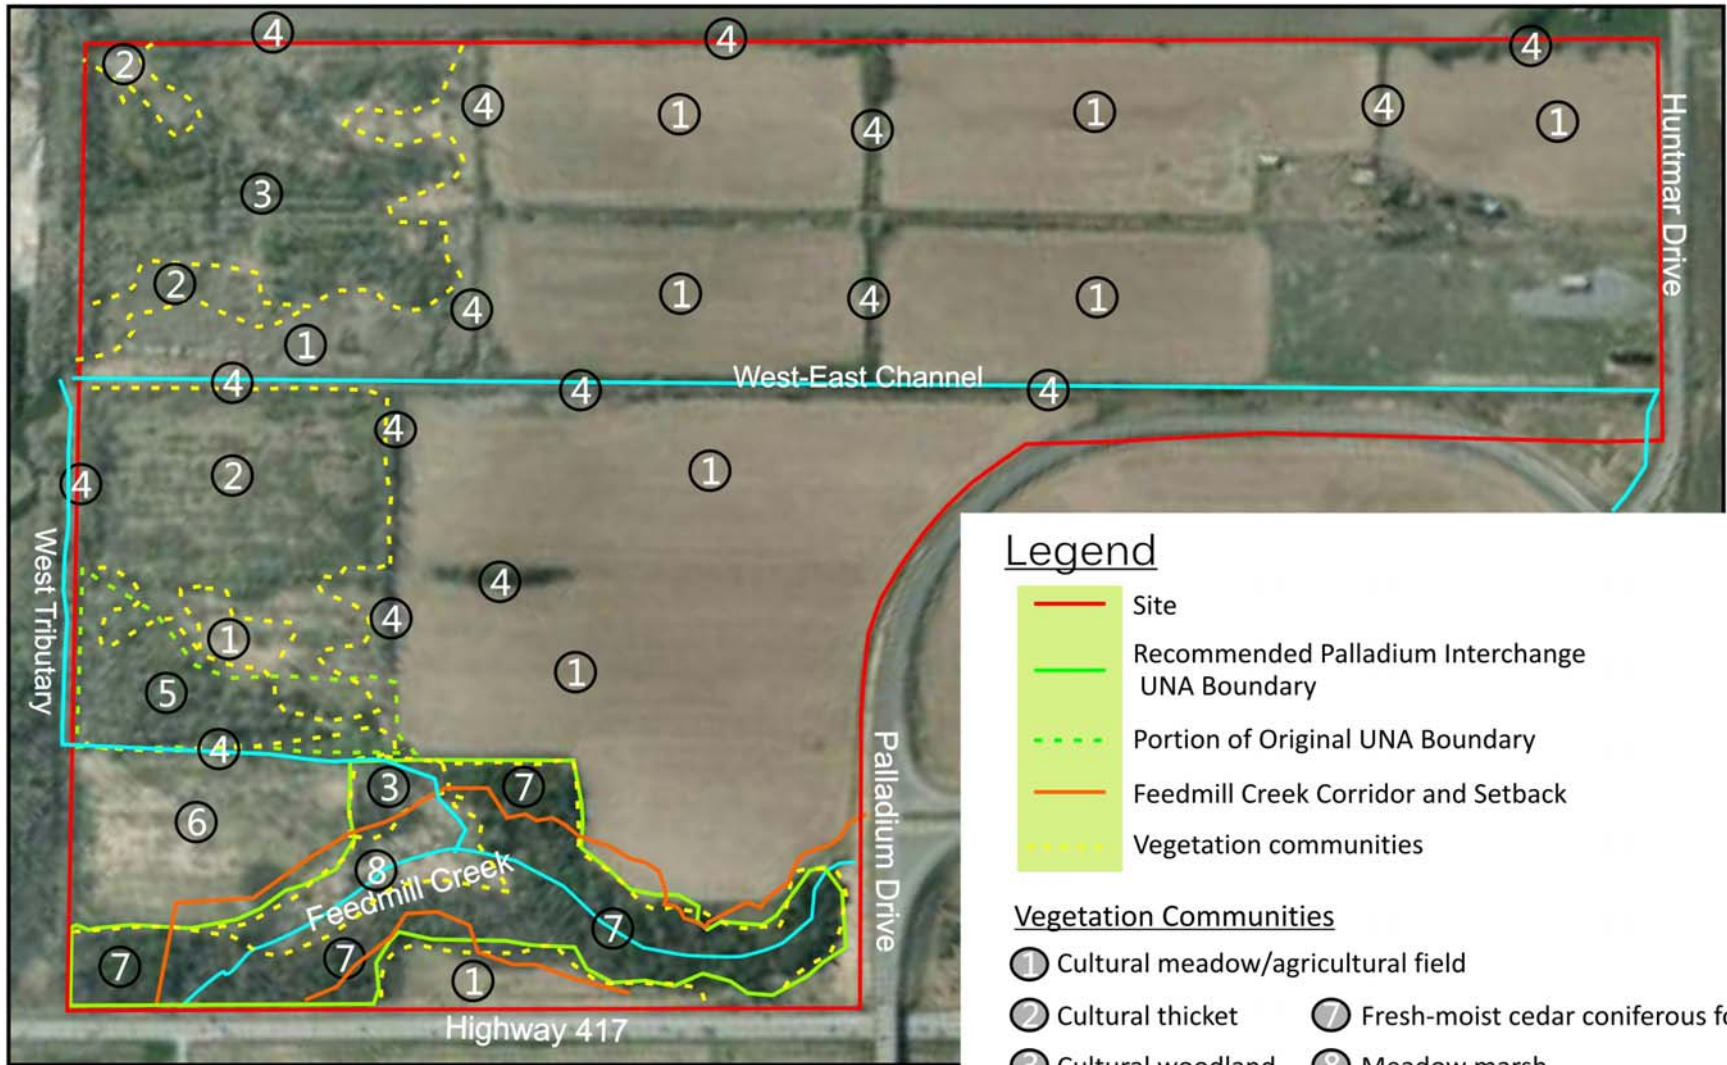
CURRENT VEGETATION

Where willow shrubs are dominant, the thicket habitat on Map 1 is referred to as a willow thicket (vegetation community 6 on Map 1).

Trembling aspen, white birch, red ash, white ash, balsam poplar and white elm are the dominant tree species in the deciduous hedgerows, identified as vegetation community 4 on Map 1. Crack willow, Manitoba maple, white cedar and sugar maple are also present. The trees are generally intermediate-aged, with the largest poplars in the range of 25 - 30cm diameter at breast height (dbh). A mature coppice crack willow in the central-west east-west hedgerow appears to be in poor condition with major trunk damage. Larger white ash, up to 40cm dbh, are along the west edge of the site. Manitoba maples are dominant in the deciduous hedgerows in the north portion of the site, with eastern cottonwood, crack willow, white birch and white elm well represented. Regenerating Manitoba maple stems are also common in the north hedgerows. Glossy buckthorn is abundant among the trees in the hedgerows with crabapple, hawthorn, slender willow, red raspberry, common buckthorn and gray dogwood also present. Most of the trees appear to be in generally good condition with fungus present on some of the ash and elm and wild grape coverage on many.

Map 1 identifies the recommended Urban Natural Area boundary. The original site Urban Natural Area boundary included more land to the northwest of the Feedmill Creek corridor (shown as a green-dashed line on Map 1). This original boundary was determined without the benefit of on-site examinations. The 2009 and 2010 fieldwork have identified in this area highly disturbed thickets dominated by buckthorn, young poplar forests with the understorey and ground flora dominated by disturbed species and deciduous hedgerows dominated by poplar. No significant features and functions were identified for this area that would add to the Urban Natural Area along the Feedmill Creek corridor. The Feedmill Creek corridor is separated by the original UNA lands to the northwest by thicket habitat.

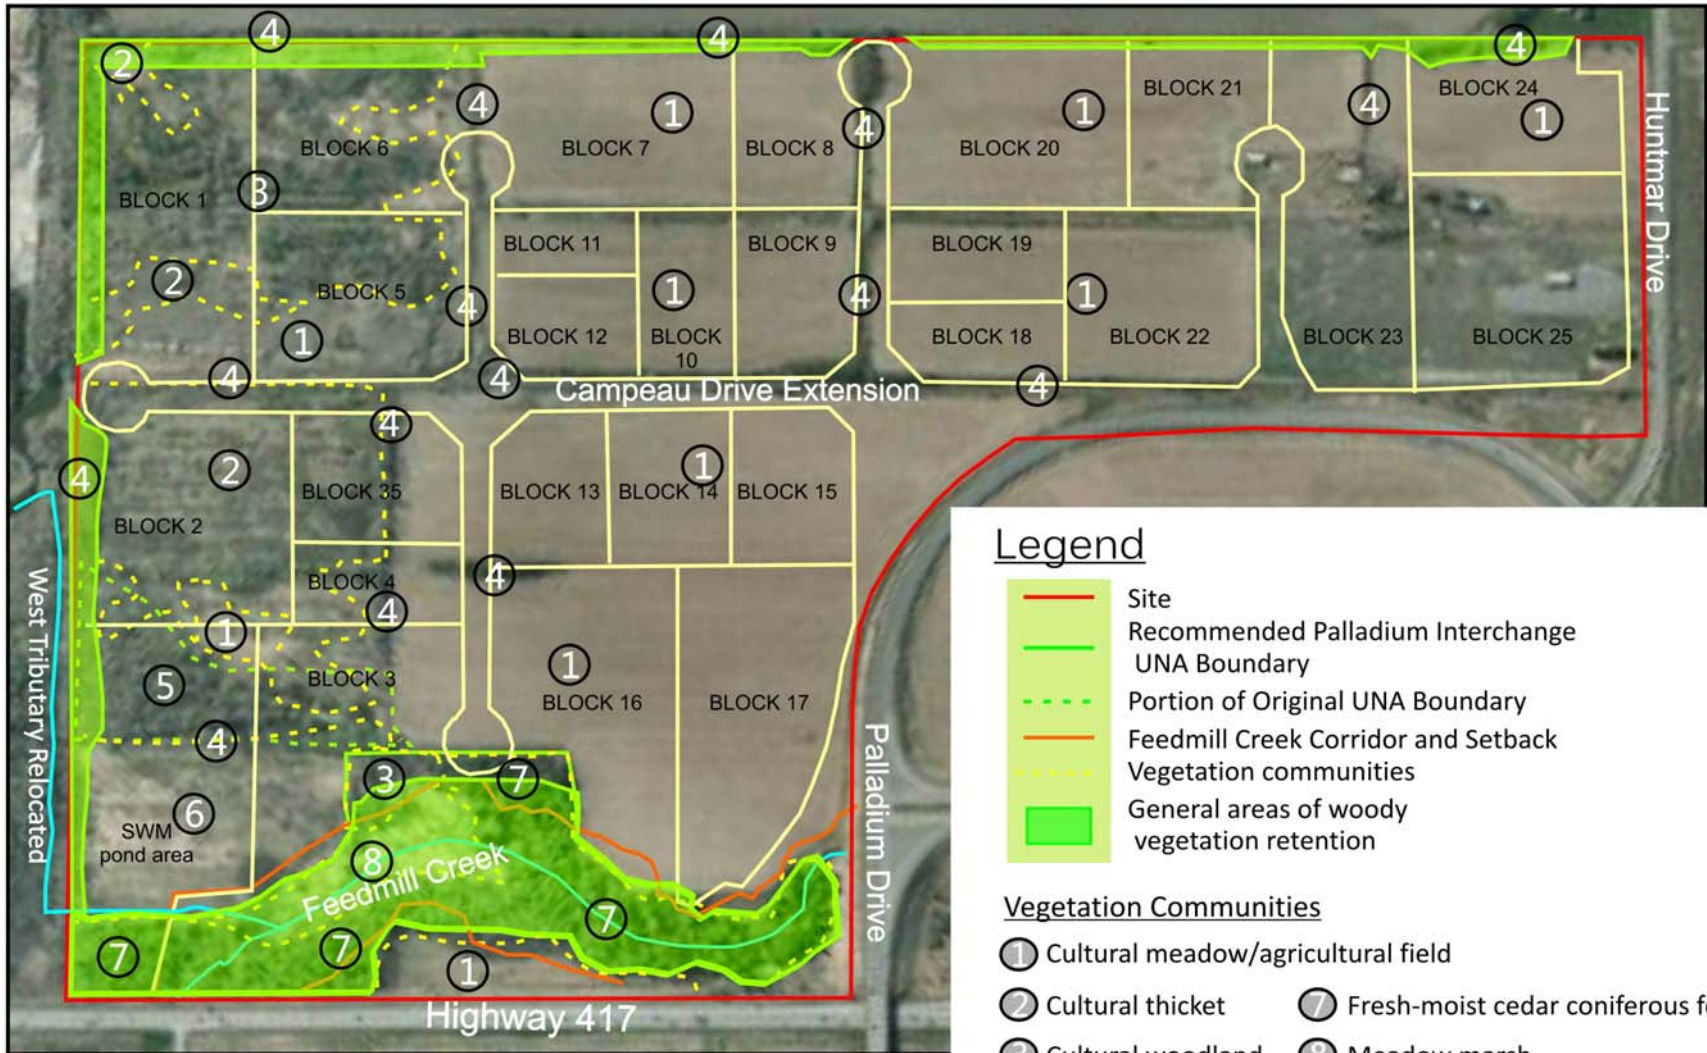
Map 2

PROPOSED CONSERVED VEGETATION
