# **Phase I – Environmental Site Assessment**

304 and 308 Donald Street  
Ottawa, Ontario

Prepared for Upscale Homes

Report: PE6501-1  
April 26, 2024

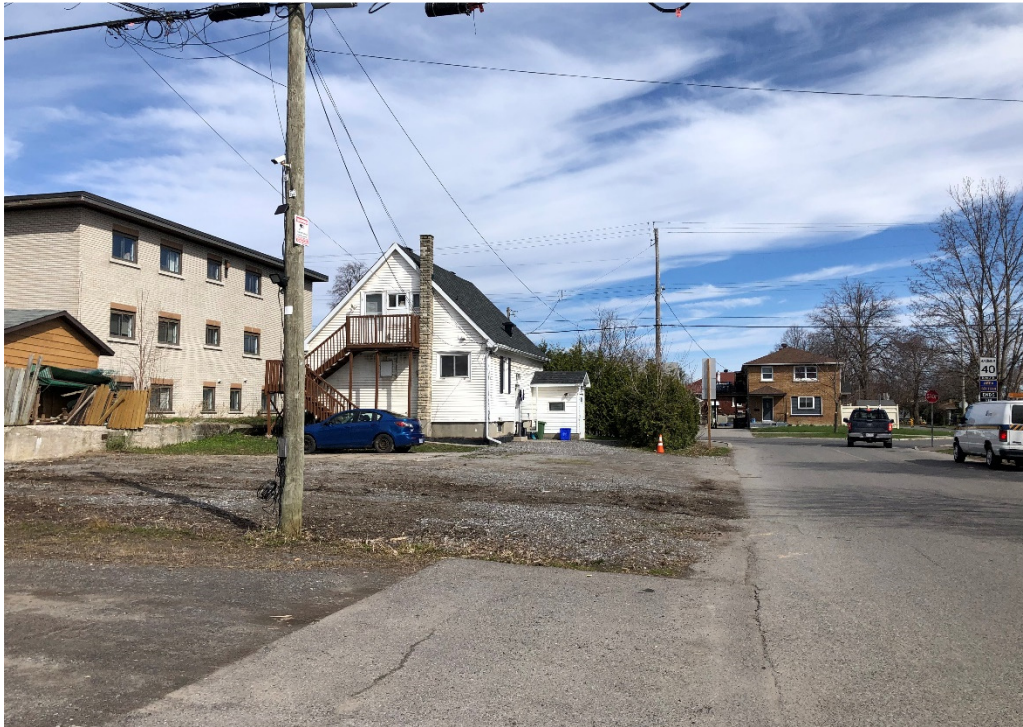
Photograph 1: View looking north, along the west side of the Phase I Property, from Edith Avenue.

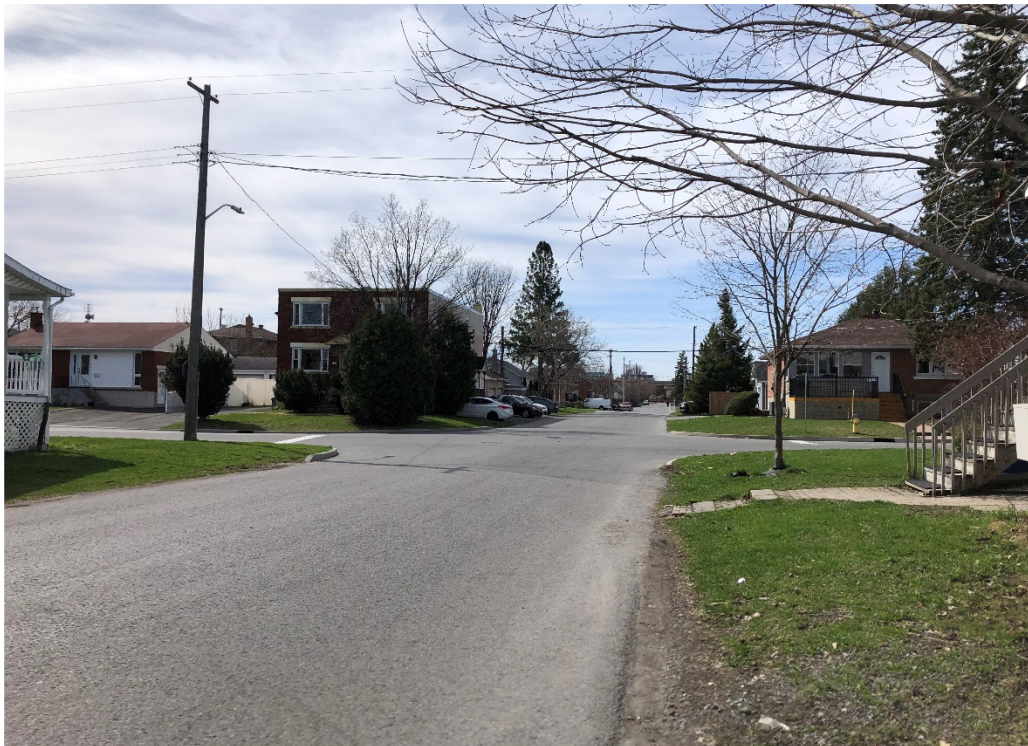
Photograph 2: View looking south, along the west side of the Phase I Property, from Edith Avenue.

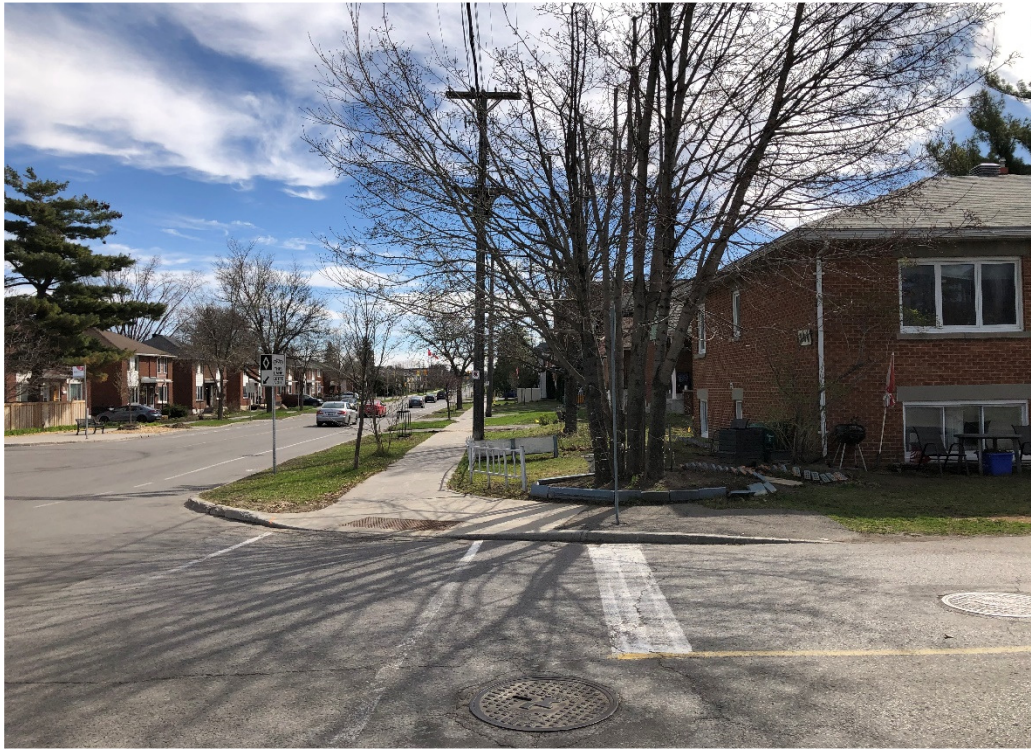
Photograph 3: View looking east, at the intersection of Edith Avenue and Donald Street.

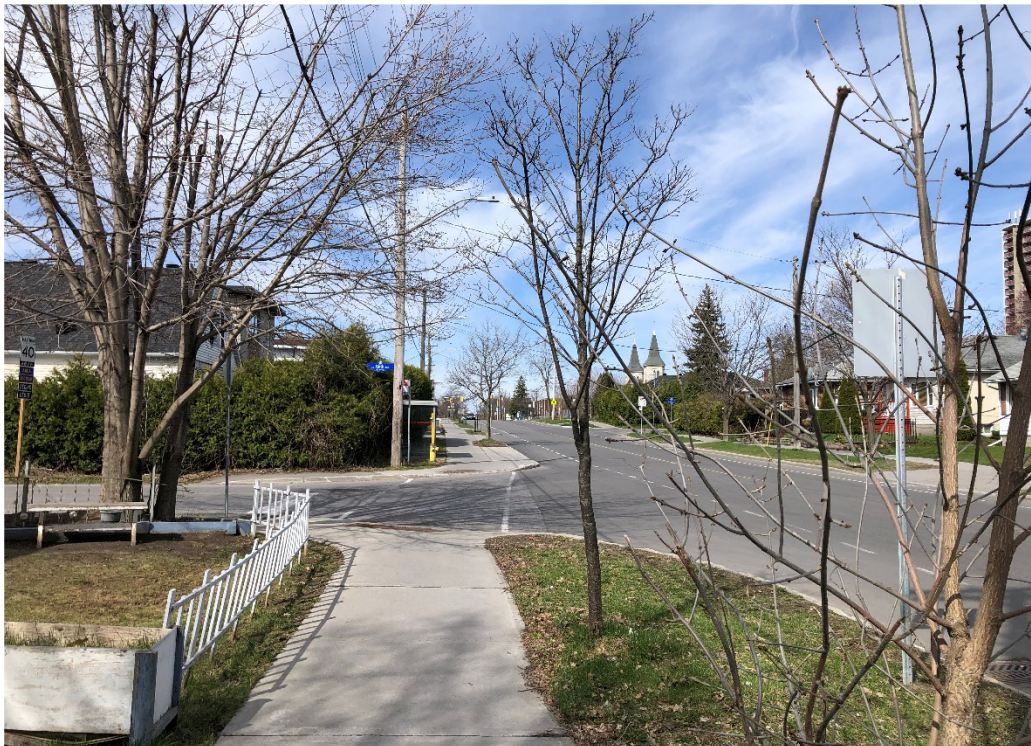
Photograph 4: View looking west, at the intersection of Edith Avenue and Donald Street.

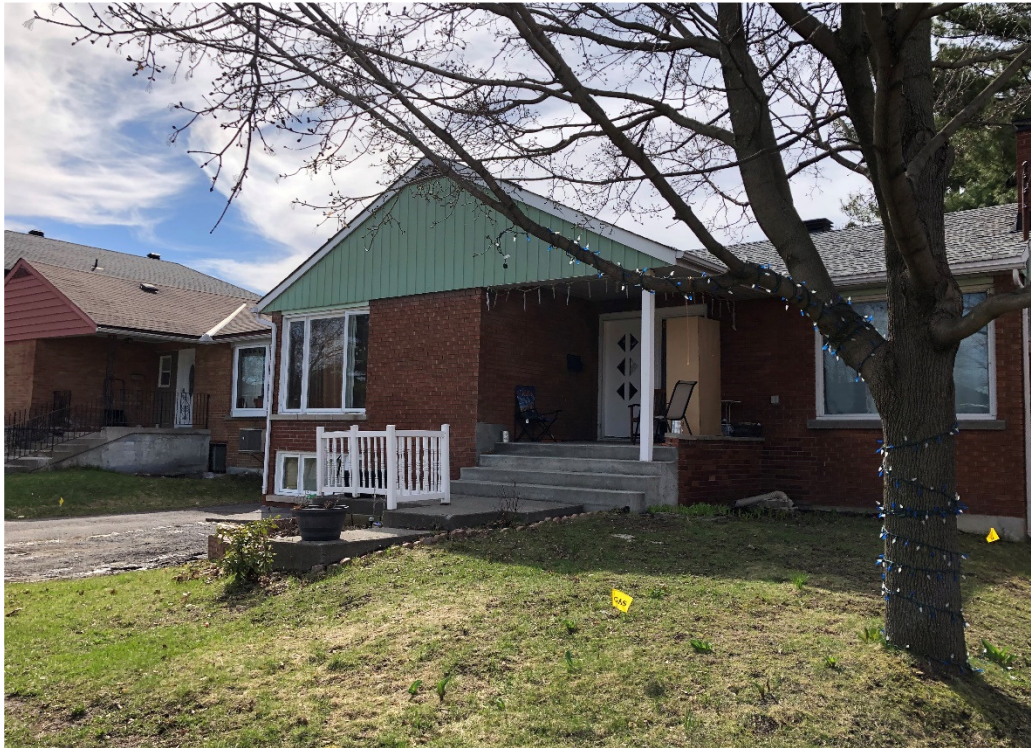
The property addressed 308 Donald Street is occupied by a one-storey residential dwelling, with one full basement level partially submerged. Built sometime in the 1950s, the residence is constructed with a poured concrete foundation and is finished on the exterior with bricks and vinyl siding along the roof. The dwelling has a sloped, shingled roof. The building is currently heated via a natural gas-fired furnace, located in the basement.

Photograph 5: View looking south from Donald Street, towards 308 Donald Street.

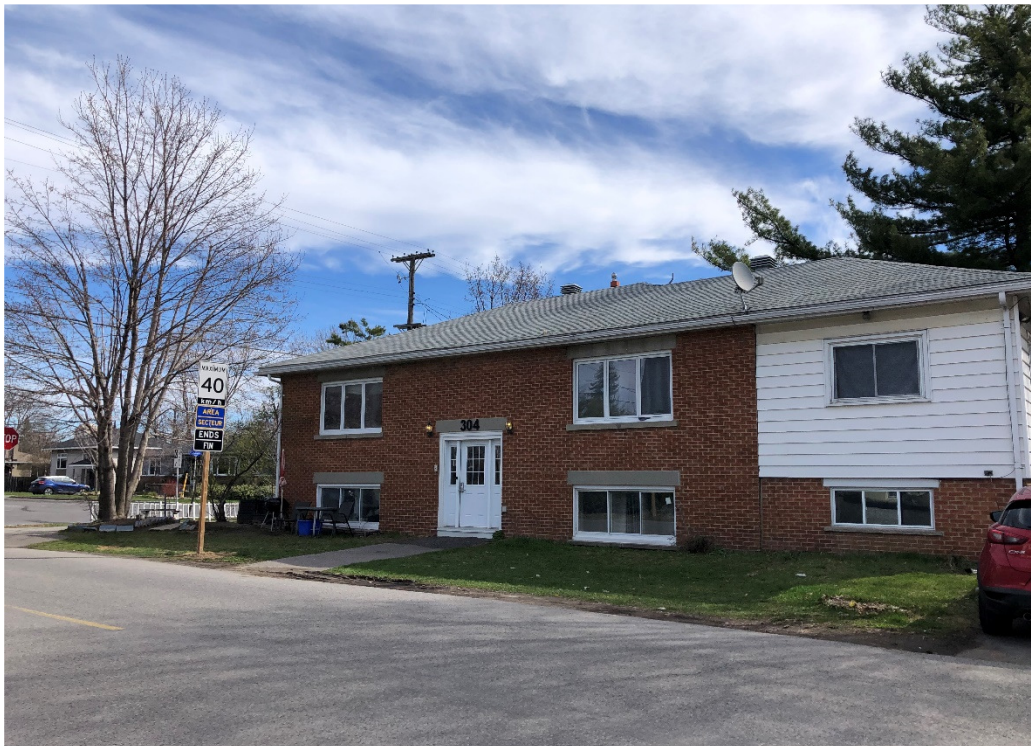
The property addressed 304 Donald Street is occupied a one-storey multi-unit residential building, with one full basement half a level below grade. Built sometime in the 1950s, the residence is constructed with a poured concrete foundation and is finished on the exterior with bricks and vinyl siding at the rear. The building has a sloped, shingled roof. The building is currently heated via a natural gas-fired furnace, located in the basement.

Photograph 6: View looking east from Edith Avenue, towards 304 Donald Street.
