**Updated Environmental Impact Study
for 6160 Thunder Road & 5368 Boundary Road, Ottawa**

2024-08-16

FINAL REPORT

Project Number: AVE 1606.3

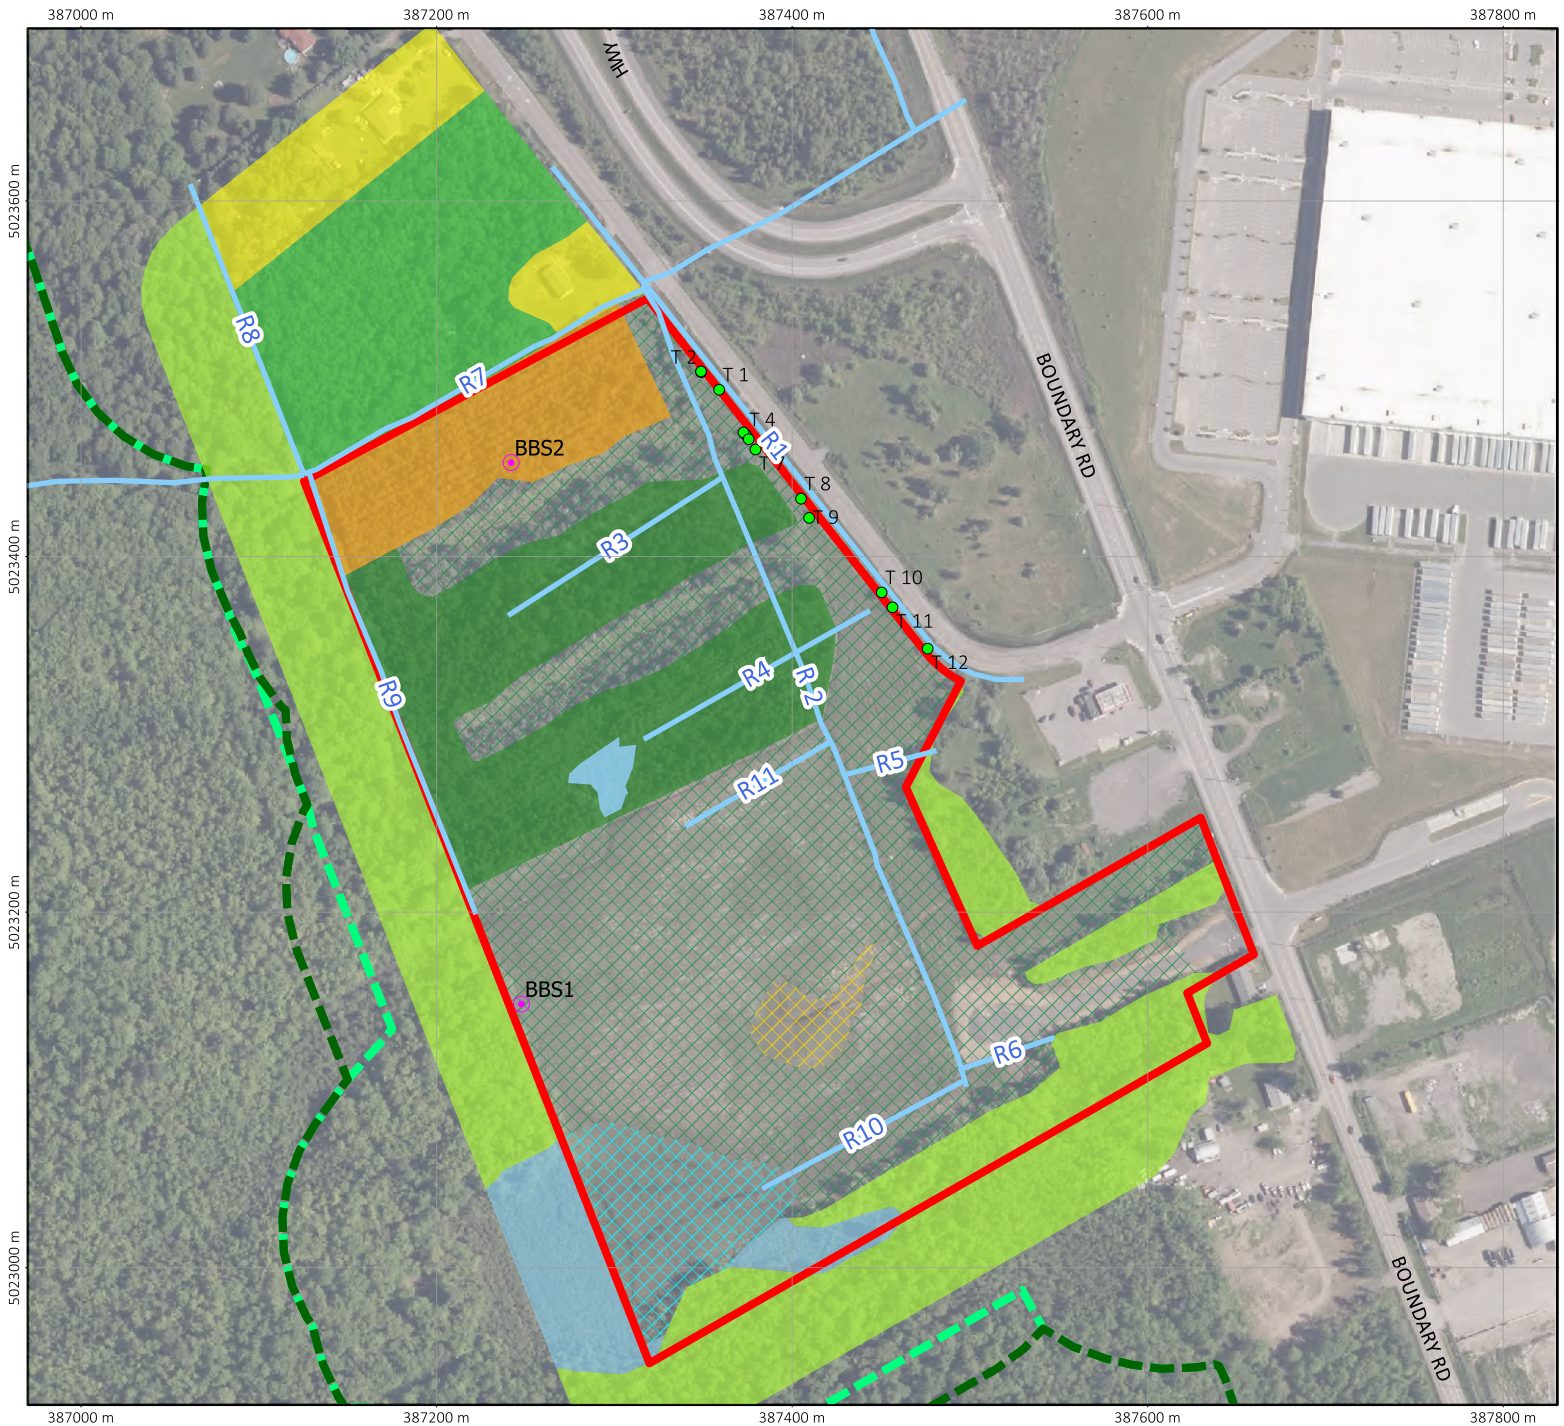
Figure 2 Existing conditions

An initial vegetation survey was conducted during the site visit on June 20, 2018, updated on October 15, 2020, and confirmed during the site visit on November 2, 2023, that delineated four distinct vegetation communities present on the Site. Vegetation communities observed include a Coniferous Plantation (TAGM1), a Naturalized Coniferous Plantation (FOCM6), a Willow Mineral Deciduous Thicket Swamp (SWT2), and a Fresh – Moist Lowland Deciduous Forest Ecosite (FOD7). The vegetation communities observed on the Site are described in detail below and are shown in Figure 2.

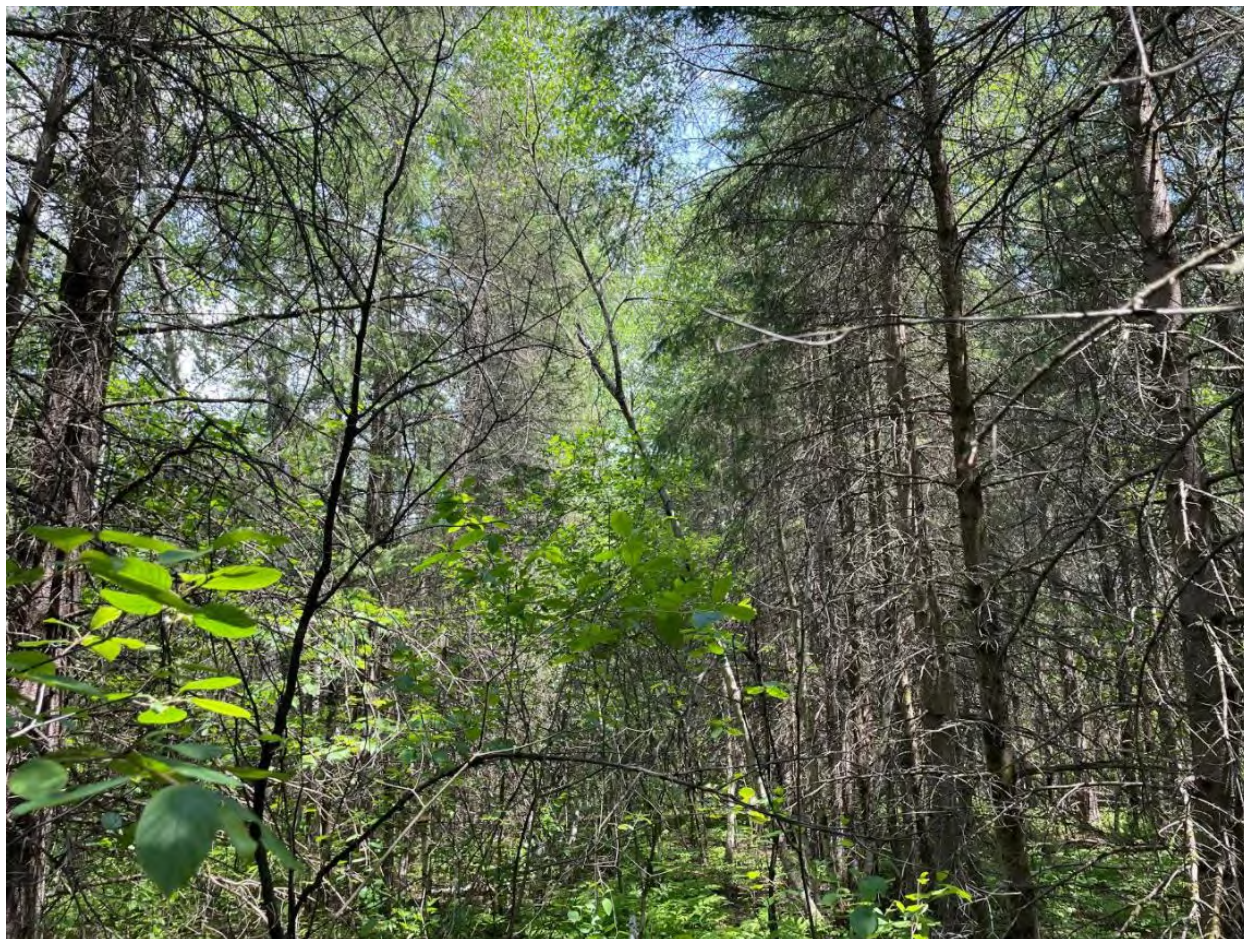
Figure 3 Coniferous Plantation (TAGM1)

The northern portion of the Site is characterized by a Coniferous Plantation (TAGM1) dominated by White Spruce (*Picea glauca*) with subordinate species of Jack Pine (*Pinus banksiana*) and Red Pine (*Pinus resinosa*) ranging from 20-35 DBH in size. This community is a disturbed, low-quality habitat with very little to no understory present. According to historic aerial imagery (City of Ottawa, 2024), the entire Site was cleared for agricultural purposes prior to 1991. Around 1991, the TAGM1 and FOCM6 communities were planted immediately north of the 2019 clearing area.

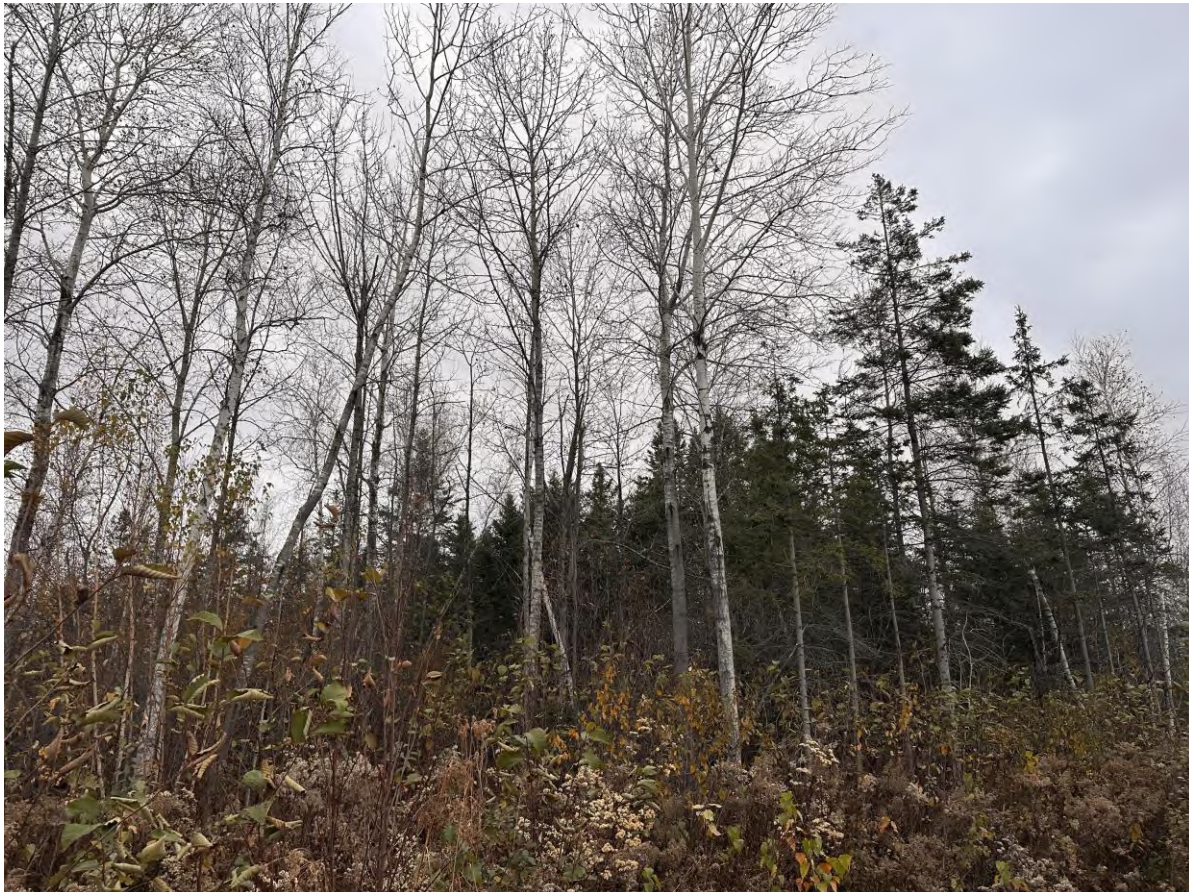
Figure 4 Naturalized Coniferous Plantation (FOCM6)

Moist Lowland Deciduous Forest (FOD7) community, however, many of the deciduous trees have downed and the community has become White Spruce dominant with associations of deciduous species.

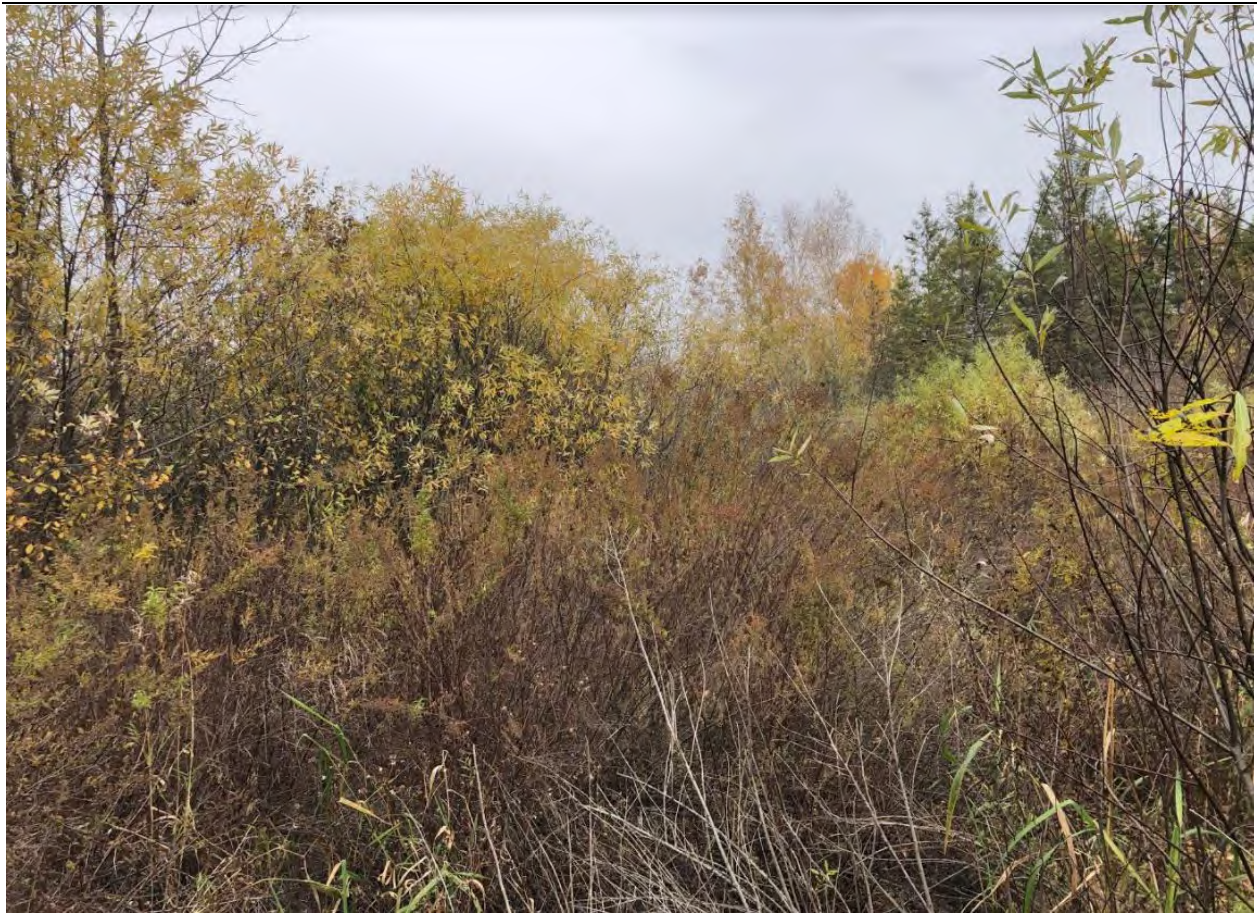
Figure 5 Willow Mineral Deciduous Thicket Swamp (SWT2)

In the centre of the Site, immediately adjacent to the cleared area, a small (0.7 ha) depression forms a Willow Mineral Deciduous Thicket Swamp (SWT2) ecosite, dominated by a mix of Bebb's Willow (*Salix bebbiana*) and Speckled Alder (*Alnus incana*) with some Buckthorn (*Rhamnus spp.*). Ground cover includes sedge (*Carex sp.*) and rush (*Juncus sp.*) species.

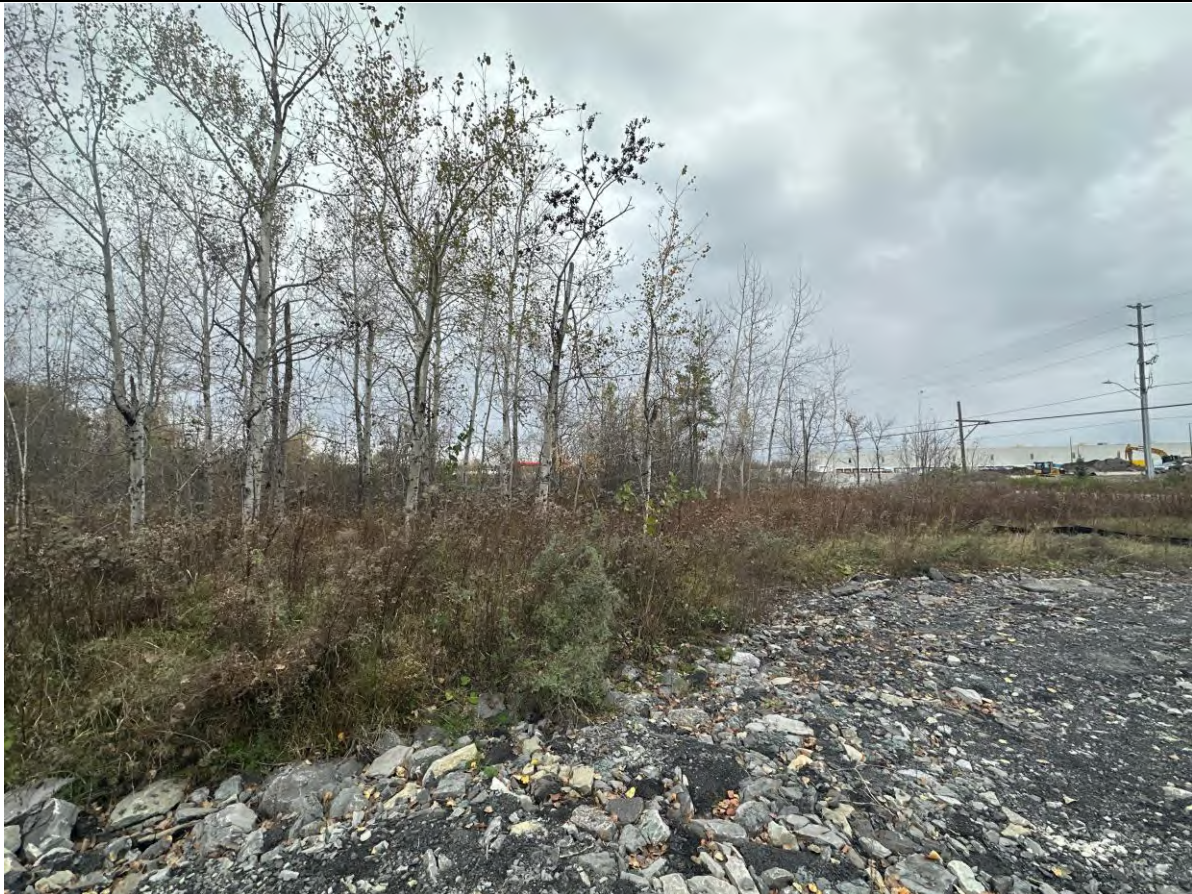
Figure 6 Fresh – Moist Lowland Deciduous Forest Ecosite (FOD7)

In the southern portion of the Site along the property boundary and adjacent to the Site access point, a Fresh – Moist Lowland Deciduous Forest Ecosite (FOD7) vegetation community is present. This community is dominated by Trembling Aspen (*Populus tremuloides*) and Red Maple (*Acer rubrum*) with associations of White Ash (*Fraxinus americana*), Green Ash (*Fraxinus pennsylvanica*). The understory is dominated by Willow species (*Salix spp.*). A small pocket of SWT2 thicket swamp is located just off the southwest edge of the Site with the same species mix present in the SWT2 pocket in the center of the site.

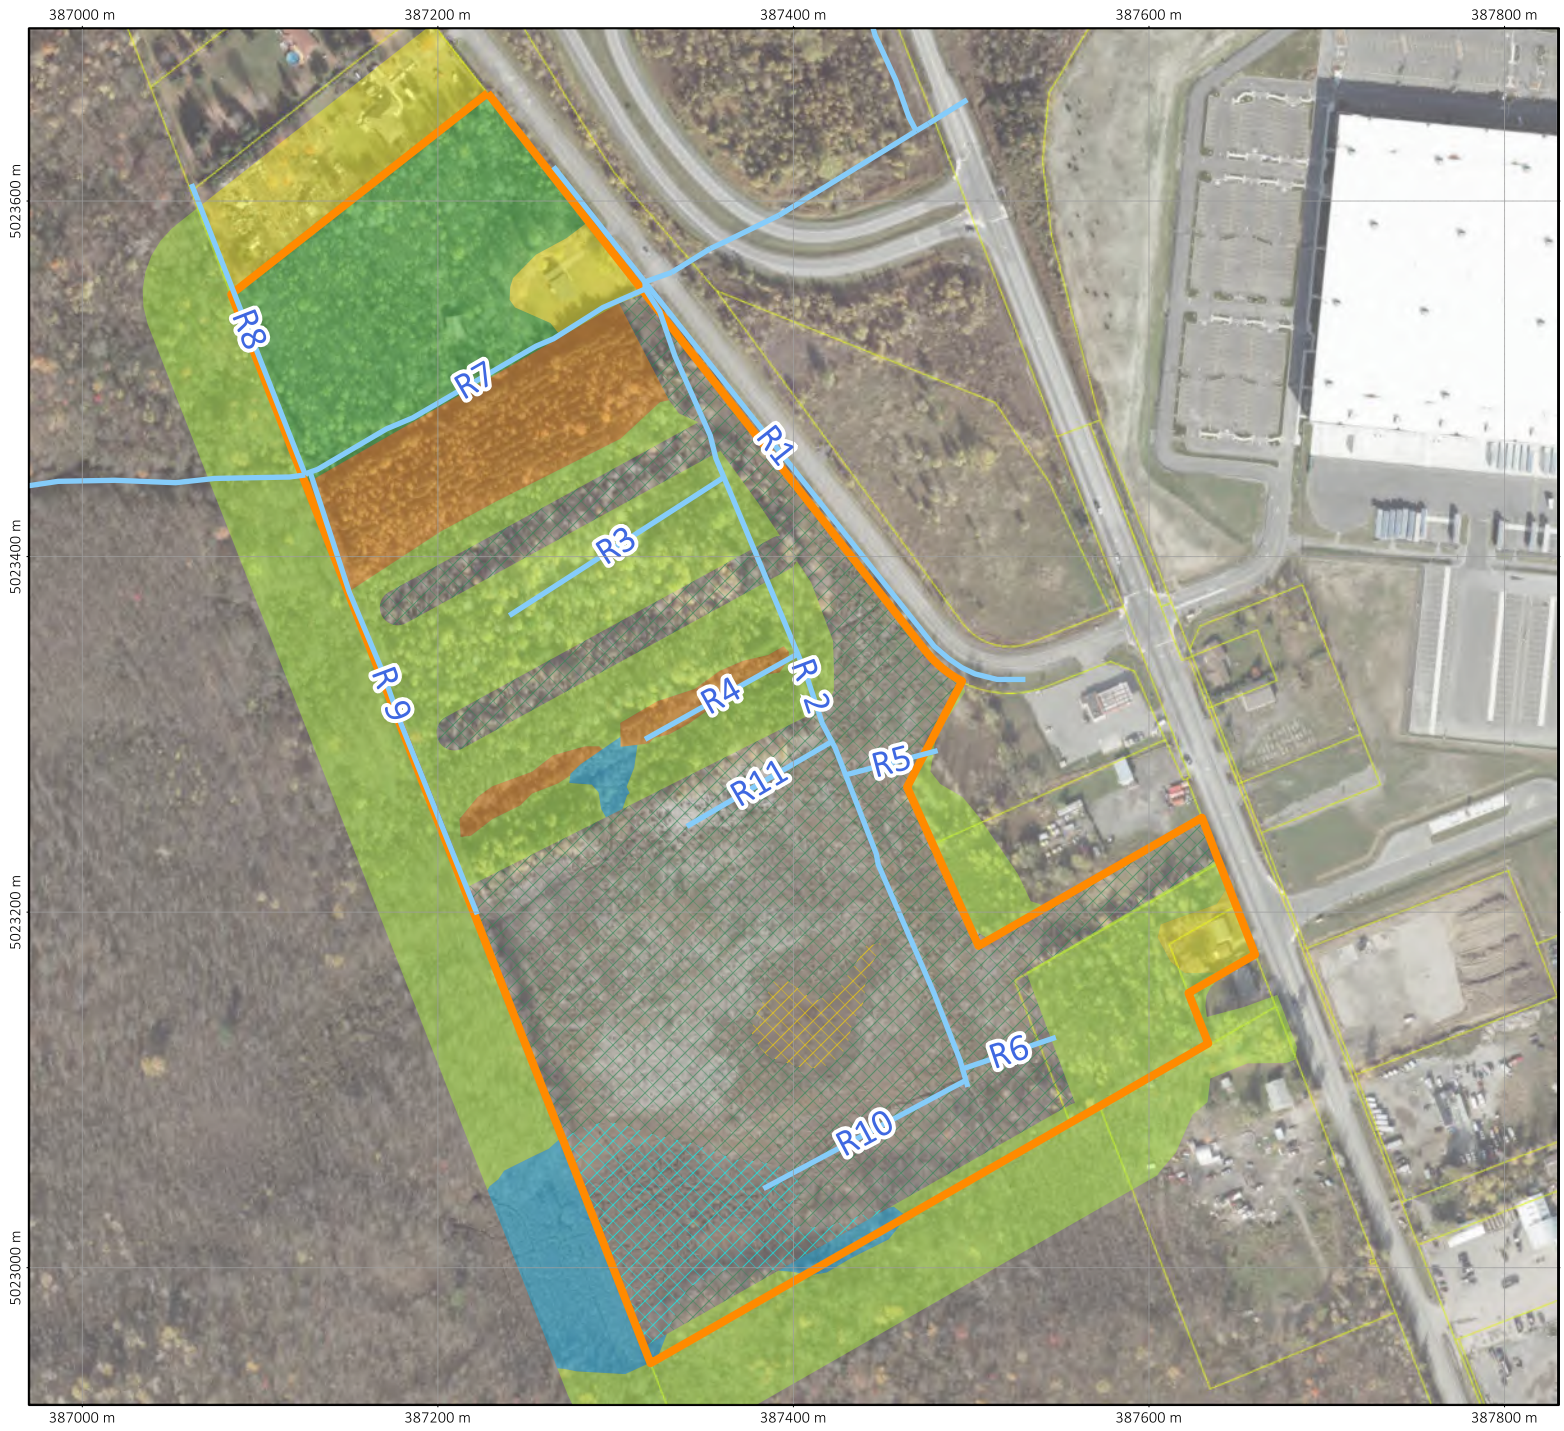
Figure 1 HDF Reaches

Channel R10 was dug as an eastward-running, linear drainage channel sometime in either late fall 2020 or spring 2020. The 2 m wide swale was excavated in the bare sandy soil of the cleared portion at the south end of the site. City of Ottawa air photos from 2019 (Ottawa, 2021) suggest some natural surface drainage may have previously occurred along that route, though no headwater features were evident there during site surveys through the 2018 field season. Channel R11 is a similarly sized and formed feature at the north end of the cleared area, dug within the same time frame. City of Ottawa air photos (Ottawa, 2021) do not suggest any channel had existed there previously. Both R10 and R11 were fully dry on June 8, 2021.
