Phase One Environmental Site Assessment

1280 Trim Road
Ottawa, Ontario

Trim Works Developments Ltd.
110 Place d'Orleans Drive
Ottawa, Ontario
K1C 2L9

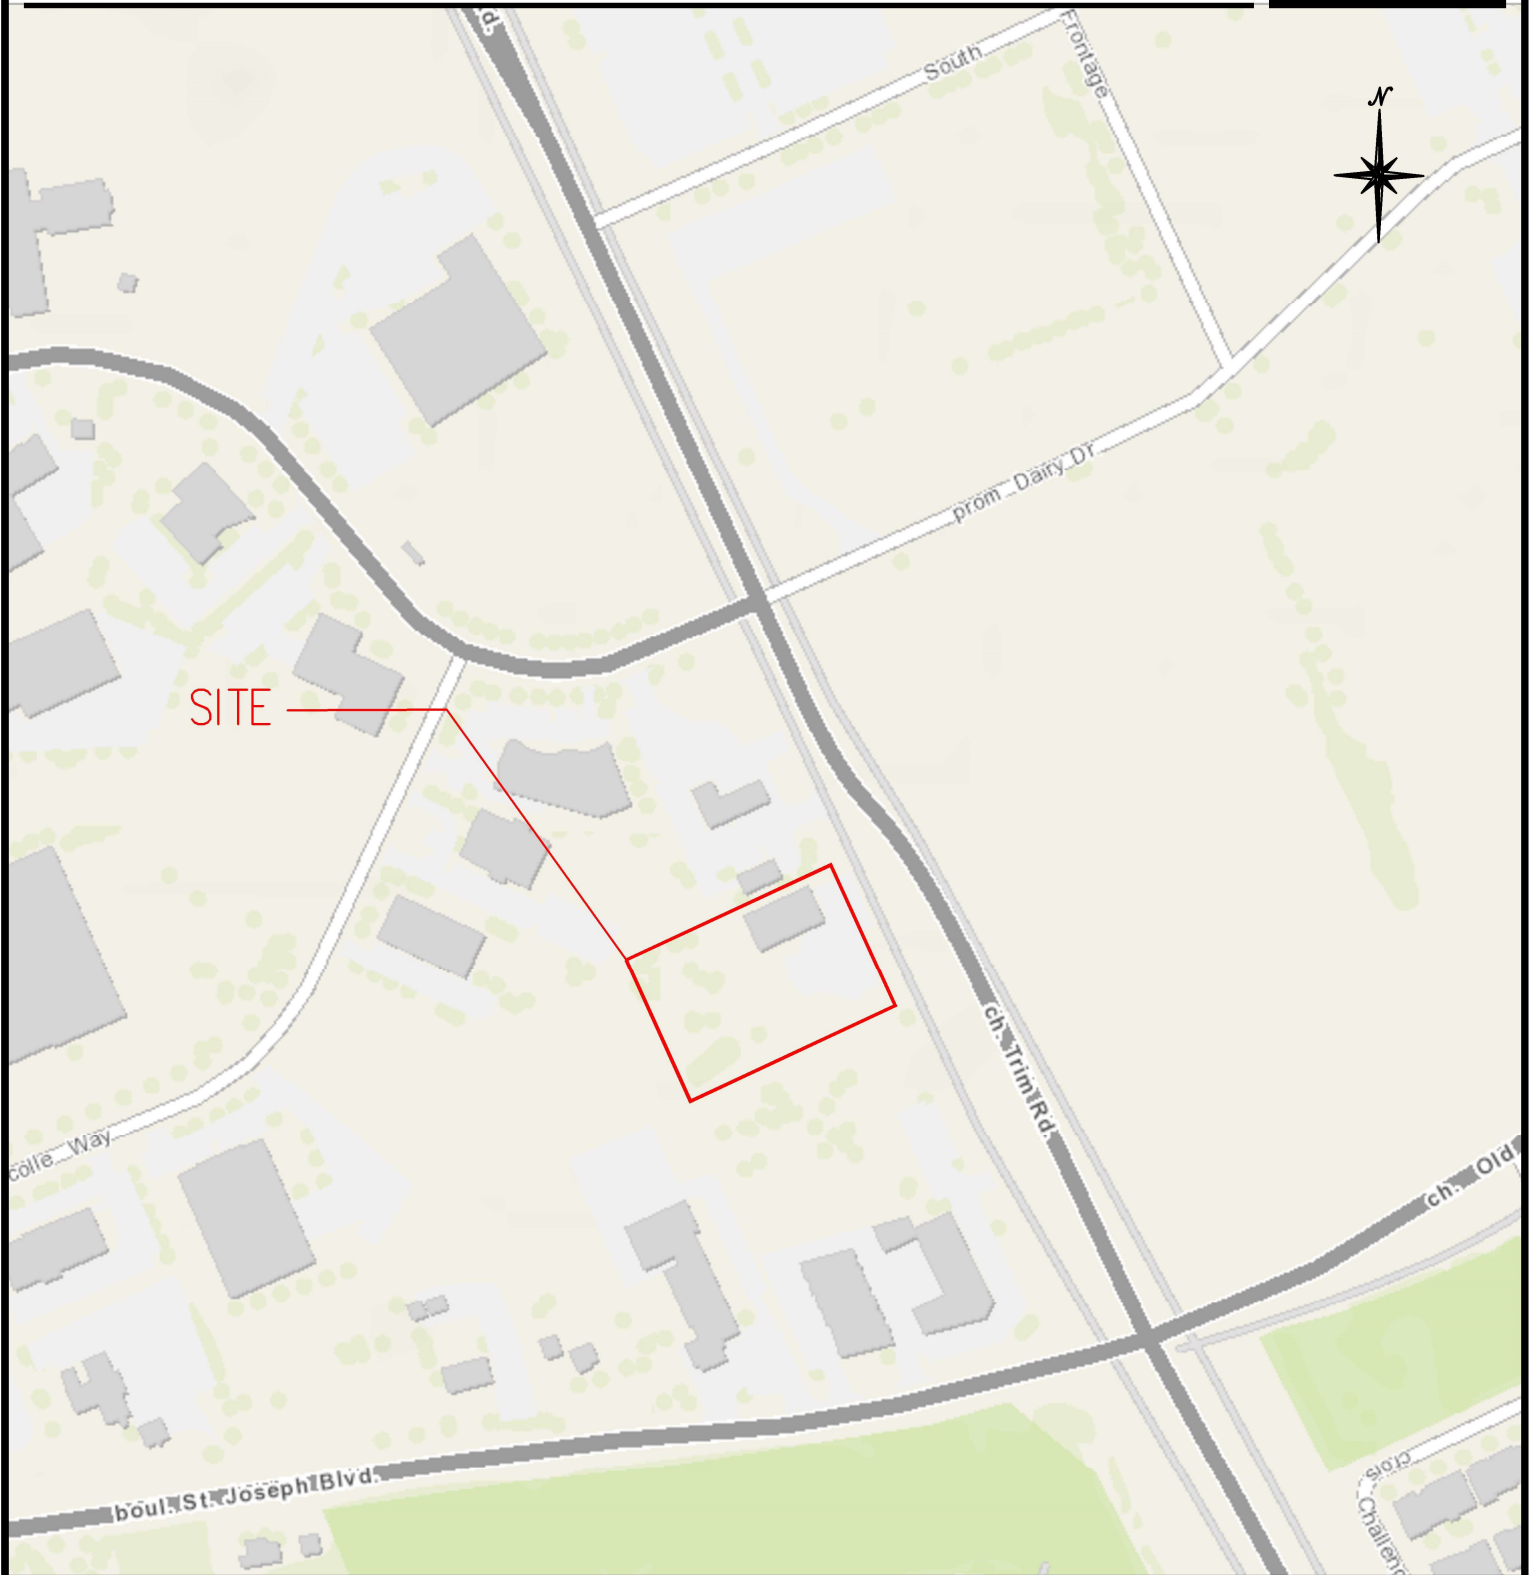
FIGURE 1

The Site's location is presented in **Figure 1**. The property has a rectangular shape and is between approximately 64 m wide (fronting Trim Road) by approximately 100 m deep, for a total area of approximately 6,430 m² (1.59 acres). The general topography of the Site is flat, however the general topography of the area slopes north. For the purpose of this report, Trim Road will be inferred as being orientated in a north-south direction.

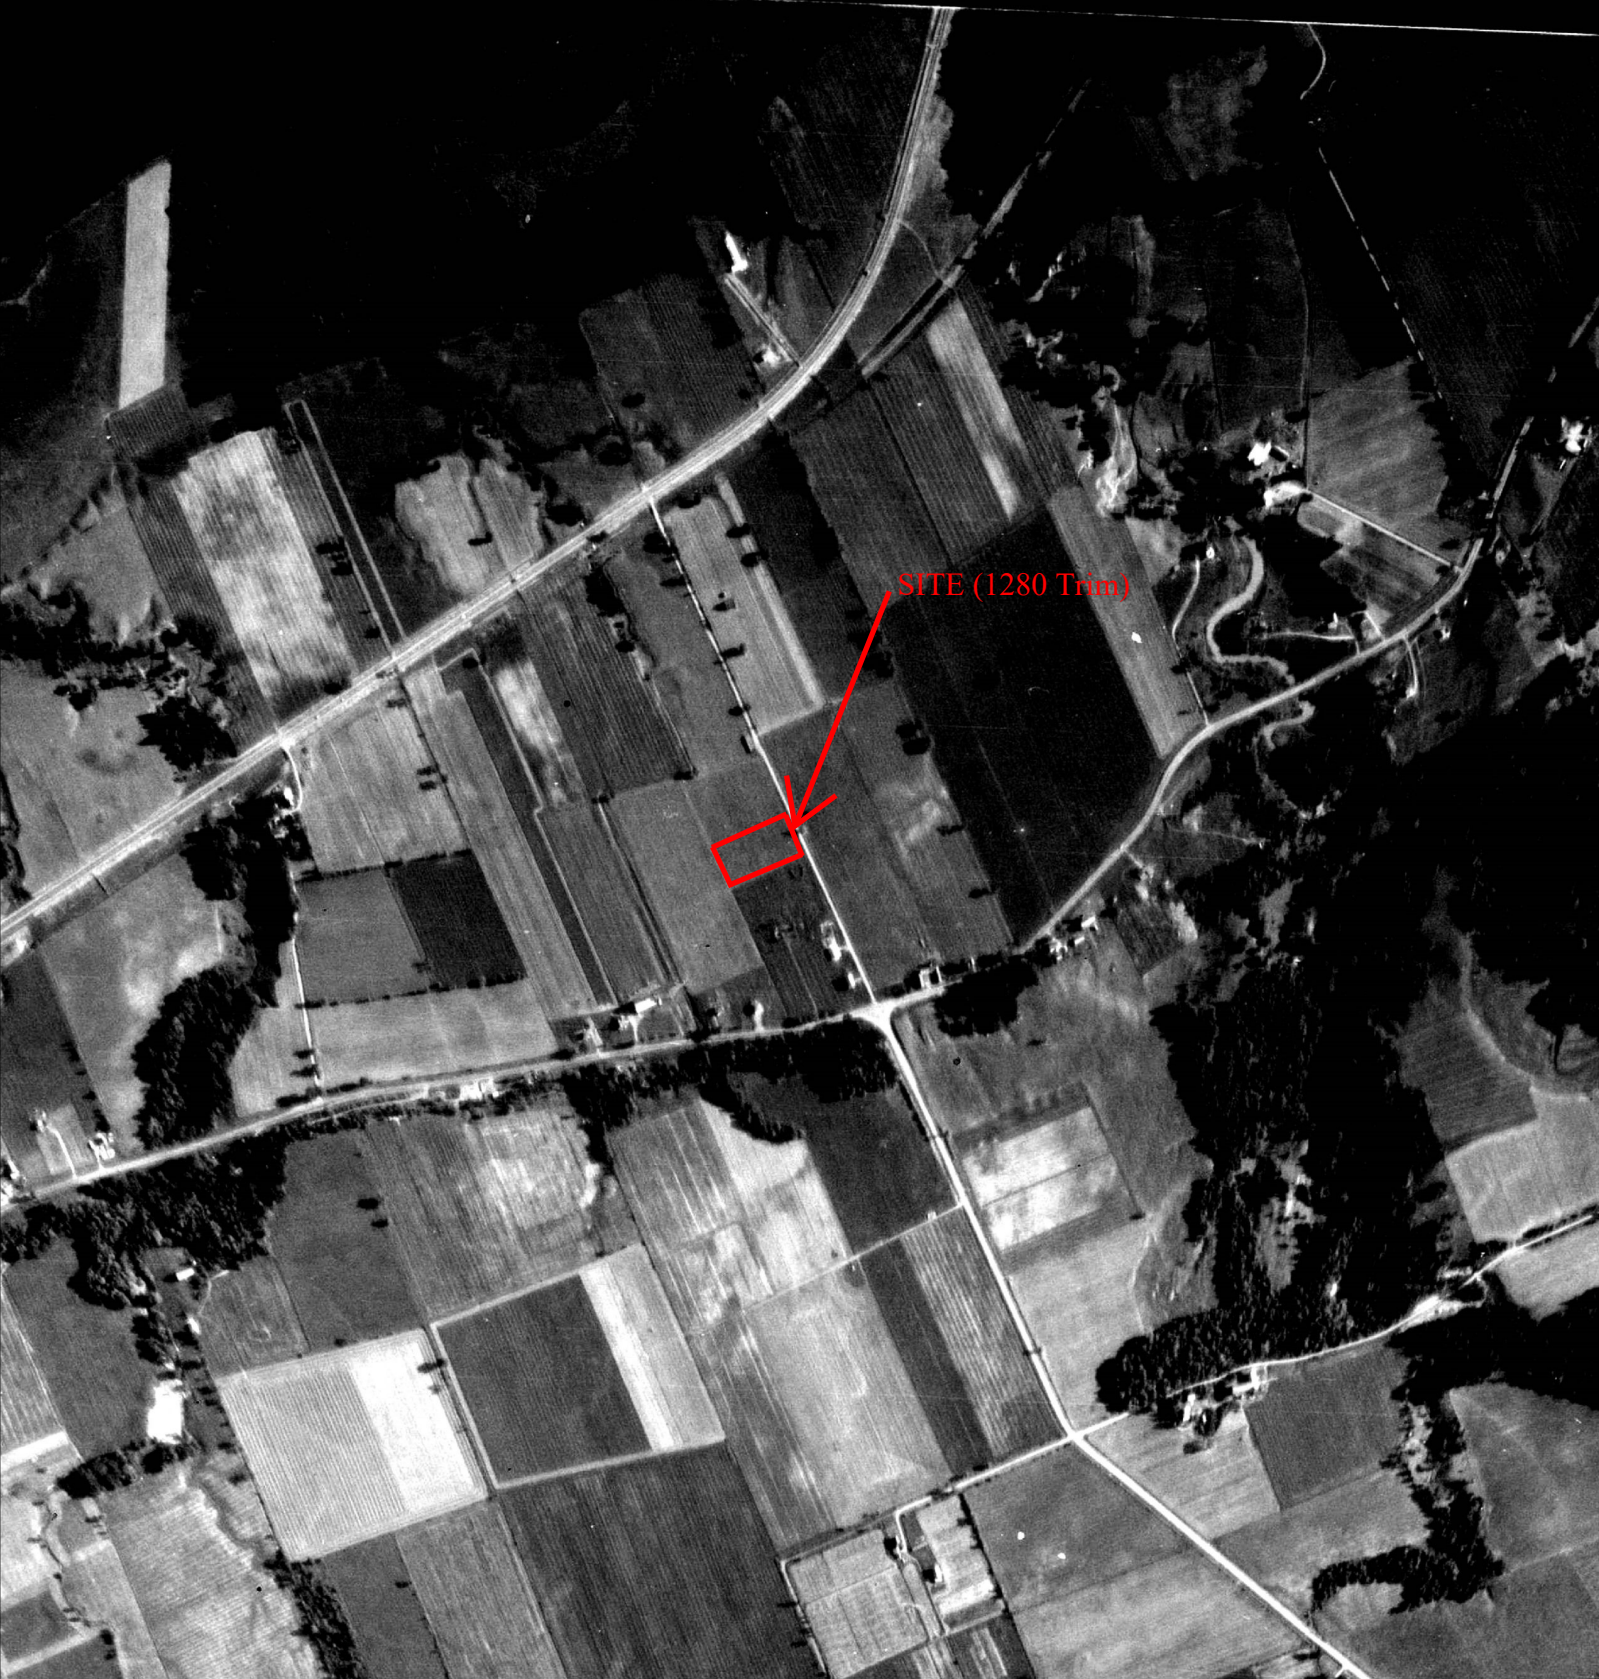
SITE (1280 Trim)

Year: 1955
Source: NAPL
Scale: 10,000
Comment:

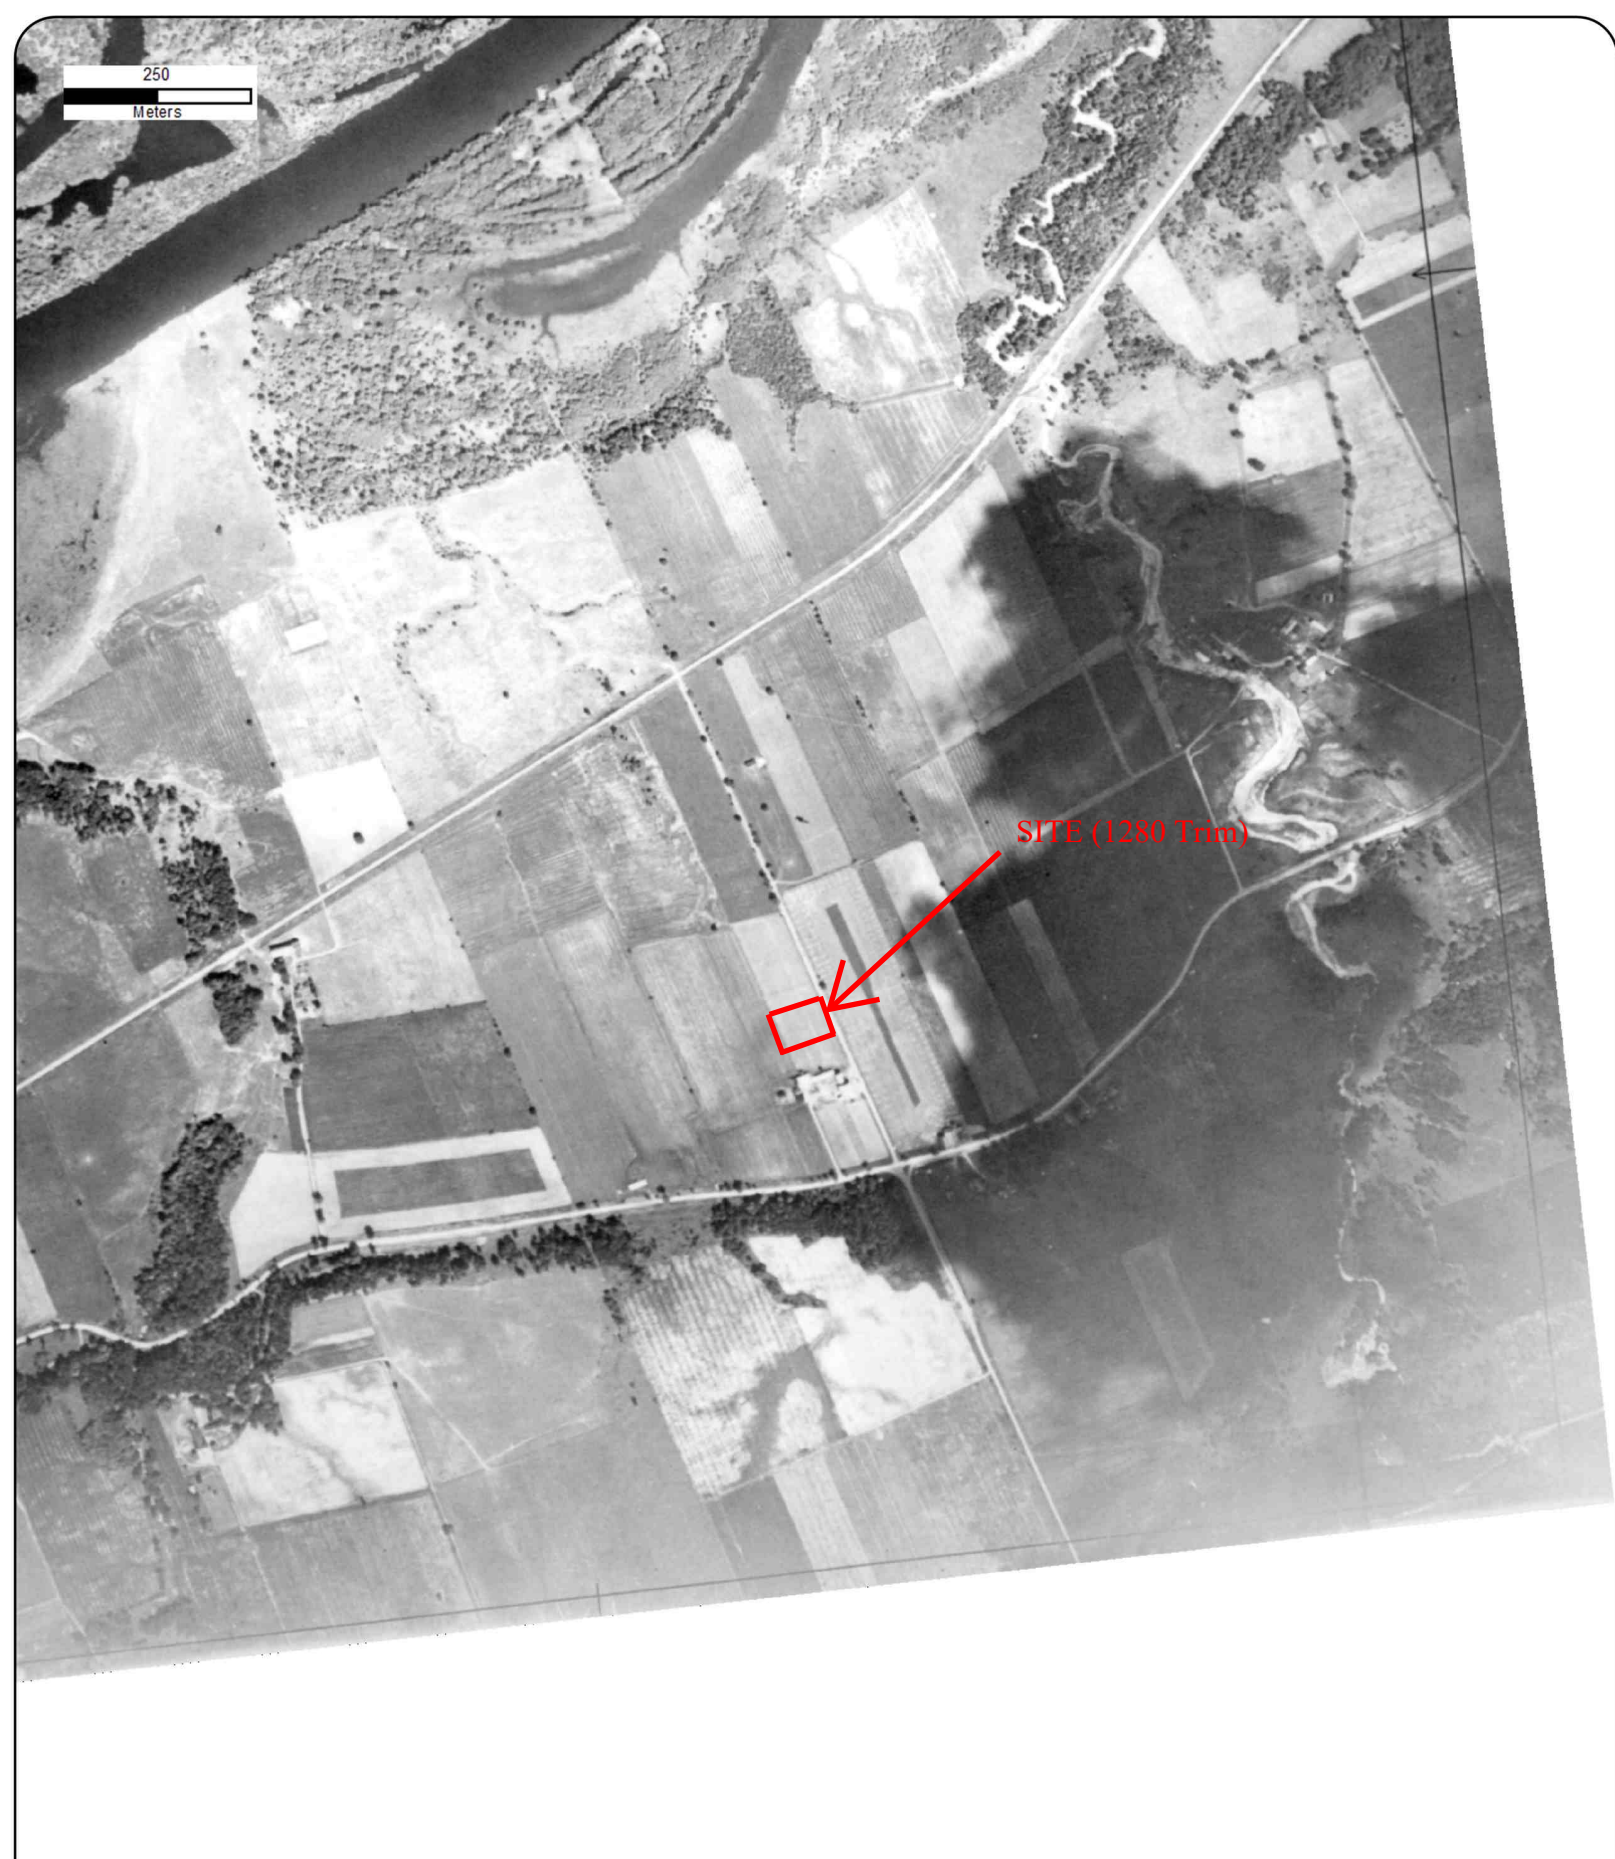
SITE (1280 Trim)

Year: 1926
Source: NAPL
Scale: 10,000
Comment:

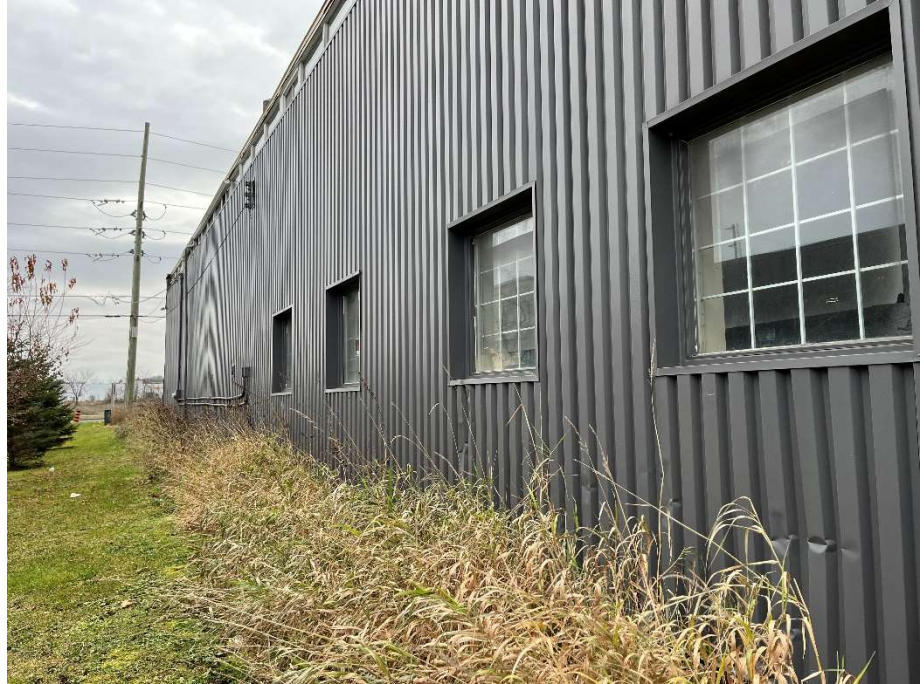
North-eastern extent of the Site and north face of the building on the Site, from west facing east.

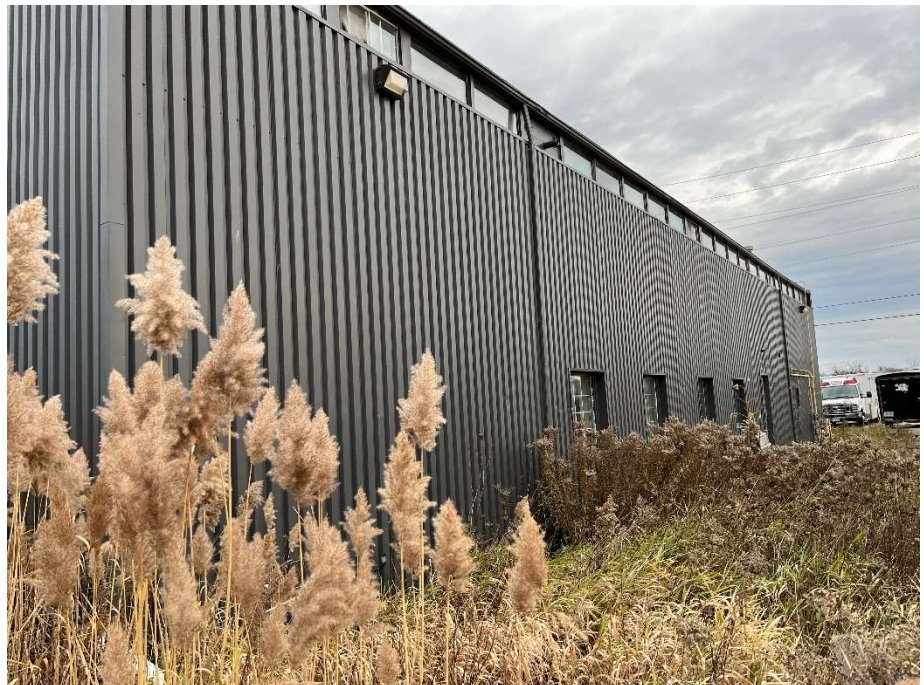
Photograph No. 2

Facing west to east along the south face of the building.

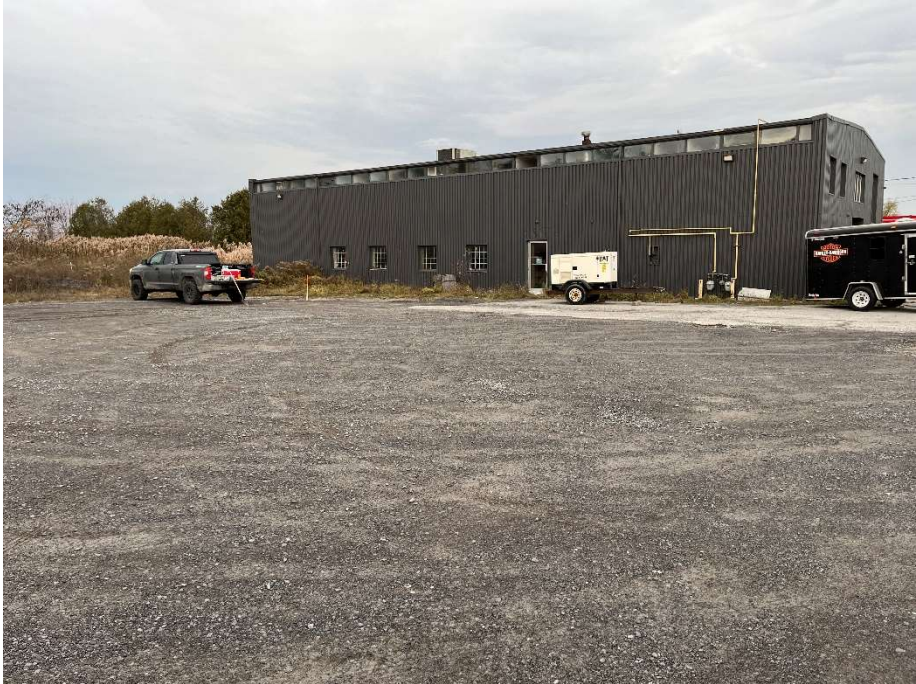
<p>Photograph No. 3</p>

<p>Date: 11/17/2023</p>	
<p>Description</p> <p>Parking and circulation area at the eastern portion of the Site, facing south to north.</p>

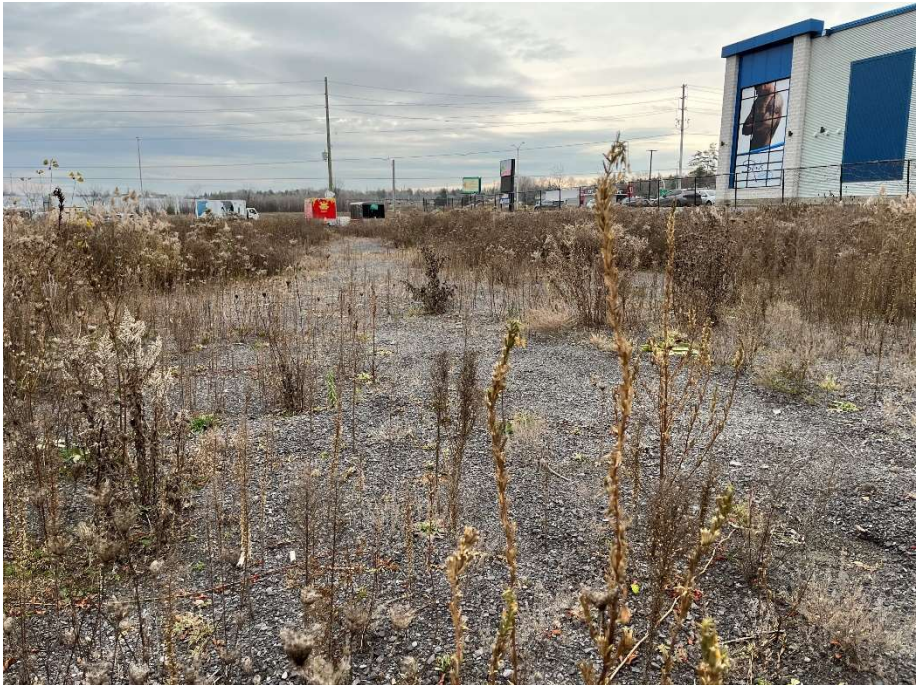
<p>Photograph No. 4</p>

<p>Date: 11/17/2023</p>	
<p>Description</p> <p>Granular crushed stone fill across the southwestern portion of the Site, facing east from western extent of the Site.</p>

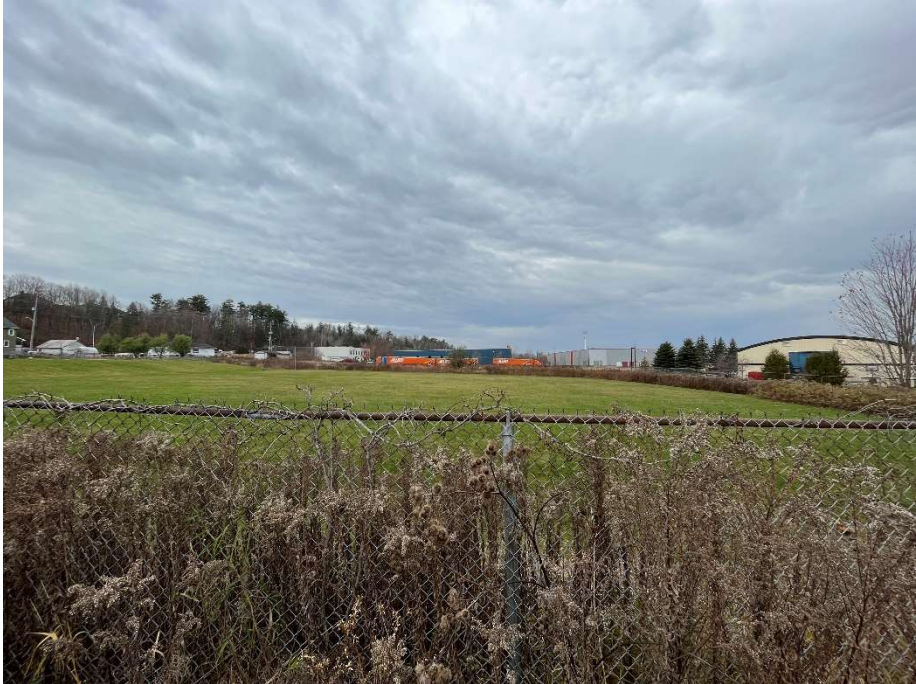
<p>Photograph No. 9</p>

<p>Date: 11/17/2023</p>	
<p>Description</p> <p>Adjacent property to the west of the Site.</p>

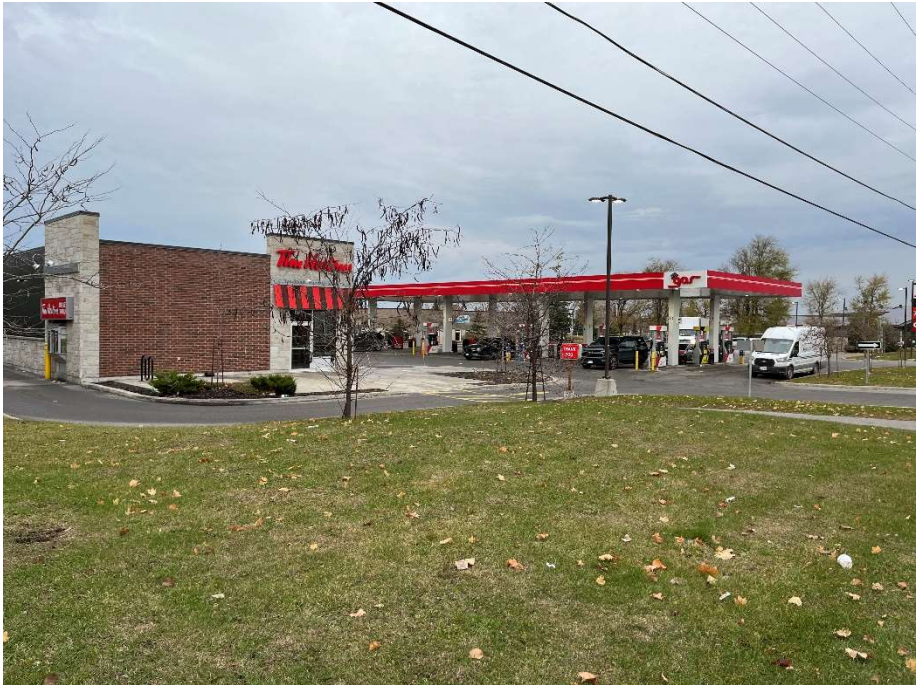
<p>Photograph No. 10</p>

<p>Date: 11/17/2023</p>	
<p>Description</p> <p>Adjacent property to the north of the Site – Retail gasoline service station.</p>

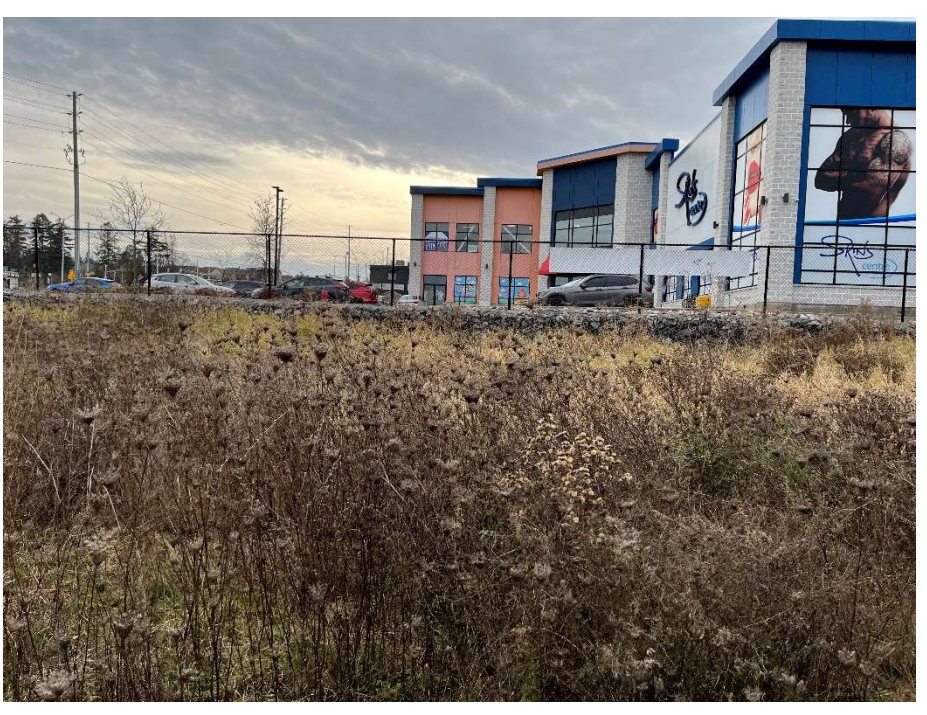
Photograph No. 11

Date: 11/17/2023	
Description Adjacent property to the south of the Site – Recreational/ Instructional facility and commercial cosmetic clinic.

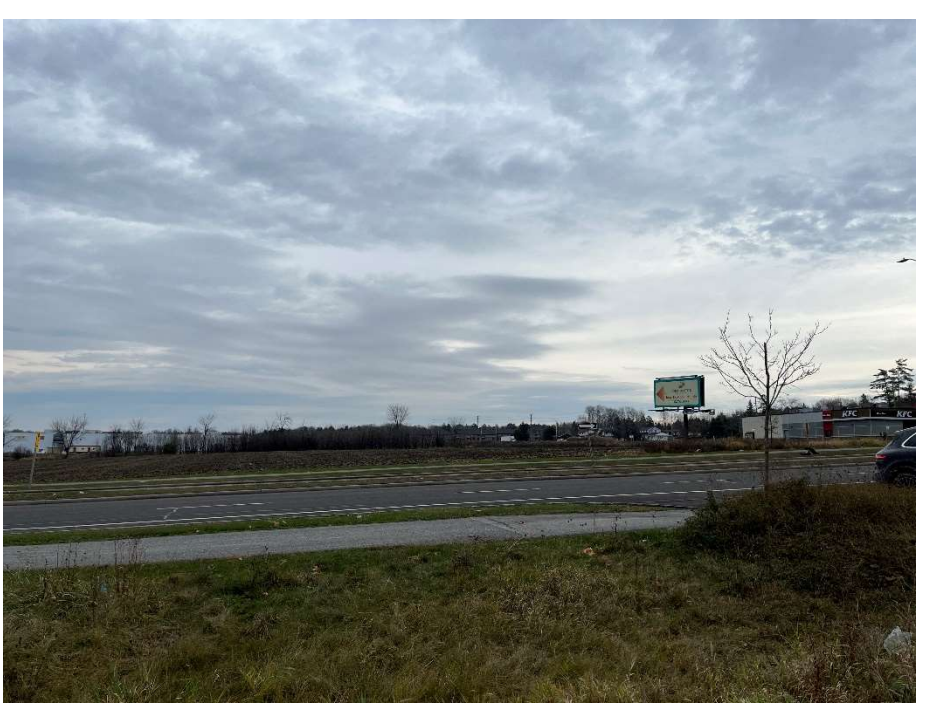
Photograph No. 12

Date: 11/17/2023	
Description Agricultural lands to the east of the Site, following Trim Road.

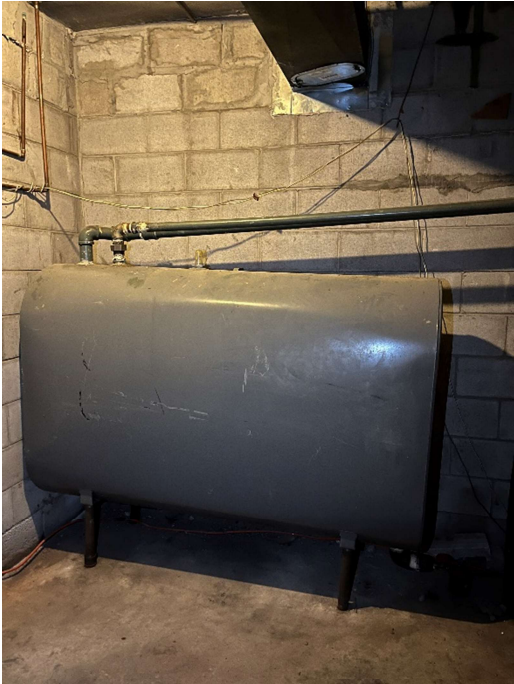
<p>Photograph No. 13</p>

<p>Date: 11/17/2023</p>	
<p>Description</p> <p>Existing AST located at the southern extent of the building.</p>

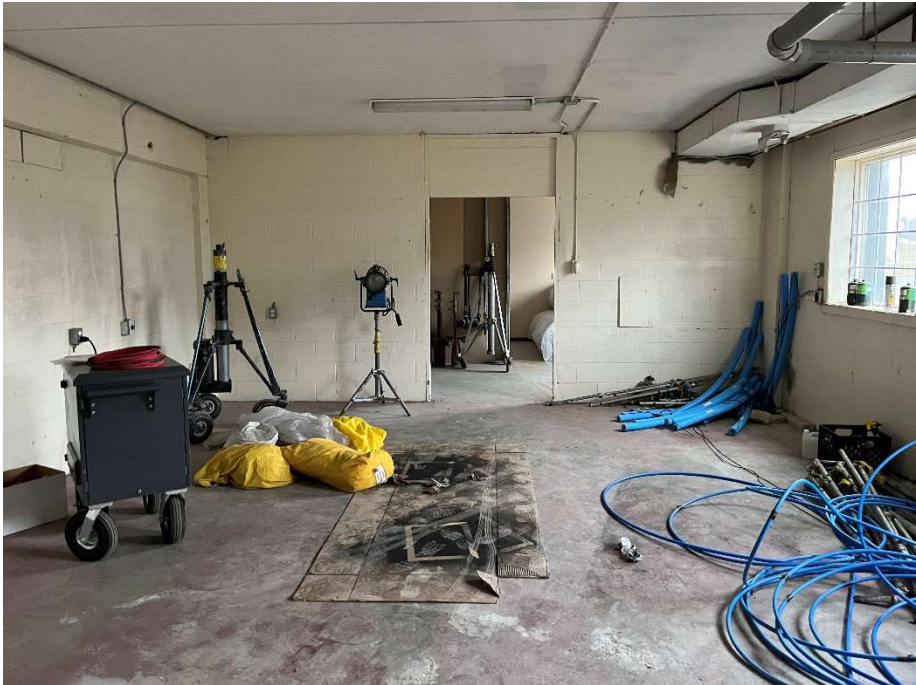
<p>Photograph No. 14</p>

<p>Date: 11/17/2023</p>	
<p>Description</p> <p>Typical conditions of the ground floor of the building – suspected area of the former commercial printing facility.</p>

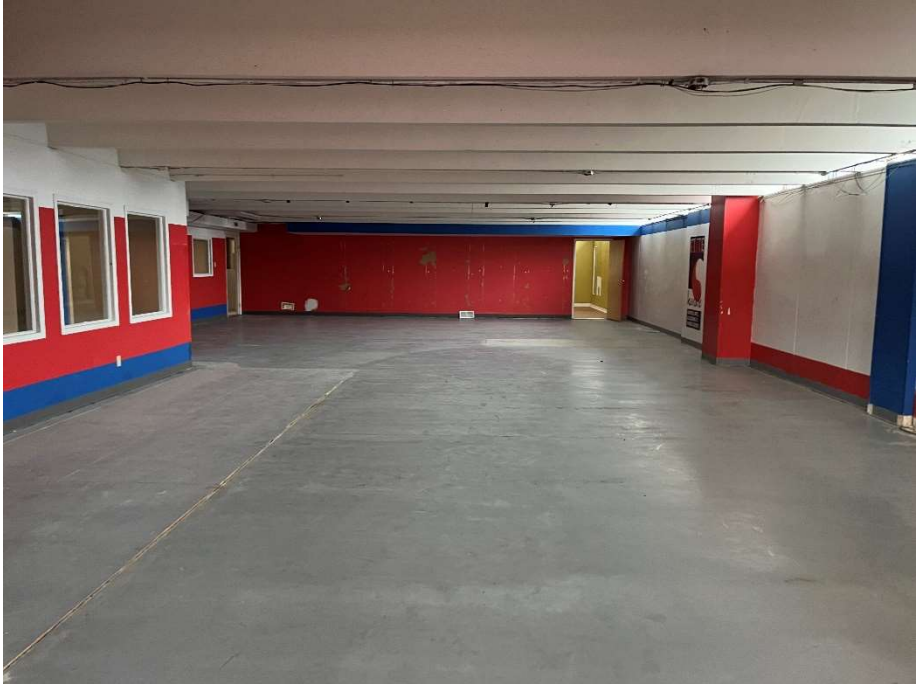
Photograph No. 15

Date: 11/17/2023	
Description Typical conditions of the second floor of the building – former martial arts area.

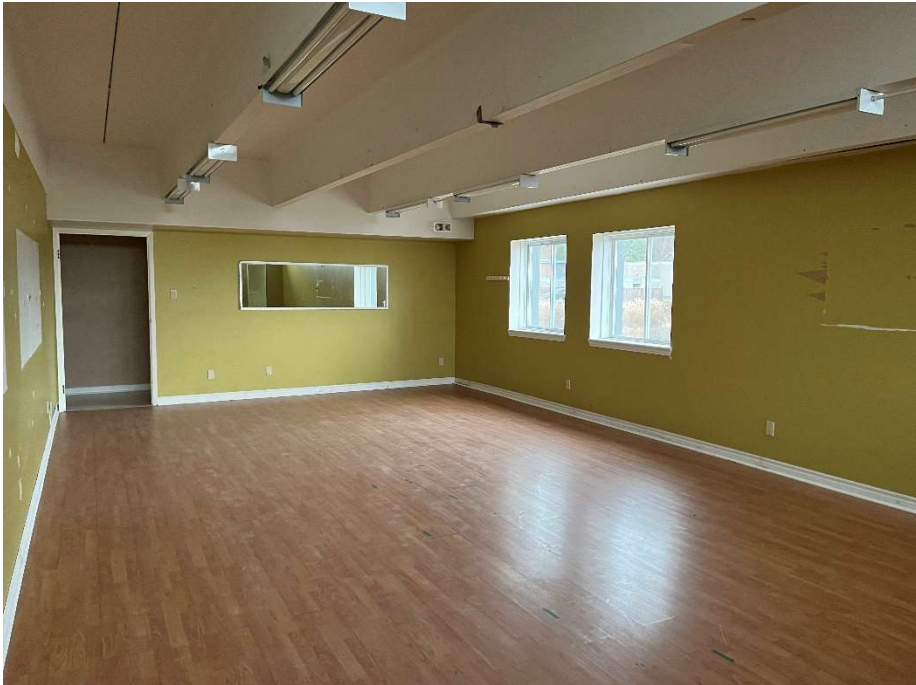
Photograph No. 16

Date: 11/17/2023	
Description Typical conditions of the second floor of the building – former martial arts area.
