RE: 1540 Star Top Road, Gloucester
Environmental Impact Study - Updated

This Environmental Impact Study (EIS) addresses the existing vegetation, potential Species at Risk utilization and the South Cyrville Municipal Drain and associated recommendations at 1540 Star Top Road in the east-central portion of the Urban Area of the City of Ottawa, northwest of the Highway 417 and Innes Road interchange. The site is on the west side of Star Top Road, approximately 220 metres north of Innes Road. The three-hectare site has approximately 73 metres of frontage on Star Top Road.

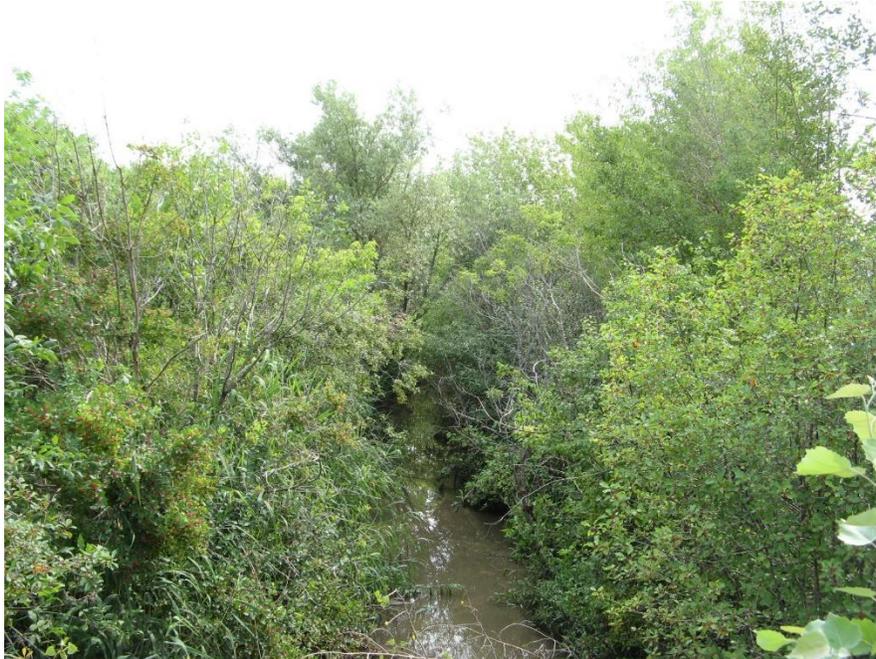
The wetted width of the South Cyrville Municipal Drain is between 2.5 and 3.5 metres. The water on July 11th was turbid (Photo 1). The canopy cover from an adjacent upland poplar deciduous forest is good in many areas. Small woody debris provides some instream habitat structure but there was no evidence of boulders, other coarse material, notable areas of aquatic vegetation, or undercut banks. The channel is straight with connecting sharp turns to the west of the site and as described above is open for approximately 750 metres.

*Photo 1 - South Cyrville Municipal Drain immediately to the north of the site.
View looking east from the northwest entrance to the site*

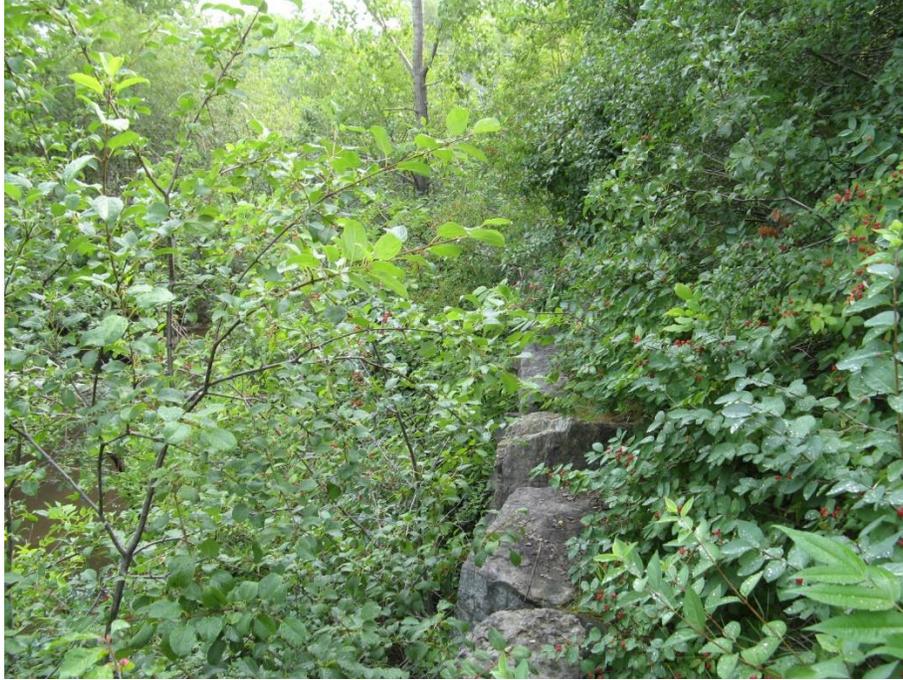
A retaining wall of large boulders is along the top of slope of both sides of the channel corridor (Photo 2). There is a setback of 7.5 metres from the retaining wall to the north edge of the site. Trembling aspens up to 30 cm diameter at breast height (dbh) are dominant in the setback, along with smaller green ash and Manitoba maple (Photos 3 and 4). The understory in the setback area is thick in most areas, with glossy buckthorn dominant in areas and staghorn sumac, red-osier dogwood, and tartarian honeysuckle common, along with regenerating stems of poplar, ash, and Manitoba maple. A chain-link fence is around the north and south edges of the channel setback and two surface connections crossing the channel between 1282 Algoma Road and the site (Photo 4). A gate in the fencing between the two crossing along the north site boundary provides access to the corridor, including for the plantings recommended below.

Photo 2 – South side of the Municipal Drain corridor to the north of the site, with large boulder retaining wall. View looking east, with site beginning 7.5 metres from wall

Although much less than a typical setback, a setback of 7.5 metres from the retaining wall top of slope to the south edge of the riparian corridor is considered suitable due to the highly disturbed nature of the channel, including limited exposed reaches, straight alignment that was excavated and associated artificial cross-section. The 7.5 metres setback is greater than that provided for other open sections of the Drain to the west of the site. The drain is enclosed to the east of Star Top Road.

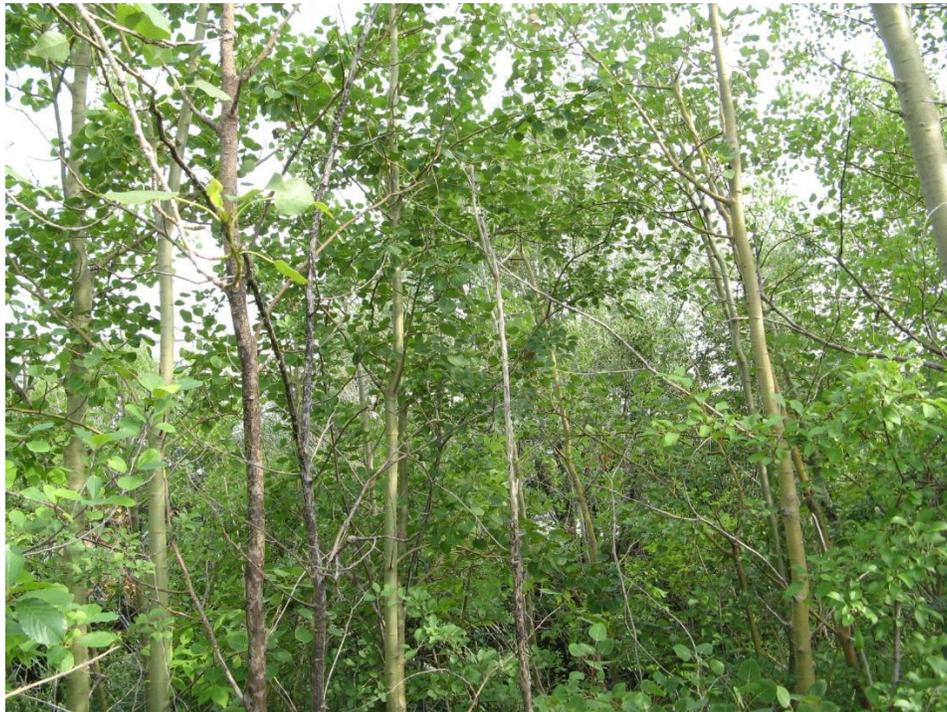
Photo 3 – The corridor between the Municipal Drain and the site is generally well treed with young poplars. View looking north from the centre of the north property line

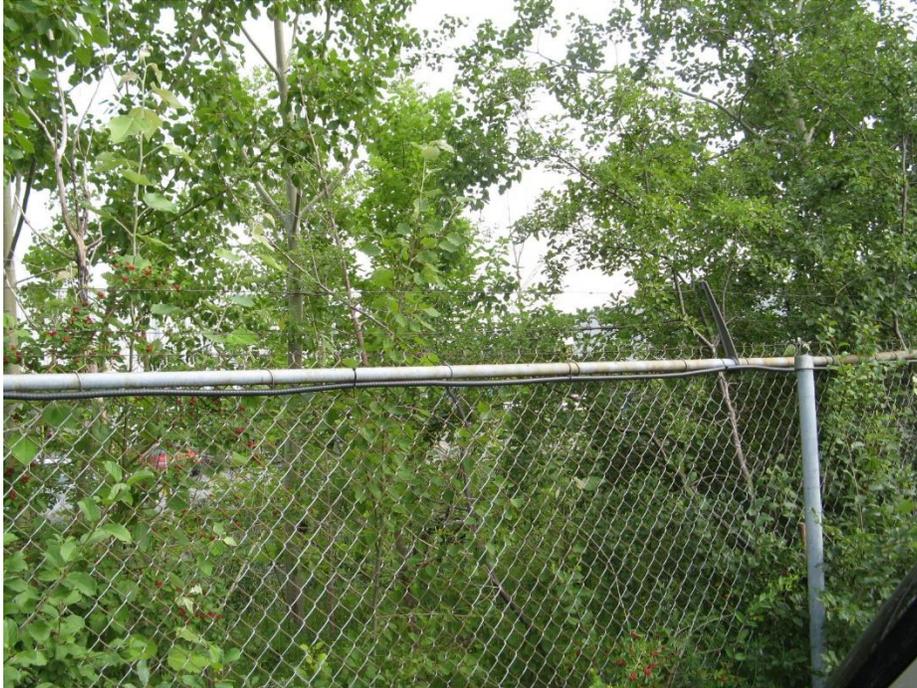
Photo 4 – The Municipal Drain corridor is protected with a chain-link fence along the north property line. This area has fewer trees and plantings are recommended to increase the diversity of the buffer function. View looking north

Natural buffers provide important functions such as filtering excess nutrients running into the channel, infiltrating rainwater, shading and food inputs for the channel, maintaining bank stability (though in this case retaining walls are present), contributing to baseflow, and providing wildlife habitat. The buffer immediately to the north of this site can be improved with plantings of native trees and shrubs where currently there are fewer poplar trees. This will provide a diversity compared to the existing woody vegetation. Recommended native species shown on the Landscape Plan completed by GJA Inc. (revised August 15th, 2024) in the buffer to the north include nannyberry, grey dogwood, and serviceberry shrubs along with sugar maple, red maple, basswood, and white spruce trees. Twenty trees and fifteen shrubs are proposed for planting in the corridor to the north. Obtaining native species from local seed sources is strongly recommended to promote adaptability and longevity.

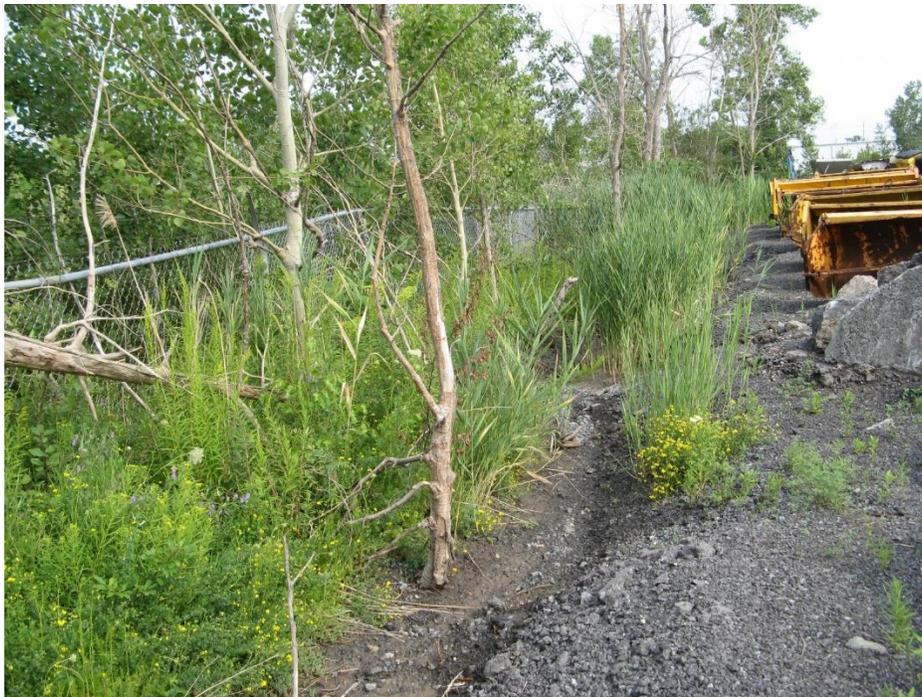
A ditch on the west side of the site was mostly dry during the field review, with small pockets of standing water (Photo 5). Significant rain had occurred within the previous 30 hours. The drain does not have an open connection to the South Cyrville Municipal Drain to the north.

Photo 5 – Dry ditch along the west boundary of the site. View looking north

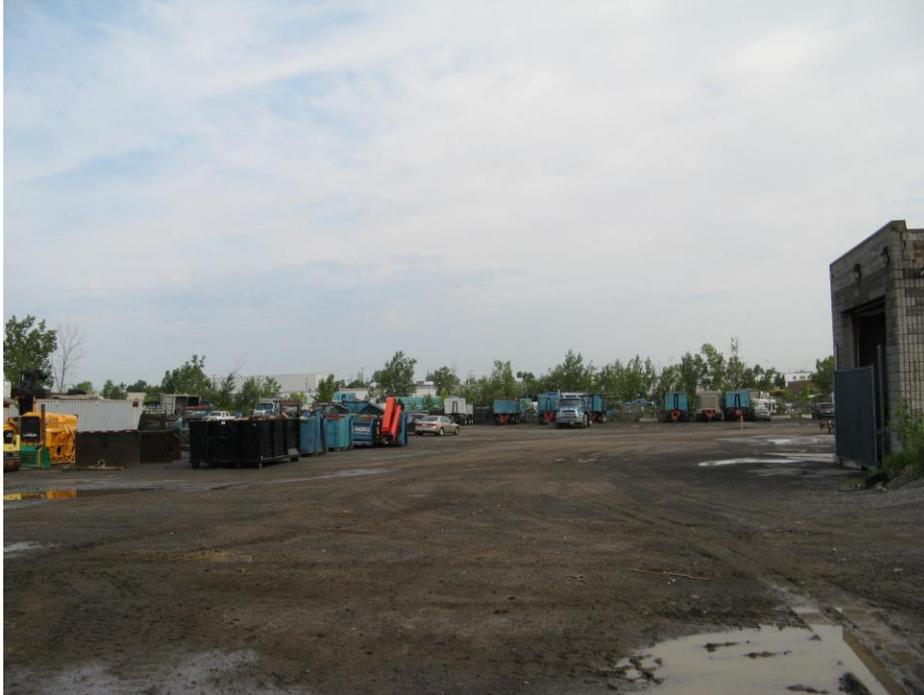
The site is dominated by fill material with a generally level topography (Photo 6). Paterson (2023) identified crushed stone, topsoil, brown silty sand, trace clay and occasional gravel in the fill. Bedrock consisting of black shale was noted by Paterson (2023) at depths ranging between approximately 1.9 to 2.9 metres below grade. Similarly, Paterson (2023) observed groundwater depths between approximately 1.9 and 2.9 metres below the existing ground surface, with groundwater flow generally in a northern direction.

Photo 6 – West portion of the site looking north from south edge

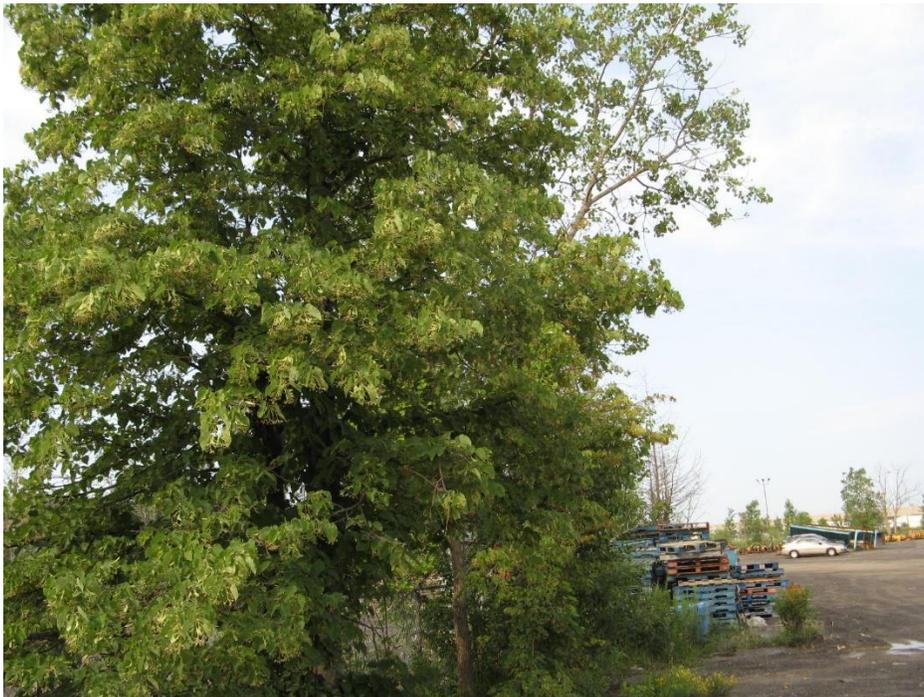
Scattered regenerating deciduous trees are along portions of the site boundaries and these areas are referred to as intermittent deciduous hedgerows on Figure 1. Trembling aspens are dominant, with eastern cottonwood well represented and green ash, white elm, and linden also present (Photo 7). Regenerating poplar, birch, ash, linden, and white poplar stems are among the intermittent hedgerow trees, along with staghorn sumac, Bebb's willow, red-osier dogwood, tartarian honeysuckle, and glossy buckthorn shrubs. The largest trees in the intermittent hedgerows are cottonwood and trembling aspen up to 32cm dbh. Many of the white elms are dead and leaf-out is greatly reduced on many of the poplars. The larger eastern cottonwoods along the west ditch appear dead as well. Wild grape coverage is common on the lower portions of some of the trees.

Photo 7 – Cottonwood along southeast boundary of the site. View looking west

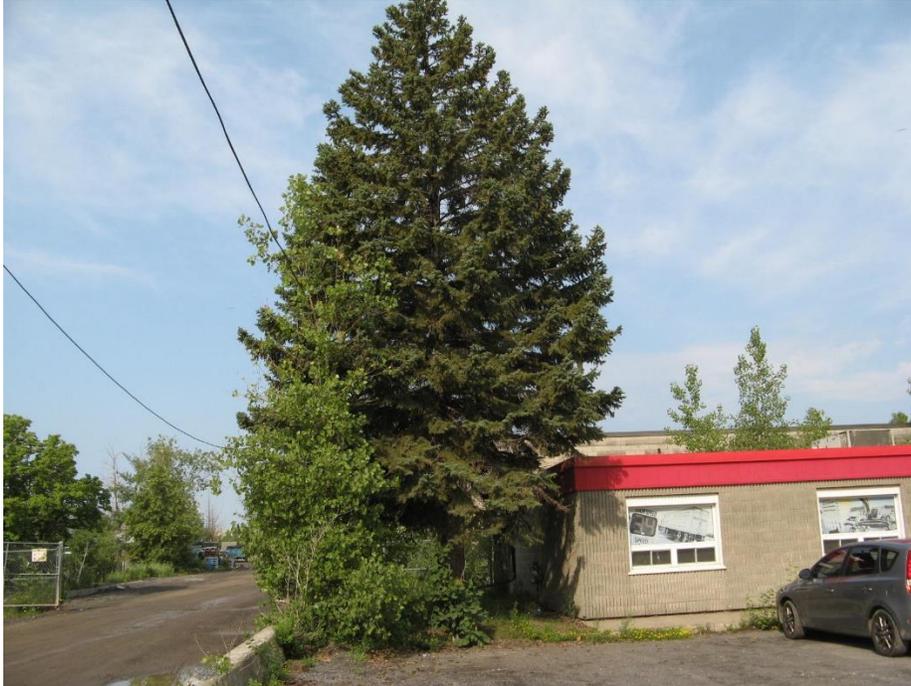
A twin-stem bur oak, with individual stems up to 30cm dbh and a 48cm dbh white spruce are adjacent to the existing office building west of Star Top Road (Photo 8).

Photo 8 – White spruce in the east portion of the site, west of Star Top Road was the largest tree observed on or adjacent to the site. View looking west

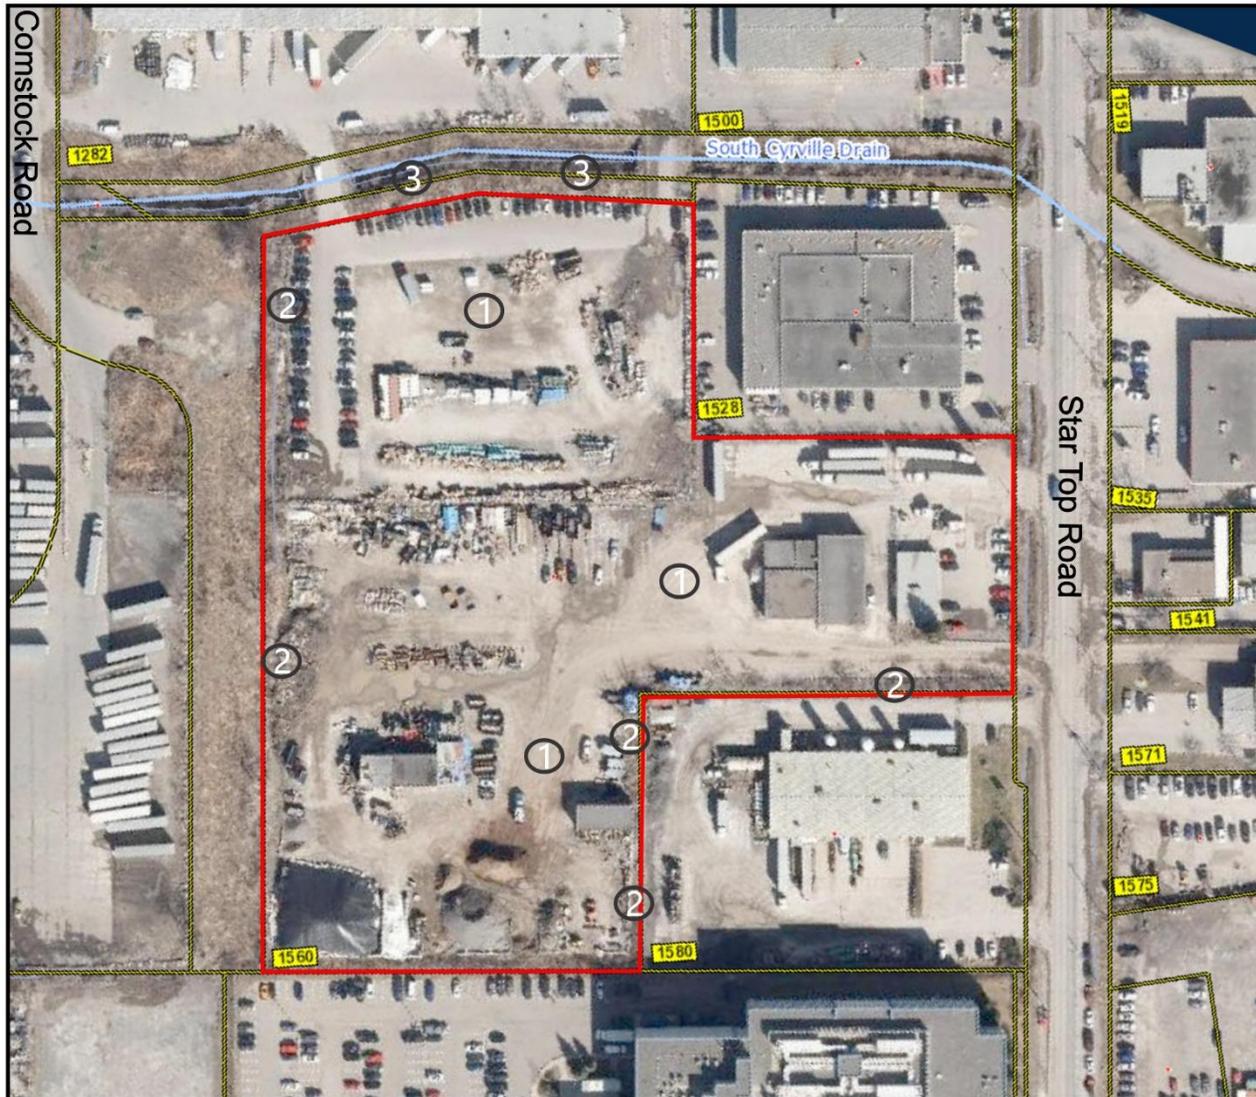
Figure 1

The site is within a light industrial area, including warehouses, commercial operations, automobile dealerships, and office buildings. The site is highly disturbed from a natural environment perspective and is dominated by gravel and asphalt areas used for surface storage and small one storey office and former maintenance buildings. The maintenance buildings were part of a former concrete plant and the offices of Transport Training Centres of Canada Inc. are currently in the east portion of the site. The South Cyrville Municipal Drain is immediately to the north of the site (Figure 1).

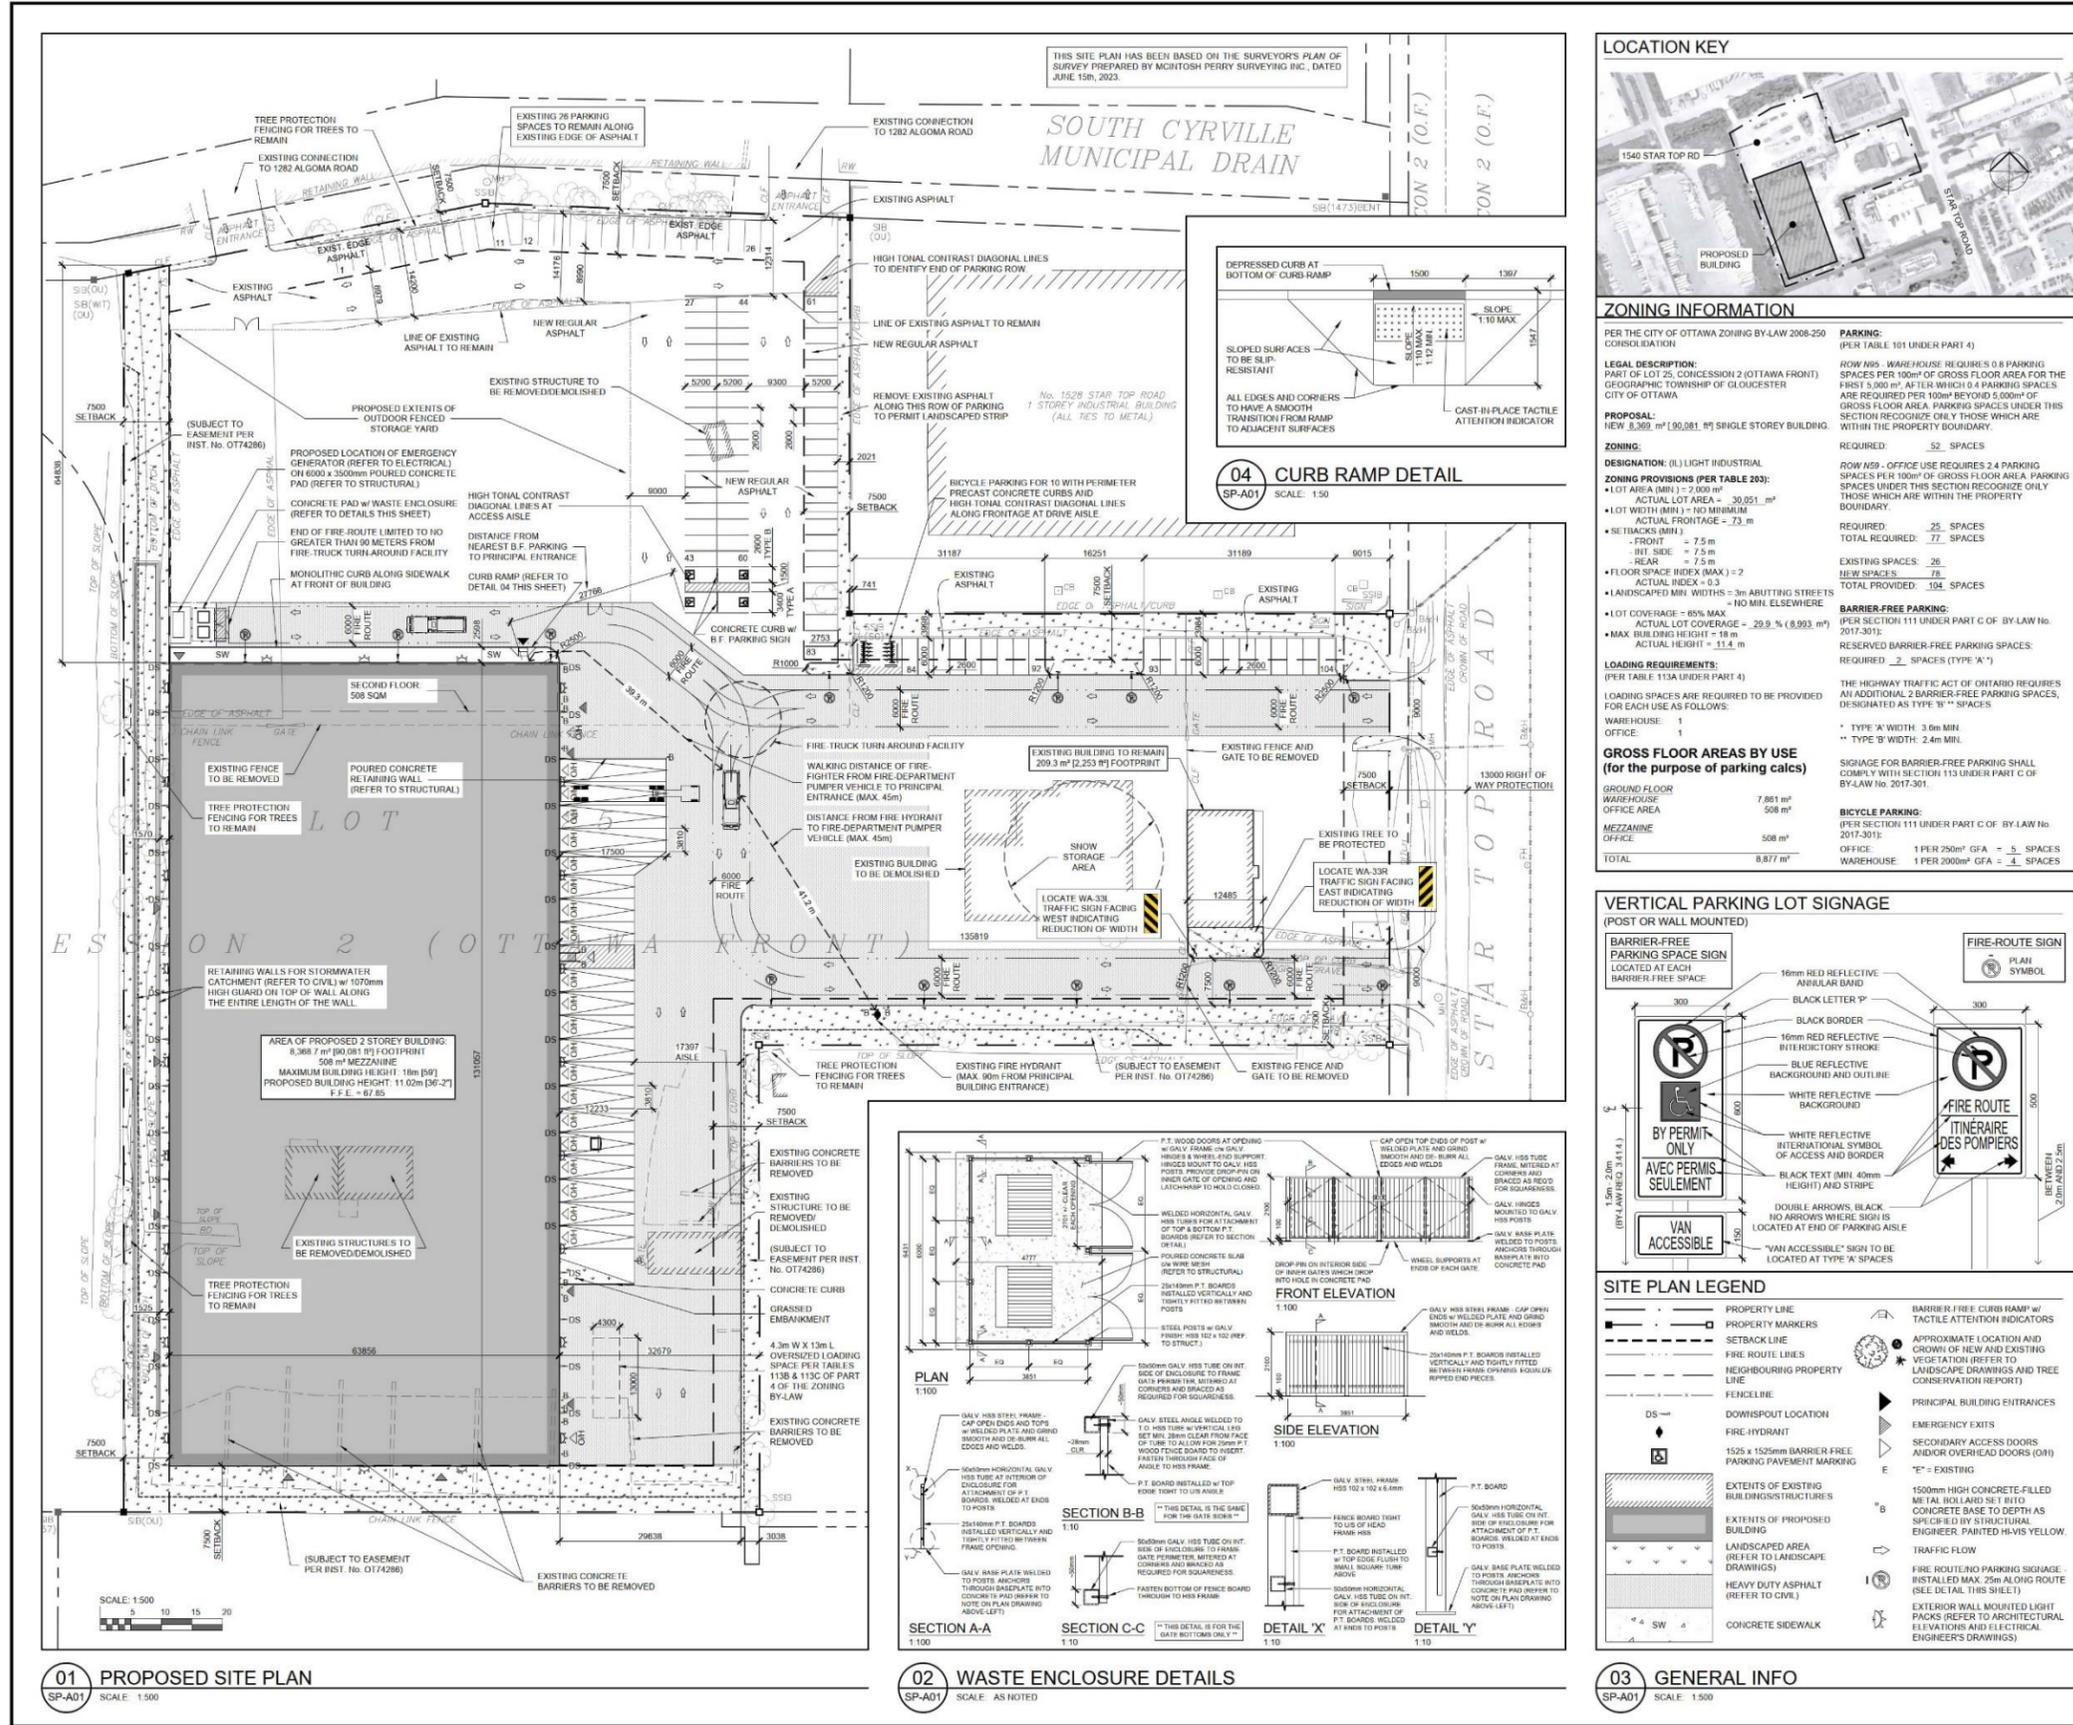
FIGURE 2 – SITE PLAN (by Deimling Architecture & Interior Design, Revised August 9, 2024)

It is proposed to construct a two storey building in the west portion of the site, with a footprint of approximately 90,000 sq ft (Figure 2). This building will be on mostly existing surface storage, with two small structures to be removed. There are two existing buildings in the east portion of the site. The smaller one closer to Star Top Road will be removed, with the one to the west, approximately 6,700 sq ft., to be retained. One-hundred and eight surface parking spaces will be provided, with the balance of the site to be used for access and an outdoor fenced storage yard.
