**Tree Conservation Report
Proposed Development Application
788 March Road
Ottawa, Ontario**

SINA
3030 Boul. Le Carrefour, Suite 1200
Laval, Quebec
H7T 2P5

September 20, 2024
Project: 103027.001

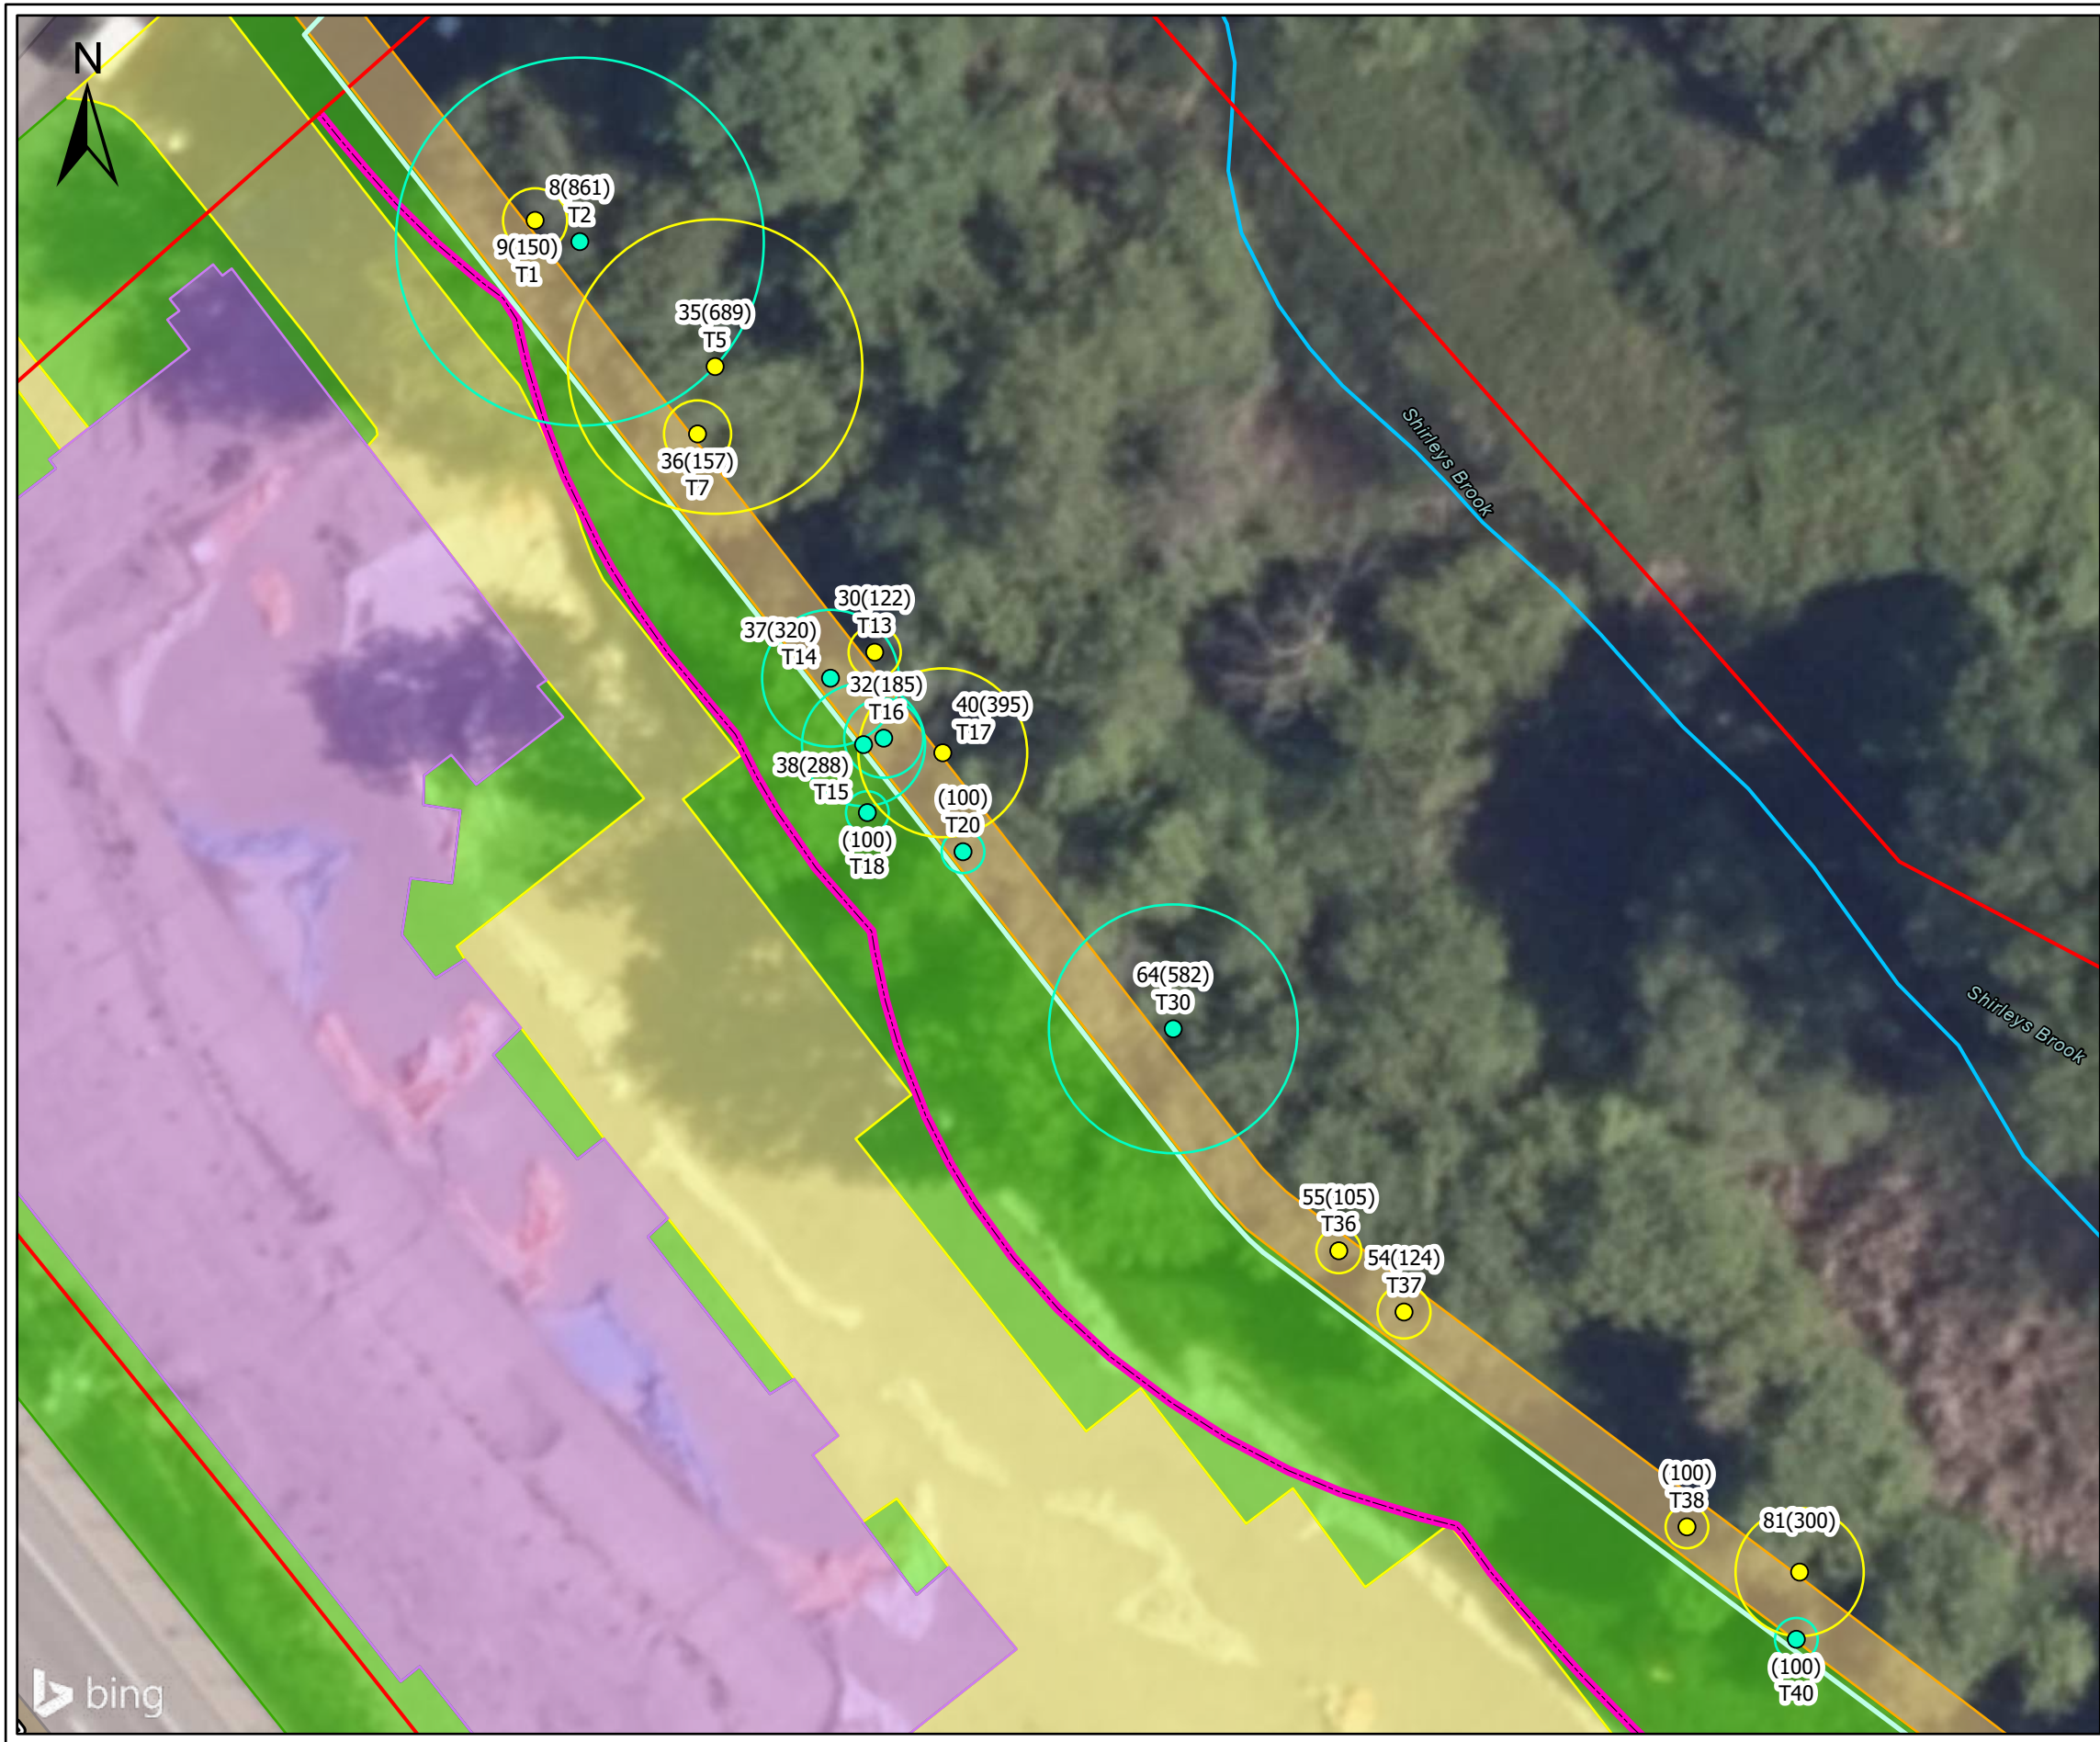
- Property Boundary
- Study Area
- Watercourse
- 30 m Setback
- Conflict - Build
- Conflict - Pathway
- Tree Protection Fencing
- Proposed Building Footprint
- Proposed Paved Area
- Conceptual Proposed Bicycle Path
- Proposed Soft Landscape Area
