Phase I-Environmental Site Assessment

137-141 Geroge Street and 110-116 York Street
Ottawa, Ontario

Prepared for Claridge Homes

Report: PE2709-4
September 4, 2024

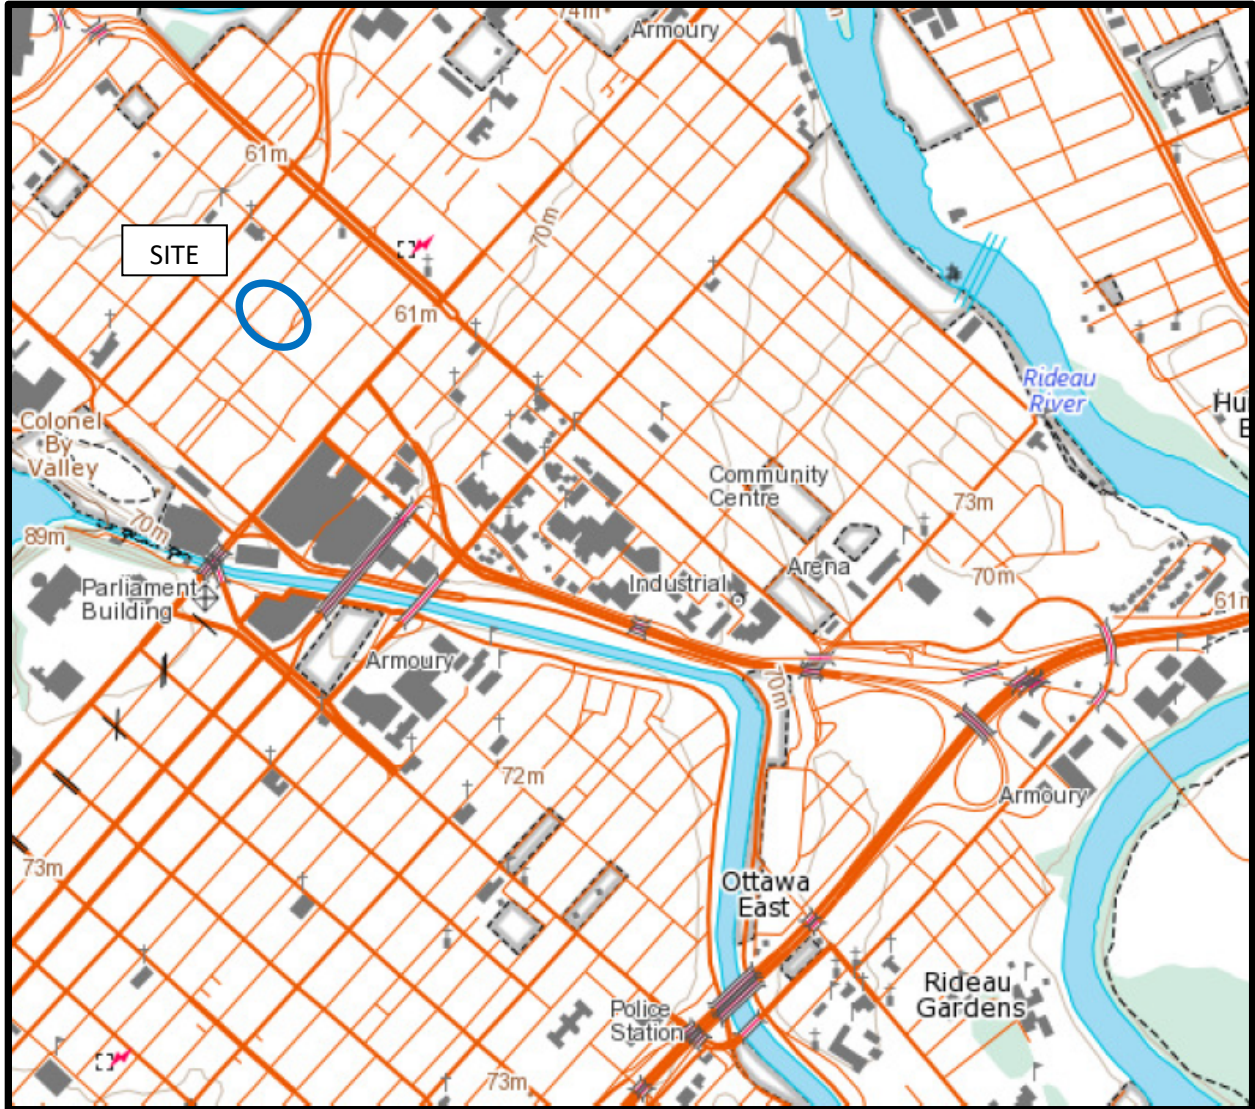
FIGURE 1

KEY PLAN

Location: The Phase I Property is located approximately 20m east of Dalhousie Street between George Street and York Street, in the City of Ottawa, Ontario. Refer to Figure 1 - Key Plan in the Figures section following the text.

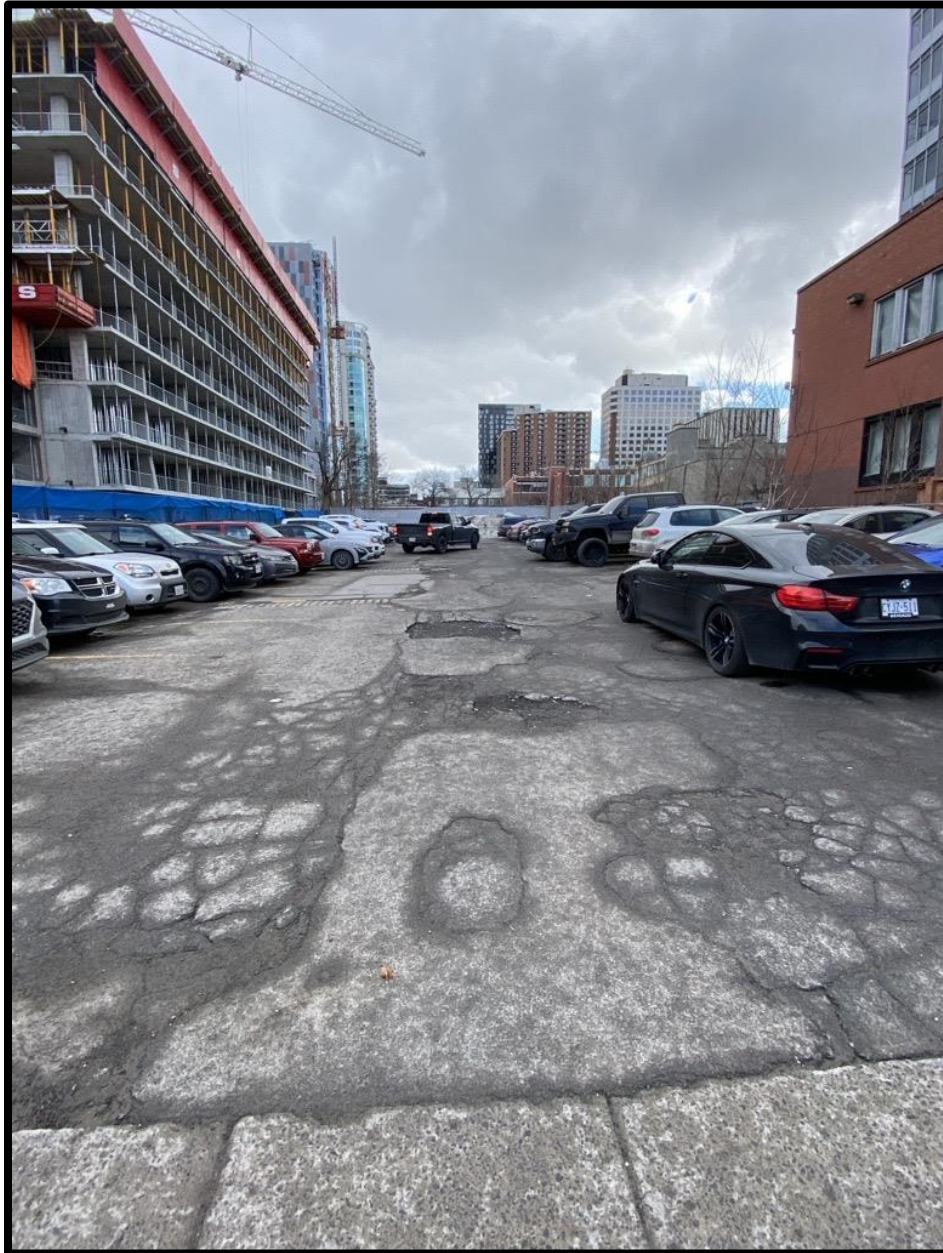
Photograph 1: View of Phase I Property facing south.

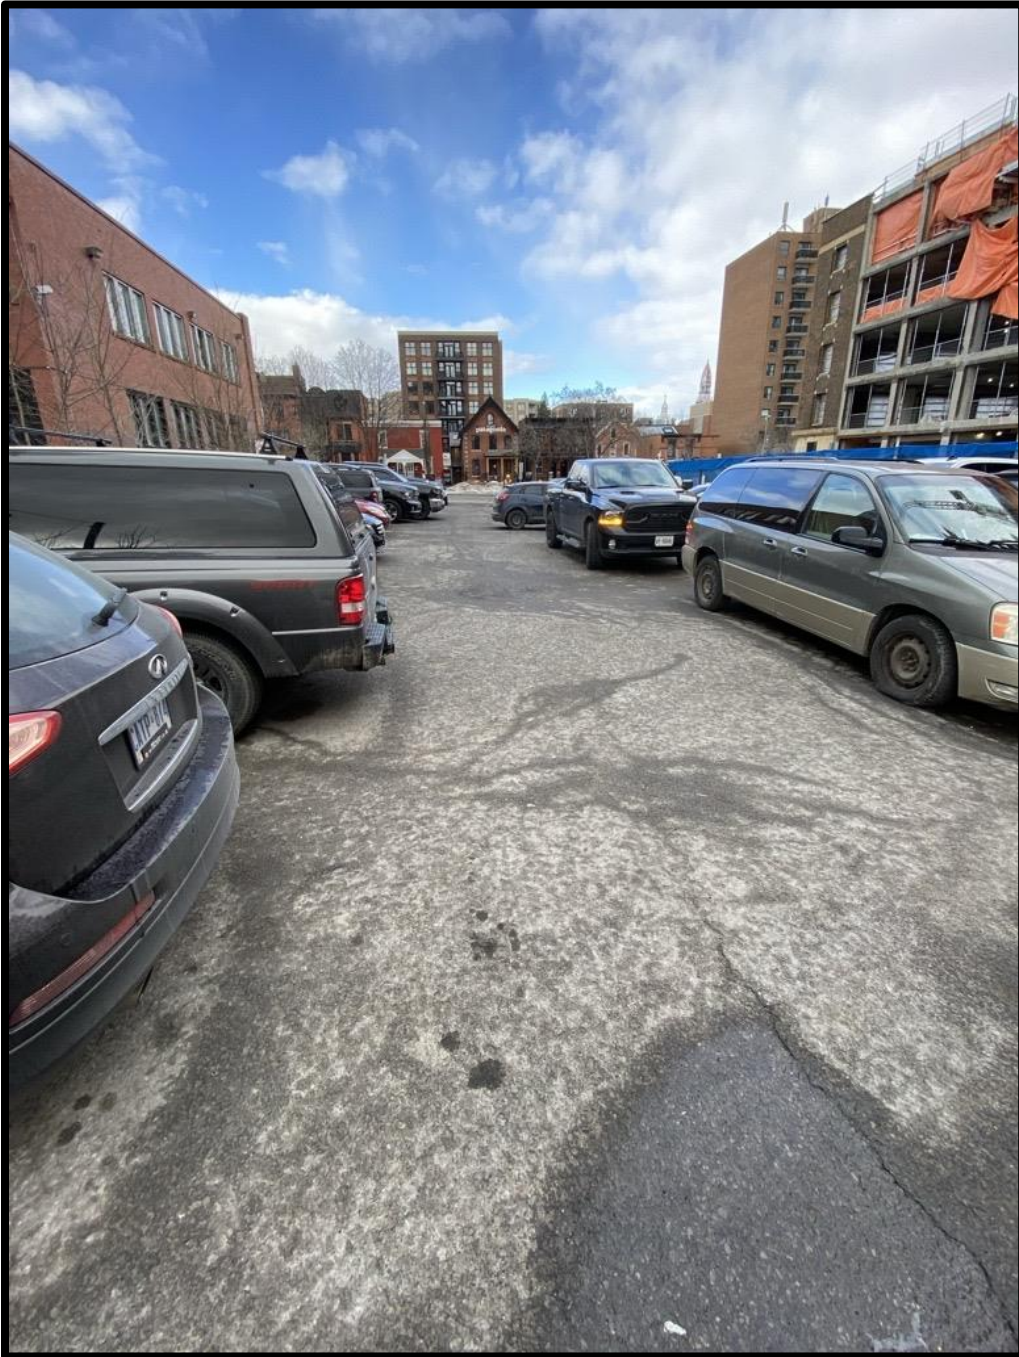
Photograph 2: View of Phase I Property, facing north.

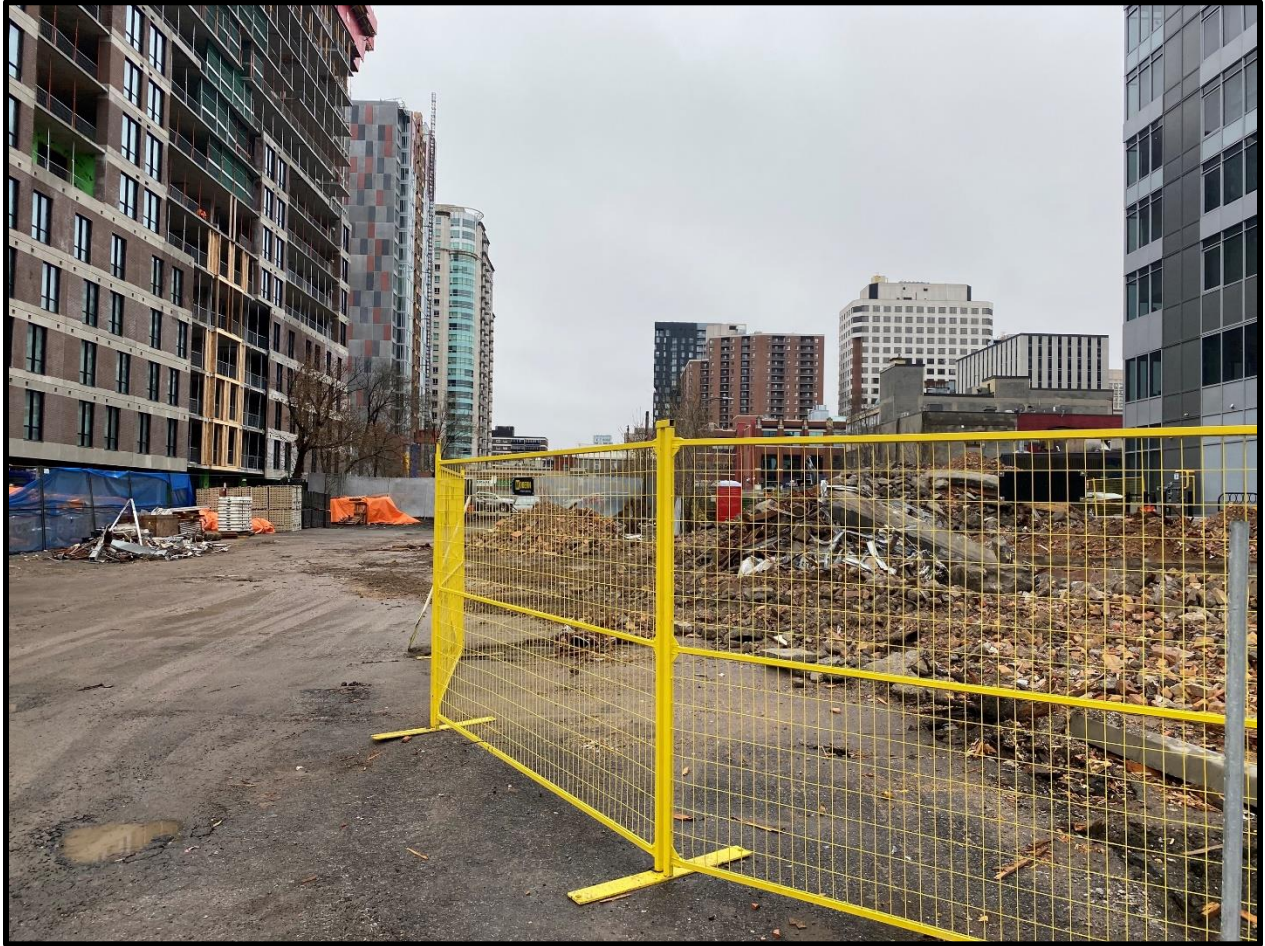
Photograph 3: View of demolished building (110 York Street), facing south.

An interior assessment of the former building was completed during a previous site visit conducted in February 2023. The findings of the interior assessment are presented below. As noted, the building was demolished in April 2024.
