A HERITAGE IMPACT ASSESSMENT 384 ARLINGTON AVENUE. OTTAWA, ON

Prepared for: Windmill Developments
By: John Stewart, Commonwealth Historic Resource Management
Revised October 2024

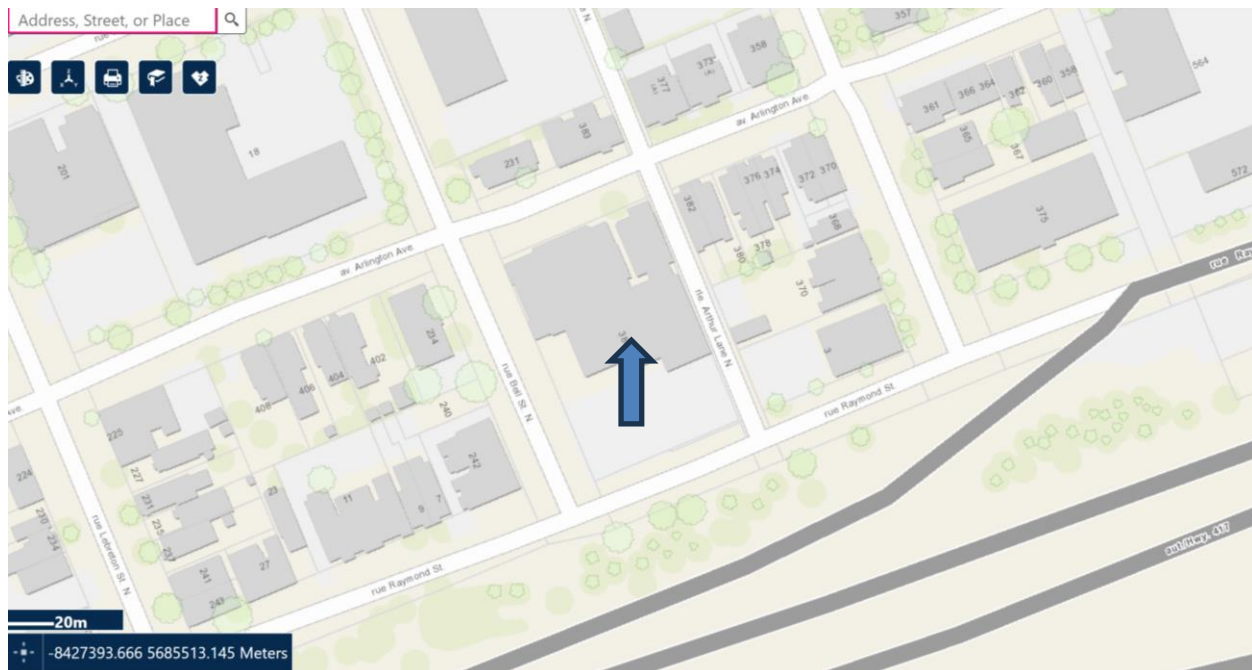
Figure 1: Block plan of the development site and adjacent context illustrating the built form. The development site encompasses a half block, in a primarily low-rise neighbourhood north of the Queensway 417. Site Arrowed.

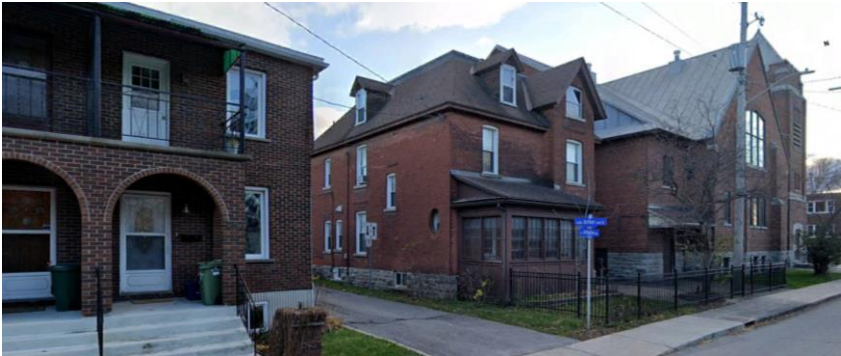
Figure 4: 2022 context view looking southwest from Arlington to the church, and parsonage set adjacent to Arthur Lane. Source: Google Earth.

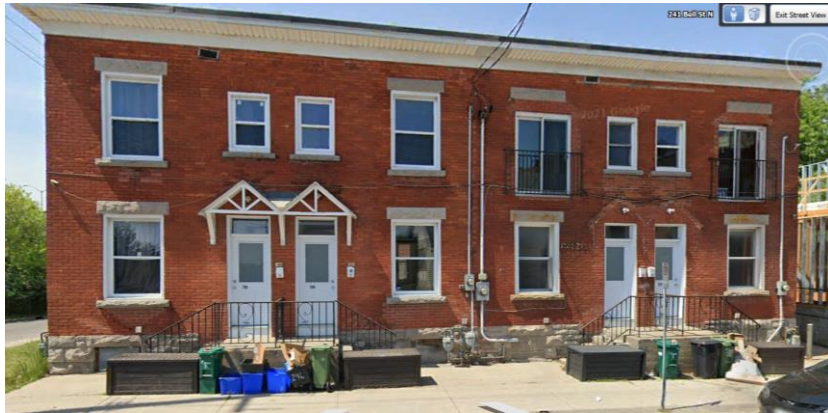
Figure 6: 2022 context view of a circa 1890 rowhouse on Bell Street to the west of the development site. Source: Google Earth

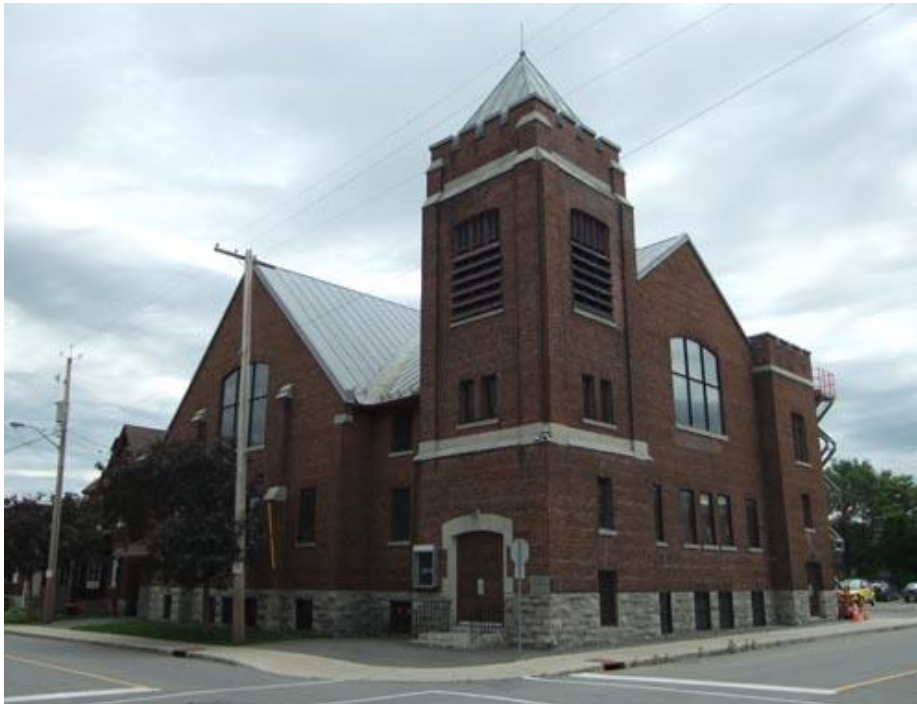
Figure 7: View looking southeast to the 1910 Bell Street United Church. The 1902 parsonage/office fronting onto Arlington Street is set on the east side (left) of the church adjacent to Arthur Lane. Source: Ontario Heritage Trust

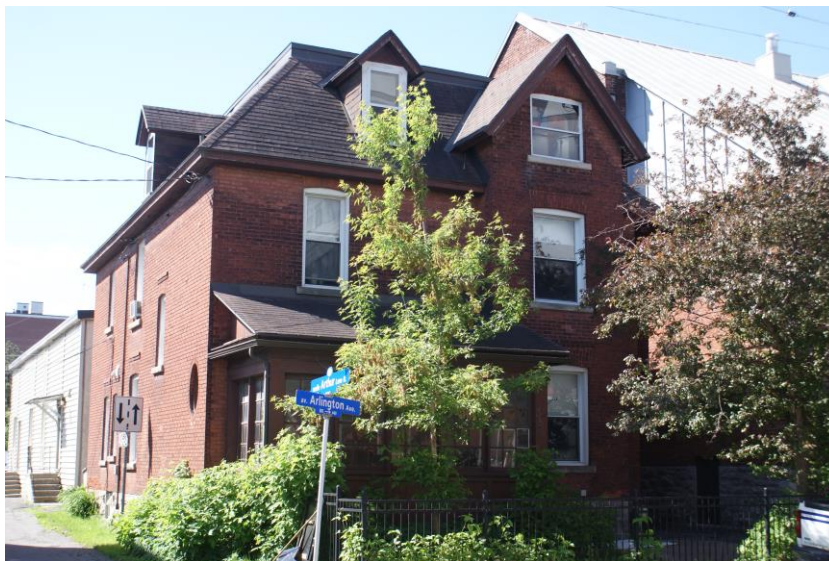
Figure 11: View of the 1902 Parsonage. The building is a brick-clad wood frame structure set on a coursed limestone foundation enclosed with a hip roof with a projecting bay enclosed with a gable roof. Source: Commonwealth 2024

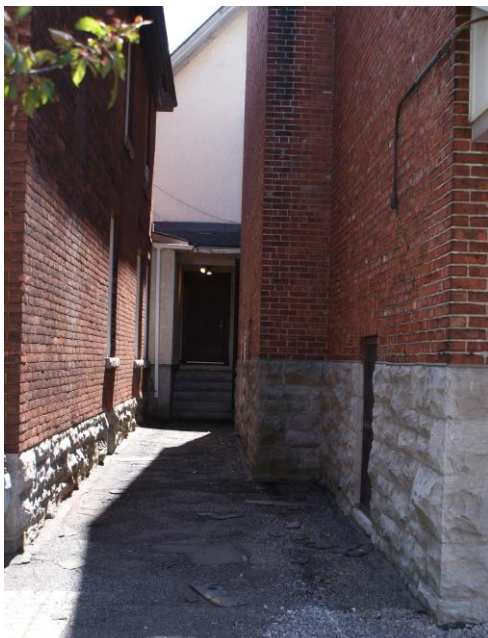
Figure 12: View of the coursed limestone foundations of the 1910 Church (right) and the 1902 Parsonage (left). Note the difference in the stone module (size and finish) between the front and side elevations of the church. The stone from the demolished foundation walls will be used to accommodate changes to the grade level windows in the Bell and Arlington facades. The limestone foundation walls of the Parsonage should be salvaged for potential landscape use. Source: Commonwealth 2024

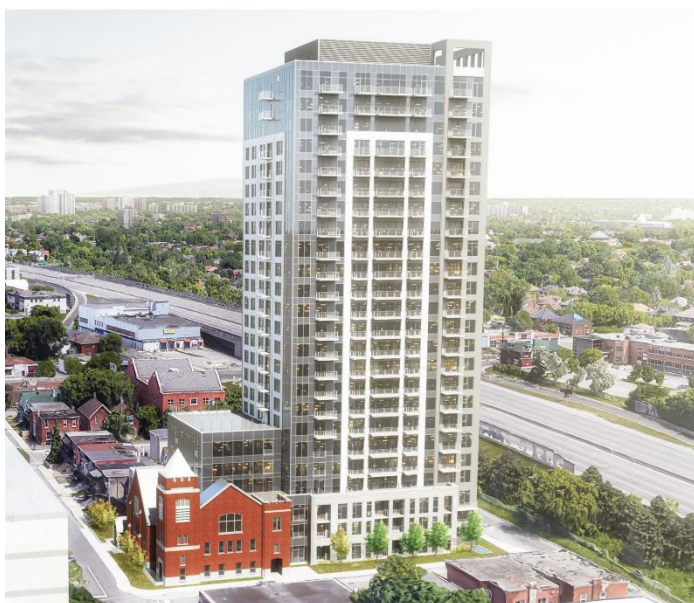
Figure 16: Rendered perspective view of the proposed development, illustrating the integration into the existing context. Source: Neuf 2024.

The proposal strives to preserve and highlight the history and sense of community that the Korean Church building once brought to its neighborhood. The conservation of the existing façades is an important priority, as it preserves the neighborhood’s vibrant community and history. The two retained façades provide a strong base that grounds the architectural elements and materials of the tower.

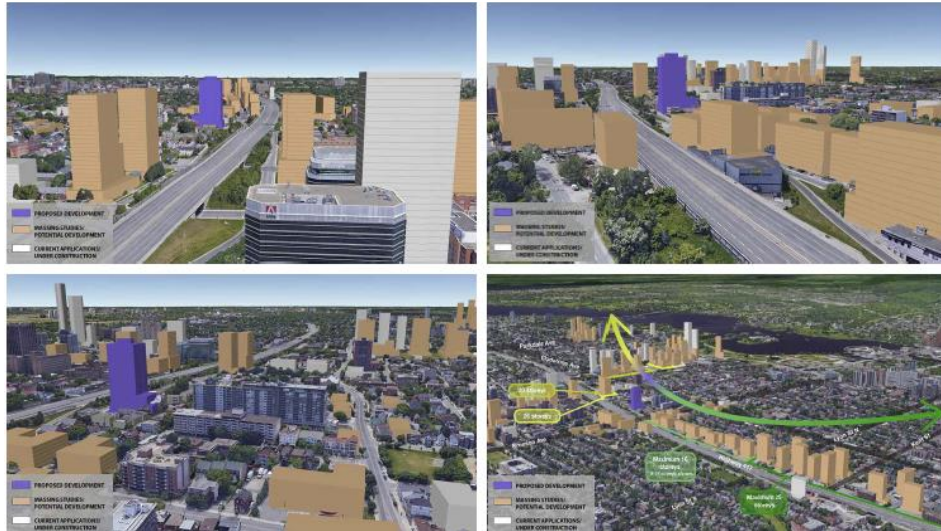
Figure 17: Neighbourhood overview of the proposed tower (purple) with an indication of other developments planned for the area. Source: Neuf 2024.

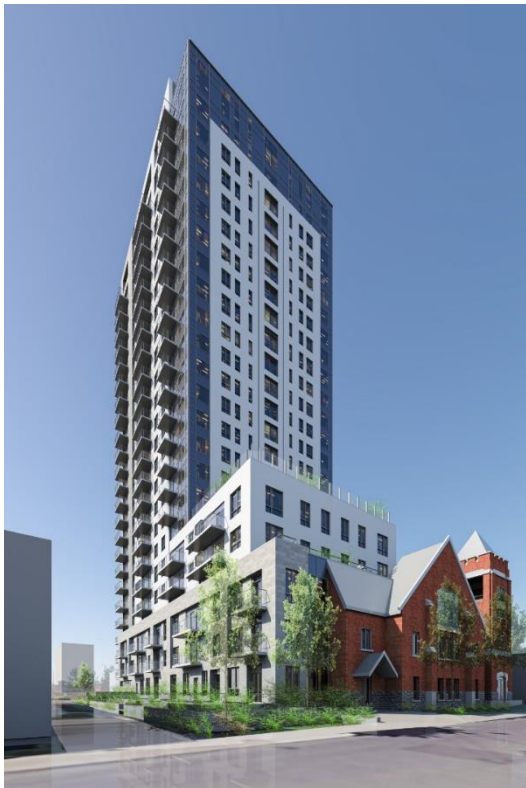
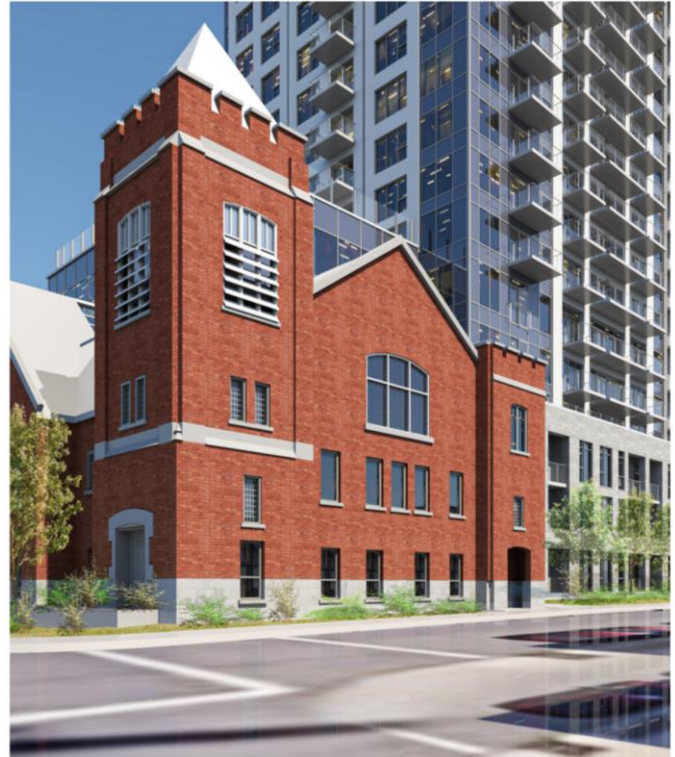
Figure 19: Perspective view of the development illustrating the integration of retained church facades. The fenestration pattern within the gable end is being altered in its vertical orientation to accommodate the floor levels of the development. Source: Neuf May 16, 2024.

Figure 20: Rendered perspective view of the Arlington and Arthur Lane facades. The fenestration pattern on the Arlington Street façade is being altered in the same fashion as the Bell Street façade. The railing for the proposed rooftop amenity area is visible. Source: Neuf October 2024.

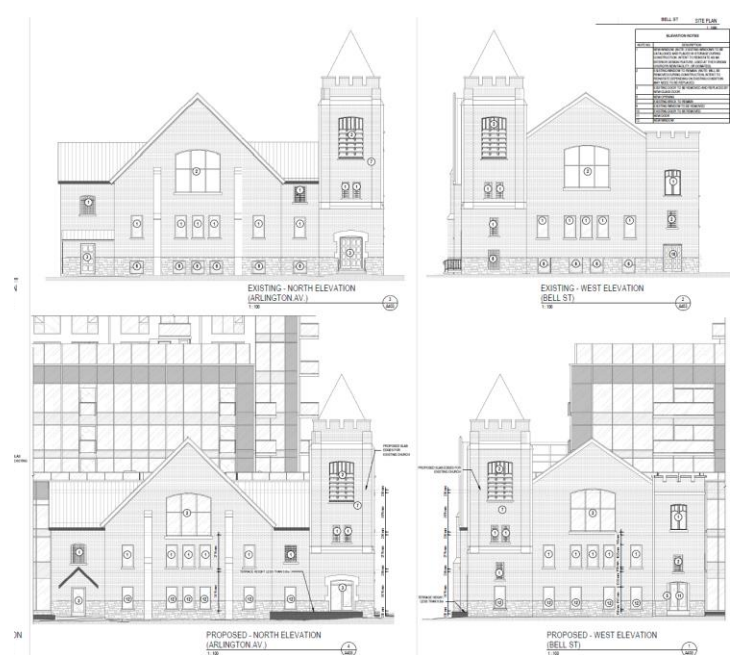
Figure 29: The insertion of floor levels that extend across the existing window openings are difficult to implement from a building code perspective, necessitating the alteration of the vertical heights of most of the windows.

Figure 30: Existing and Proposed Arlington/north elevation and West Bell elevation, illustrating the vertical alteration of the windows. The large three-storey windows on the third level will not be altered. Elevation notes (left) describe the treatment for all the windows will be impacted. Source: Neuf 2024

To integrate the church into the plan, it will be necessary to adjust floor levels in the church, which has resulted in floor levels passing through the large stain glass windows and the ground floor windows. The strategy for synchronizing floor levels and windows requires extensive alteration of the window openings. Figure 29 & 30 illustrates the existing façade and proposed changes to the windows pattern on the Bell and Arlington facades. The proposed conservation methods and treatments are in progress and will be submitted as part of the John Cooke’s Shoring Feasibility Report . The alteration of the windows’ vertical heights will involve the removal of the gauged brick arches (flat and segmental) and stone sills. Cutting new openings into the brick walls, and Infilling areas with brick, including the gauged brick arches and stone sills. The extent of the required alterations to the exterior walls that are two bricks in thickness requires extensive masonry work. The existing door opening at the southwest corner will be retained, and the door removed to form an entrance to the development. This will require modifications of the Bell Street entrance, with a new opening cut in the south wall and glazed doors installed. It is the client’s plan to update the shoring and conservation plan with detailed masonry treatment, as part of the detailed development phase.

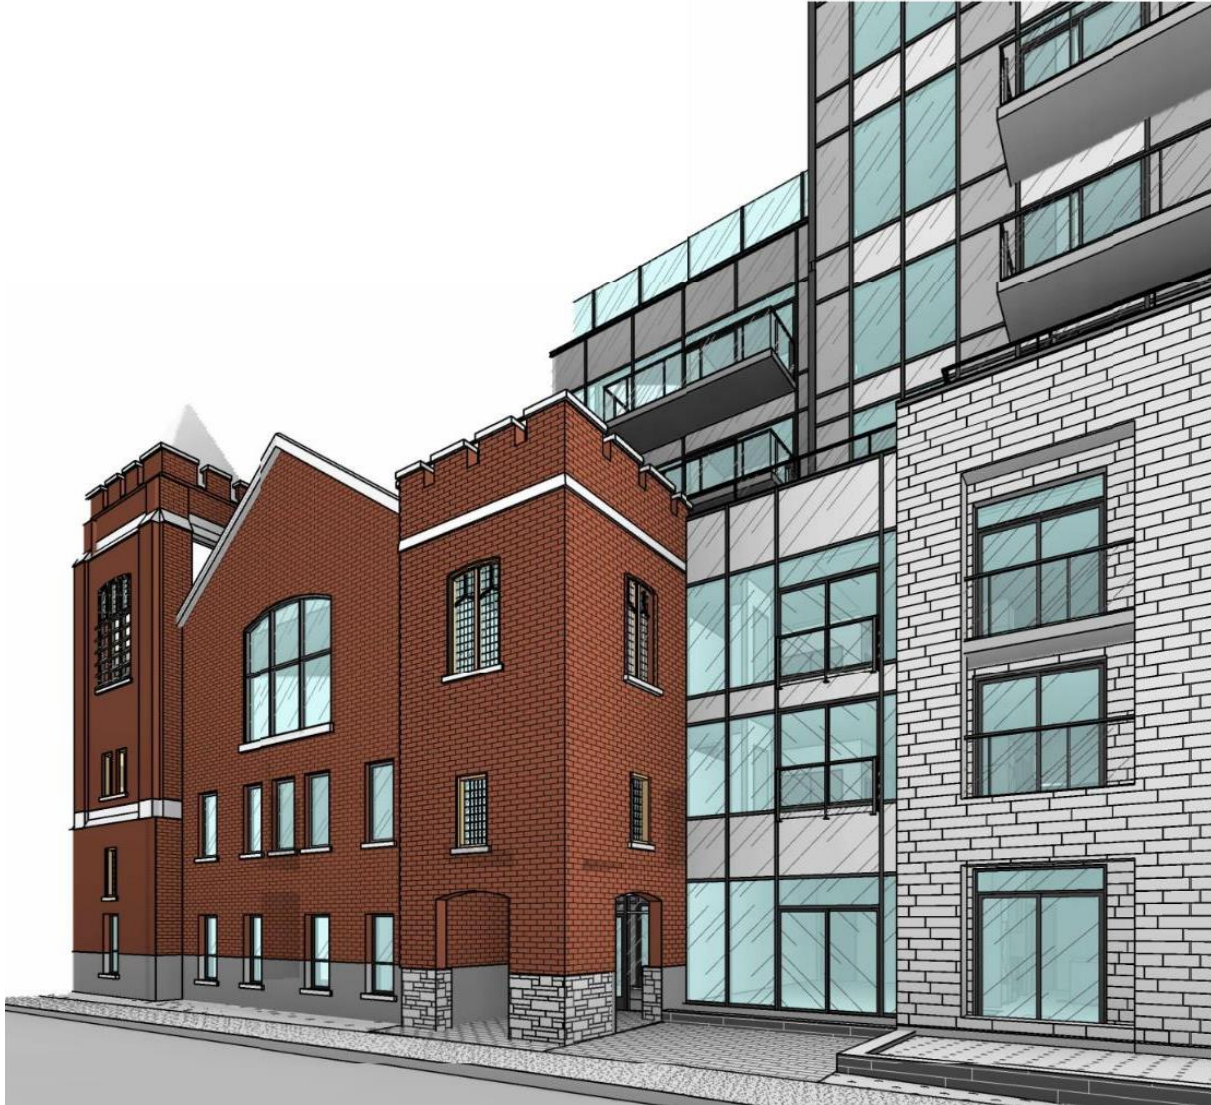
Figure 31: A view of the (West) Bell elevation, illustrating the vertical alteration of the windows. The Bell Street entrance has been enlarged and will serve as the main entrance to the new residential tower. A new opening will be cut in the south wall and glazed doors installed. Source: Neuf June 2024r. The historic Arlington Street entrance at the corner will serve as an on-street entrance to one of a unit. Source: Neuf :

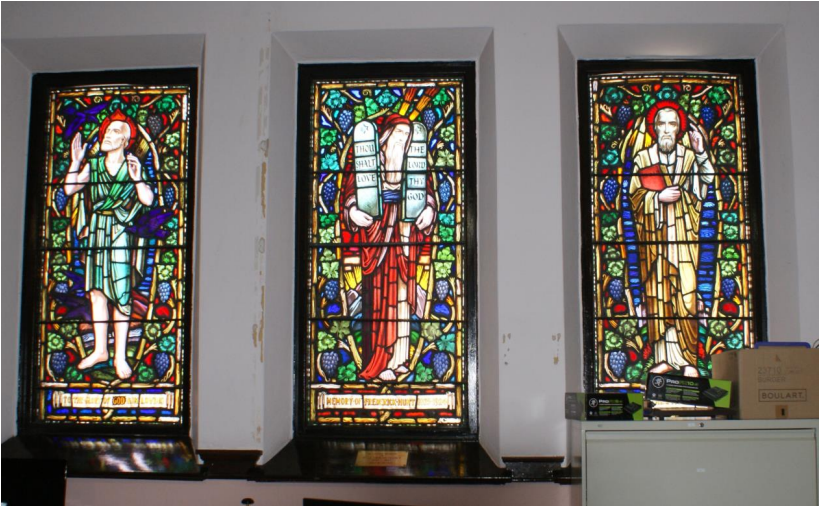
Figure 34: A memorial window in the north gable of the church is one of three that will be retained and integrated into the new space.

The stained-glass windows were installed after the second world war and are considered important attributes of the heritage building. A conservation plan is being developed that will see the three large, segmented windows retained and incorporated into the new common amenity area. All the windows will be cataloged and stored during construction. The Korean Church's former owners have first right to take the windows for reuse at their new church. Those that remain will be incorporated into the new development. Those not used will be sold or donated.

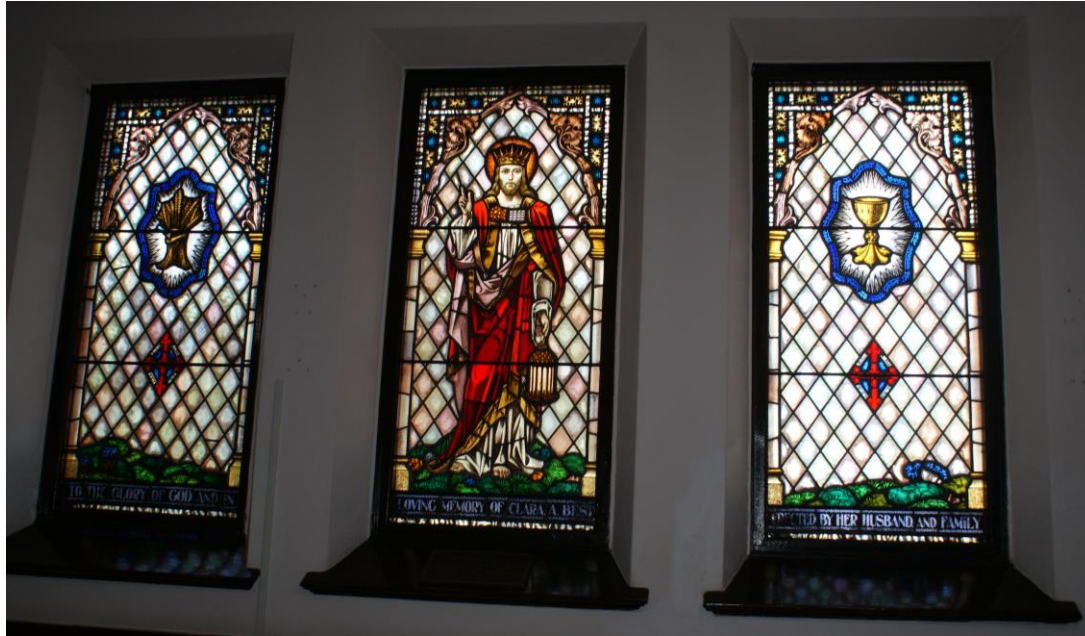
Figure 35: View of the memorial windows installed at the ground floor level. The windows memorialize Clara A. Best and were funded by her husband and family. Source: Commonwealth May 2024.

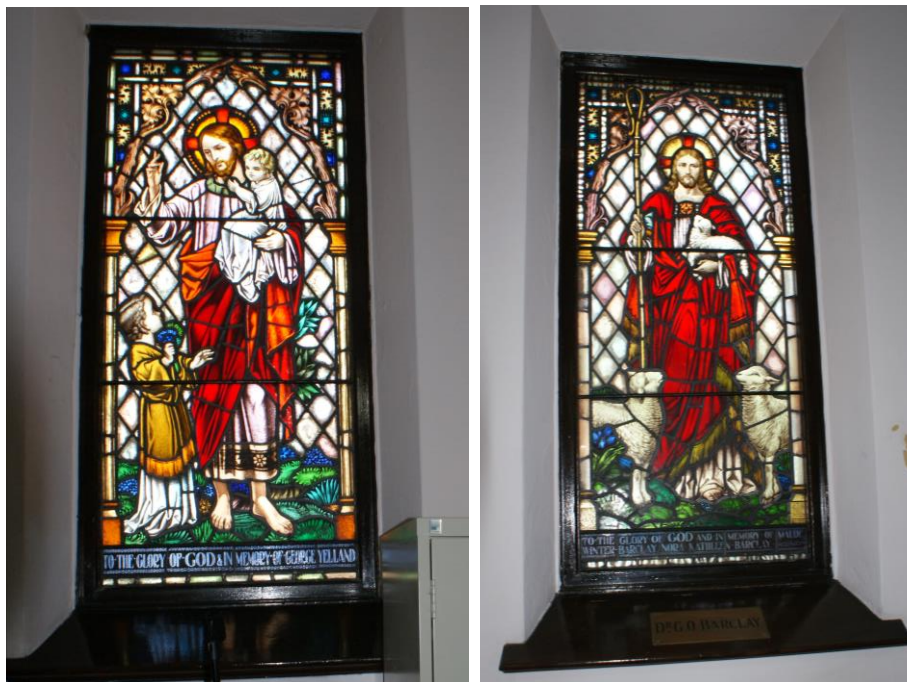
Figures 36 and 37: View of art glass windows on the north elevation at ground floor level. The windows memorialize George Yellen (left) and Maude and Nora Barclay (right). Source: Commonwealth May 2024.

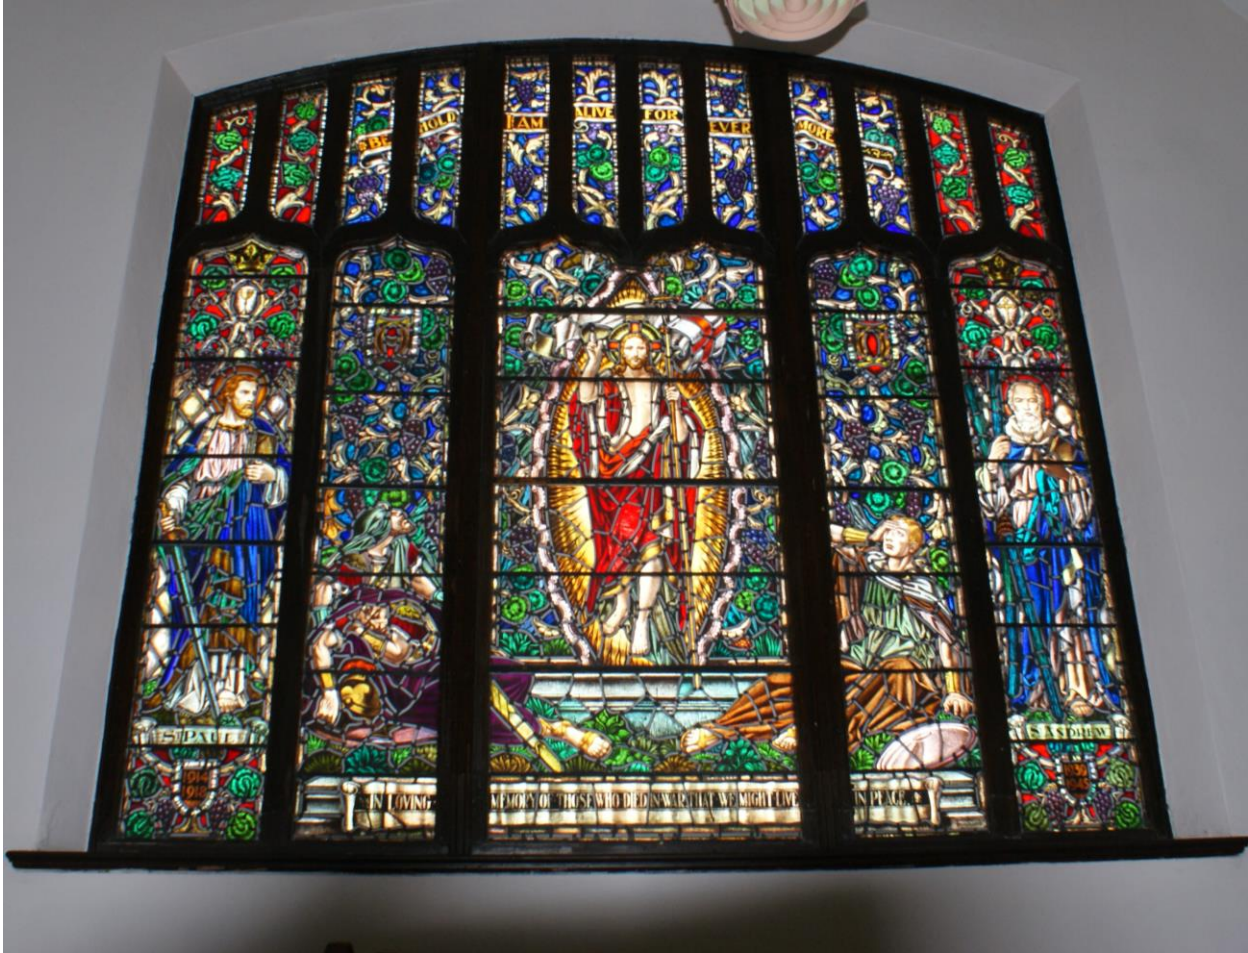
Figure 38 and 39: Memorial windows in the north elevation dedicated to the memory of Archibald Amos & Vincent Merrill Morrison. Confirm location. Source: Commonwealth May 2024.

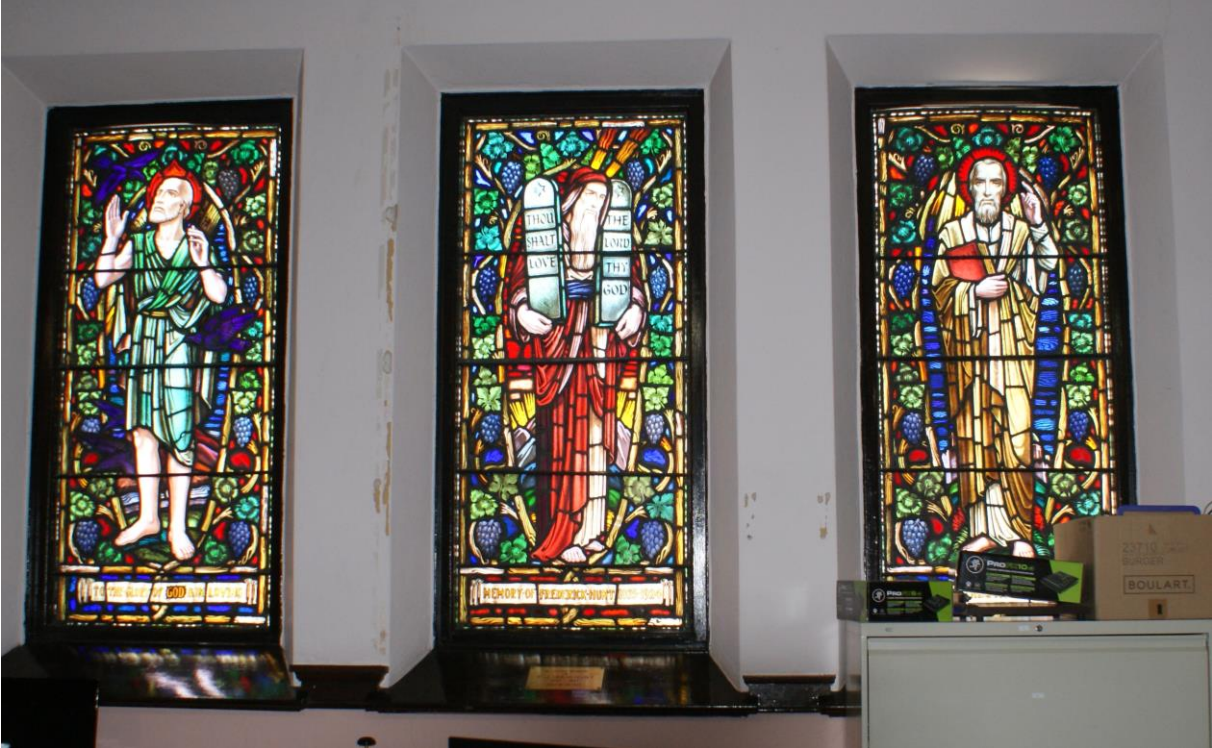
Figure 40: Memorial window in the west elevation ground floor level dedicated to the memory of Frederick Hunt (centre) among others. Source: Commonwealth May 2024.

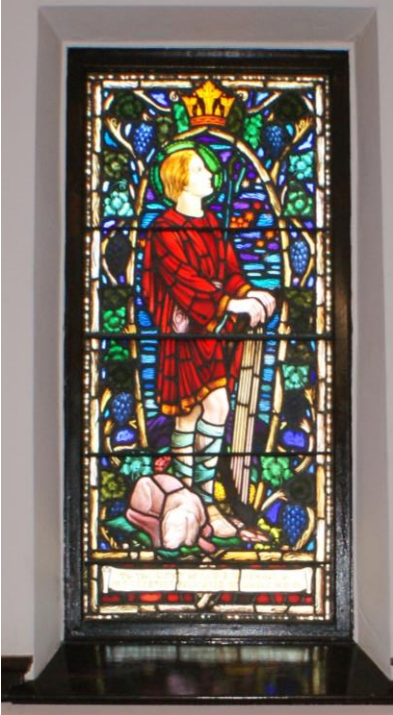
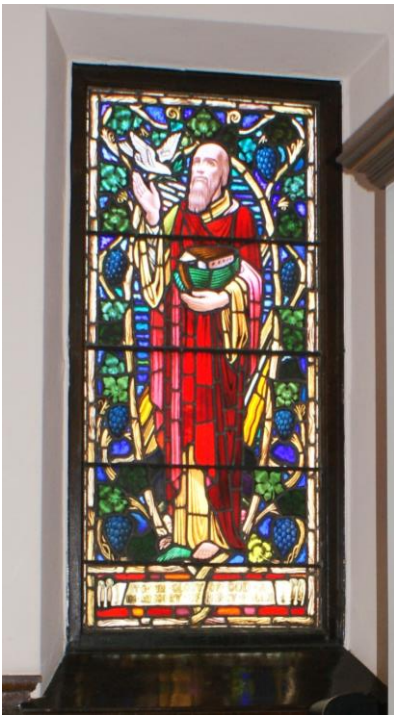
Figures 41 & 42: Memorial windows on the west elevation ground floor level. Source: Commonwealth May 2024.

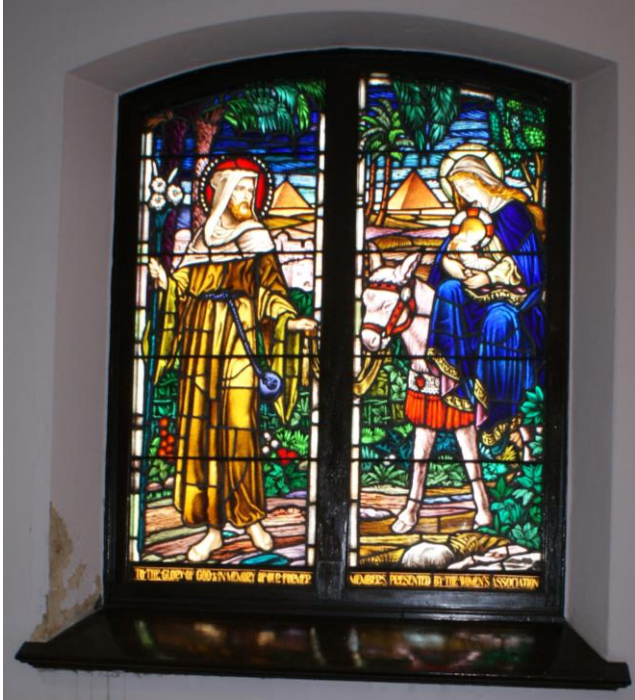
Figure 43: Memorial windows dedicated to the Women’s Association on the west elevation, ground floor level. Source: Commonwealth 2024.

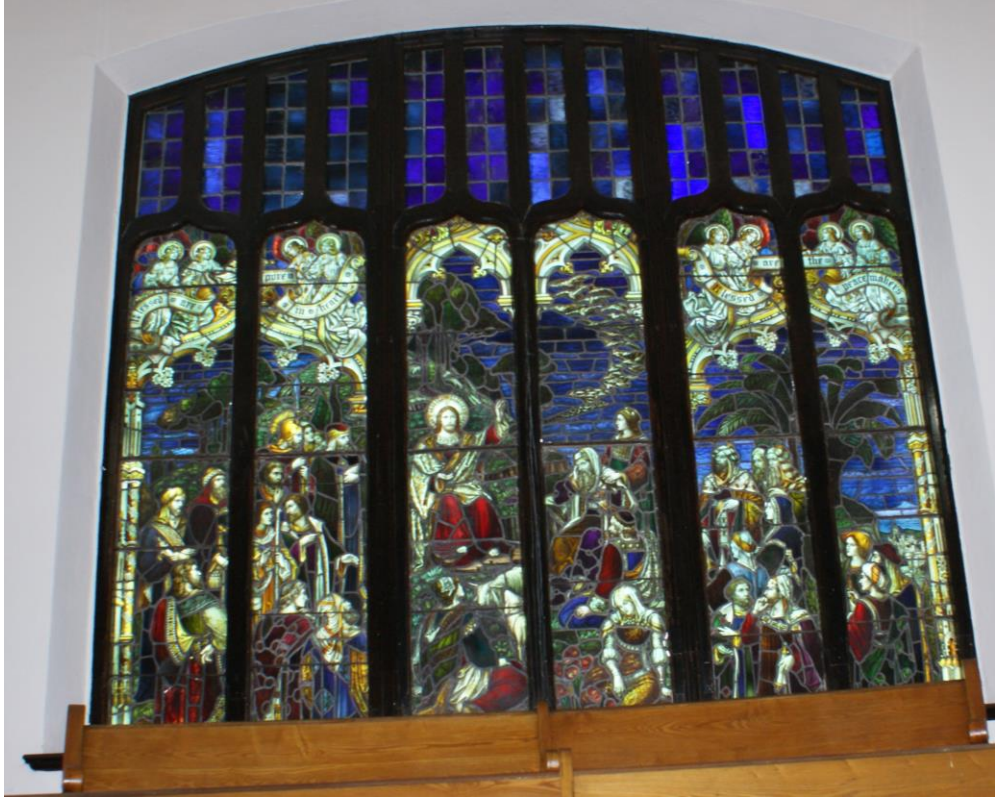
Figure 44: Memorial window in the west gable. The upper portions of the west gable window appears to have stained/coloured glass that was not replaced.

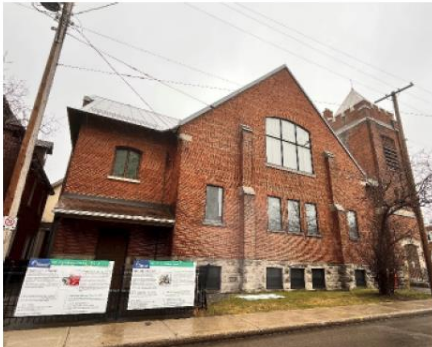
Figure #1: Heritage Façade along Arlington Ave. [JCAL 2024]

Refer below to Figures #1 and #2, for the facades on Arlington Avenue and Bell Street that require shoring, during the construction phase of the new development.

- **North Elevation:**
 - Upper ledge of belltower: displaced ashlar stone, displaced brick, masonry is moving at this location due to long term water infiltration. This is a fall hazard, brick should be removed or anchored as soon as possible, and the area under this entrance fenced off immediately.

- Around belltower louvre:
 - Along top of gable: mortar joints are cracked
 - East Return wall of belltower: large bulge in brick masonry above church roof level, this is a fall hazard and needs to be rectified immediately.
