Phase I Environmental Site Assessment

The Salvation Army Barrhaven Church
102 Bill Leathem Drive
Ottawa, Ontario

April 12, 2016

Report: PE3779-1

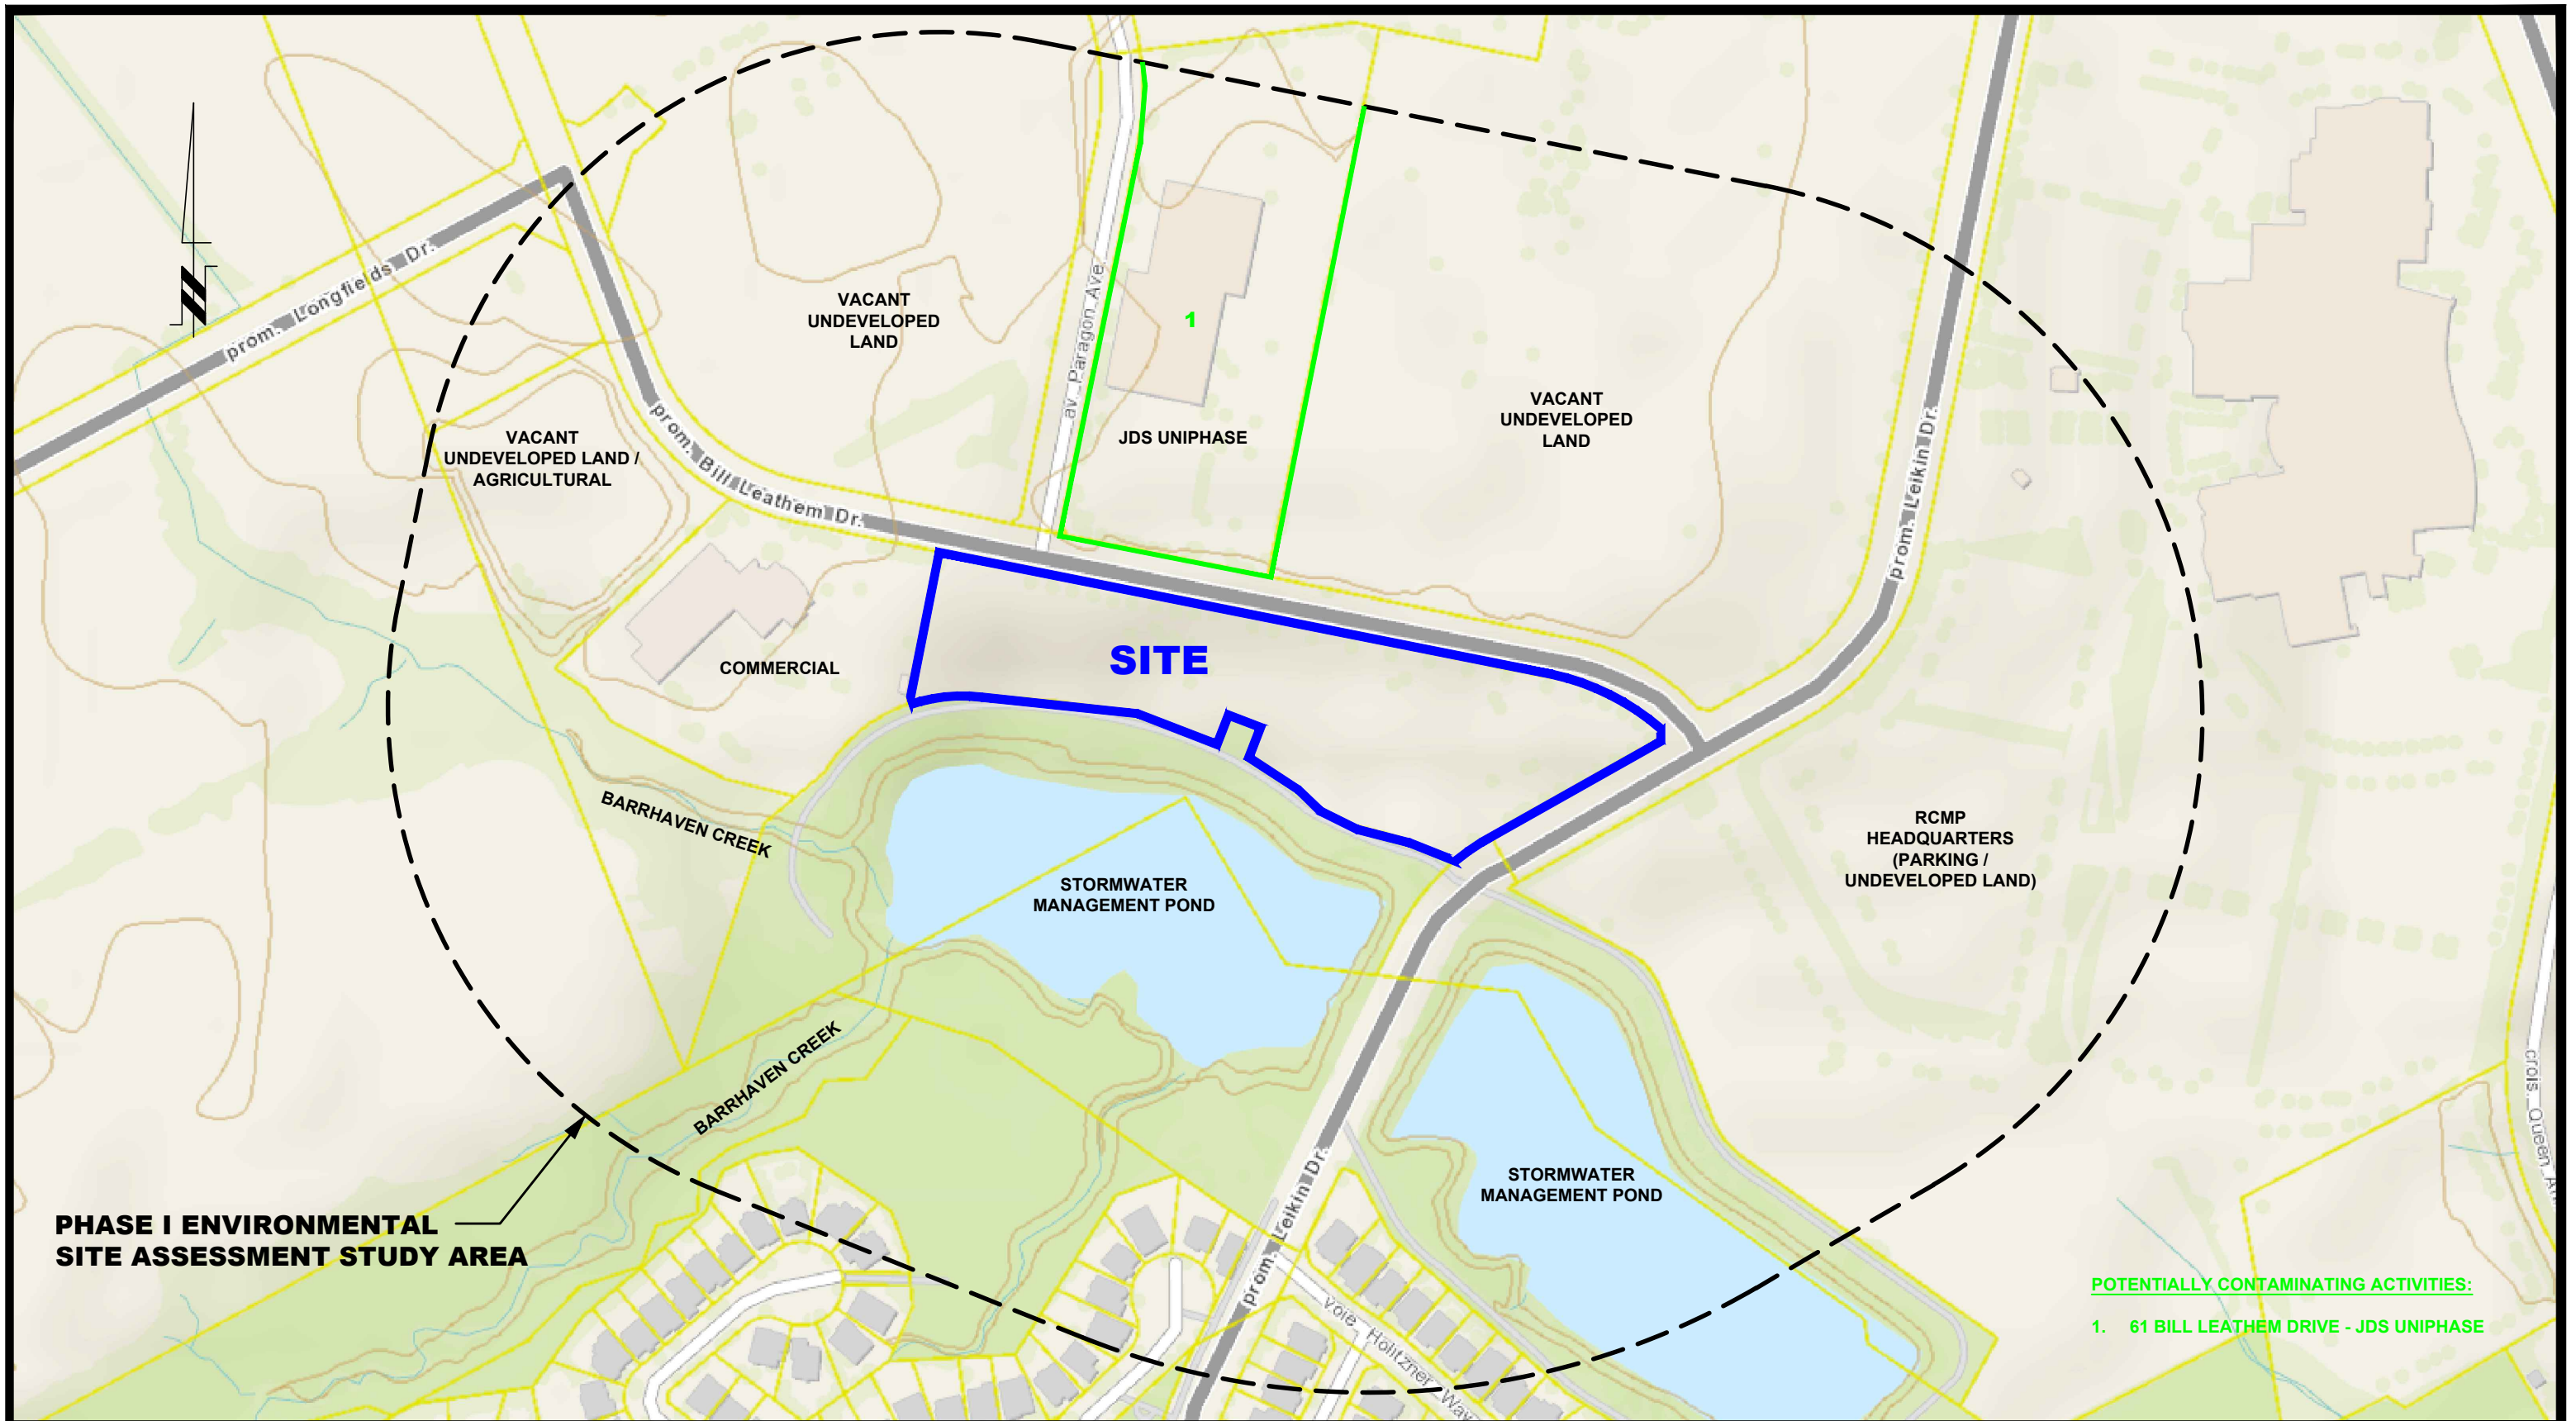
DRAWING PE3799-2 – SURROUNDING LAND USE PLAN

POTENTIALLY CONTAMINATING ACTIVITIES:
 1. 61 BILL LEATHEN DRIVE - JDS UNIPHASE

The property to the north occupied by JDS Uniphase, a laser and electronic component manufacturer was also considered to be a PCA. Based on the distance of the building from the Phase I property, its recent construction (2006/2007) and information contained in our files, it is not considered to represent an APEC on the subject land. Current land use in the Phase I Study area is illustrated on Drawing: PE3779-2 – Surrounding Land Use Plan in the Figures section of this report, following the text.

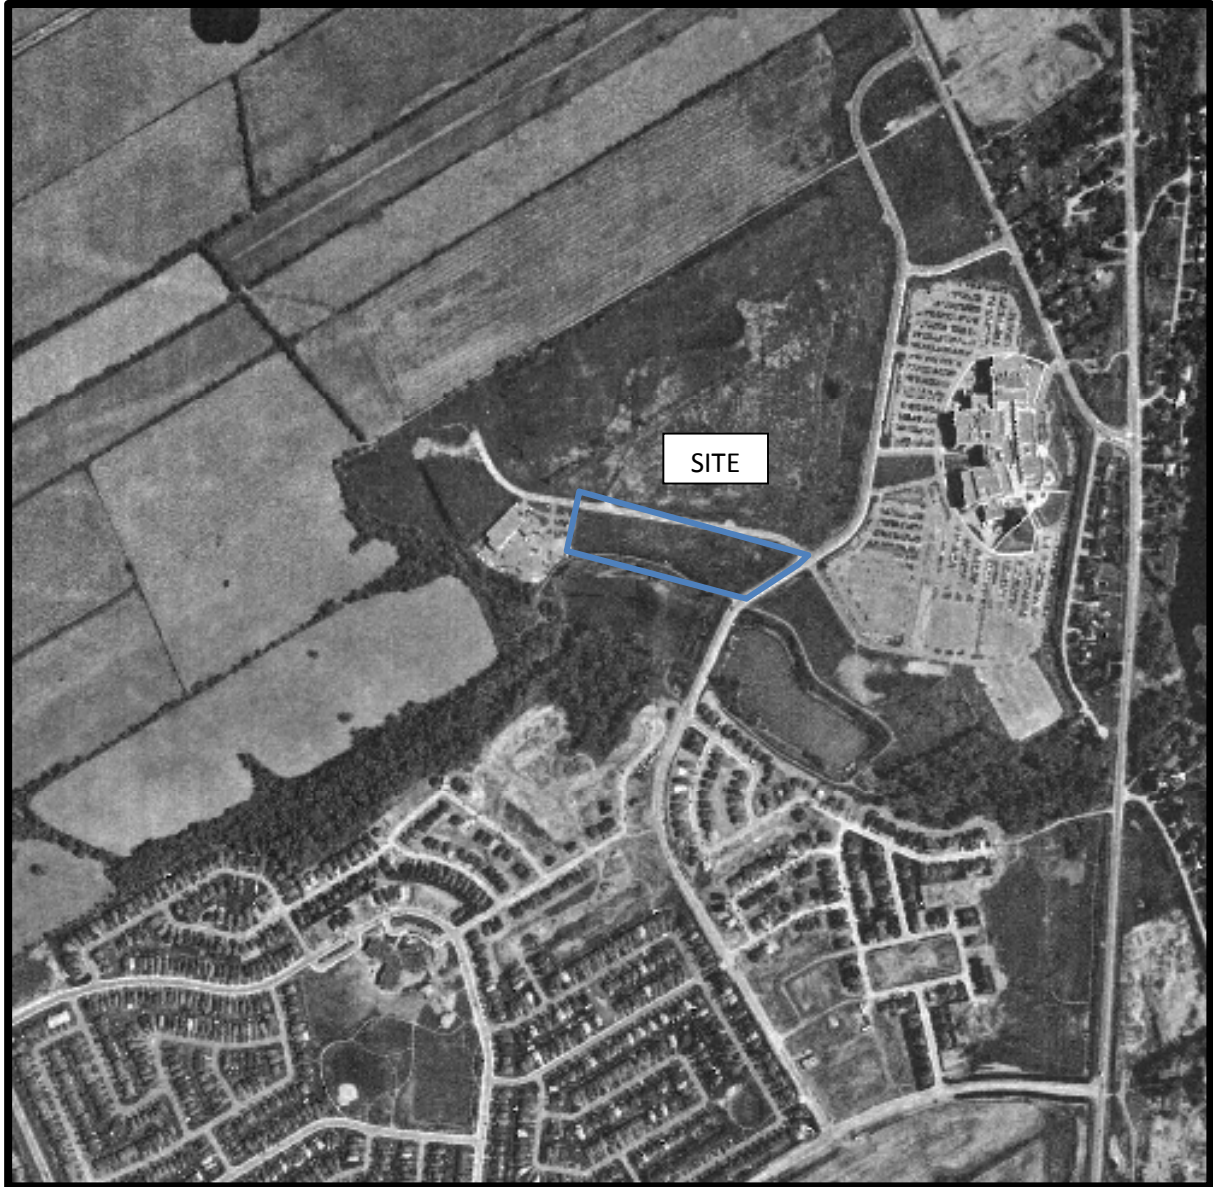
AERIAL PHOTOGRAPH
2002

- 2002 The Phase I property appears as it currently exists. The construction of Bill Leathem Drive and Leiken Drive is now completed. A commercial property has been developed on the adjacent property to the west of the Phase I property, while JDS has been constructed on the adjacent property to the west. A residential subdivision is now present further to the south of the subject land.

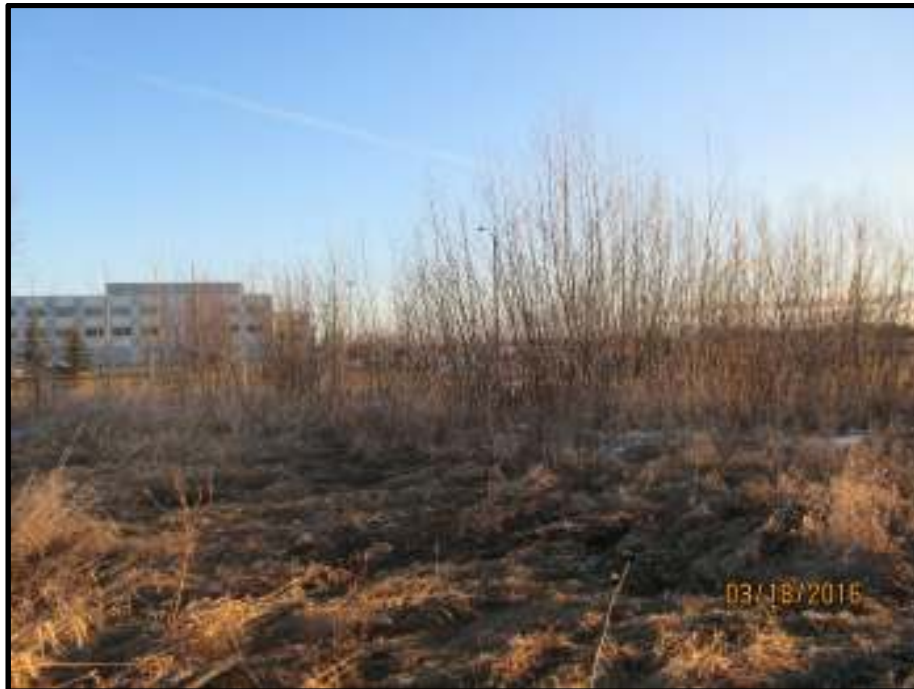
Photograph 4: View of treed area on central portion of site, facing north.
