Geotechnical Investigation

Proposed Mixed-Use Development 1518-1526 Stittsville Main Street Ottawa, Ontario

October 11, 2024

Report: PG5418-1 Revision 4

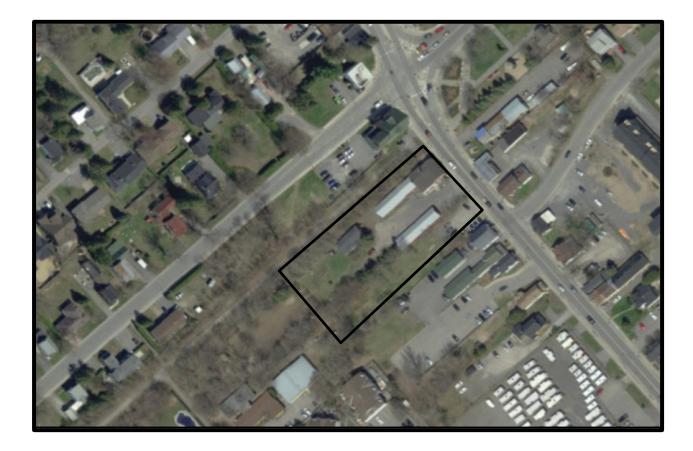
FIGURE 2

Aerial Photograph - 2014

Based on available historical photographs of the subject site, a building was located in the northeast portion of the site fronting onto Stittsville Main Street as recently as 2014, and was no longer present in 2017. Reference should be made to the aerial photographs in Figure 2 - Aerial Photograph - 2014 and Figure 3 - Aerial Photograph - 2017 which illustrate the former and present site conditions, respectively.

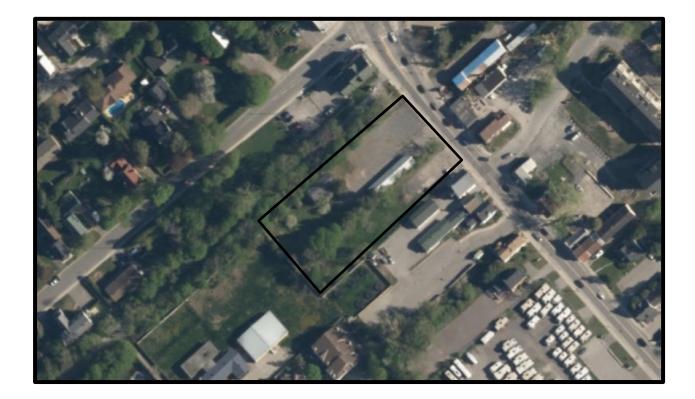
FIGURE 3

Aerial Photograph - 2017

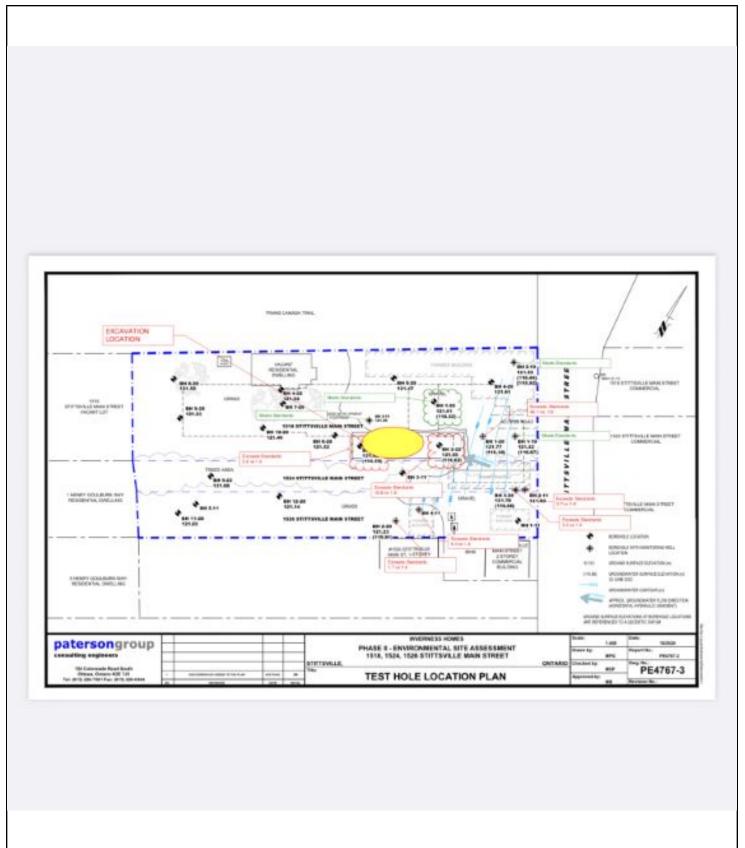
TEST LOCATION PLAN

TO:	Inverness Homes Inc.	DATE: Jun 05.2023	8:00 AM	FILE: PM14602
PROJECT:	1518 Stittsville Main Street - Excavation Backfill			
ADDRESS:	1518 Stittsville Main Street, Stittsville			
LOCATION:	Sand Backfill - for the location see the sketch marked as Excavation Location			
AUTHOR:	Mohit Taheliyani			
Nates if any recommendations are ideal to the Determine Areas and itis an additional cast the contractor shall obtain with arisation from the
