**1440 Prince of Wales Drive,
Ottawa, Ontario**

Shell Canada Products

AtkinsRéalis Ref: 694129

FINAL - Phase One Environmental Site Assessment

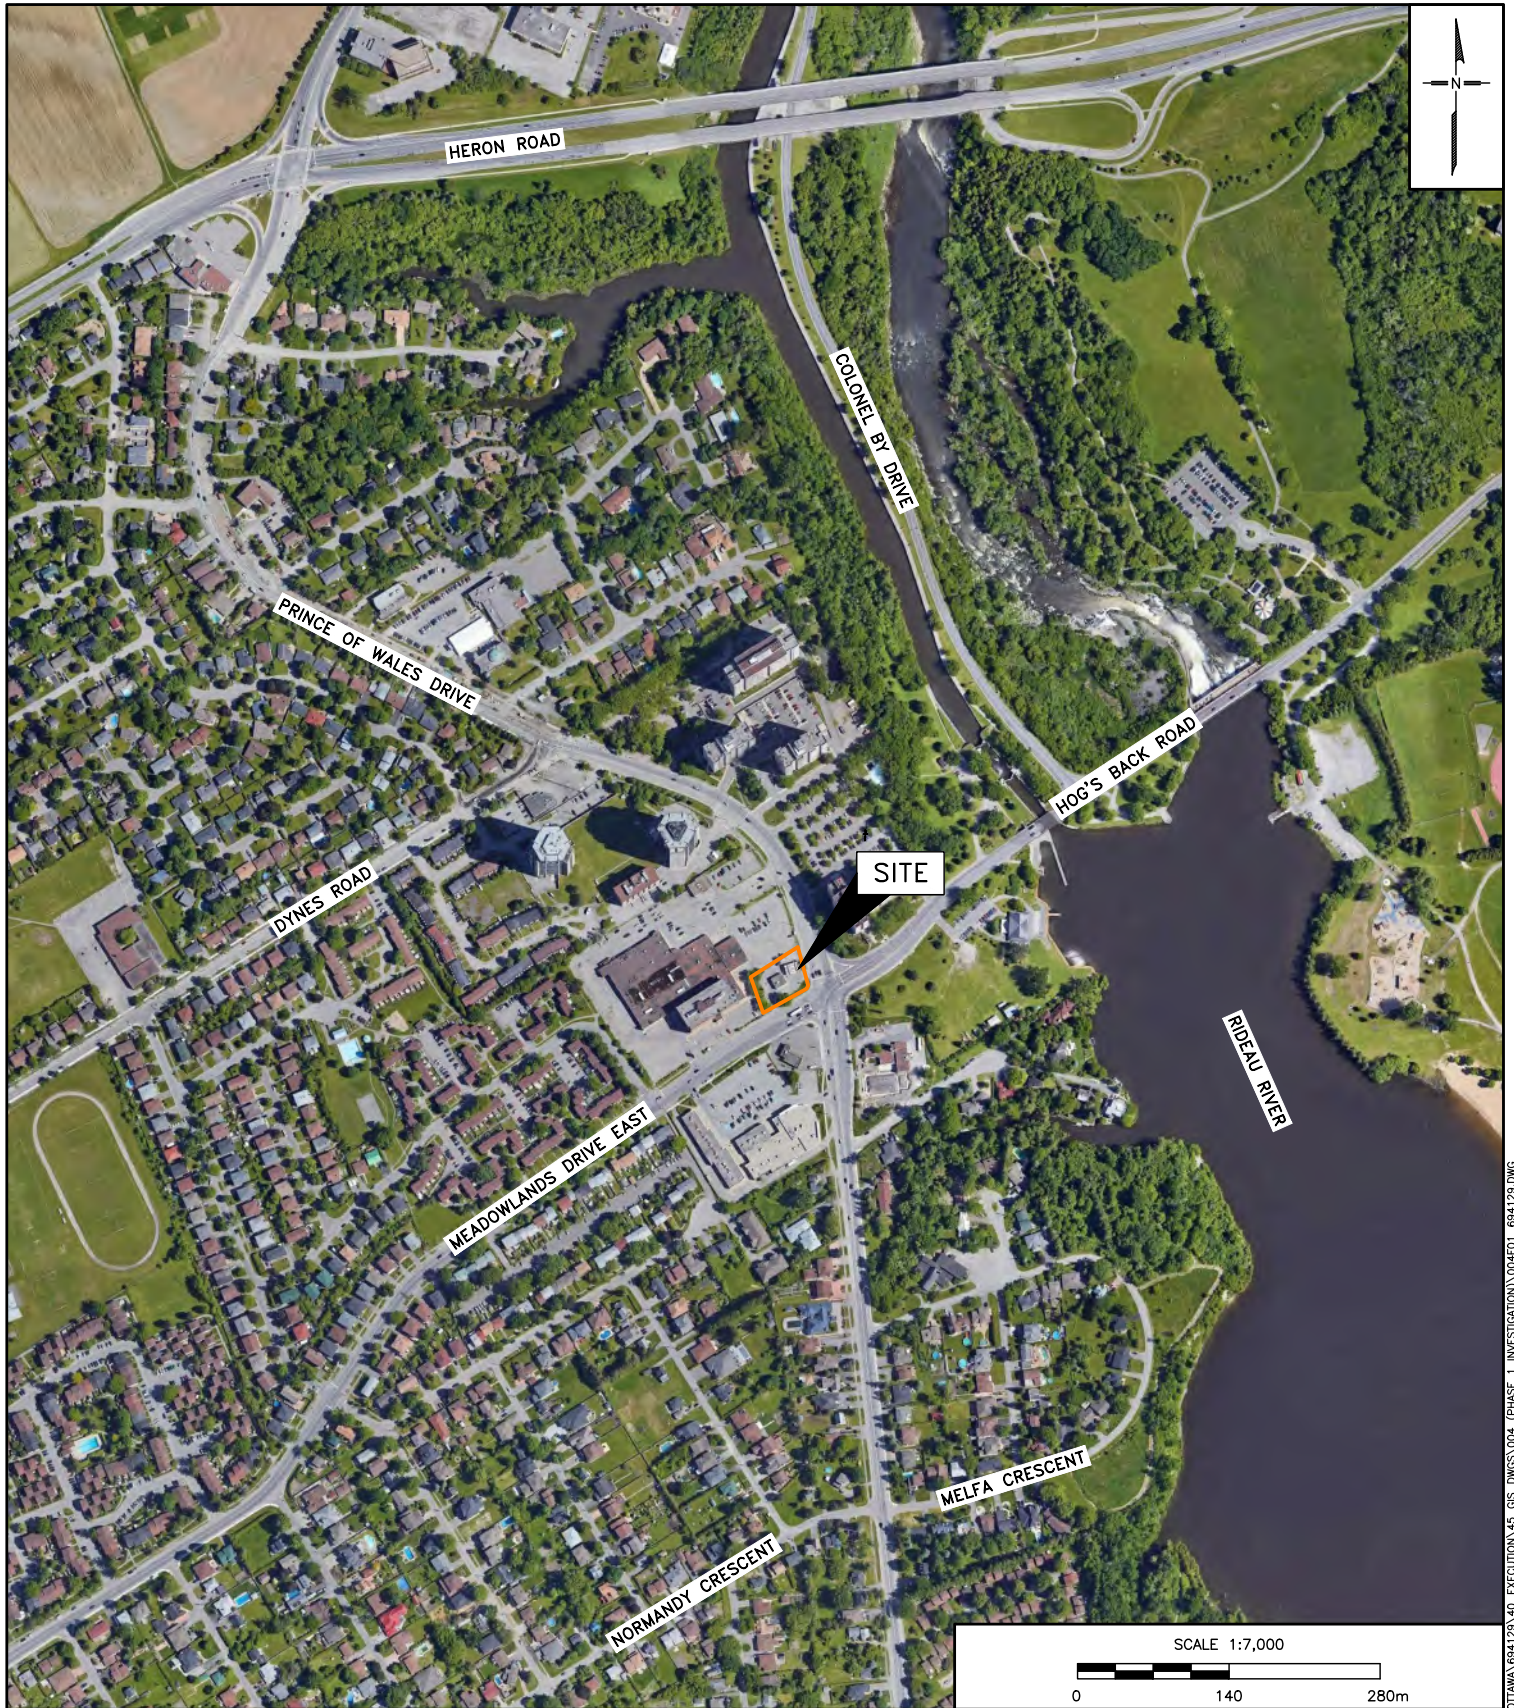
Client Name: SHELL CANADA PRODUCTS	Location: 1440 PRINCE OF WALES DRIVE (C03311), OTTAWA, ON	
Title: HISTORICAL/CURRENT BOREHOLE/MONITORING WELL LOCATION PLAN AND ANALYTICAL RESULTS		
Drawn: AG/EM	Date: OCTOBER 2023	Project No: 694129
Verified: AA	Project Manager: AA	Dwg No: FIGURE 4

Historical and current borehole/monitoring well location plan along with the status of the soil and groundwater exceedances compared to the selected MECP Table 3 standards is presented on Figure 4. Historical soil analytical results for boreholes BH98-1 to BH98-6 were not available in the 1998 report, as such, results from these boreholes were not compared to the MECP Table 3 standards.

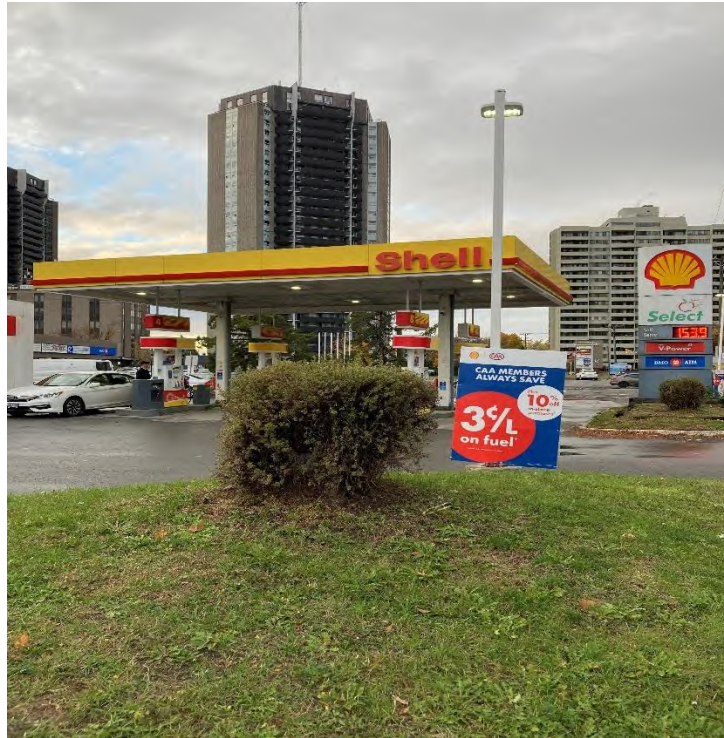
Photograph 1: View of the Phase One Property – looking north

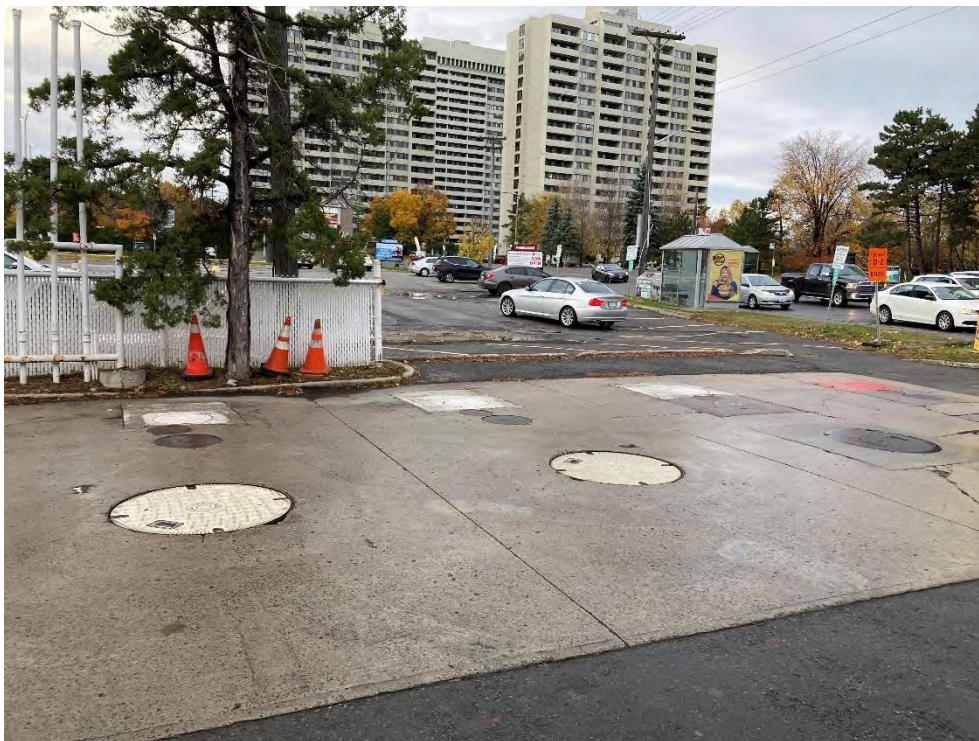
Photograph 2: View of the tank nest located by the northern portion of the Phase One Property looking north

Hazardous materials at the Phase One Property primarily comprise gasoline, which are stored in five (5) USTs, located within the tank nest to the northeast of the convenience store. In addition, the convenience store sells small quantities of commercial vehicle maintenance products, such as engine oil and washer fluid, all of which are stored on shelving in the store area. Finally, propane gas cannisters are stored in a dispenser located to the south of the convenience store.

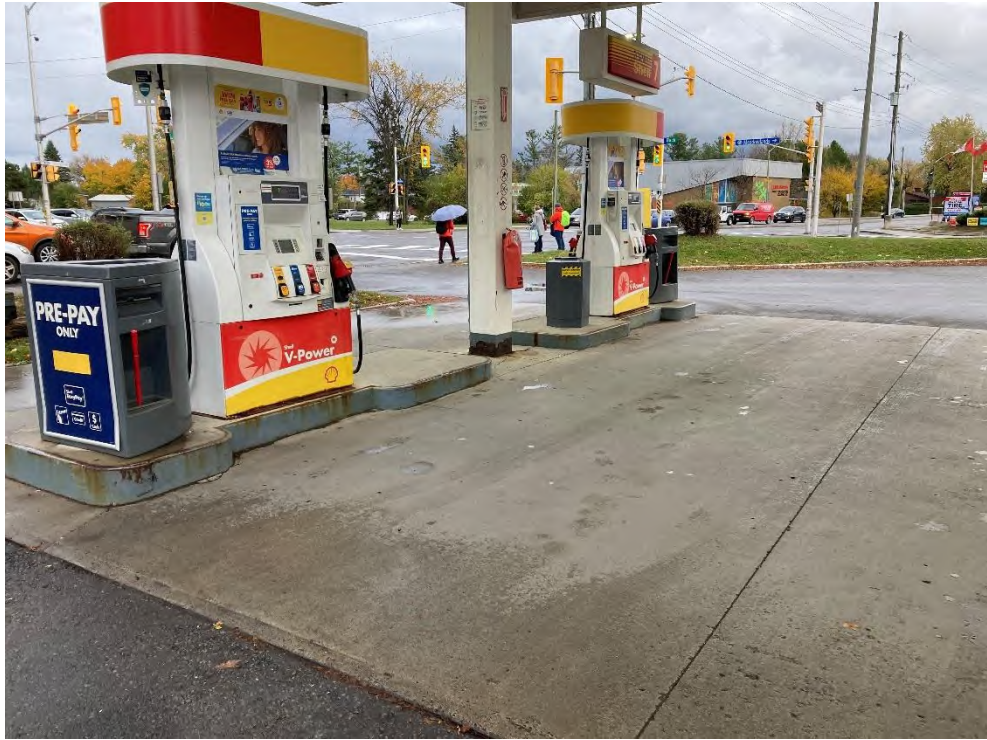
Photograph 3: View of the pump island on the Phase One Property – looking southeast

Minor surface hydrocarbon staining was noted in the vicinity of the fuel dispensers; however, each location was equipped with a spill kit. Furthermore, the concrete ground cover was observed to be in good condition (i.e., no cracking/deterioration). No stained soil or vegetation was noted.

Minor surface hydrocarbon staining was noted in the vicinity of the fuel dispensers. No other signs of spills were observed at the Phase One Property.

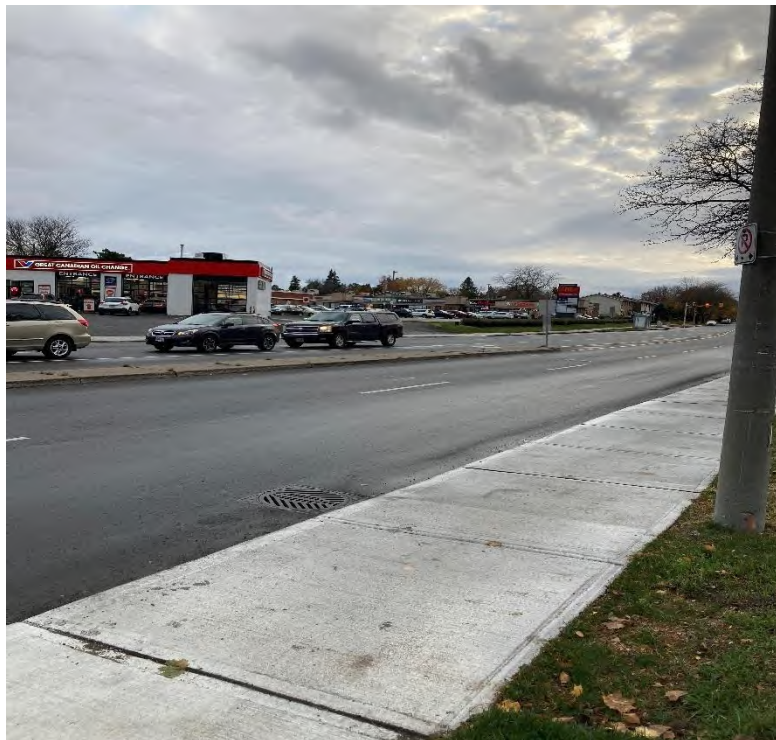
Photograph 8: View of Oil Changing facility at 1488 Prince of Wales Drive (located south/southeast of the Phase One Property) – looking south/southeast.

- 1448 Prince of Wales Drive (located south/southeast of the Phase One Property): An oil change business was identified at this location which is inferred to be in a hydraulically gradient position. This location is classified as PCA Item 28 – Gasoline and associated products storage in fixed tanks and PCA Item 52 – Storage, maintenance, fuelling and repair of equipment, vehicles, and material used to maintain transportation systems.
