Phase I Environmental Site Assessment
360 Bobolink Ridge (Block 203 – Fernbank Village)
Ottawa, Ontario

Canadian Rental Development Services Inc.

June 2, 2017

Report: PE4034-1

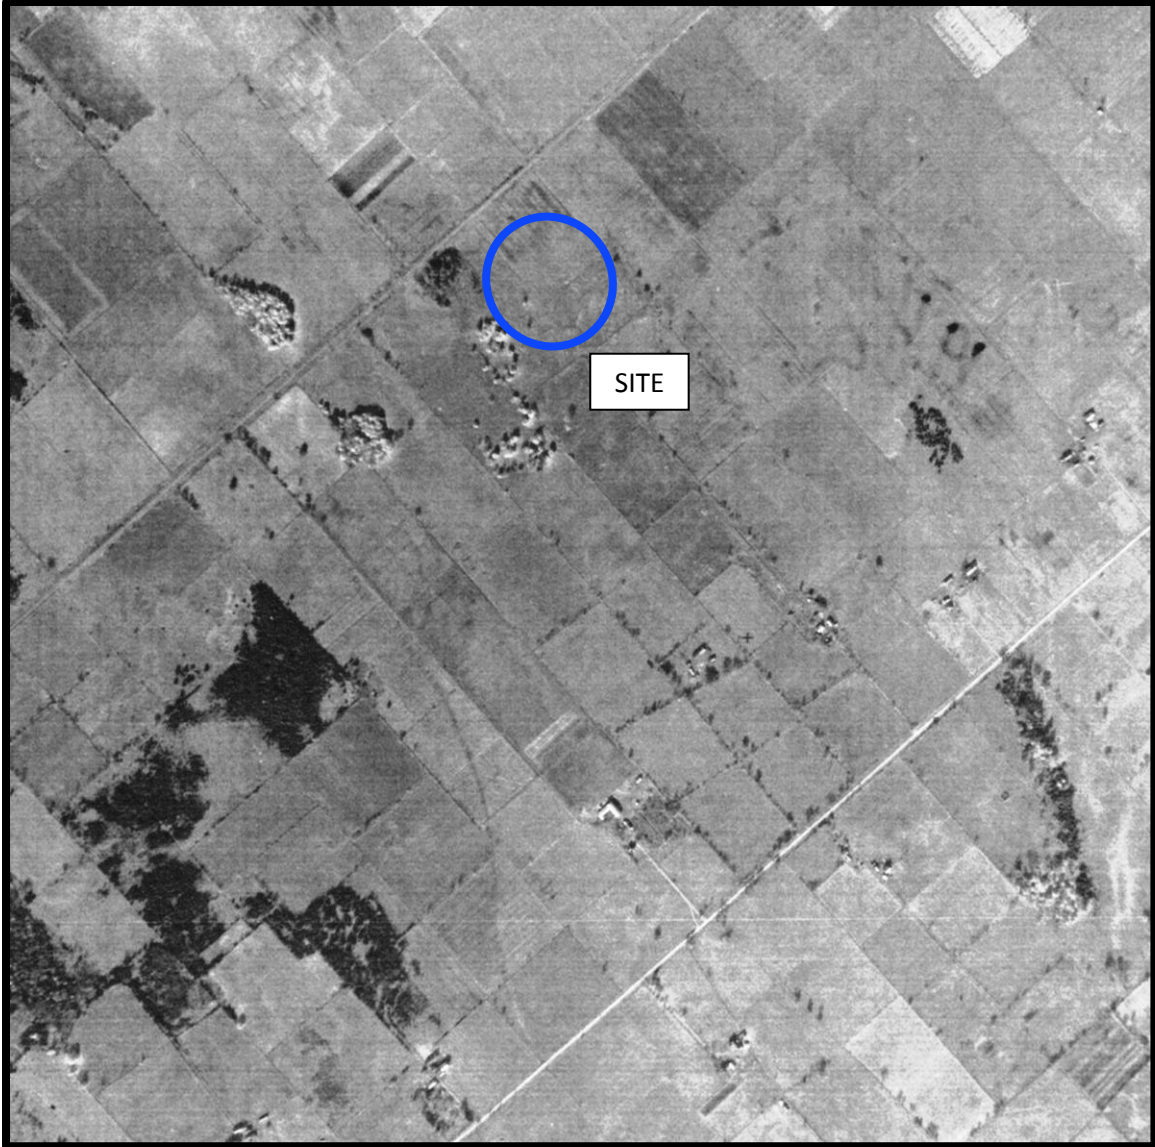
AERIAL PHOTOGRAPH
1945

| 1945 | The subject property and surrounding lands appear undeveloped and used for agriculture. To the northwest of the property a rail line is visible along the alignment of the current TransCanada Trail. Farmsteads are visible along Fernbank Road, to the south. |

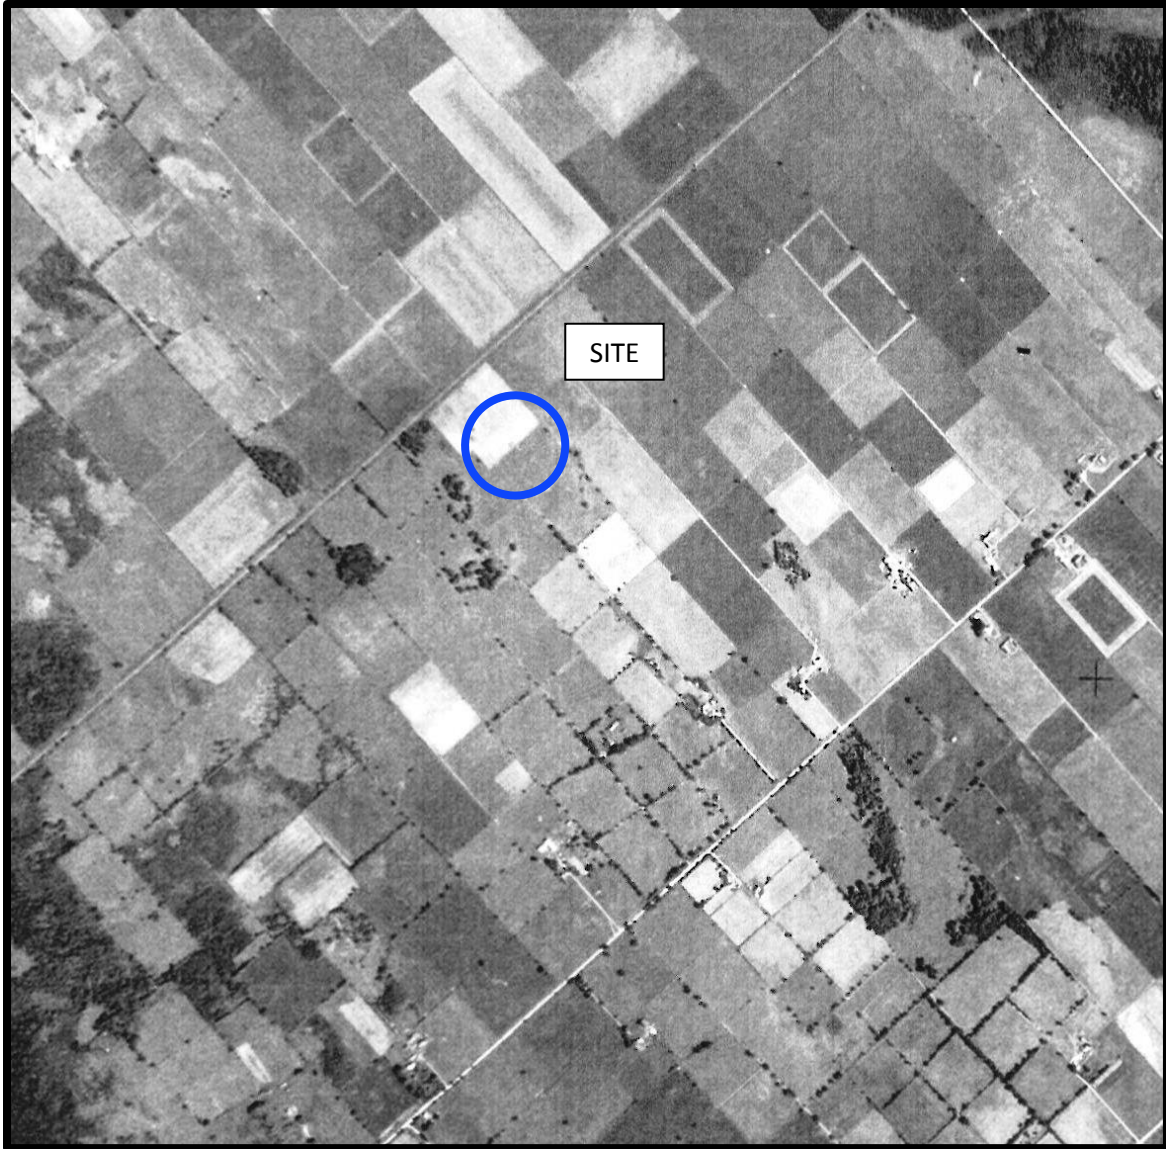
AERIAL PHOTOGRAPH
1955

| 1955 | No significant changes have been made to the subject or to neighbouring properties |

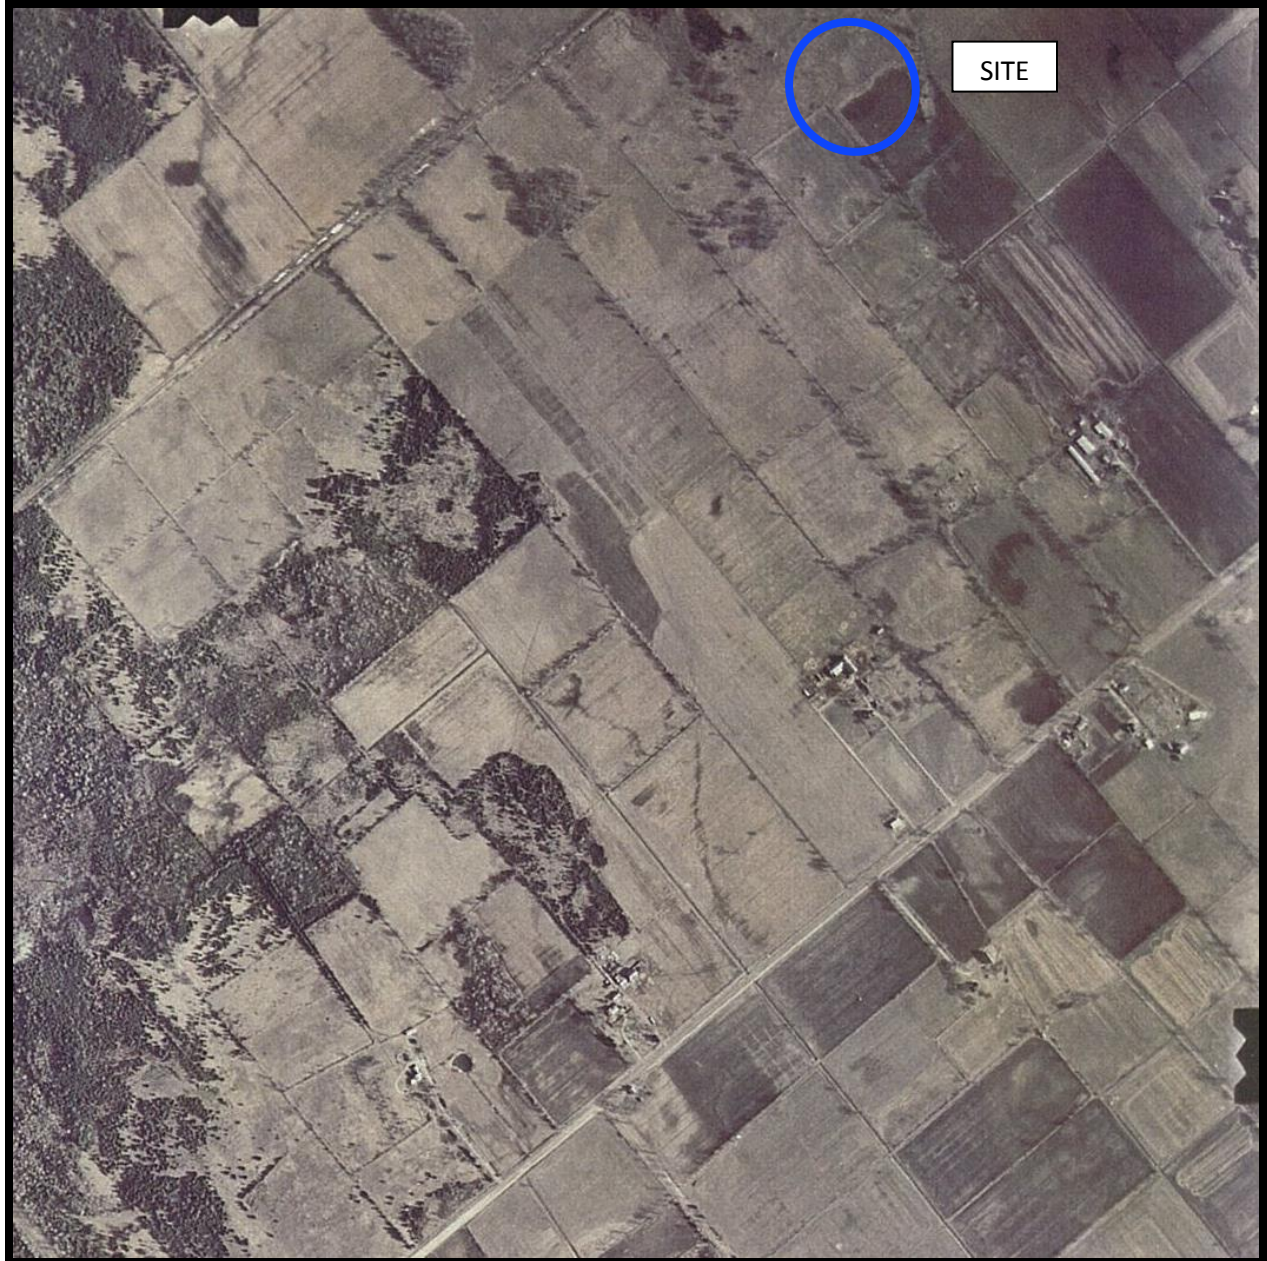
AERIAL PHOTOGRAPH
1975

| 1975 | No significant changes have been made to the subject site or adjacent properties. |

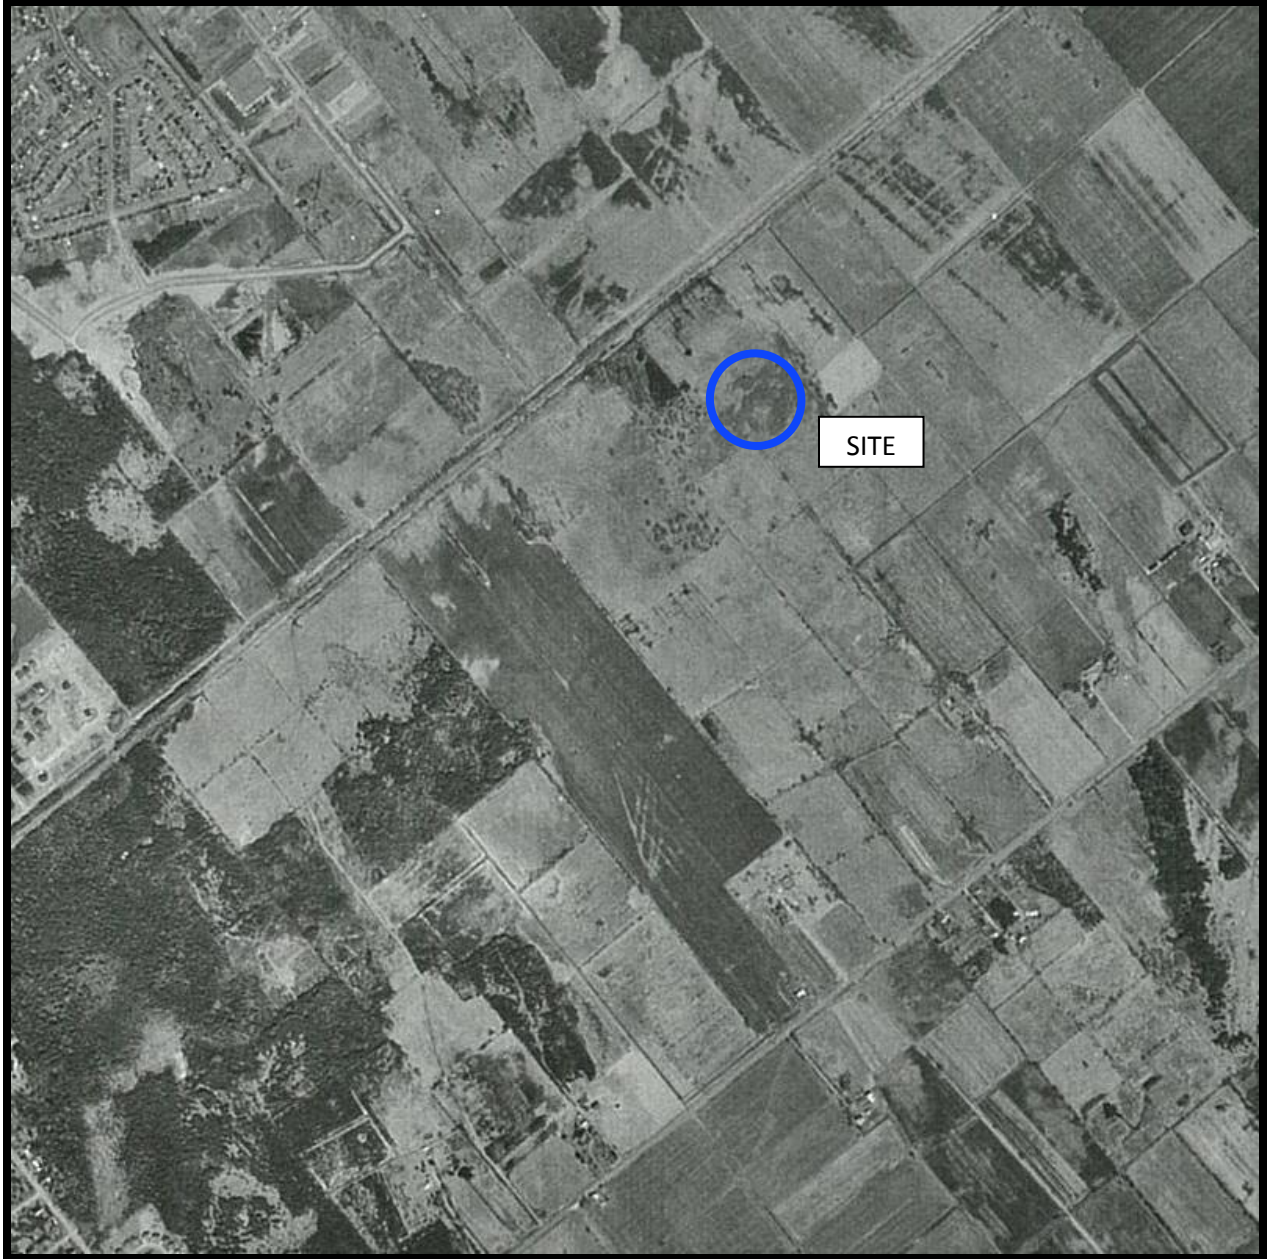
AERIAL PHOTOGRAPH
1985

| 1985 | No significant changes appear to have been made to the subject property, which still appears to be undeveloped and used for agriculture. Further northwest, past the railway line, residential dwellings are visible. |

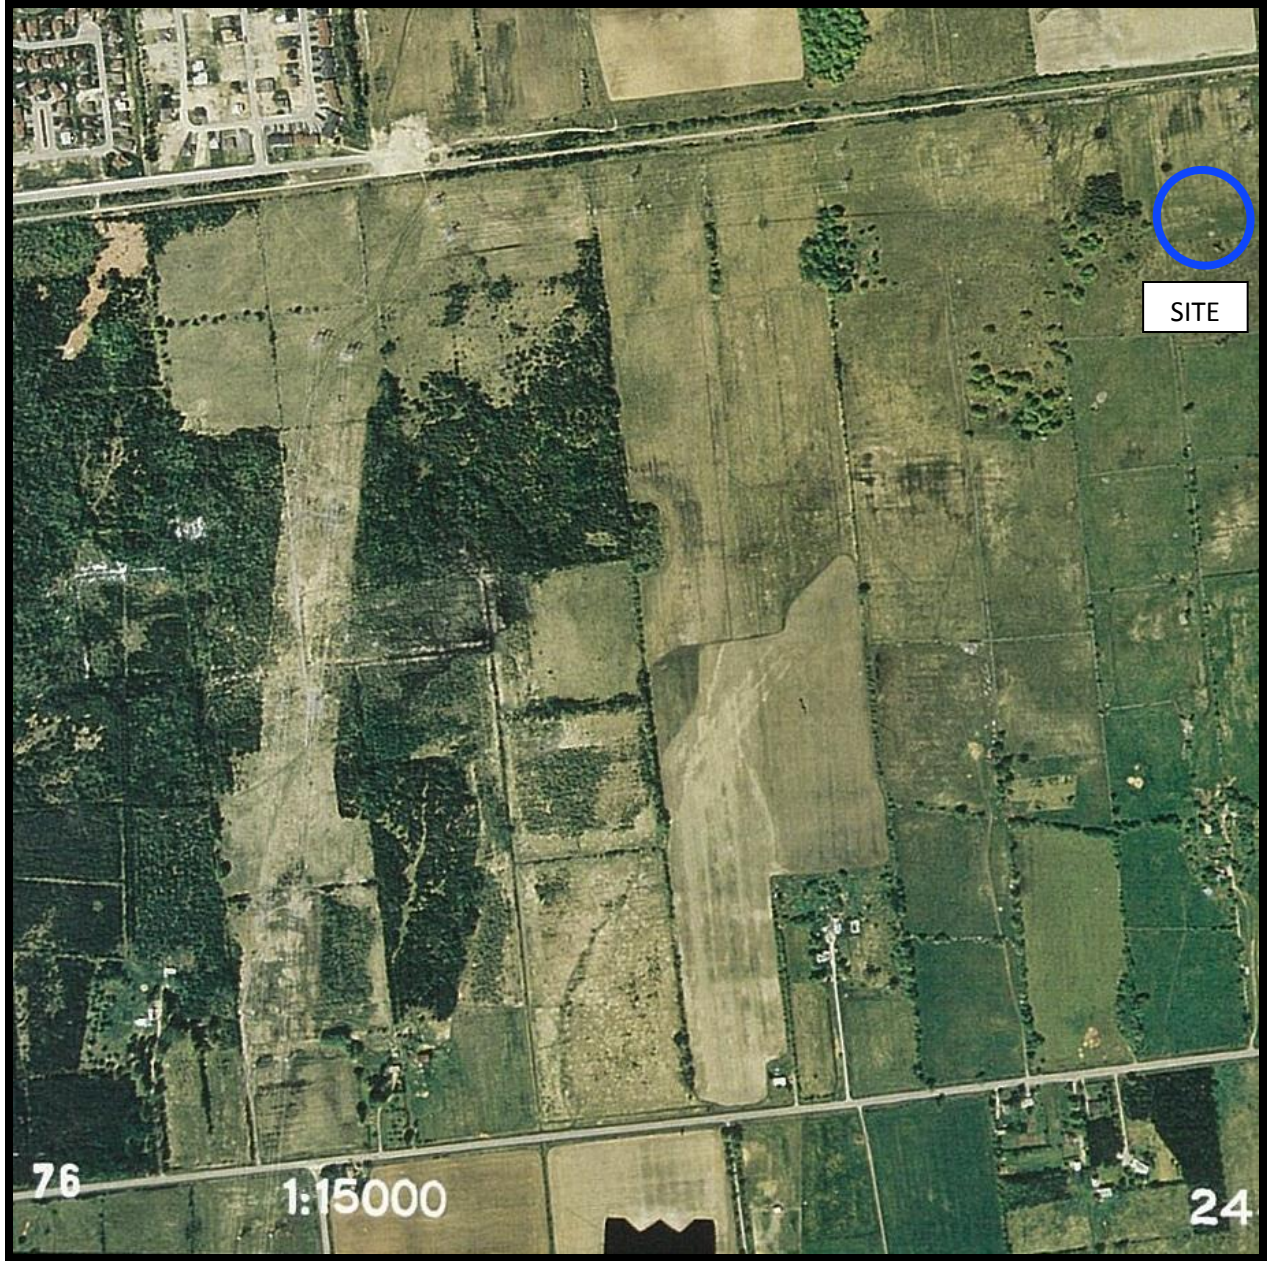
AERIAL PHOTOGRAPH
1996

| 1996 | No significant changes have been made to the subject site. Neighbouring properties to the southwest have been developed for residential purposes. |

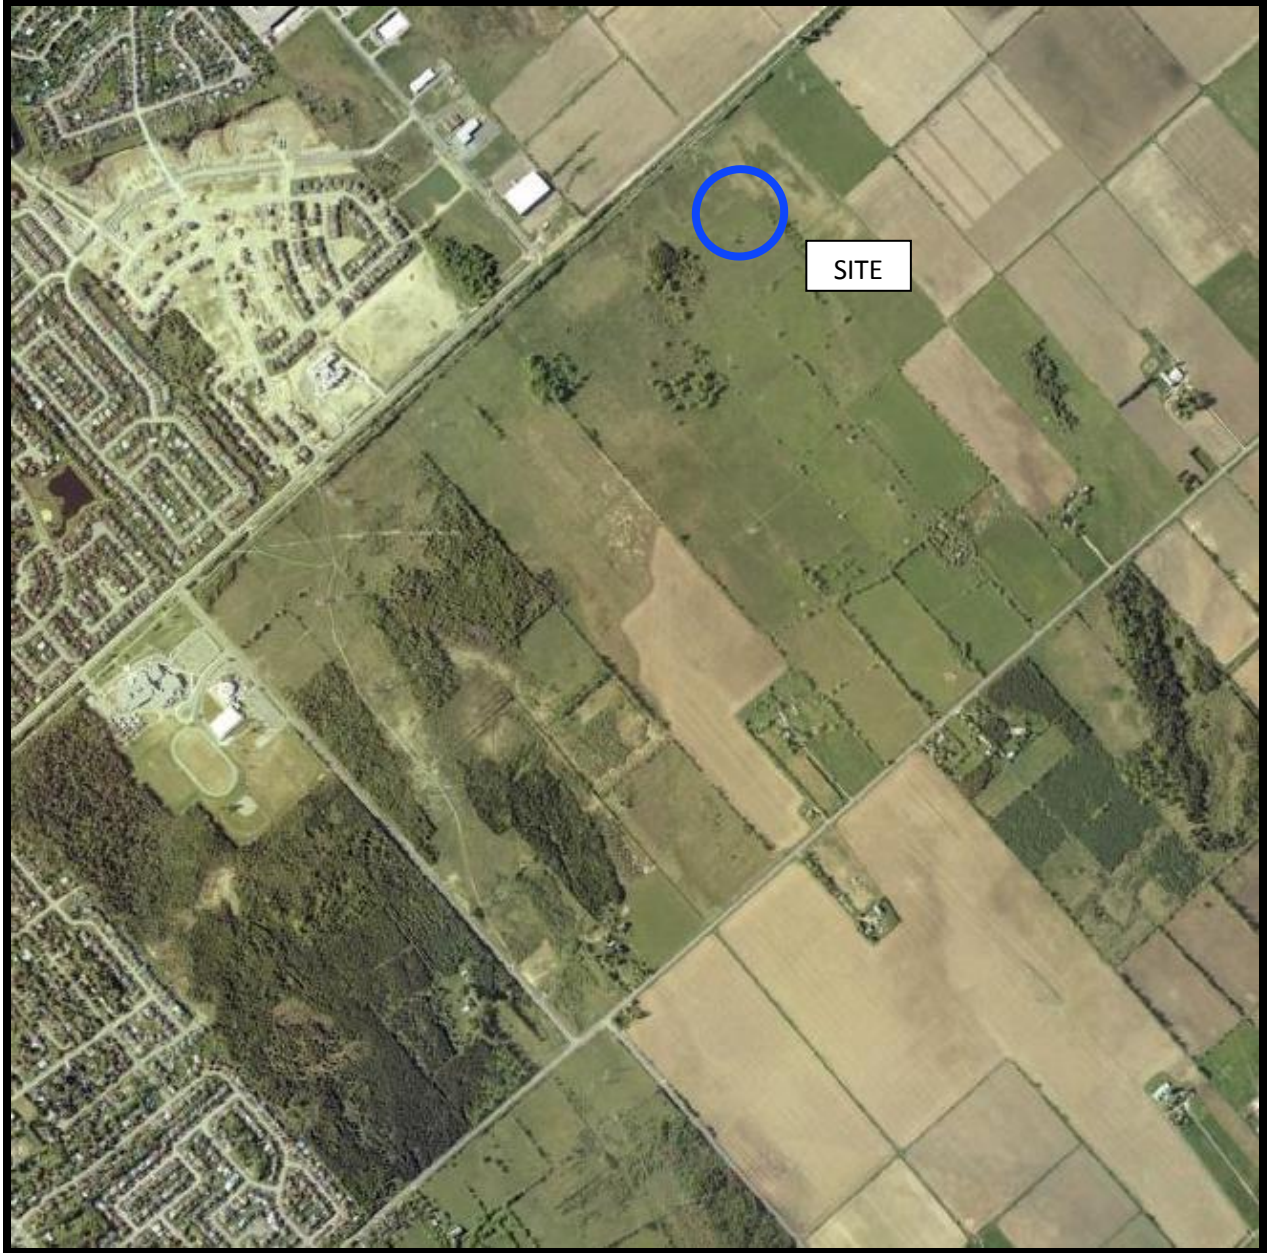
AERIAL PHOTOGRAPH
2002

| 2002 | No significant changes have been made to the subject. Neighbouring properties to the west have been developed for residential and commercial purposes. |

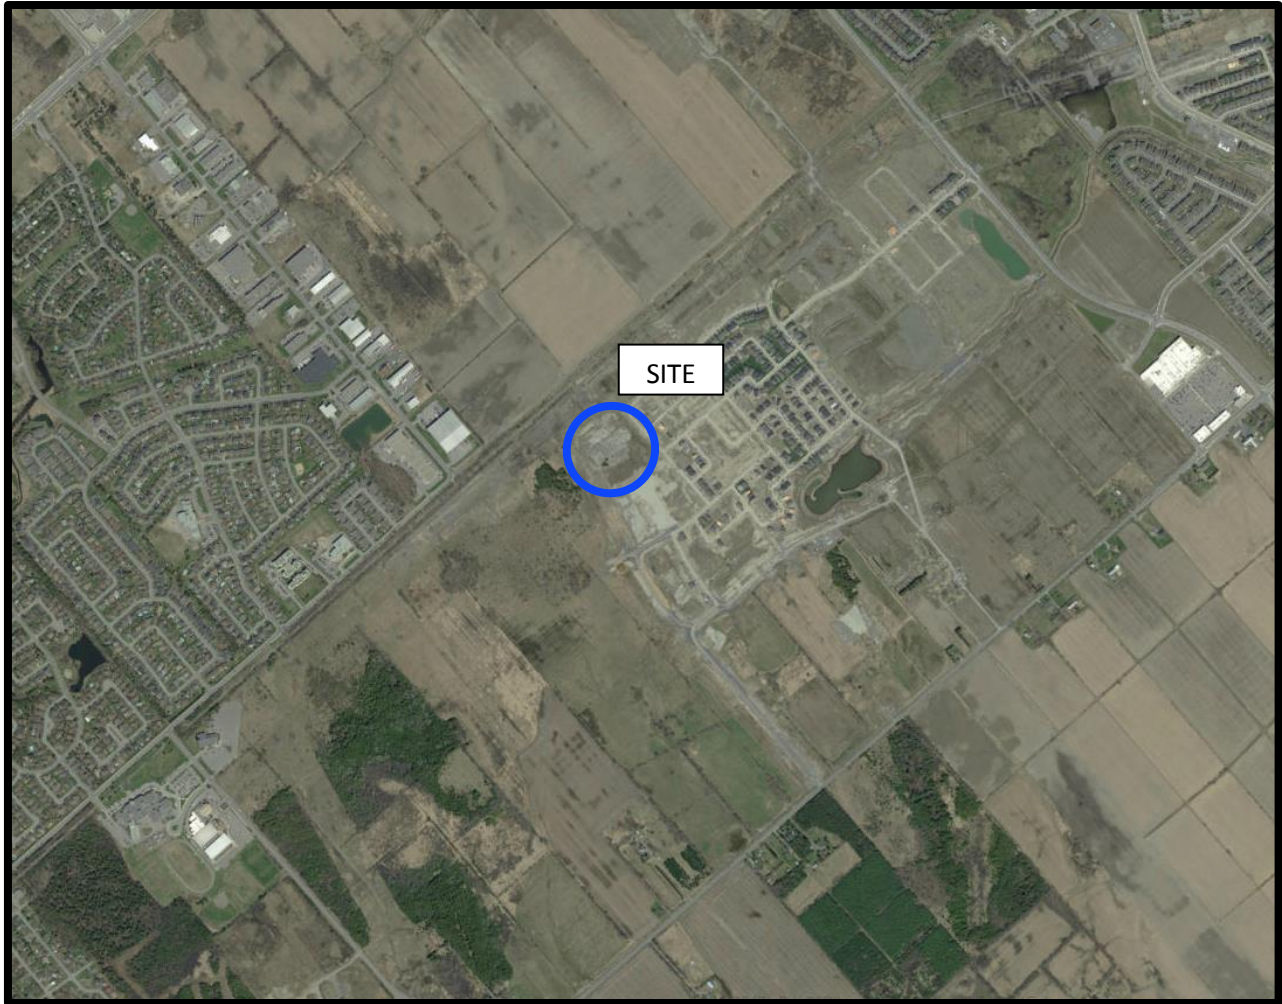
AERIAL PHOTOGRAPH
2014

| 2014 | (City of Ottawa Website) Grass and trees have been removed on the subject site. No significant changes have been made to the subject site. Neighbouring properties to west have been developed for residential and commercial purposes. Properties to the east and south have been developed or are being developed for residential use. Roads have been developed to the south and east. No other significant changes have been made to the subject site or adjacent properties. |

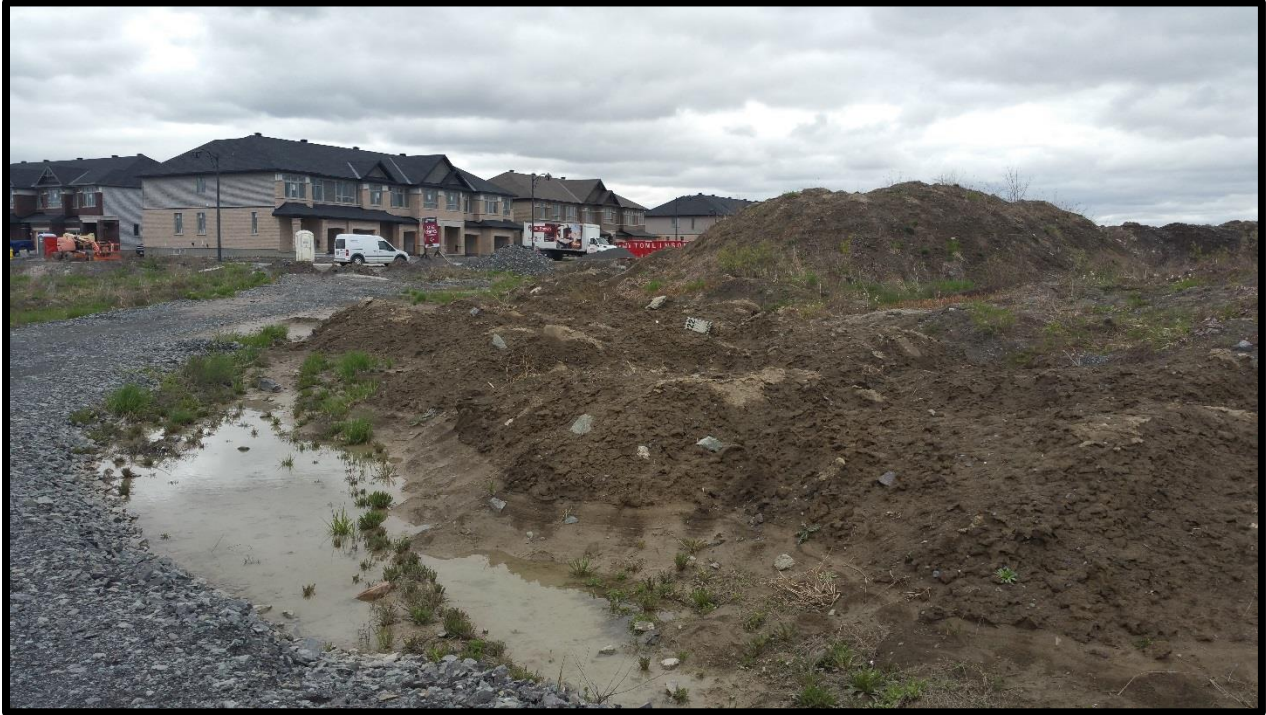
Photograph 1: View of the northwest side of the site, facing east. Photograph illustrates the entrance to the subject site on the left and the main land cover.

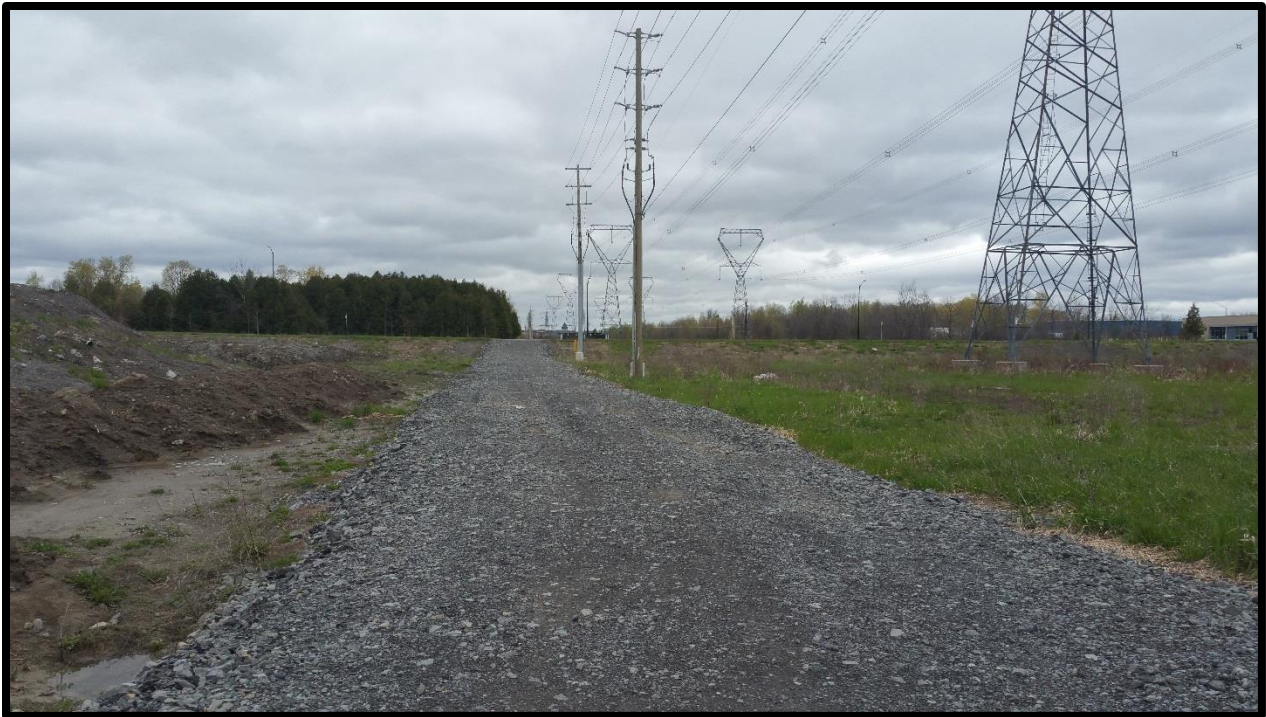
Photograph 2: View of the western side of the site, facing southwest. Photograph illustrates a gravel road on the property.

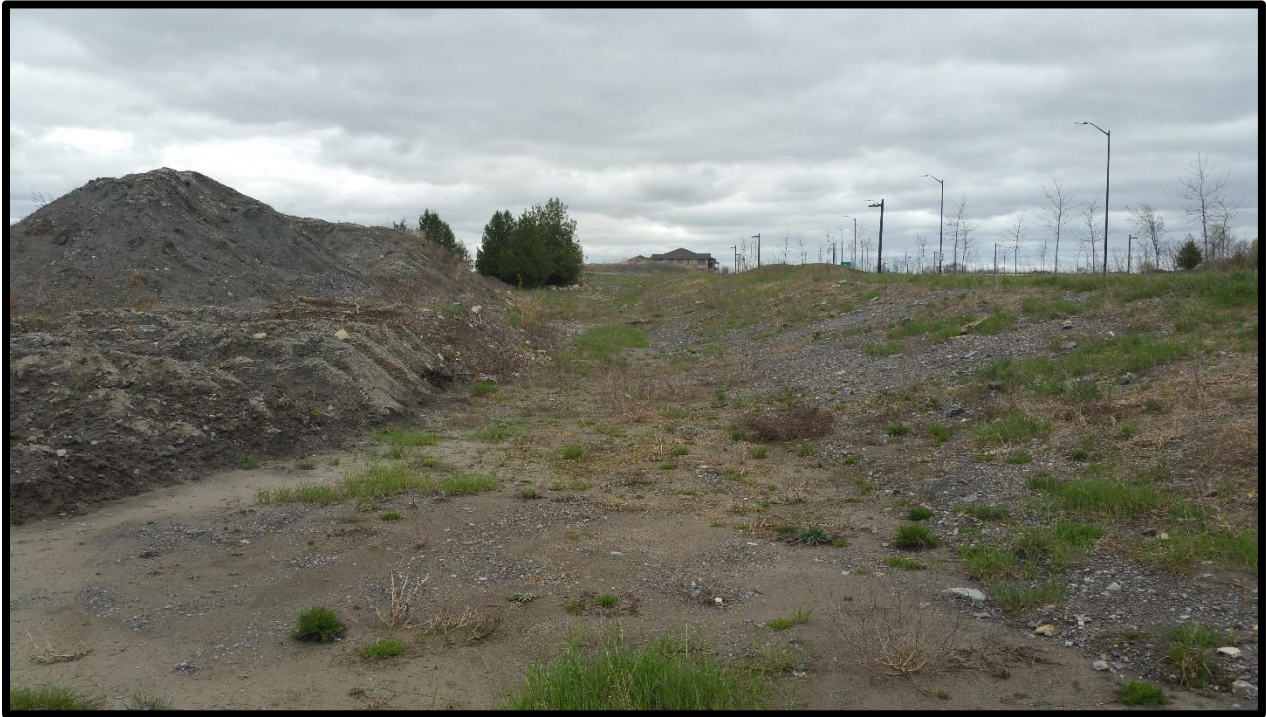
Photograph 3: View of the main land cover of the site on the southwestern perimeter of the site. Photograph taken facing southeast.

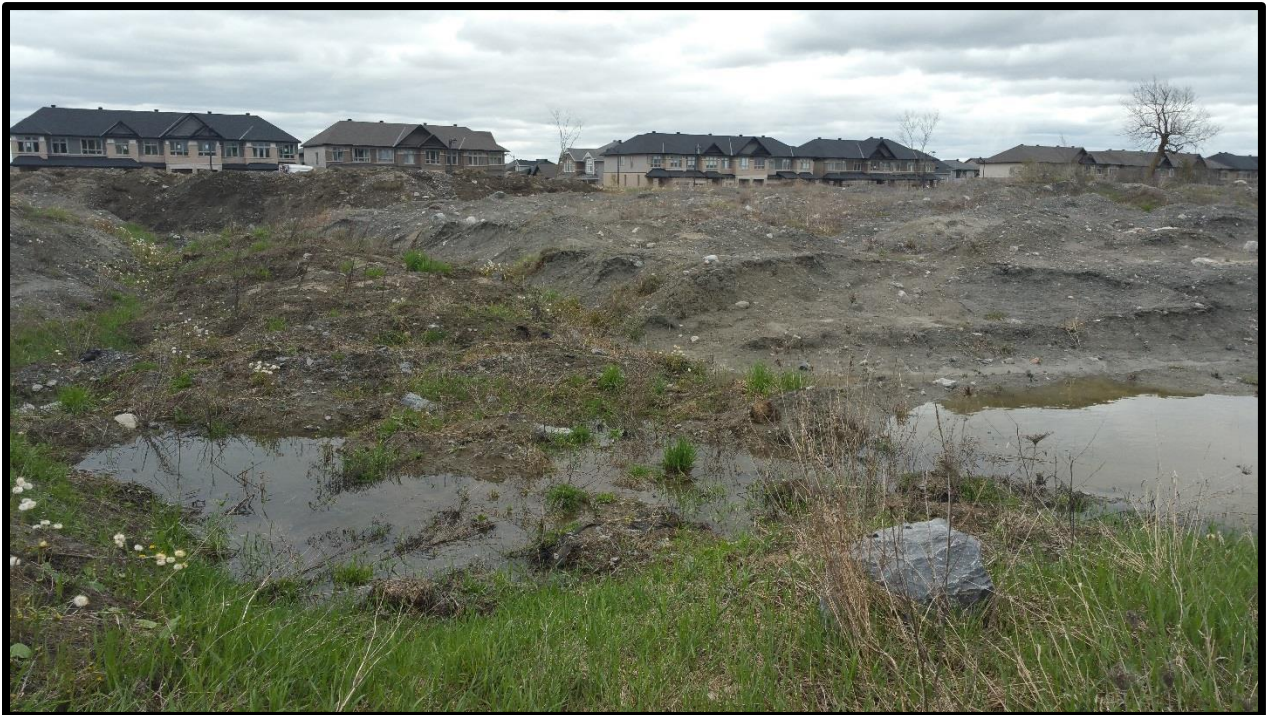
Photograph 4: View of the middle of the vacant subject lot. Photograph taken facing northeast.
