Ottawa-Carleton District School Board

**Phase Two Environmental Site Assessment
700 Spring Valley Drive
Ottawa, Ontario**

ER1087

November 25, 2024

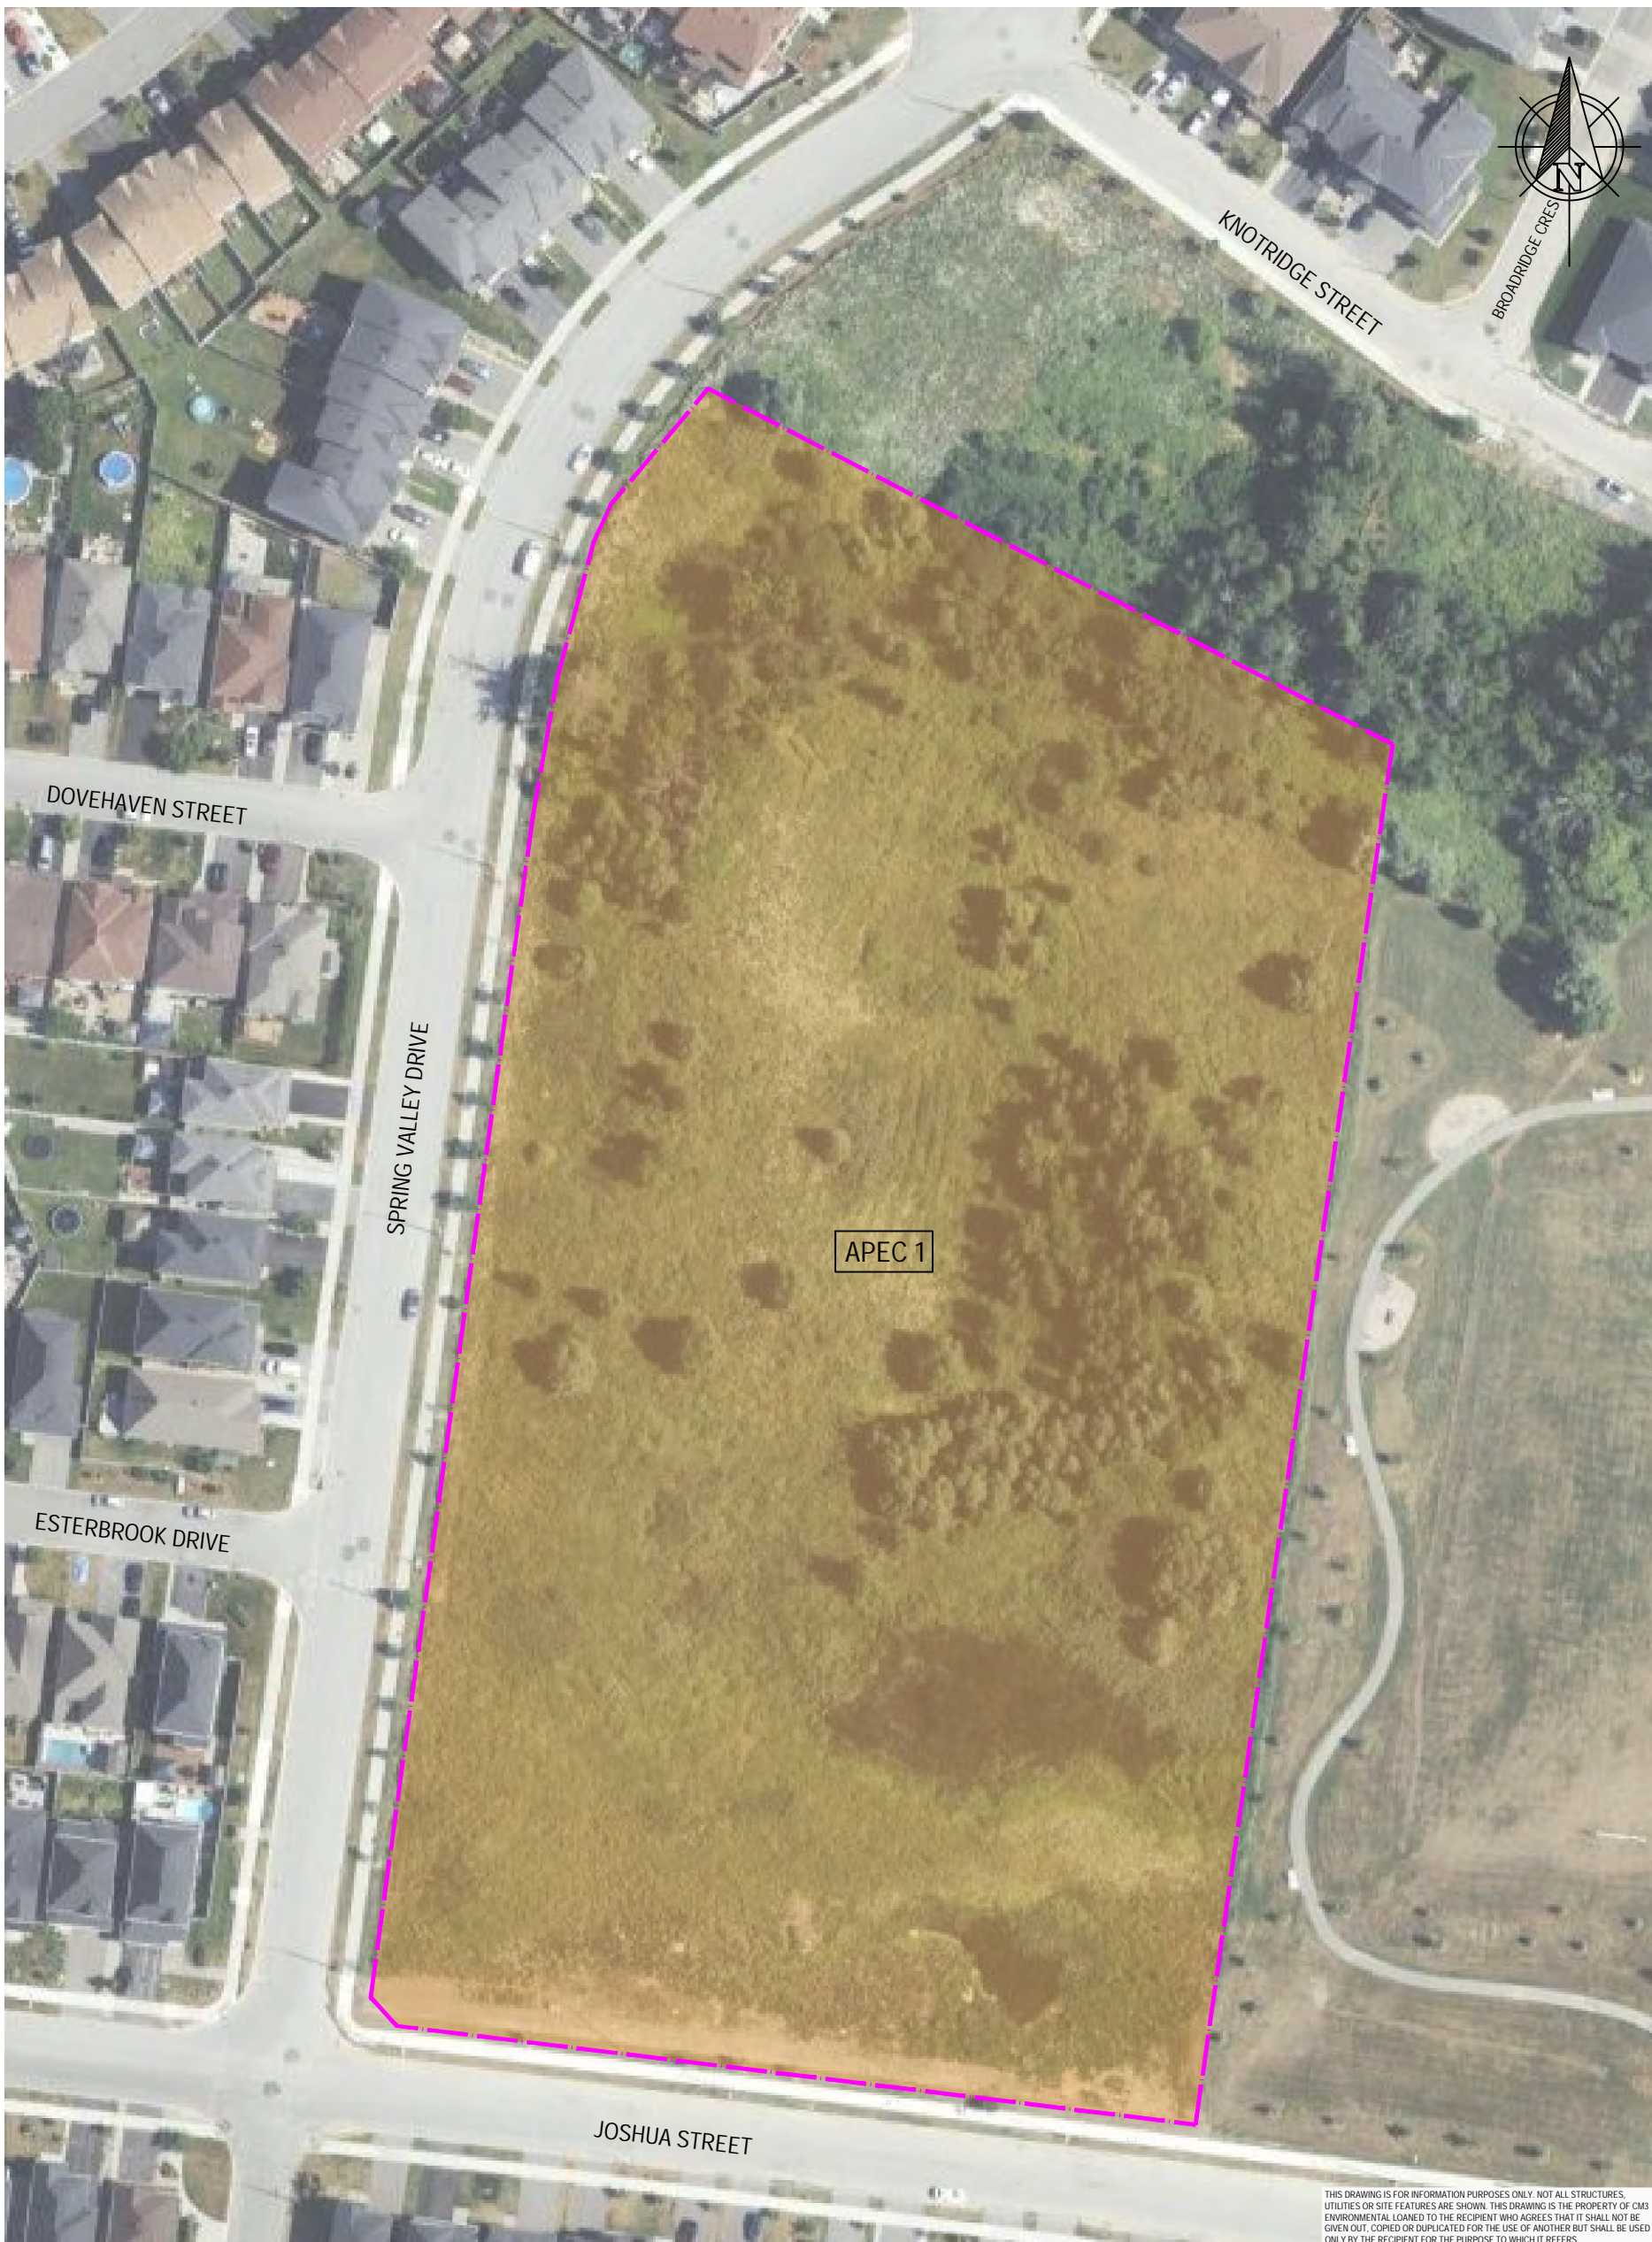
The subject property is roughly rectangular in shape, apart from the north section which follows the curvature of Spring Valley Drive. The site is bound by open space to the north, Goldfinch Park to the east, Joshua Street to the south, and Spring Valley Drive to the west. The subject property is located in a primarily residential area and is approximately 2.83 hectares with no buildings or structures on-site. The property is grass covered with trees positioned sporadically throughout the site. Site features are shown on **Figure 2**.

The subject property has remained undeveloped since its use for agriculture prior to 2007. Small depressions were identified at the south, south-east, and east sections of the site. The depressions were surrounded by tall grasses. Wetlands were not identified on-site in the Ministry of Natural Resources and Forestry (MNR) Natural Heritage maps or on the ERIS PSR wetland map. Based on aerial photographs, it is presumed that the depressions formed naturally on-site within the last decade. A watercourse is shown on the Ontario Base Map leading from the neighbouring property to the east (Goldfinch Park) to the Mer Bleue Bog (to the south). Wetlands and ANSI were not identified within the Phase One study area. The site features are provided on **Figure 2**.
