**Phase I Environmental Site Assessment**

Part of 2190 Halifax Drive  
Ottawa, Ontario

December 13, 2024

Report: PE4234-1R

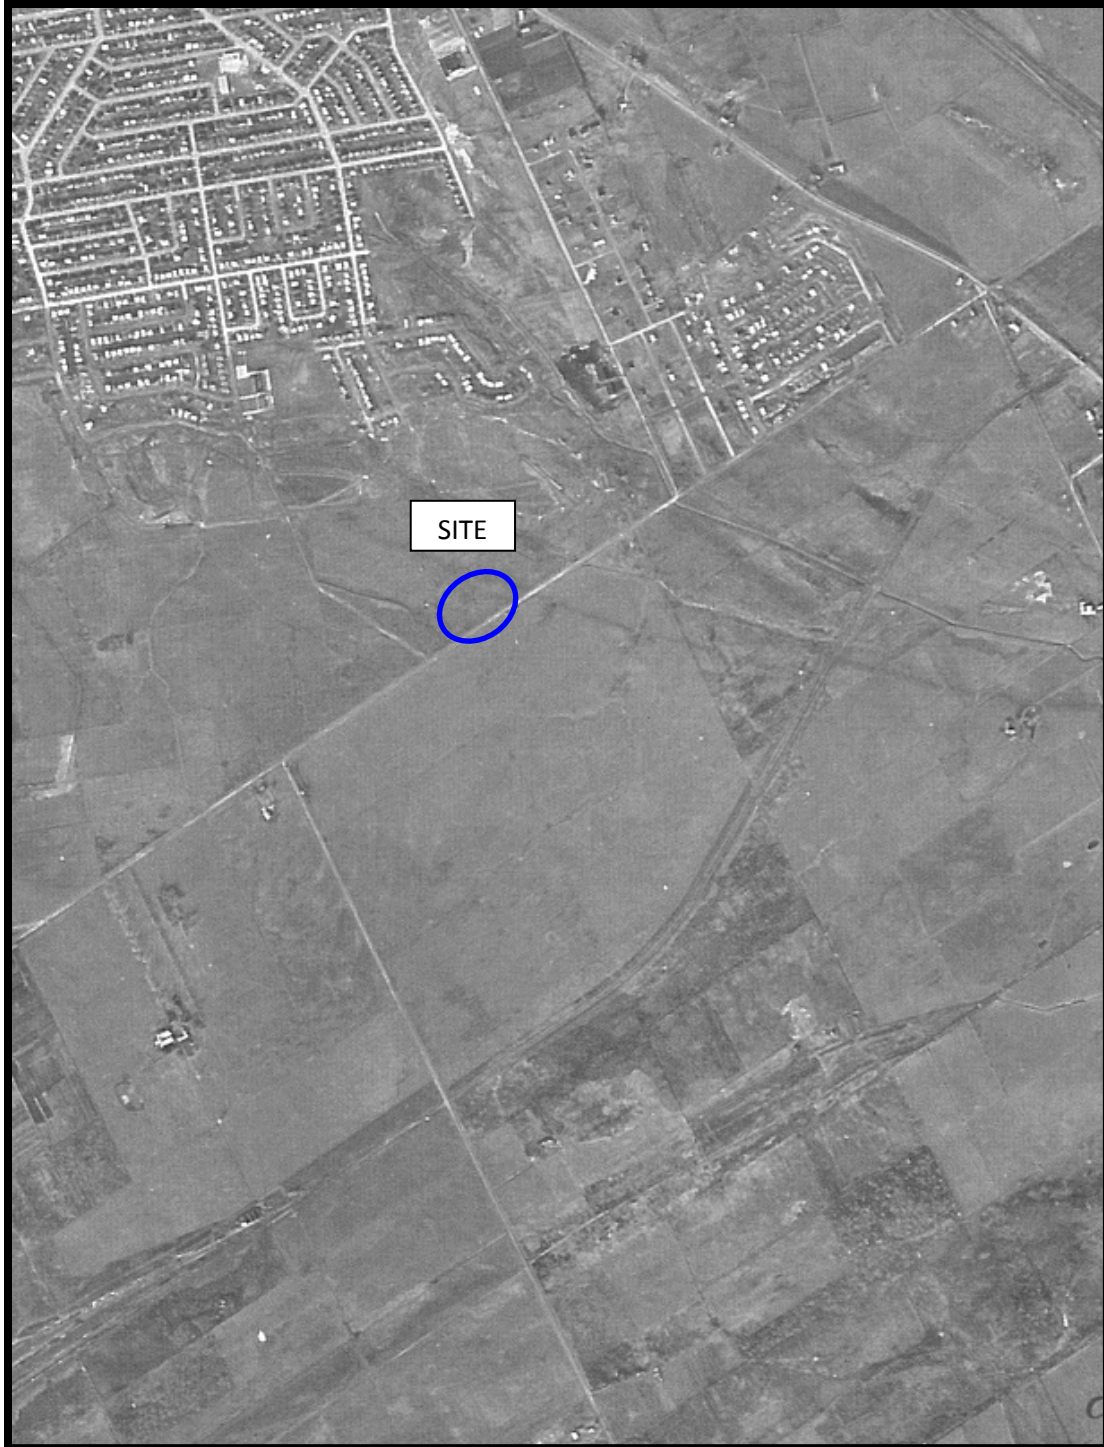
AERIAL PHOTOGRAPH  
1960

1960	The Phase I Property is vacant, undeveloped land. Surrounding lands are also vacant and undeveloped, with the exception of Walkley Road which is present immediately to the south.
------	--

A residential subdivision is present further to the north. Lands further to the east and west of the Phase I Property appear to be in the initial stages of land development. An apparent creek is present further to the southwest of the Phase I Property, on the south side of Walkley Road.

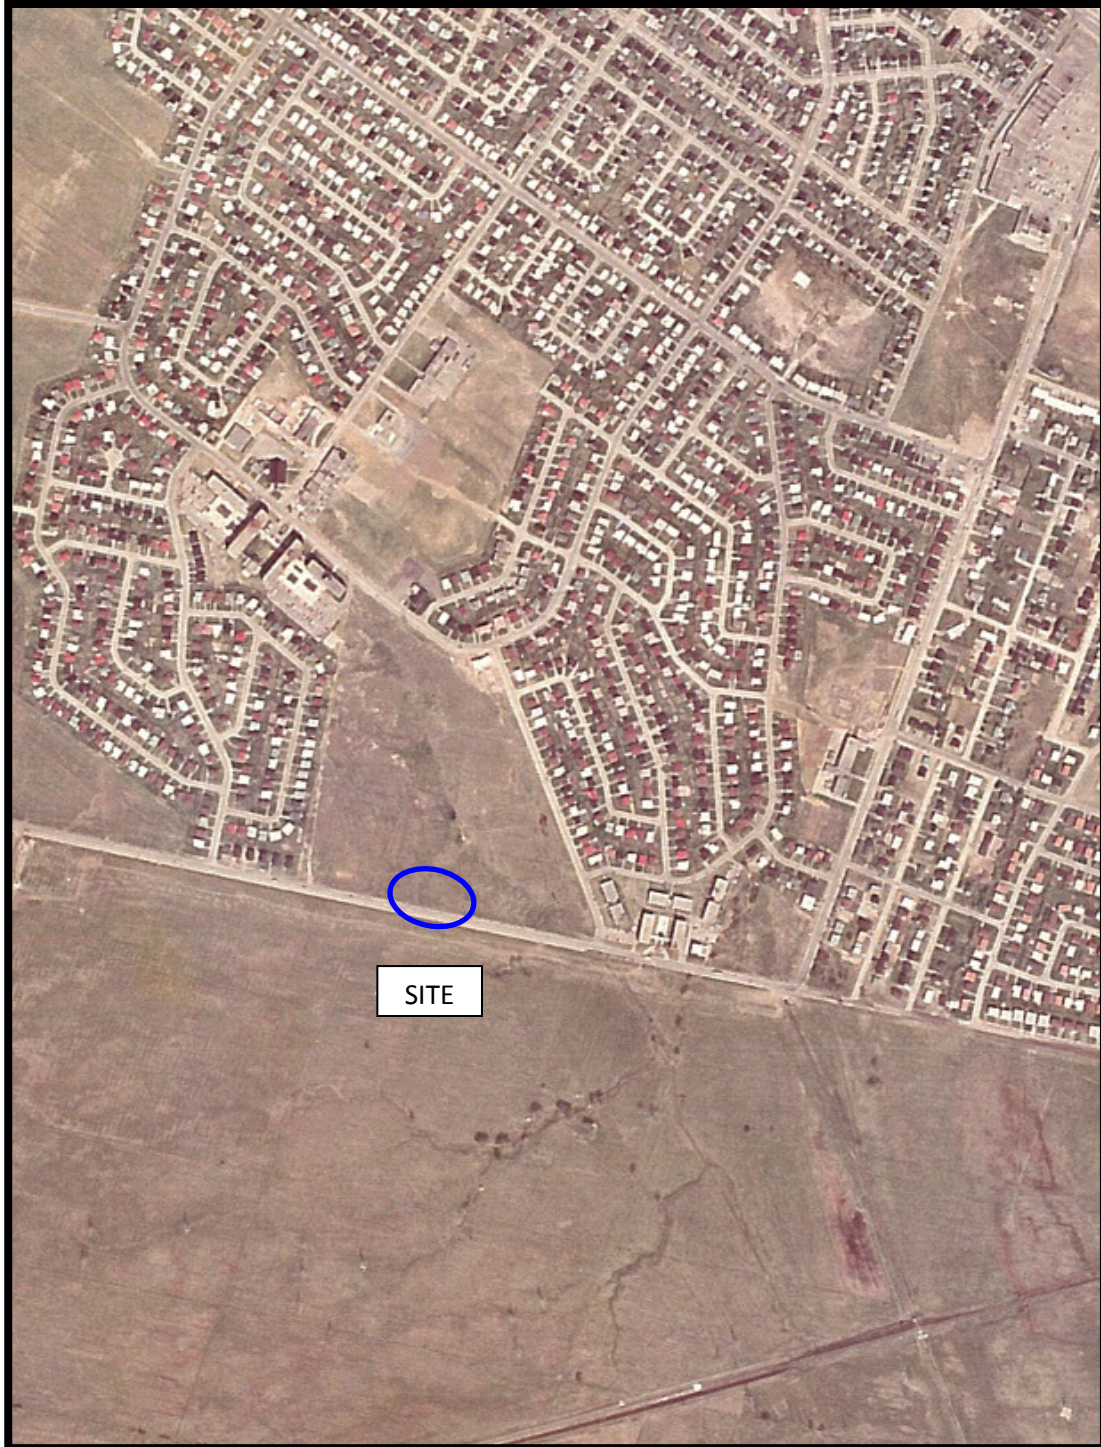
AERIAL PHOTOGRAPH  
1968

| 1968 | The Phase I Property and immediately adjacent properties remain unchanged from the previous photograph. Halifax Drive is present further to the east, followed by residential development. Residential development has also occurred further west of the site |

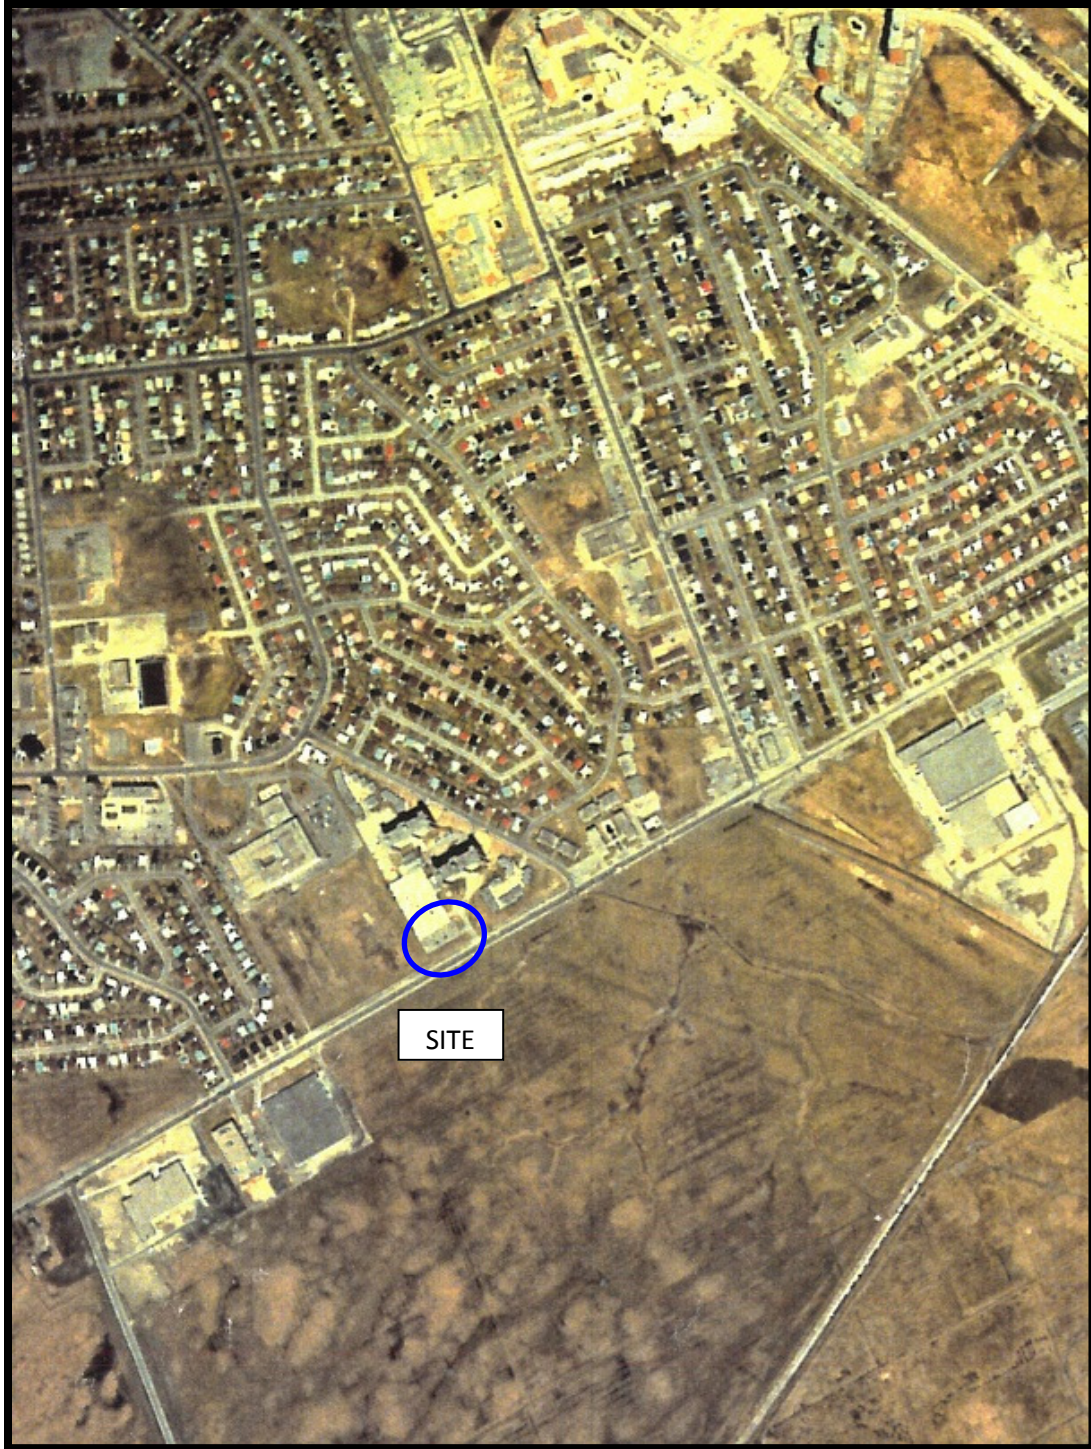
AERIAL PHOTOGRAPH  
1975

| 1975 | The northern portion of the Phase I Property is paved and used as a parking lot, while the southern portion of the site is landscaped. The adjacent lands to the north and east are occupied by the existing residential development which consists of several apartment buildings and townhouse units as well as a parking garage. The land adjacent to the west remains vacant, while the land to the northwest has been developed with a school. Apparent commercial development has occurred on the south side of Walkley Road, further to the southwest of the Phase I Property. |

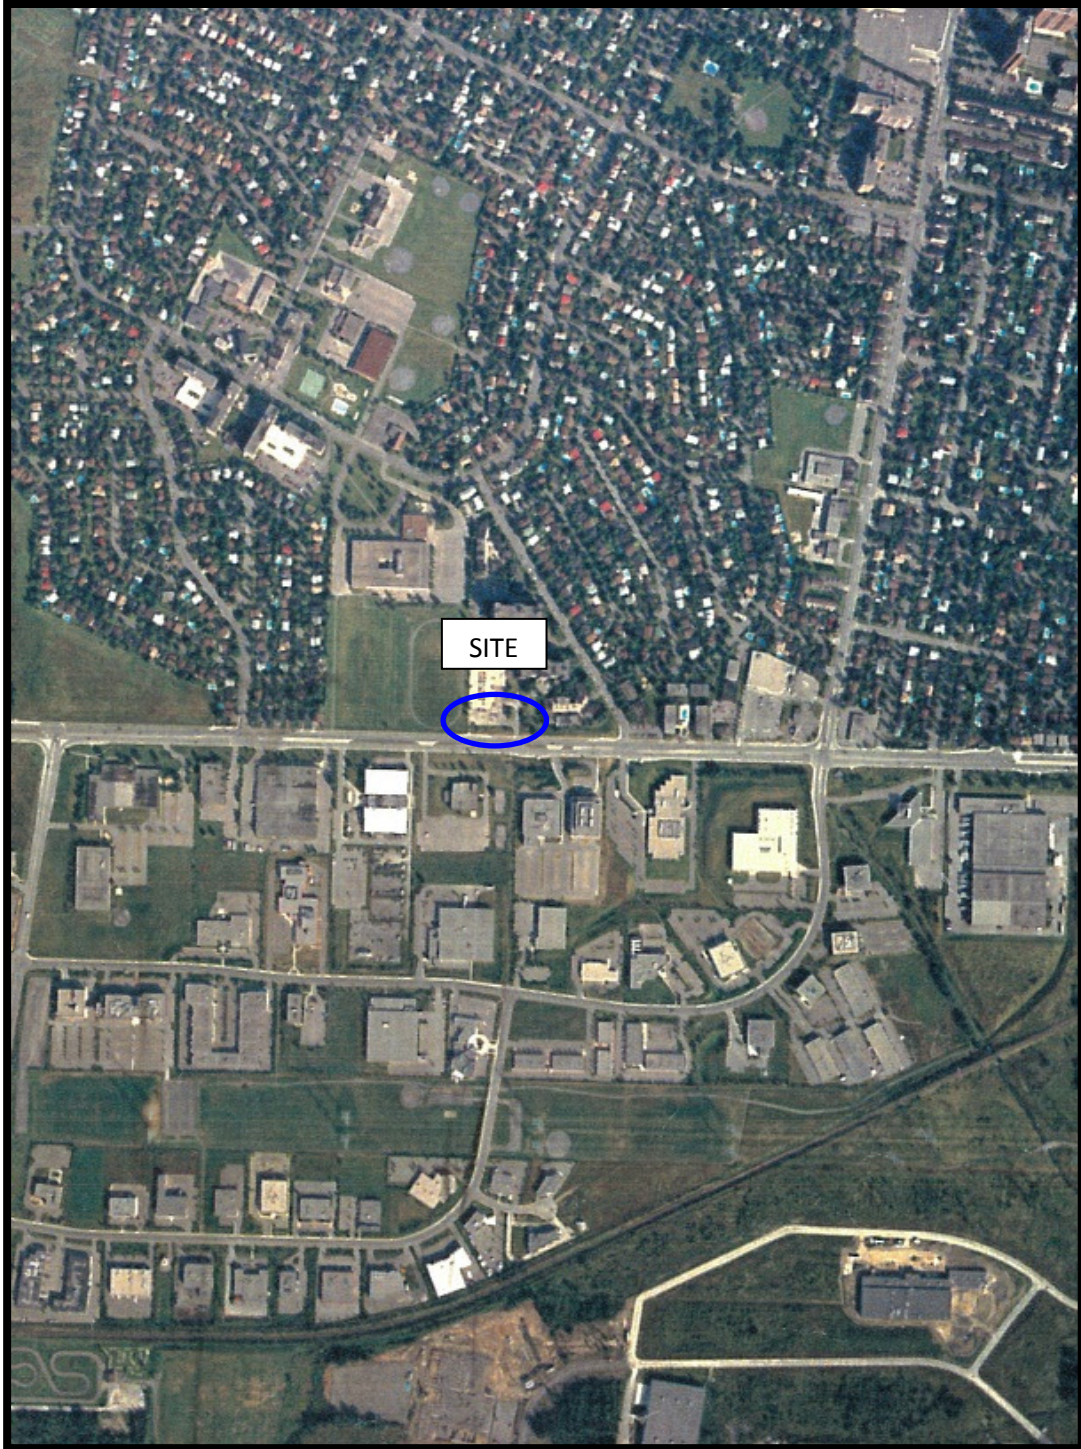
AERIAL PHOTOGRAPH  
1993

| 1993 | No significant changes appear to have been made to the Phase I Property or to the immediately adjacent lands. Further commercial development has occurred along the south side of Walkley Road, further south and southeast of the Phase I Property. |

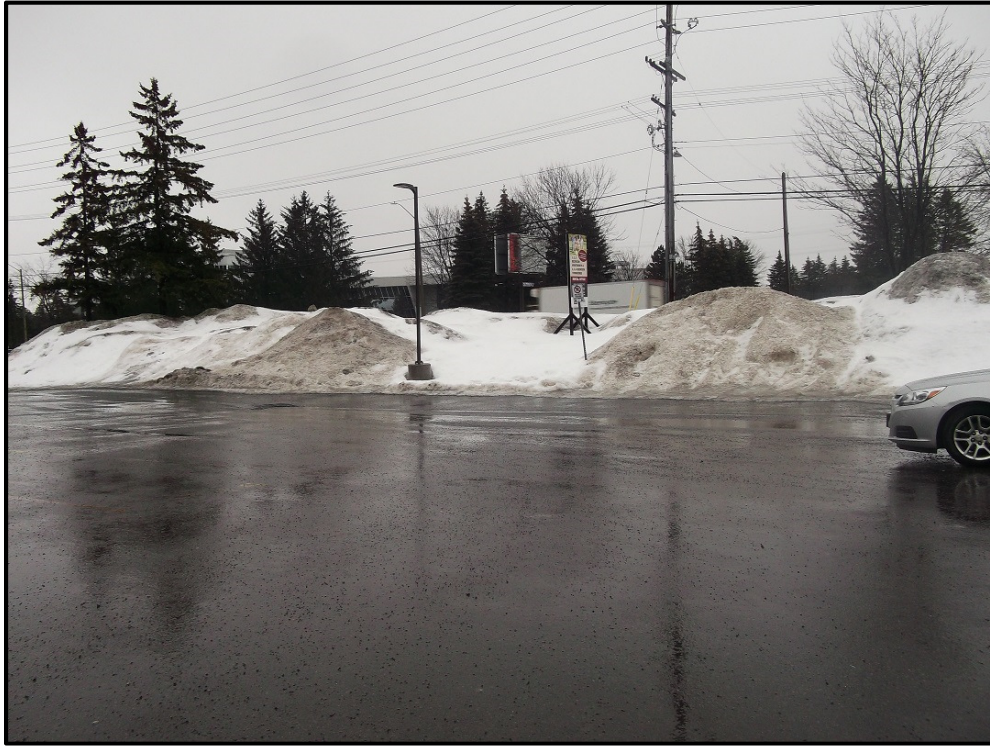
Photograph 1: View of the Phase I Property, facing southeast.

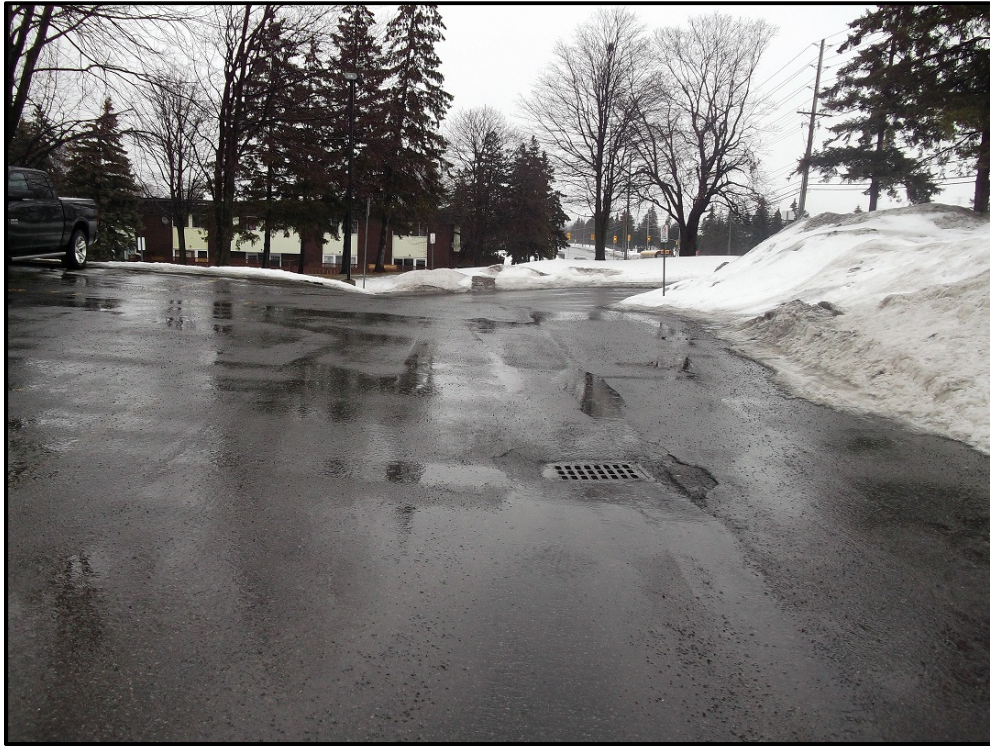
Photograph 2: View of Phase I Property, facing east. Photograph also depicts residential dwellings on the property further to the east.
