Ottawa-Carleton District School Board

**Phase One Environmental Site Assessment
Earl of March Secondary School
4 The Parkway
Kanata, Ontario**

MM1083

May 24, 2024

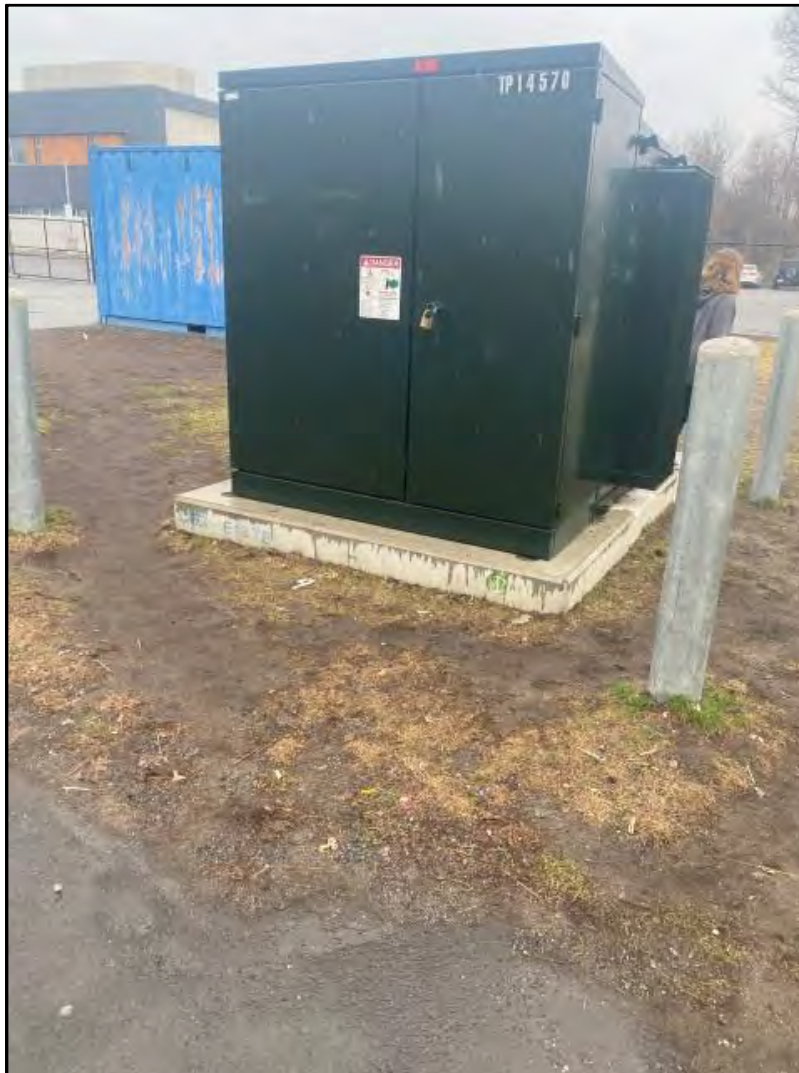
Polychlorinated Biphenyls (PCBs) may be present in transformers, capacitors, electromagnets, heat transfer units, and fluorescent lamp ballasts. Fluorescent lamp ballasts were present throughout the school. One transformer was on a concrete pad on the exterior south side of the school. The transformer identified appeared to be in good condition and no staining was observed.

Photograph 3: View of the ground mounted transformer on the south-west side of the building.

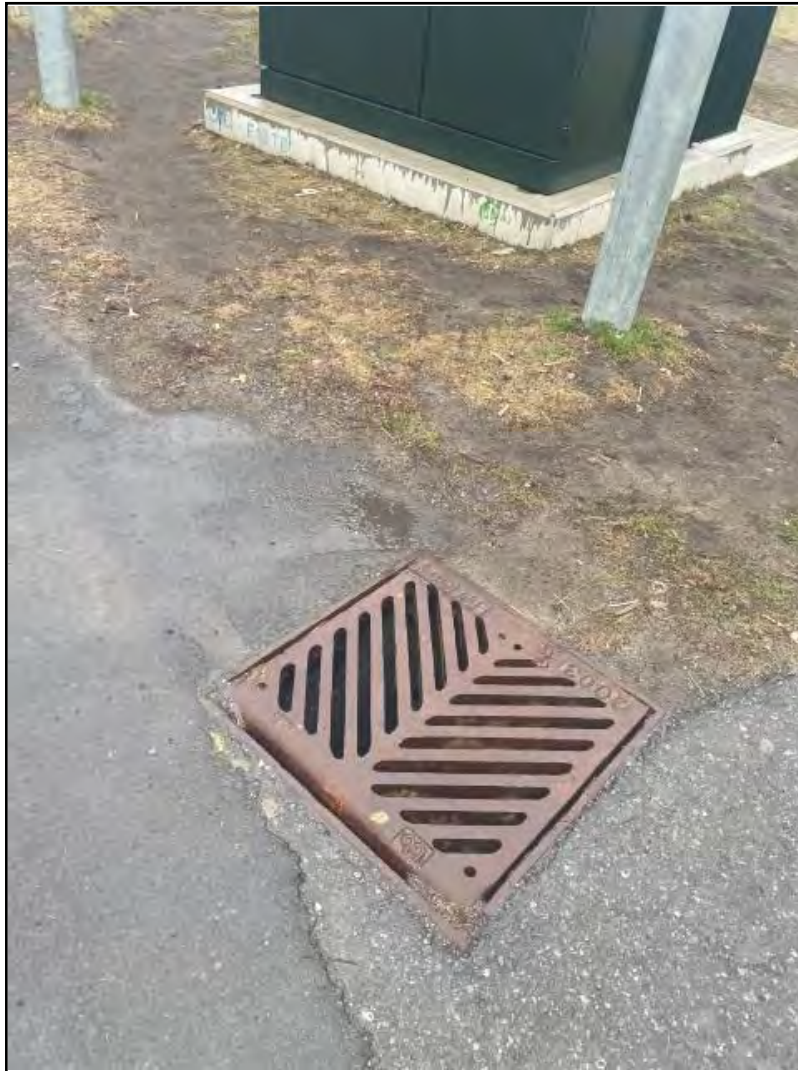
Underground services (gas and water) are provided to the site and come from the south-east from Campeau Drive. Stormwater catch basins were identified surrounding the on-site building. Drainage on the subject property is likely by infiltration on the grass covered areas and overland flow to the catch basins on the asphalt covered areas.

Photograph 4: View of a stormwater catch basin on the south-west side of the building.

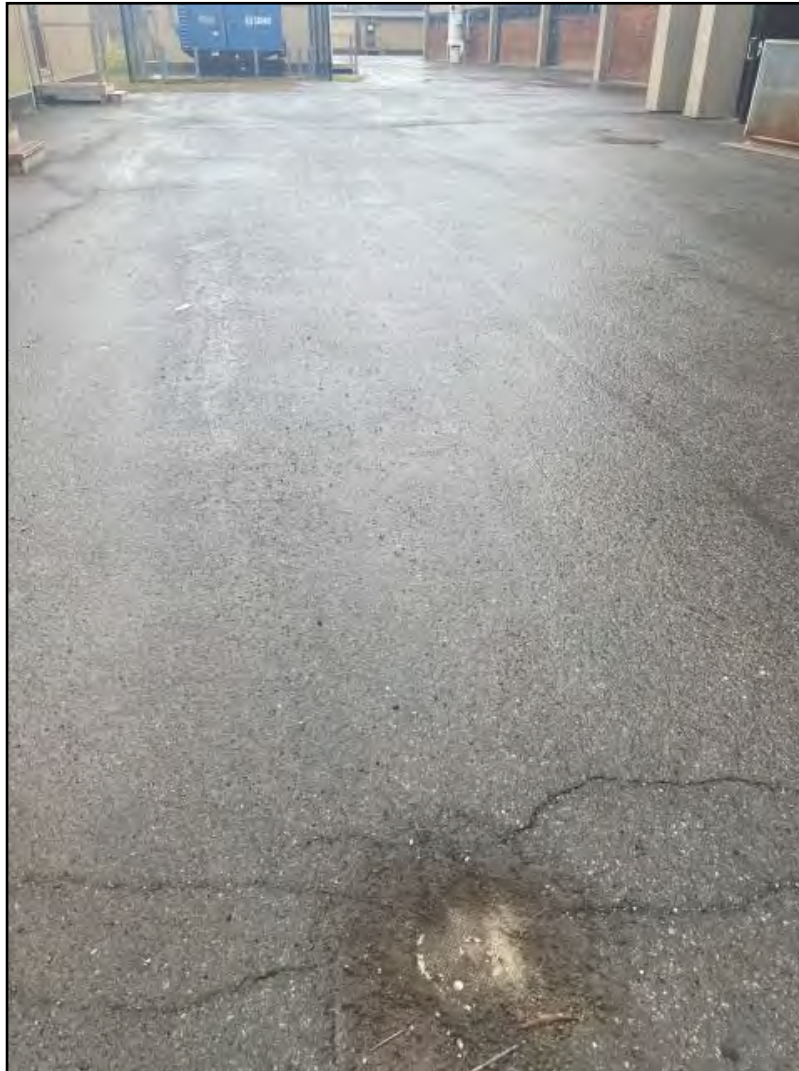
Photograph 5: View of a flush mount cover for a monitoring well on the south-west side of the building. The monitoring well is within the PHC impacted area.

Based on the above, it is CM3's opinion that the contaminants on-site that are above the applicable MECP SCS have been delineated and the contaminant plume has stabilized. The distance between the limits of the contaminated area and the proposed addition is approximately 90 m. Based on the above, CM3 does not recommend a Phase Two ESA as part of the Site Plan Control application for the proposed addition. If work does occur near the contaminant plume (such as rerouting utilities), it is recommended that remedial action be taken.

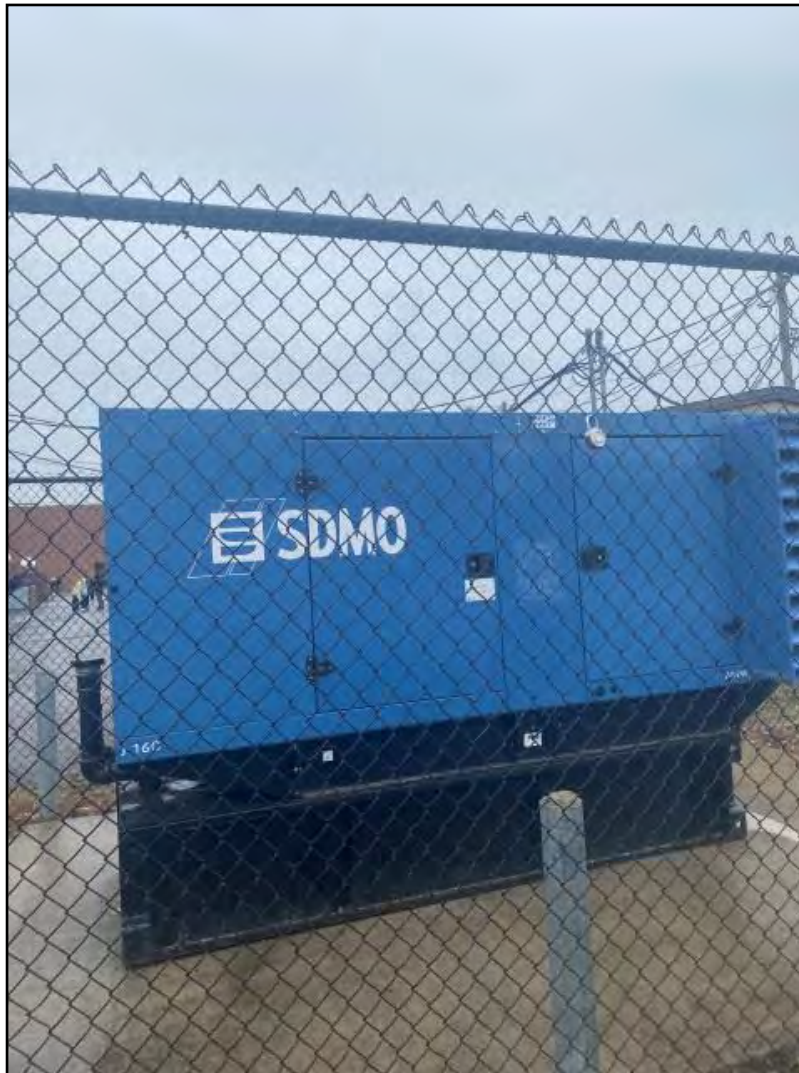
A diesel-powered generator (SDMO J160) was located on the exterior south-west side of the on-site building. The generator has a built-in fuel storage tank and is on a concrete pad. No evidence of leaking or spillage was observed. No other fixed fuel storage tanks were identified at the subject property. Hot water tanks and natural gas fired boilers were identified in mechanical rooms within the school.

Photograph 6: View of the diesel-powered generator on the exterior west side of the building.

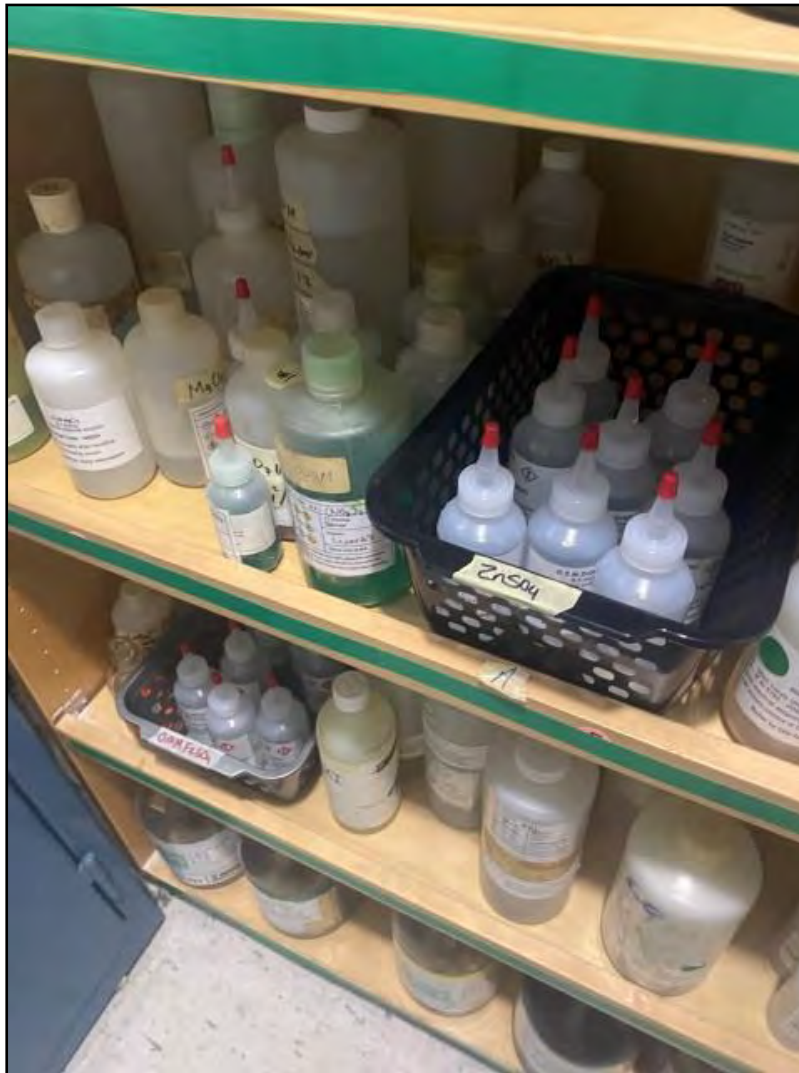
Hazardous waste was not observed during the site reconnaissance. Chemical storage for cleaning and laboratory use were observed on-site in minor quantities.

Photograph 9: View of (one of four) laboratory chemical storage rooms.

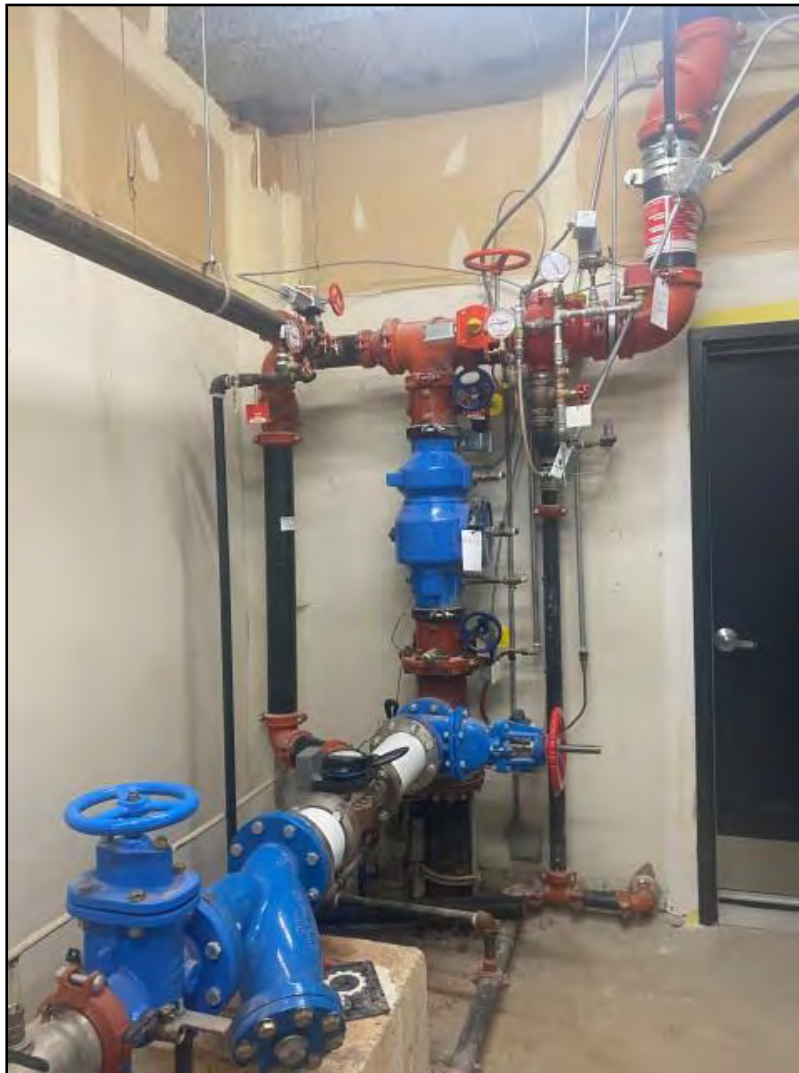
Photograph 12: View of the backflow preventor on the south-east side of the school (adjacent to entrance D1).

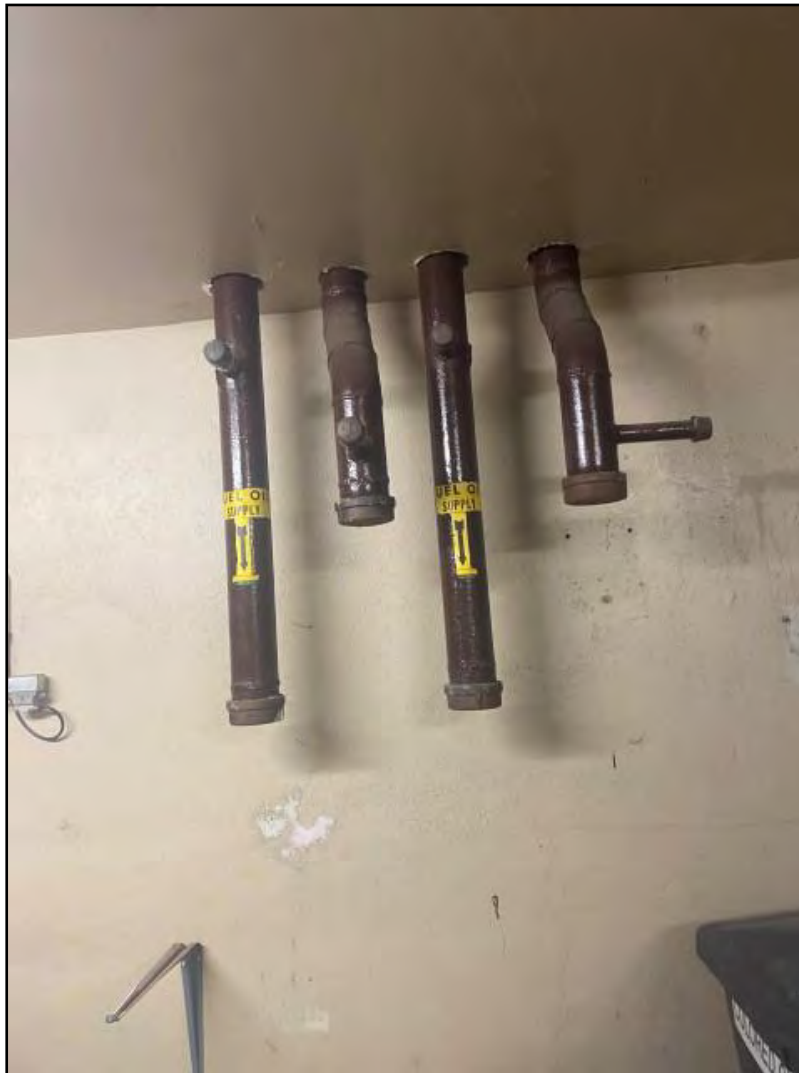
Photograph 14: View of former fuel oil pipes in room B001.

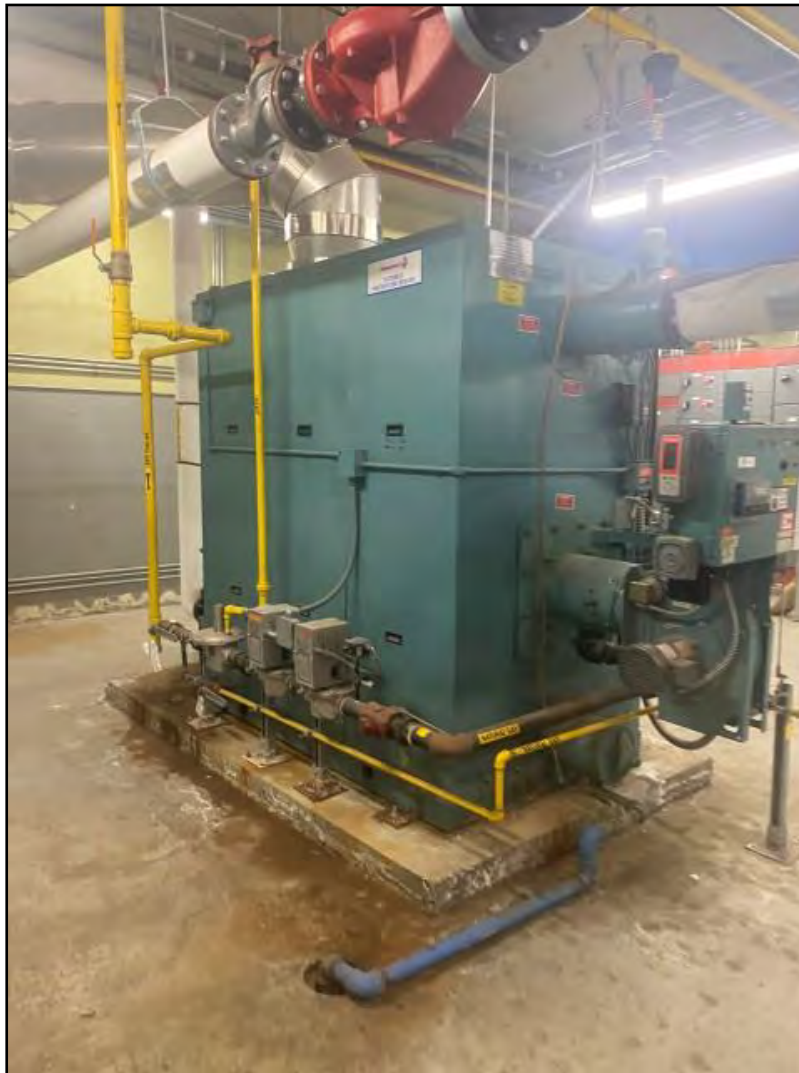
No areas of stained soil, vegetation, or pavement were observed on-site. Staining (likely rust and water) was observed around floor drains in the boiler room.

Photograph 15: View of the boiler room (B006). Minor staining from rust/water is in view.
