1194 WELLINGTON STREET W., OTTAWA, ON
**CULTURAL HERITAGE IMPACT
STATEMENT**

WELLDAL LIMITED PARTNERSHIP
JUNE 30, 2022

This Cultural Heritage Impact Statement (CHIS) was requested by the City of Ottawa to evaluate a redevelopment of the property located at 1186-1194 Wellington Street West in Ottawa’s Hintonburg neighbourhood.

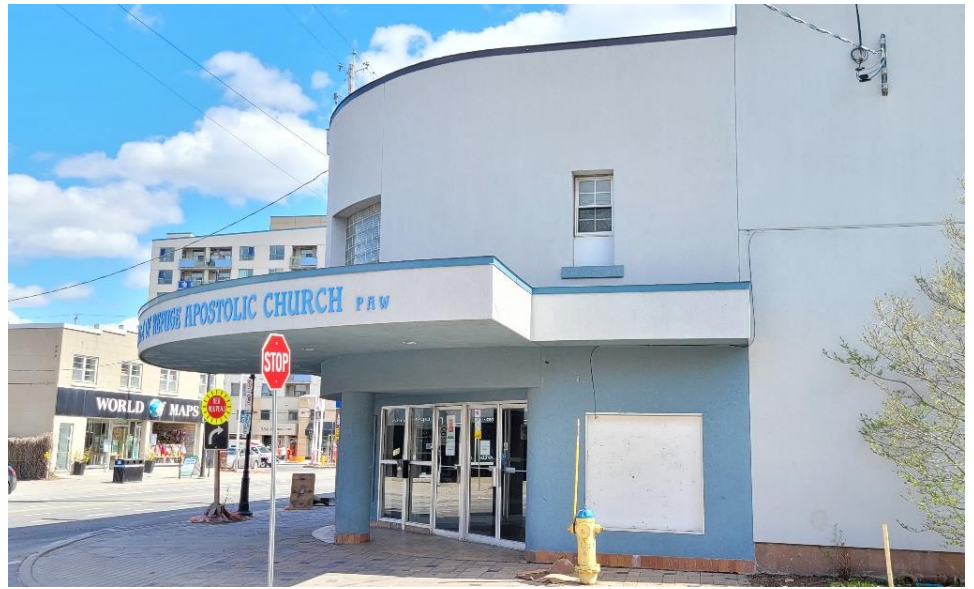
2 Cornerstone House of Refuge Apostolic Church, former Elmdale Theatre, corner of Wellington St W and Hamilton Avenue North. MTBA.

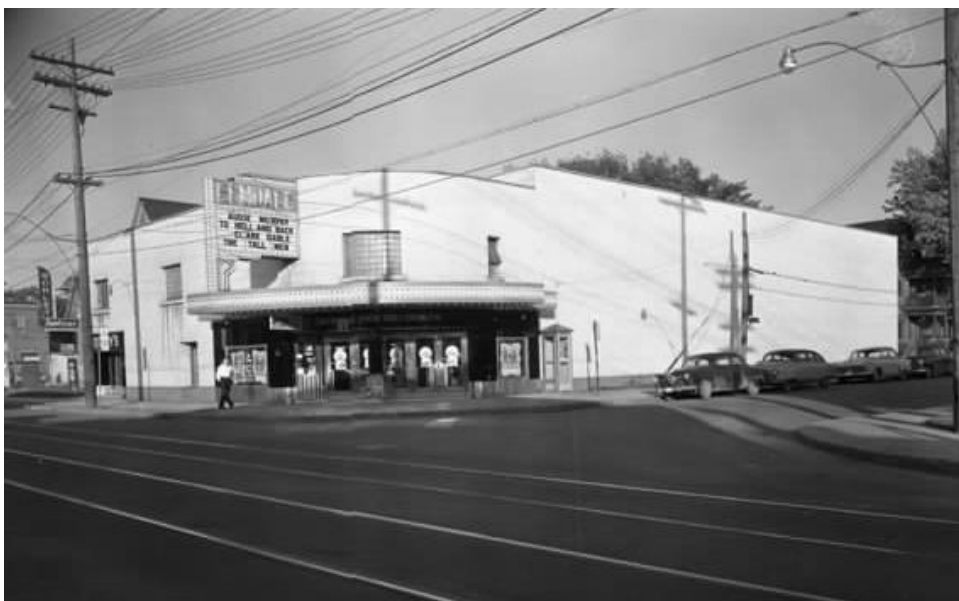
18 Exterior of the Elmdale Theatre and corner of Wellington St W and Hamilton Ave N in 1956. *City of Ottawa Archives, CA038871.*

In the authors' view, the corner entry architectural element of the former Elmdale Theatre (1947) is the only perceived heritage attribute of the subject properties. It contrasts with the severely minimal, rectilinear "warehouse/auditorium box" of the rest of the building. Clearly, the original architects were putting all effort and funds into the "first impression arrival experience" for the cinemagoer, with the curving marquee, lighting, and Moderne detailing at this one location, as was generally common for a neighbourhood level movie theatre ("Nabe") constructed during this period. Unfortunately, much, if not all, the heritage fabric has been removed by subsequent renovations and retrofits. The character-defining elements of this one heritage attribute are clearly visible in the 1950s photographs and included, at the time***:

- the sweeping curved corner wall up to the second storey parapet.
- the sweeping curved corner marquee, with its tripartite arrangements of wings and bands, continuous lighting, and reflective smooth soffit with integrated down lighting;
- the corner column, stout in proportion and hard polished finish;

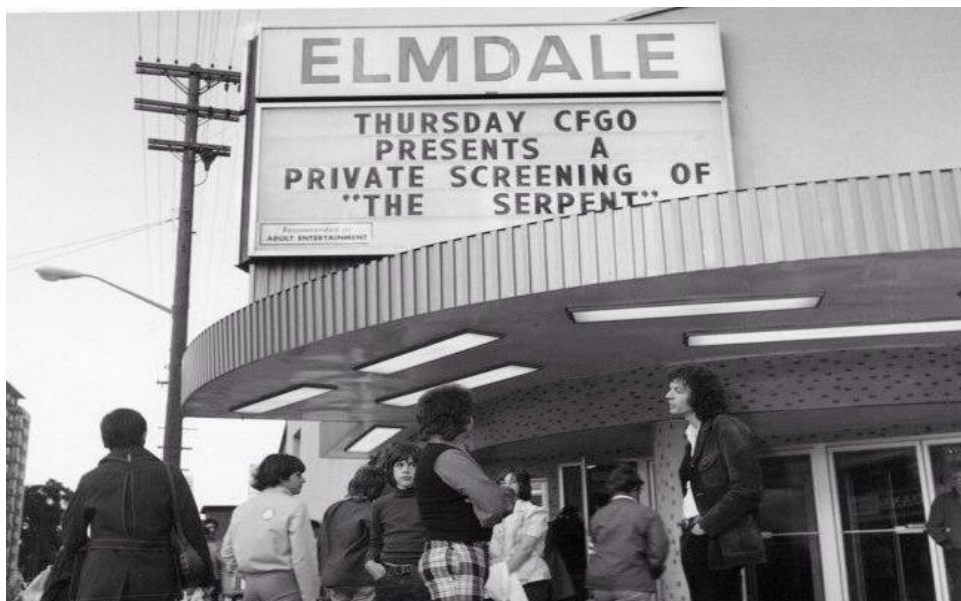
20 Elmdale Theatre c. 1973, showing early renovations that saw the the original heritage fabric removed. *Flickr.*

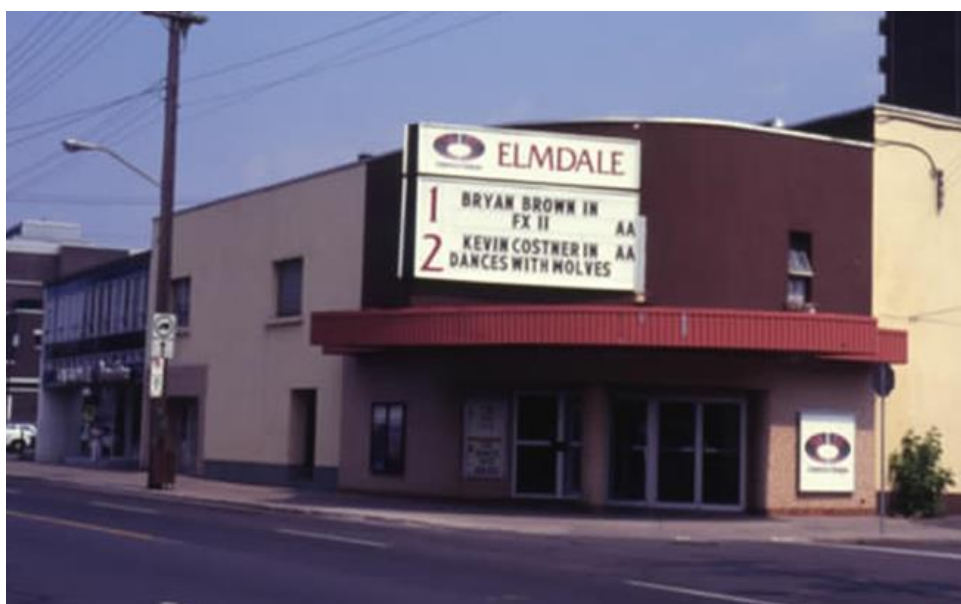
21 Elmdale Theatre, corner of Hamilton Ave N and Wellington St W, 1991, showing early renovations that removed the original heritage fabric. *City of Ottawa Archives, CA024334*

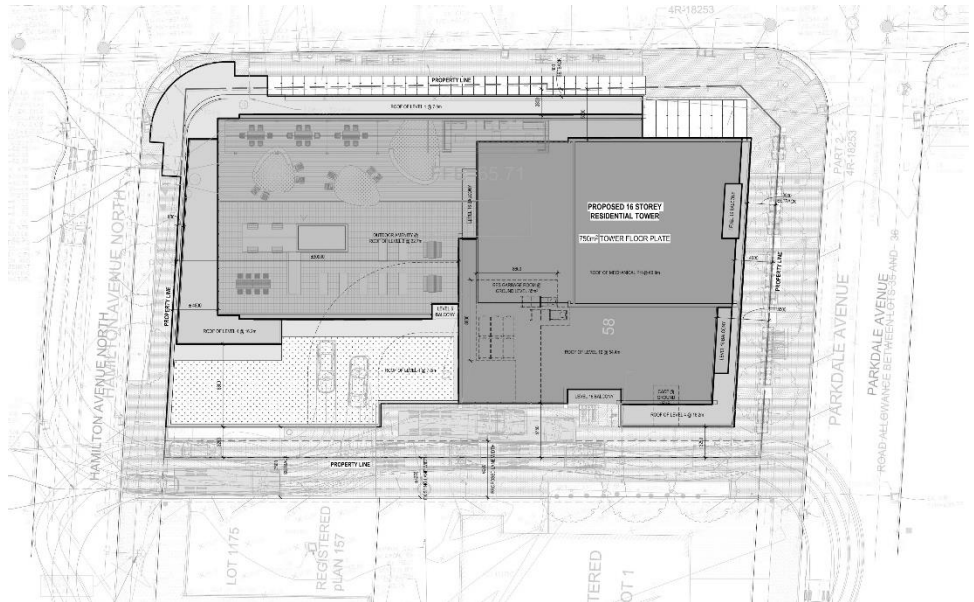
- 44 Site Plan of the proposed development. *DIALOG.*

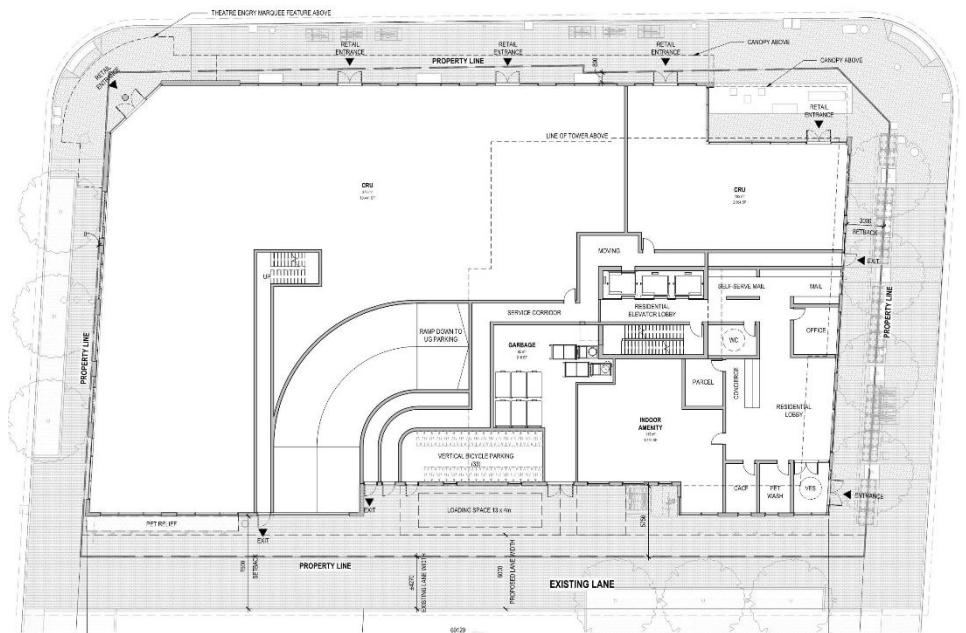
- 45 Ground Floor Plan of the proposed development. *DIALOG.*

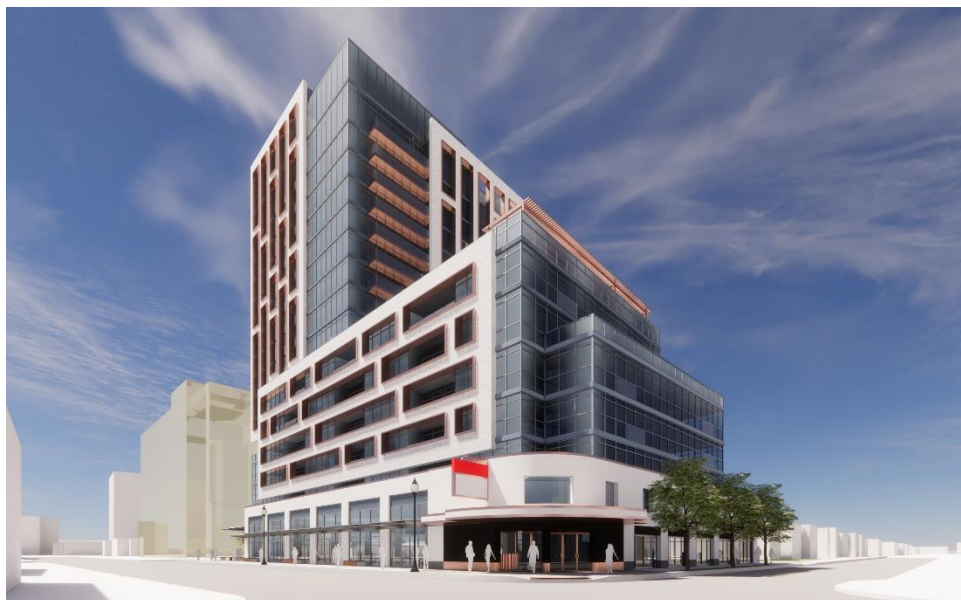
47 Looking southeast towards the proposed development along the corner of Wellington St W and Hamilton Ave N. *DIALOG.*

- Sweeping curved corner marquee, with its tripartite arrangements of wings and bands and reflective smooth soffit;
 - Metal and glass entry door system, with expressive hardware and polished finish. While shown as copper colour, it would be preferable for these to be finished in stainless steel;

- Metal scalloped or fluted wall dado-base. While shown as copper colour, it would be preferable for these to be finished in stainless steel;
 - Hard black reflective wall cladding;

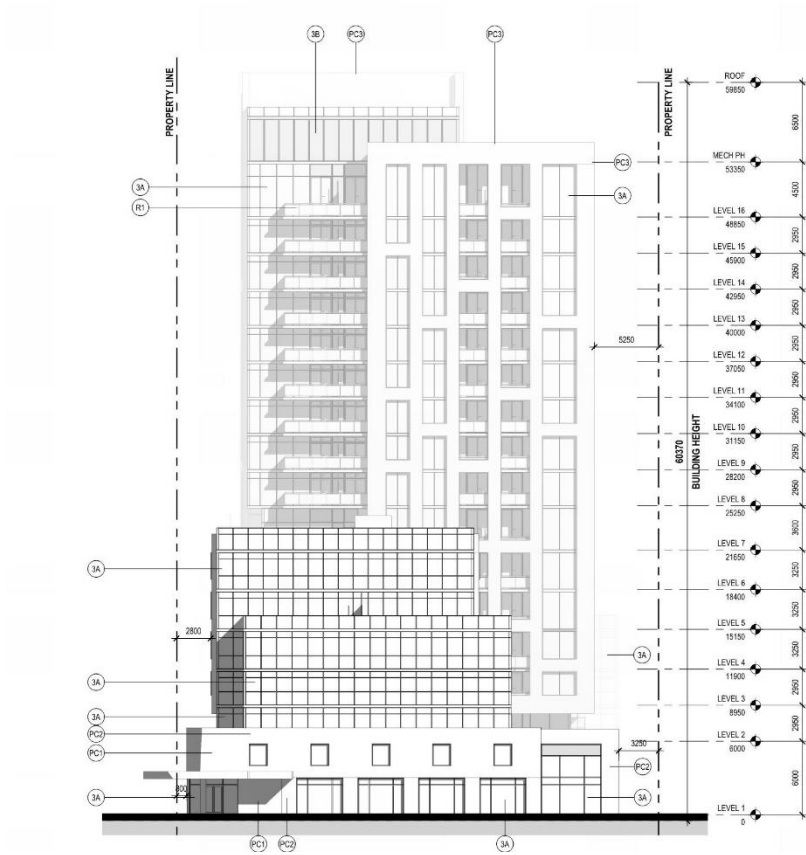
52 Hamilton Ave N Elevation (West).
DIALOG.

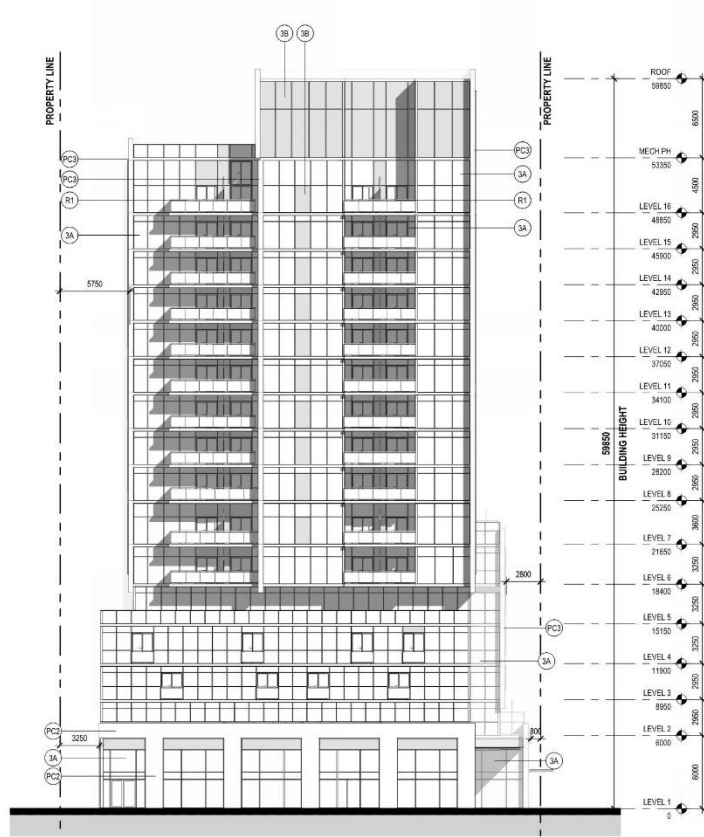
54 Parkdale Avenue Elevation (East).
DIALOG.

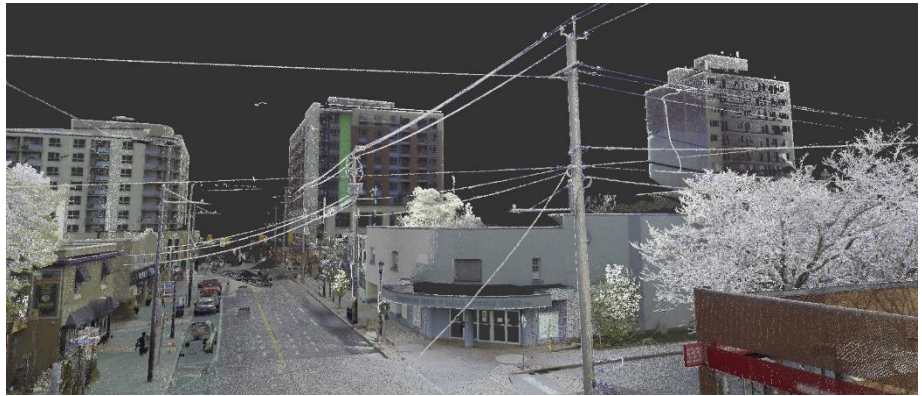
- 1 3D Scan of site looking east along Wellington St W. *If/Then Architecture Inc.*

As part of the site investigations of heritage assets, MTBA retained subconsultants If/Then Architecture Inc, to scan the existing conditions of the site. If/Then provided MTBA with point clouds and a 3D BIM (Building Information Model) model using 3D laser scanning technology. Laser scanning allows for an accurate recording of ‘as-is’ conditions of the property and its heritage assets. The scans then generate point clouds of information that can be used as a baseline for the creation of a BIM model.

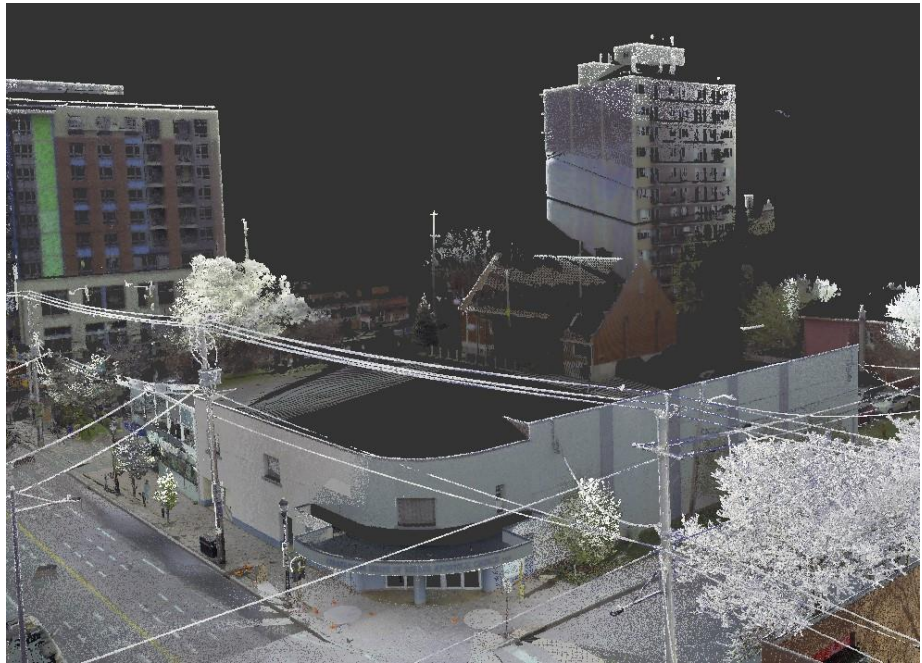
- 2 3D Scan of site looking southeast at corner of Wellington St W and Hamilton Ave N. *If/Then Architecture Inc.*

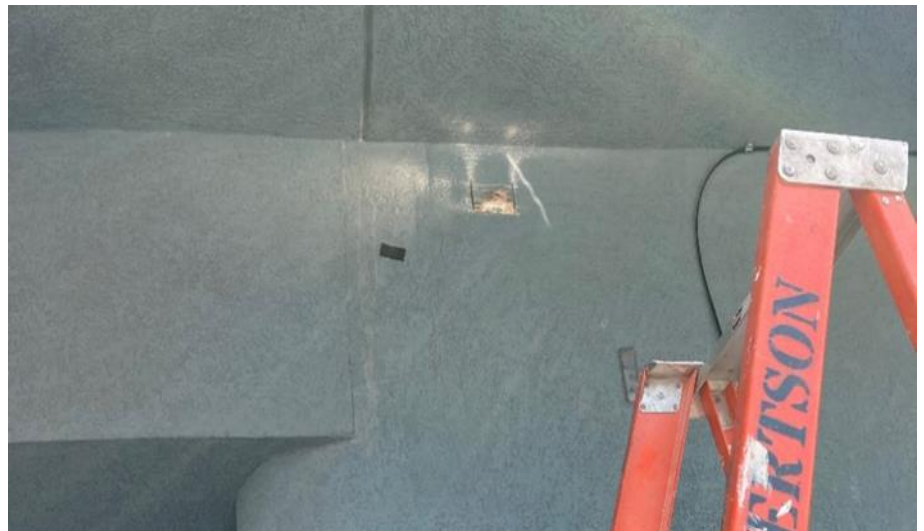
5 Canopy Fascia Upper Wall (Investigation 4 & 5): Location of Opening.

4/5	Investigative opening of Upper Wall to determine if hard polished finish, or vitrolite remains behind parging. Investigative opening done in one section to limit the amount of damage to existing parging and post investigation repair. Upper Wall, central portion examined. No original fabric observed.	5, 6	May 11, 2021
6	Investigative opening done on Column to determine if any original hard polished finish, or vitrolite remains behind parging. Small opening made in existing parging revealed tiles under parging layer. Opening in tile, revealed concrete backing and no original granite. Tile part of previous renovation work. No original fabric observed.	7, 8	May 11, 2021
7	Similar investigative purpose as investigation 6, Lower Wall at base was examined to determine if hard polished "Vitrolite" wall cladding remains behind parging, under Southwest Signage Board. Wood framing was revealed, no remaining scalloped or fluted wall material observed. Additionally, no original fabric observed from Southwest Signage Board (Investigation 8).	9, 10	May 11, 2021

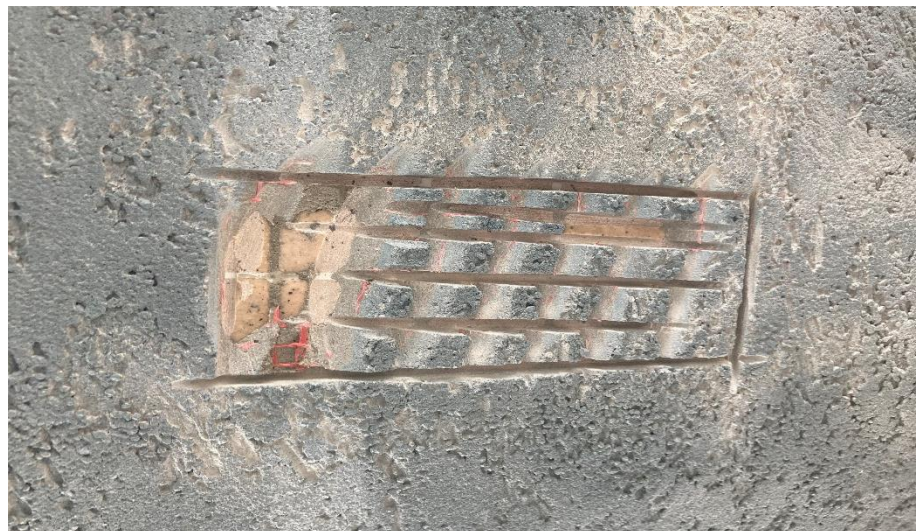
6 Canopy Fascia Upper Wall (Investigation 4 & 5): Removal of parging revealed ceramic tile (Same as column). Tile removal revealed concrete backing. Original fabric not observed.

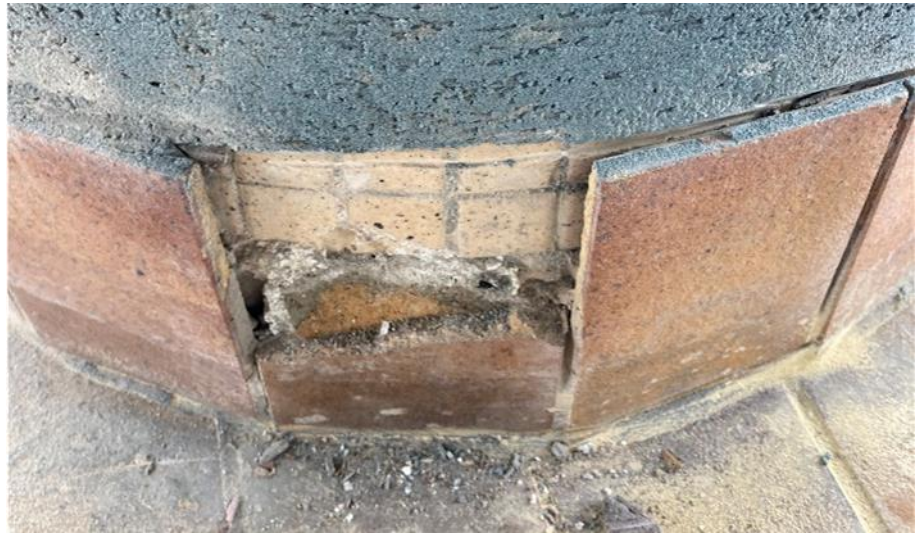
- 7 Column base (Investigation 6): Base tile removed to examine if original hard polished finish, or vitrolite, remains behind existing tile or parging. Investigation revealed ceramic tiling from previous renovation. Original Fabric not observed.

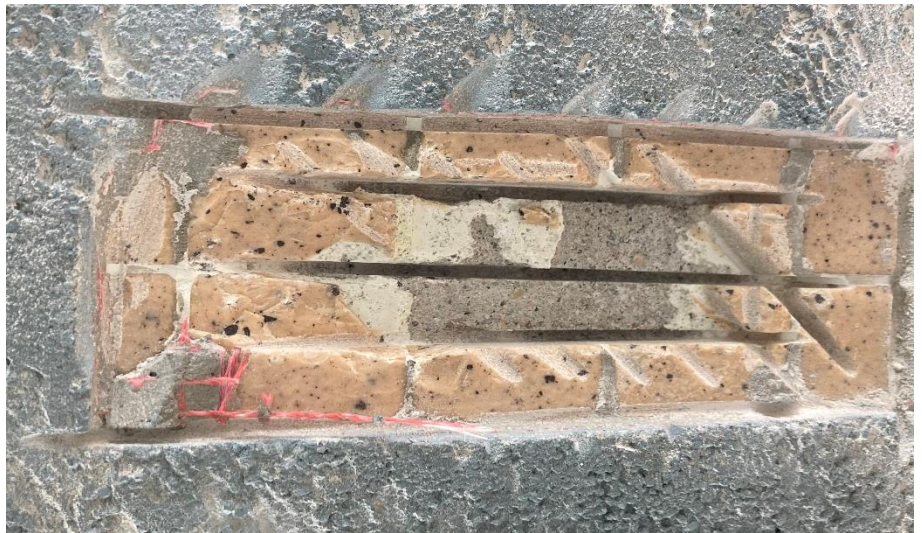
- 8 Column Parging (Investigation 6): Second investigative opening into column parging. Investigation revealed ceramic tile from previous renovation. Further opening on tile revealed cement backing. Original Fabric not observed.

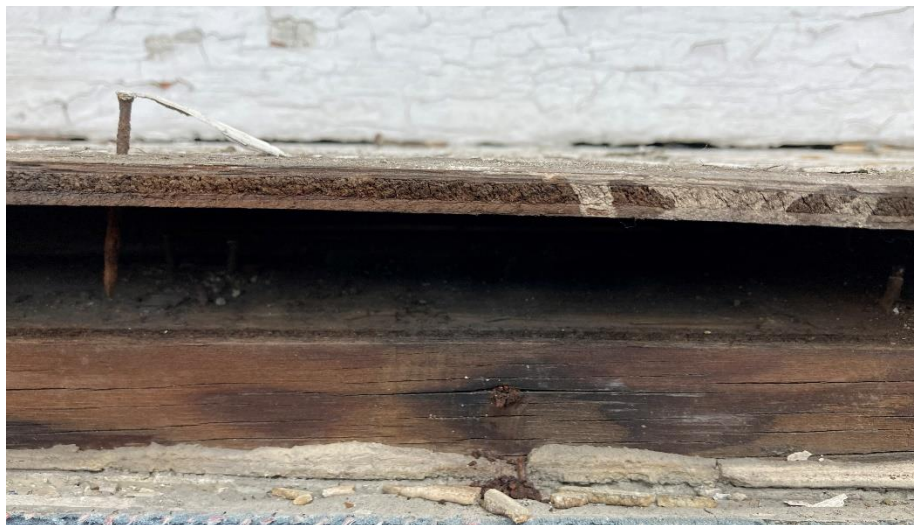
- 9 Lower Wall at Base (Investigation 7): conducted to check for metal, expressive hardware and polished finish, scalloped or fluted wall observed in historic photographs.

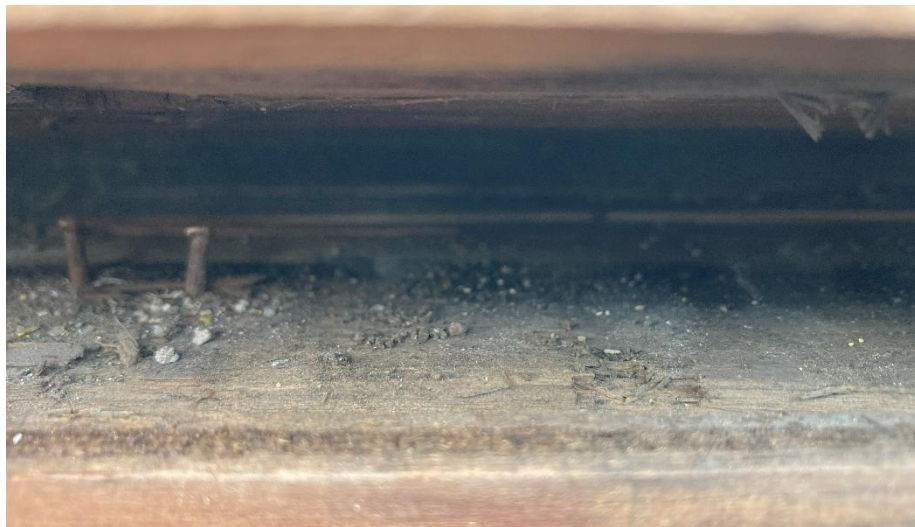
- 10 Lower Wall at Base (Investigation 7): Lower Wall at Base, investigation revealed wood board and parging layer. No scalloped or fluted wall observed.

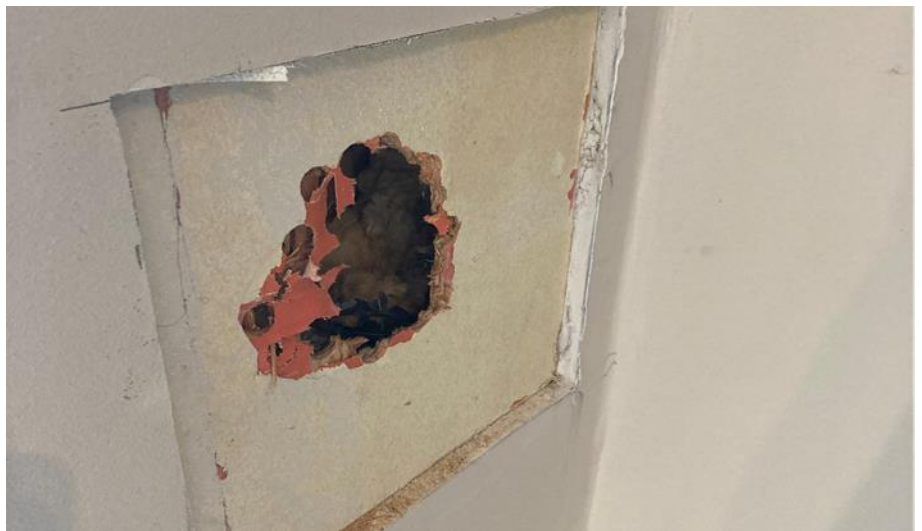
- 15 Former Ticket Booth Interior
(Investigation 9): Interior wall
investigation revealed drywall
(gyprock), layers of wall paper.

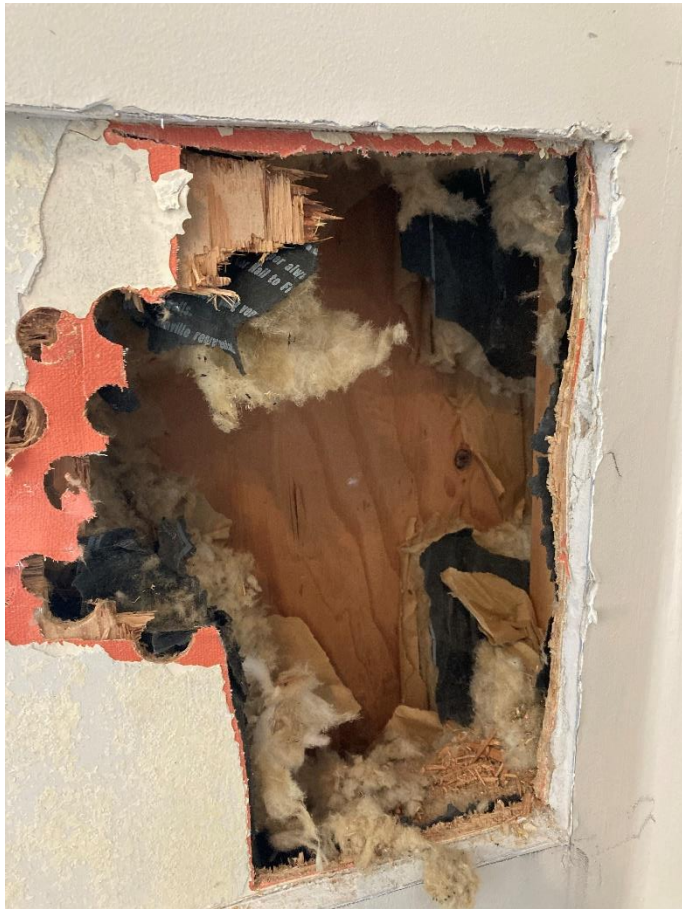
- 16 Former Ticket Booth Interior (Investigation 9): Further investigation demonstrated insulation and wood layer (which was also noted in exterior investigation)

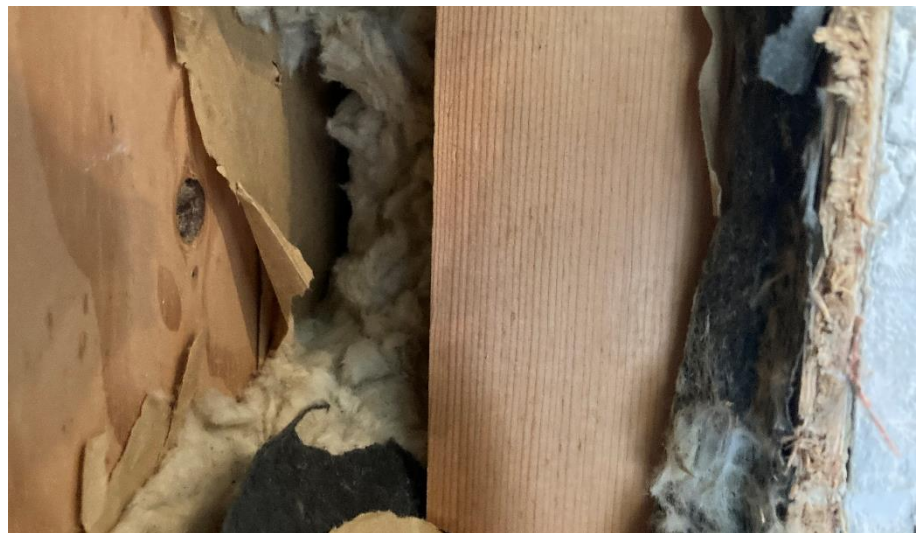
- 17 Former Ticket Booth Interior (Investigation 9): Wood framing examined. No original material found.
