Updated: January 30, 2025

Re: Hydrogeological Assessment, 6688 Franktown Road, Ottawa ON, Addendum 1  
Project #: CCO-17-0503

# HYDROGEOLOGICAL STUDY 6688 FRANKTOWN ROAD

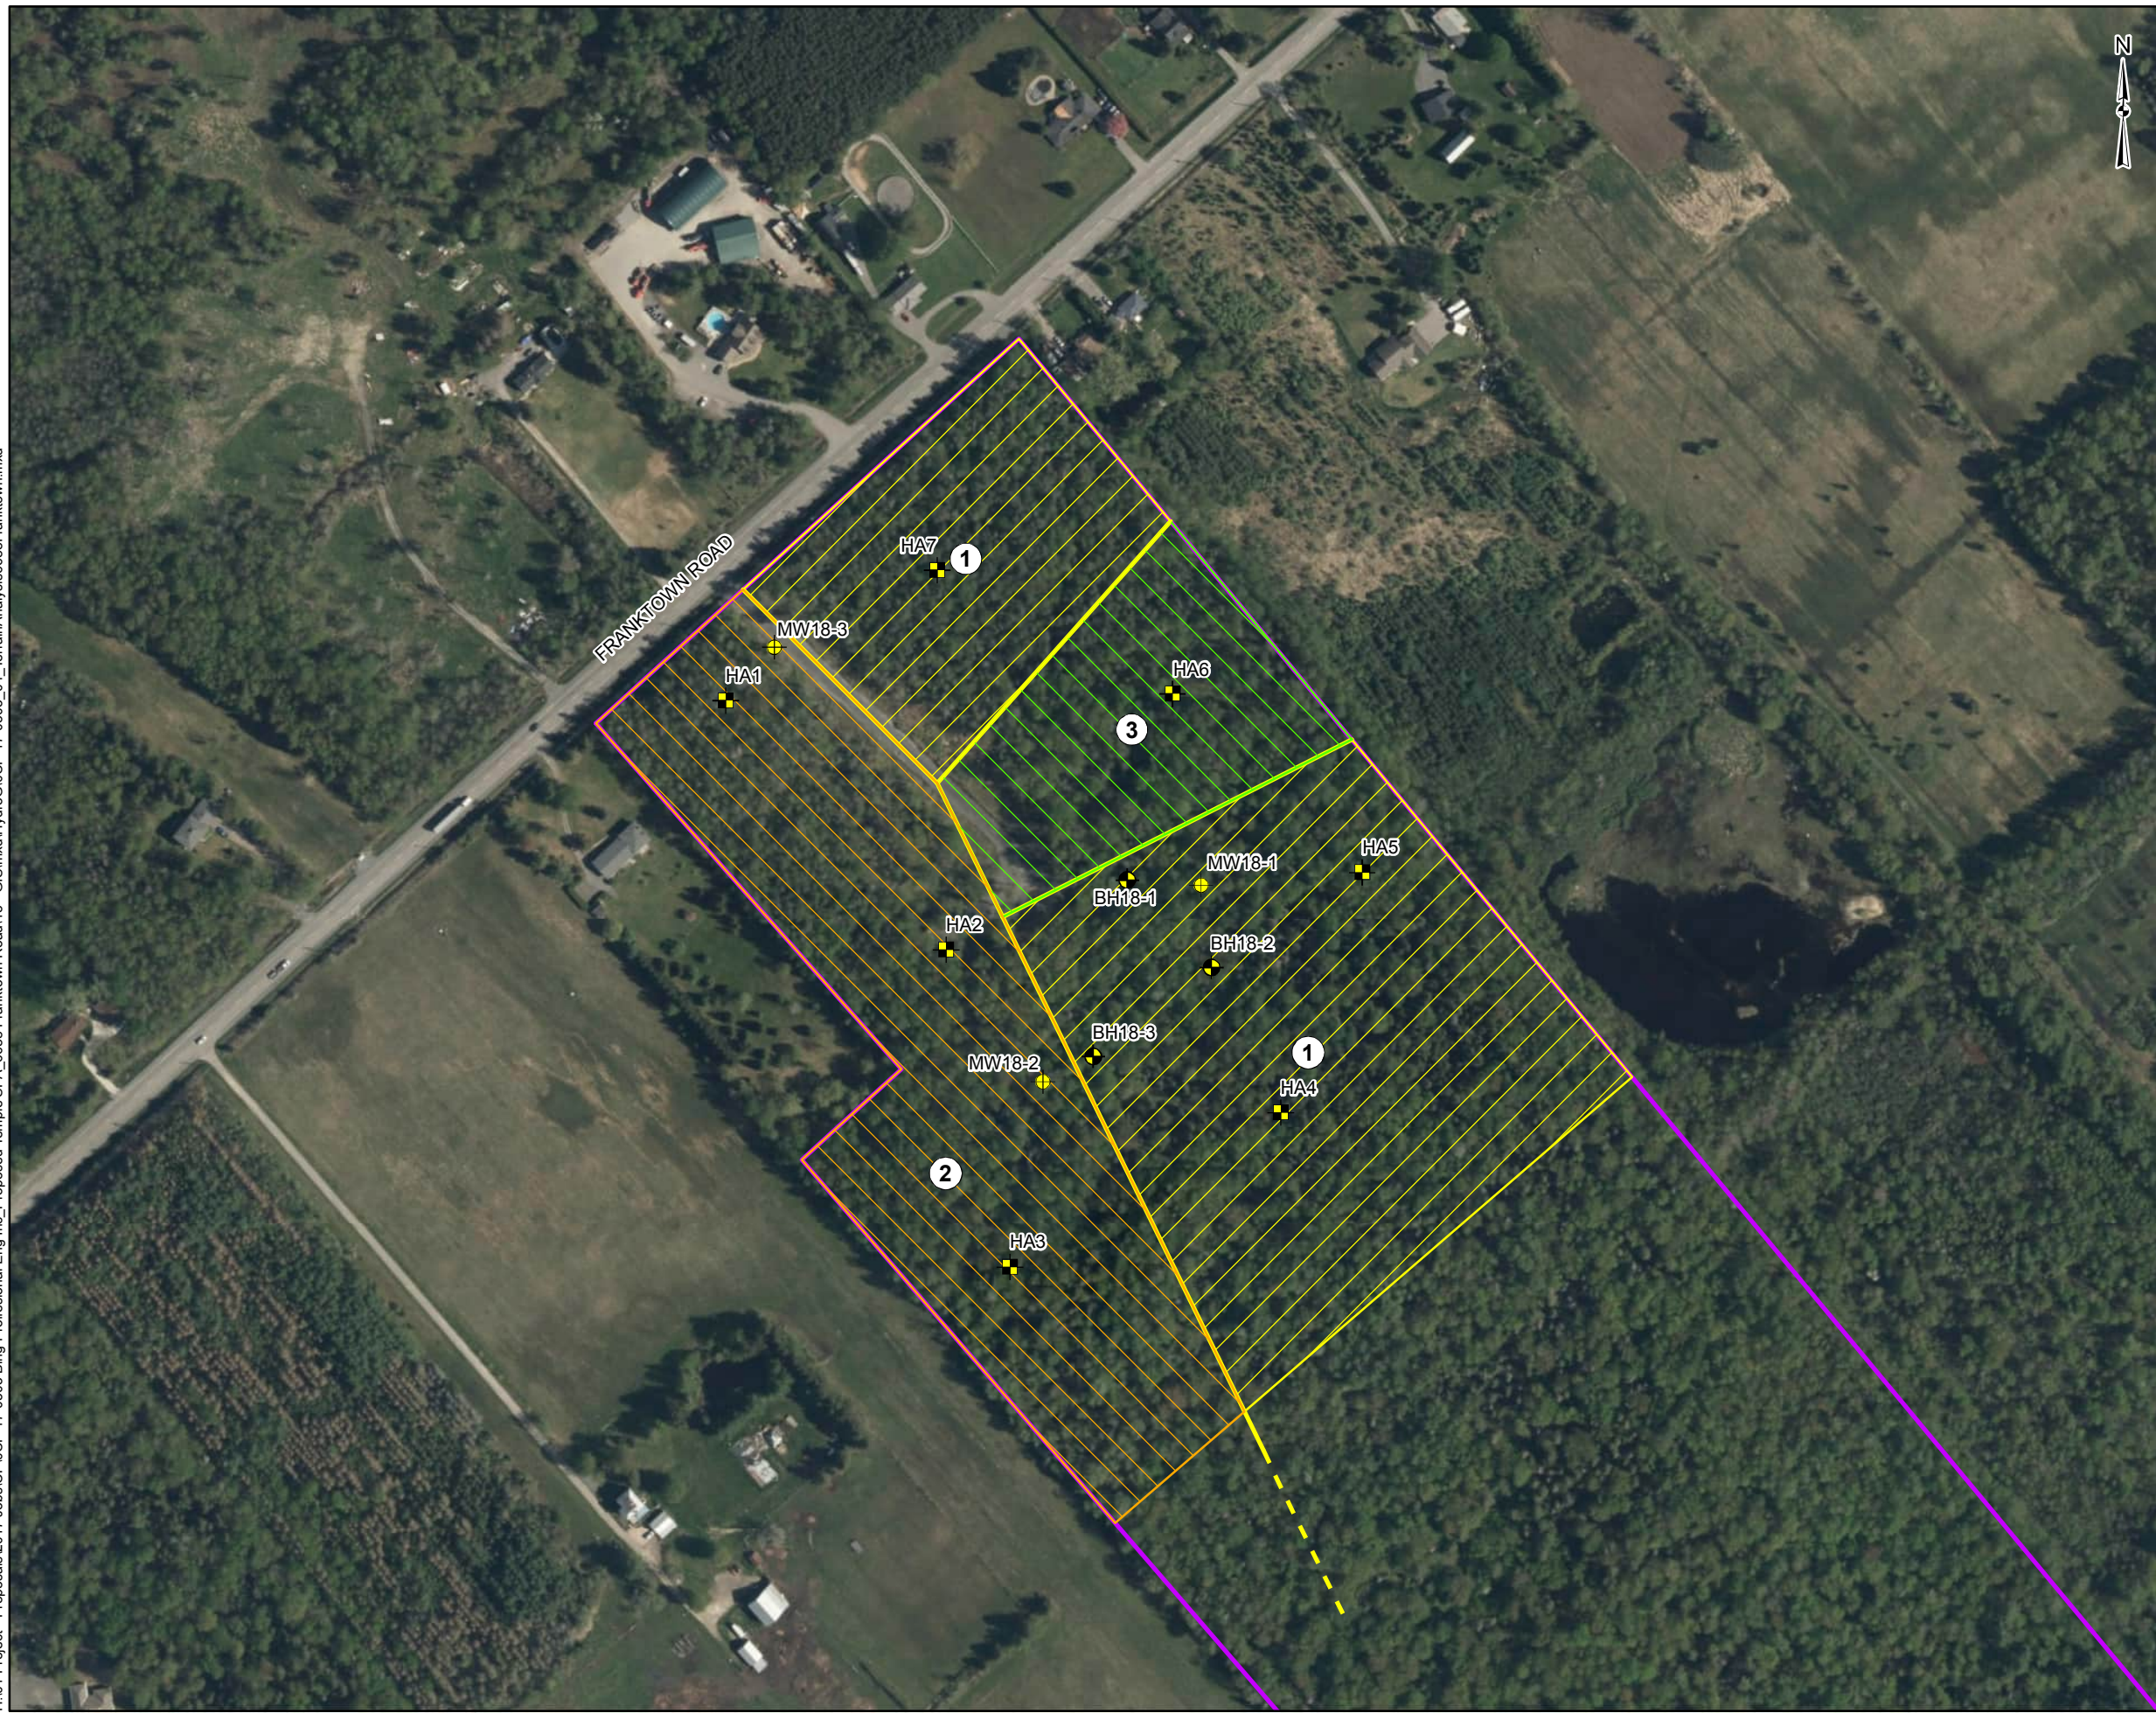
- Hand Auger
- Borehole
- Monitoring Well
- Site Boundary
- Zone 1 - MEDIUM SAND, some to trace fines
- Zone 2 - SILT and CLAY, trace sand
- Zone 3 - Silty FINE SAND

On-site soils in the area of the proposed development appear to consist of a thick layer of sand with some areas of silt and clay. Overburden was observed to generally become coarser with depth, and limestone bedrock was encountered between 4.9 – 5.7 m below ground surface (bgs). Based on the general characterization of overburden in the vicinity of the proposed septic leaching bed, imported fill materials are likely necessary to provide the required vertical separation from groundwater. Further investigation of soil will likely be required to support the MOECP Sewage Works application process.

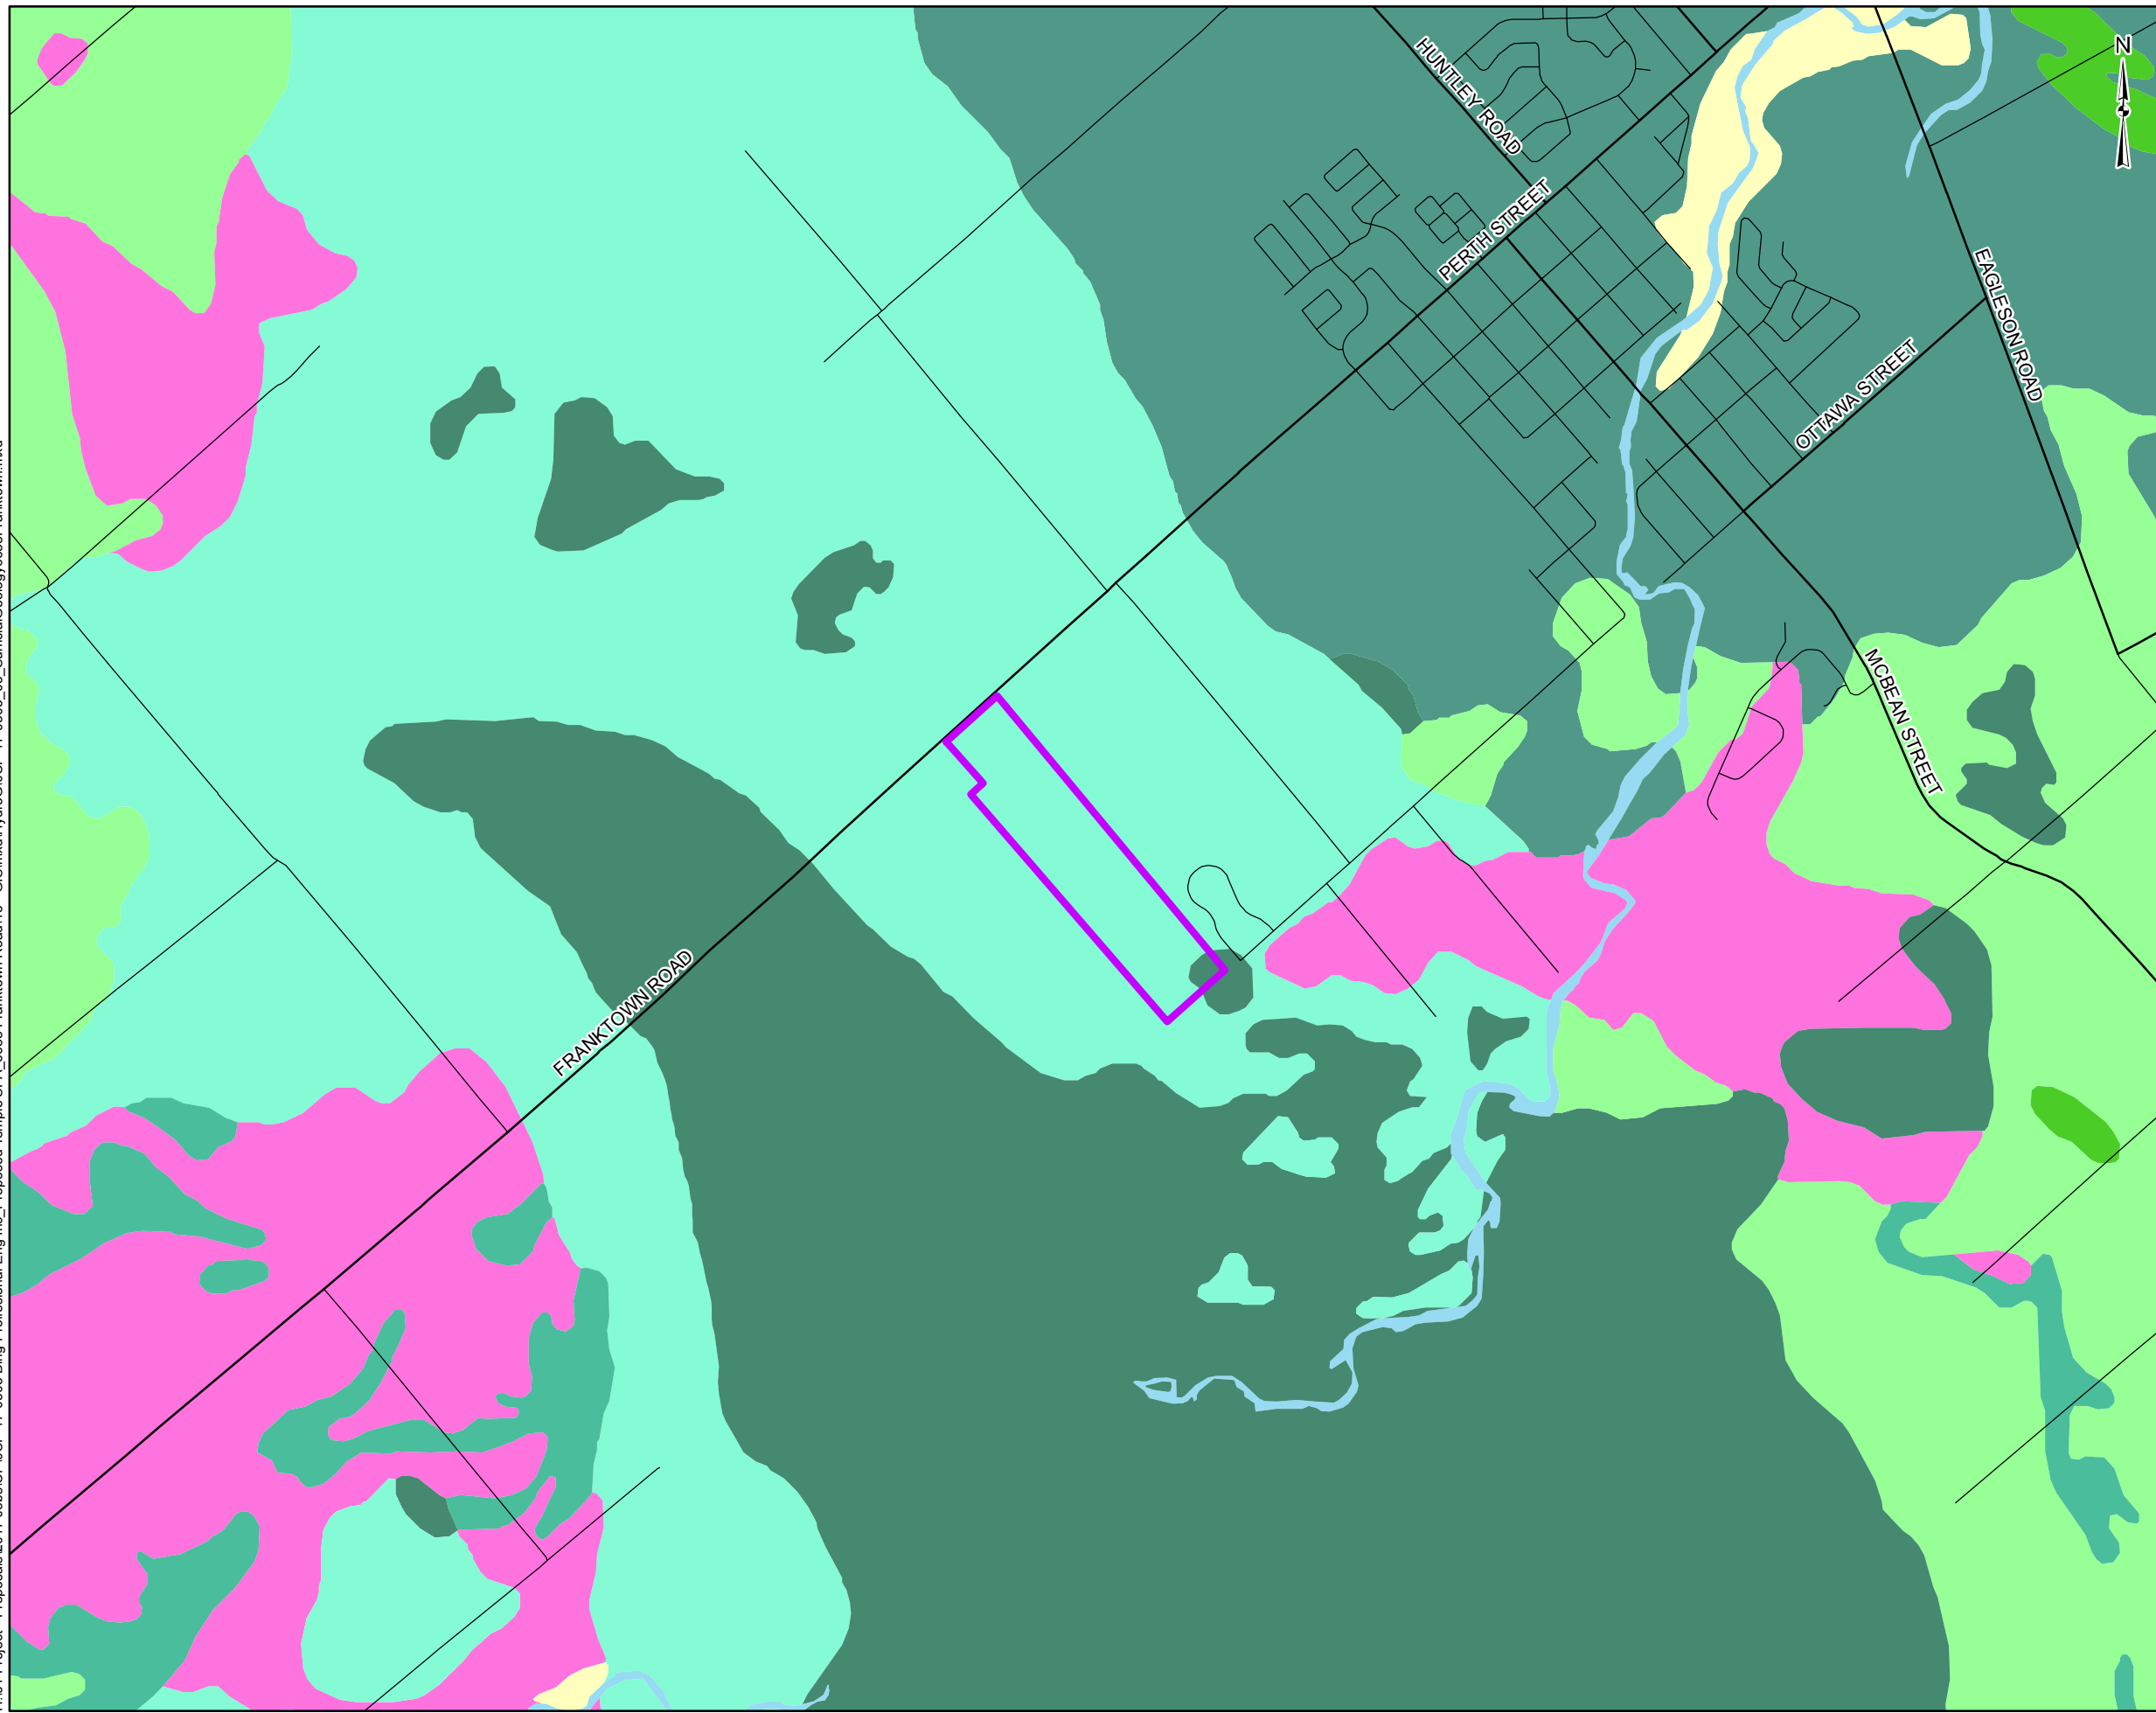
- Property Boundary
  - Local Road
  - Major Road
- Surficial geology**
- Description**
- Organic Deposits
  - Sand Dunes
  - Floodplains, sand, silt, clay
  - Fluvial Terraces, sand, silt
  - Reworked Marine Sediments
  - Beach Formations
  - Sand, reworked glaciofluvial
  - Deltaic and Estuarine Deposits
  - Marine Deposits, clay, silt
  - Erosional Terraces
  - Glaciofluvial Deposits
  - Till, plain
  - Till, drumlinized
  - Till, hummocky to rolling
  - Paleozoic Bedrock
  - Precambrian Bedrock
  - Water

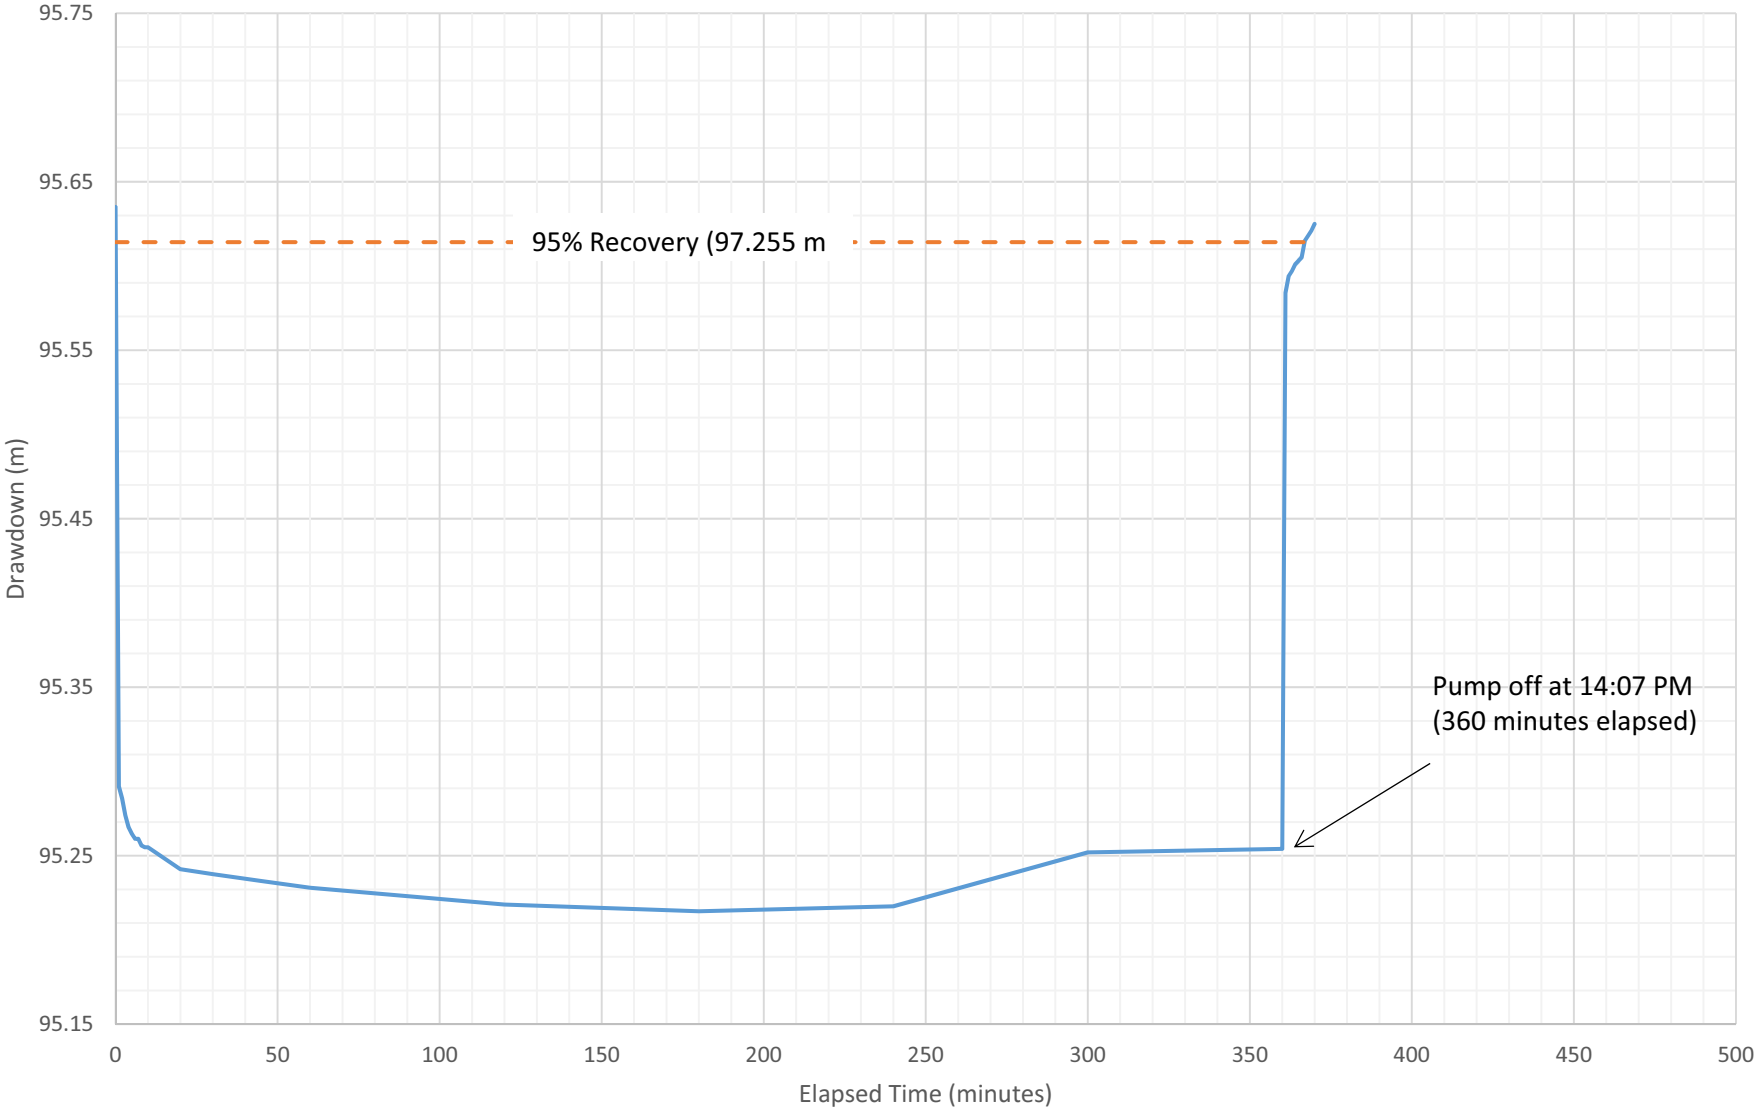
Drawdown vs Time  
TW1 Pumping Test (Drawdown), July 13, 2018  
6688 Franktown Road, Ottawa, ON

The water level ranged between 95.217 m to 95.625 m local (4.375 to 4.783 m btoc), with a maximum drawdown of 0.418 m observed. 100% recovery was achieved in the well within 10 minutes of pump shut down.

By extrapolating the drawdown data on a semi-logarithmic scale, it is estimated that a conservatively maximum pumping rate of 92 L/min could be sustained for over 100,000 minutes (69 days) of continuous pumping with a maximum drawdown of under 1 m (see Appendix E). It is noted that this situation is inherently conservative, as the pump will cycle on and off on a much shorter time scale, allowing the well to recharge.

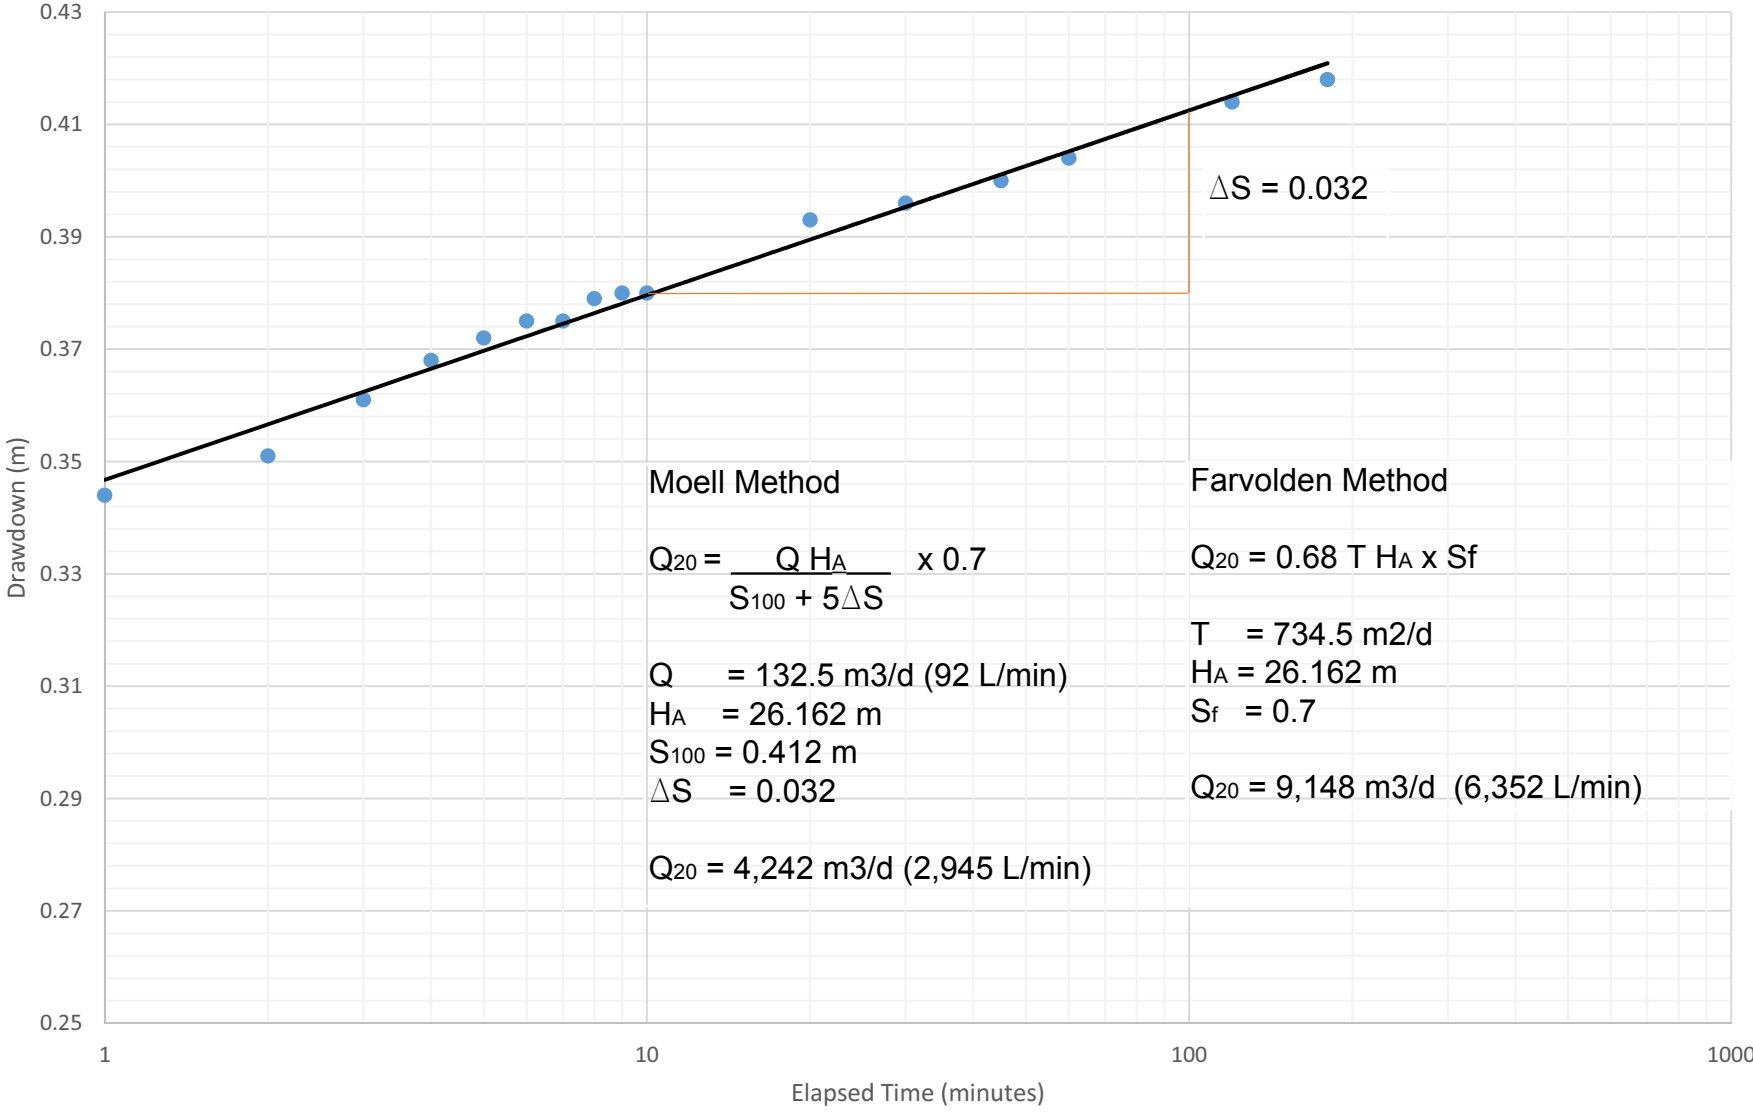
**Drawdown vs Log Time**  
**TW1 Pumping Test (Drawdown), July 13, 2018**  
**6688 Franktown Road, Ottawa, ON**

**Moell Method**

$$Q_{20} = \frac{Q H_A}{S_{100} + 5\Delta S} \times 0.7$$

**Q<sub>20</sub> = 9,148 m<sup>3</sup>/d (6,352 L/min)**
