**Tree Conservation Report
Proposed Development Application
788 March Road
Ottawa, Ontario**

November 5, 2024
Project: 103027.001

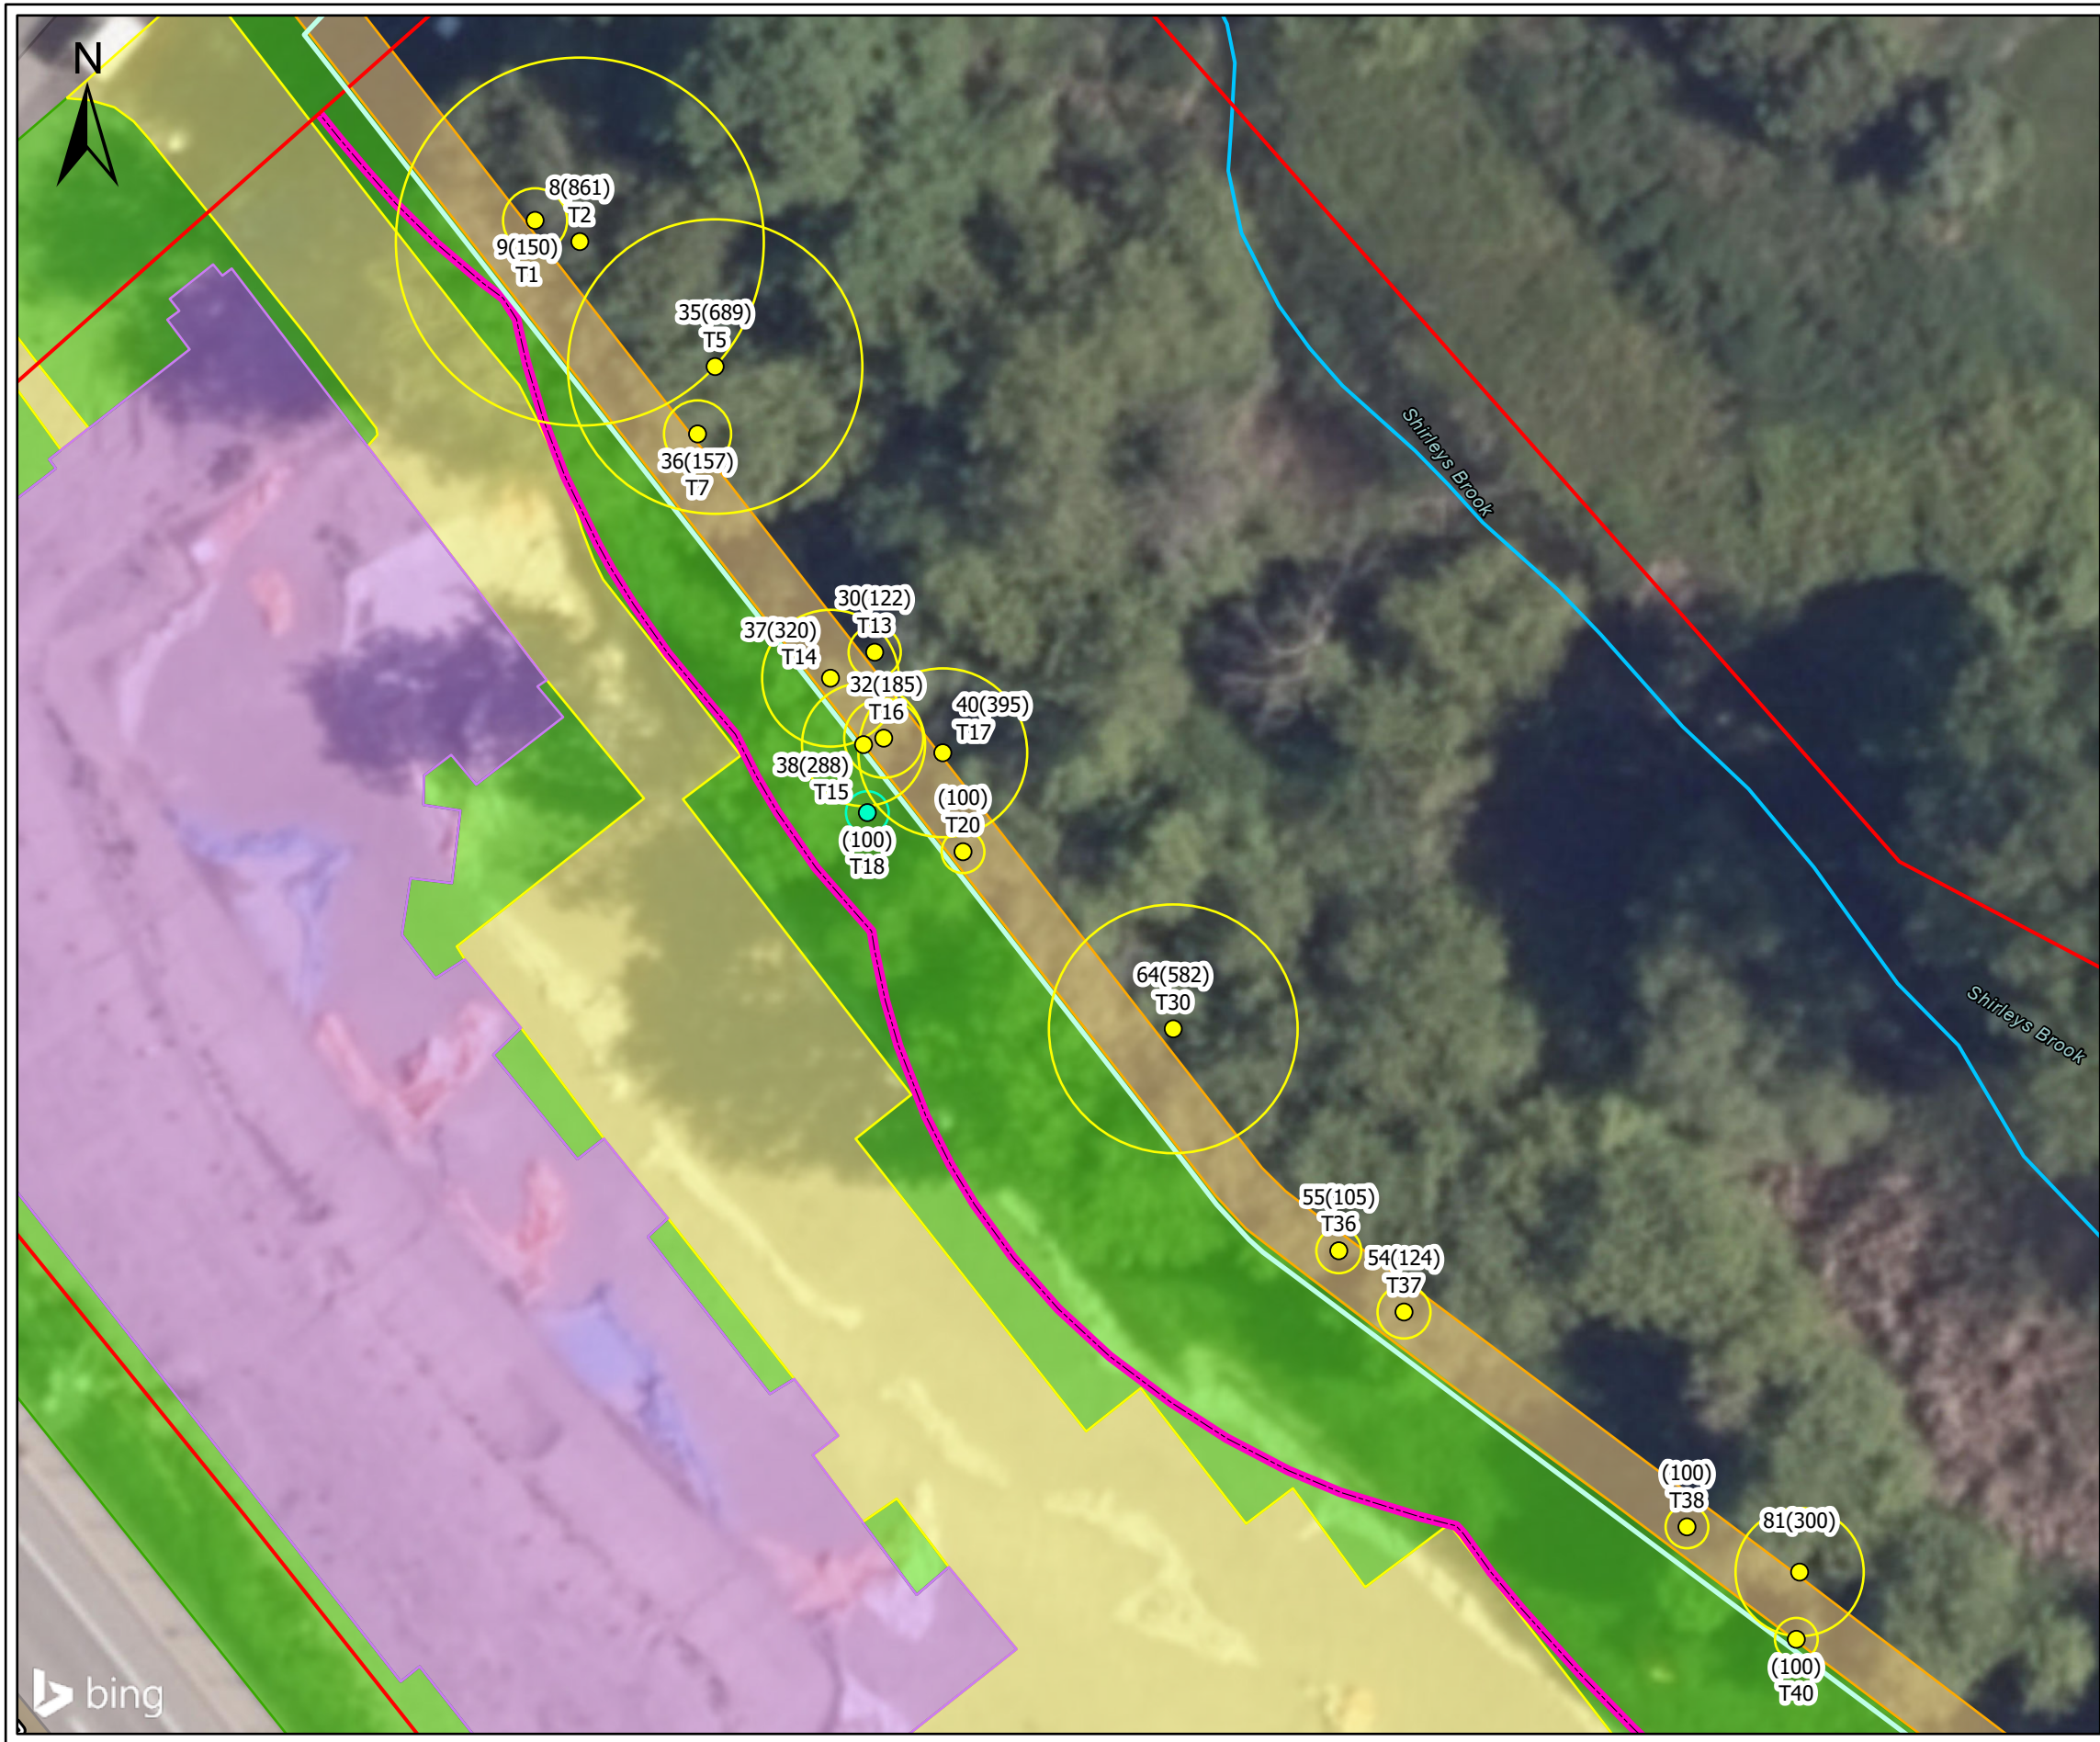
- Property Boundary
- Study Area
- Watercourse
- 30 m Setback
- Tree Protection Fencing
- Proposed Building Footprint
- Proposed Paved Area
- Conceptual Proposed Bicycle Path
- Proposed Soft Landscape Area
- Conflict - Build
- Conflict - Pathway

- Conflict - Build
- Conflict - Pathway

trees were identified as conflict, non-retainable. Of the 20 conflict trees six were identified as having greater than 30% of their CRZ impacted (trees numbered 9, 8, 30, 35, 64 and T18). These trees occur within the grading area with greater than 30% of their root structures overlapping the development plan. 14 trees (trees numbered 32, 34, 37, 36, 38, 39, 40, 42, 54, 55, 81, T20, T38 and T40) were identified as directly in conflict with the development plan. The trunks of these trees occur within or on the boundary of the development plan or proposed bicycle path. Conflict trees are illustrated on Figures A.4a, A.4b and A.4c. Figure A.5 illustrates the distinction between the trees that are impacted by the building development (T18) and the trees that are impacted by the proposed bicycle path (T1, T2, T5, T7, T13, T14, T15, T16, T17, T20, T30, T36, T37, T38, T40, and GEMTEC tree 81). The trees impacted by the building footprint and the bicycle path are also detailed and identified in Table C.1 of Appendix C. It has been identified by the City of Ottawa that separate tree removal permits will be required for the development footprint and the bicycle path. The proposed bicycle path will be field fit in Spring 2026 and should consider maintaining the distinctive trees identified in this report, in addition to other healthier, more mature trees.

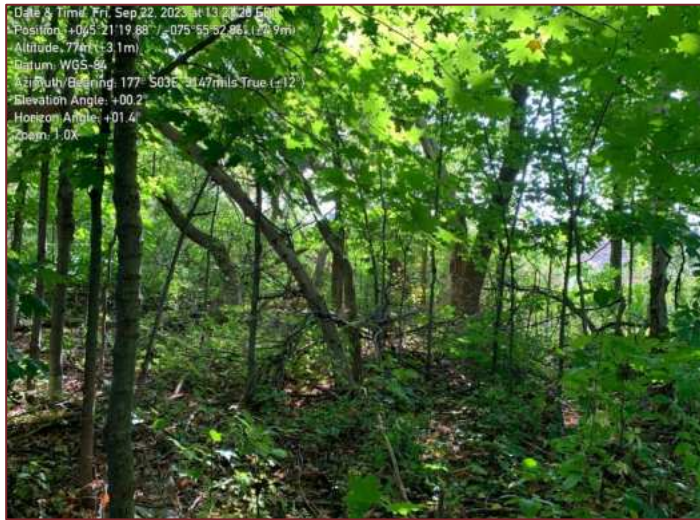
Site Photograph 1 – Wooded Area

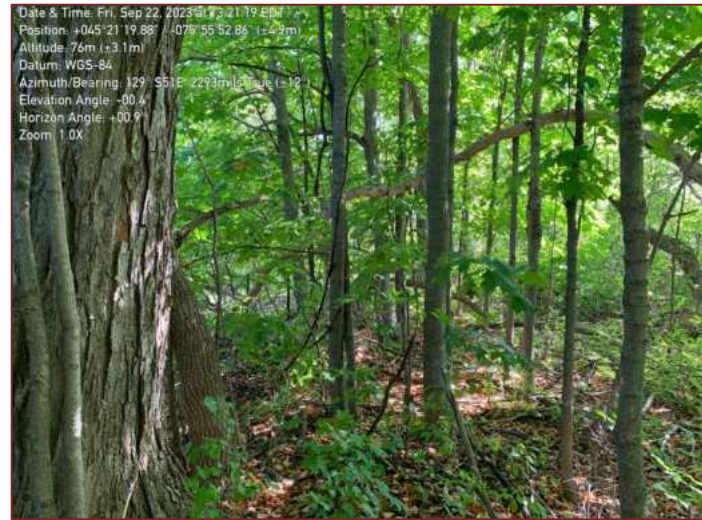
Site Photograph 2 – Wooded Area

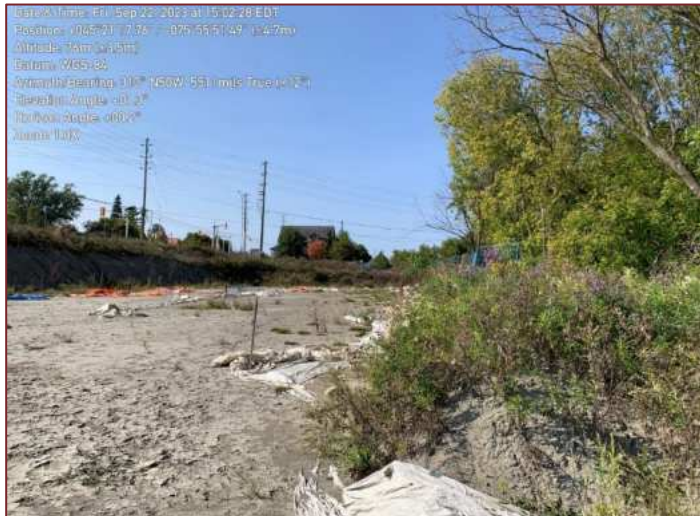
Site Photograph 3 – Disturbed Area and Wooded Area

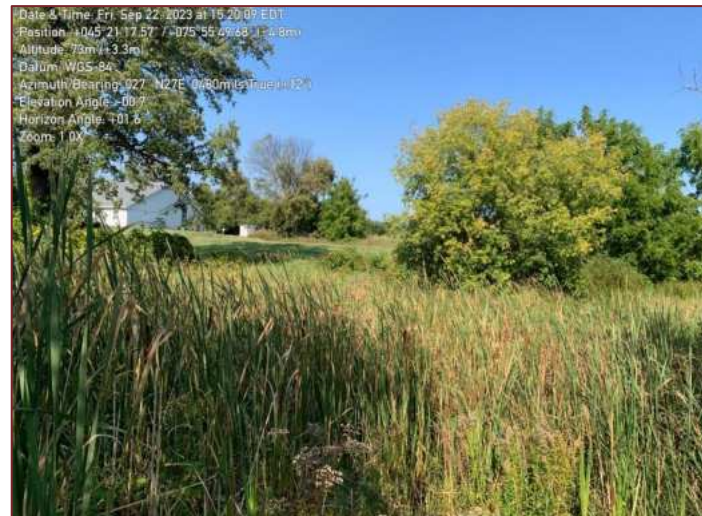
Site Photograph 4 – Shirley's Brook and Riparian Area
