Phase I Environmental Site Assessment

1291 Summerville Avenue
Ottawa, Ontario

Concorde Management Development

Report: PE5083-1

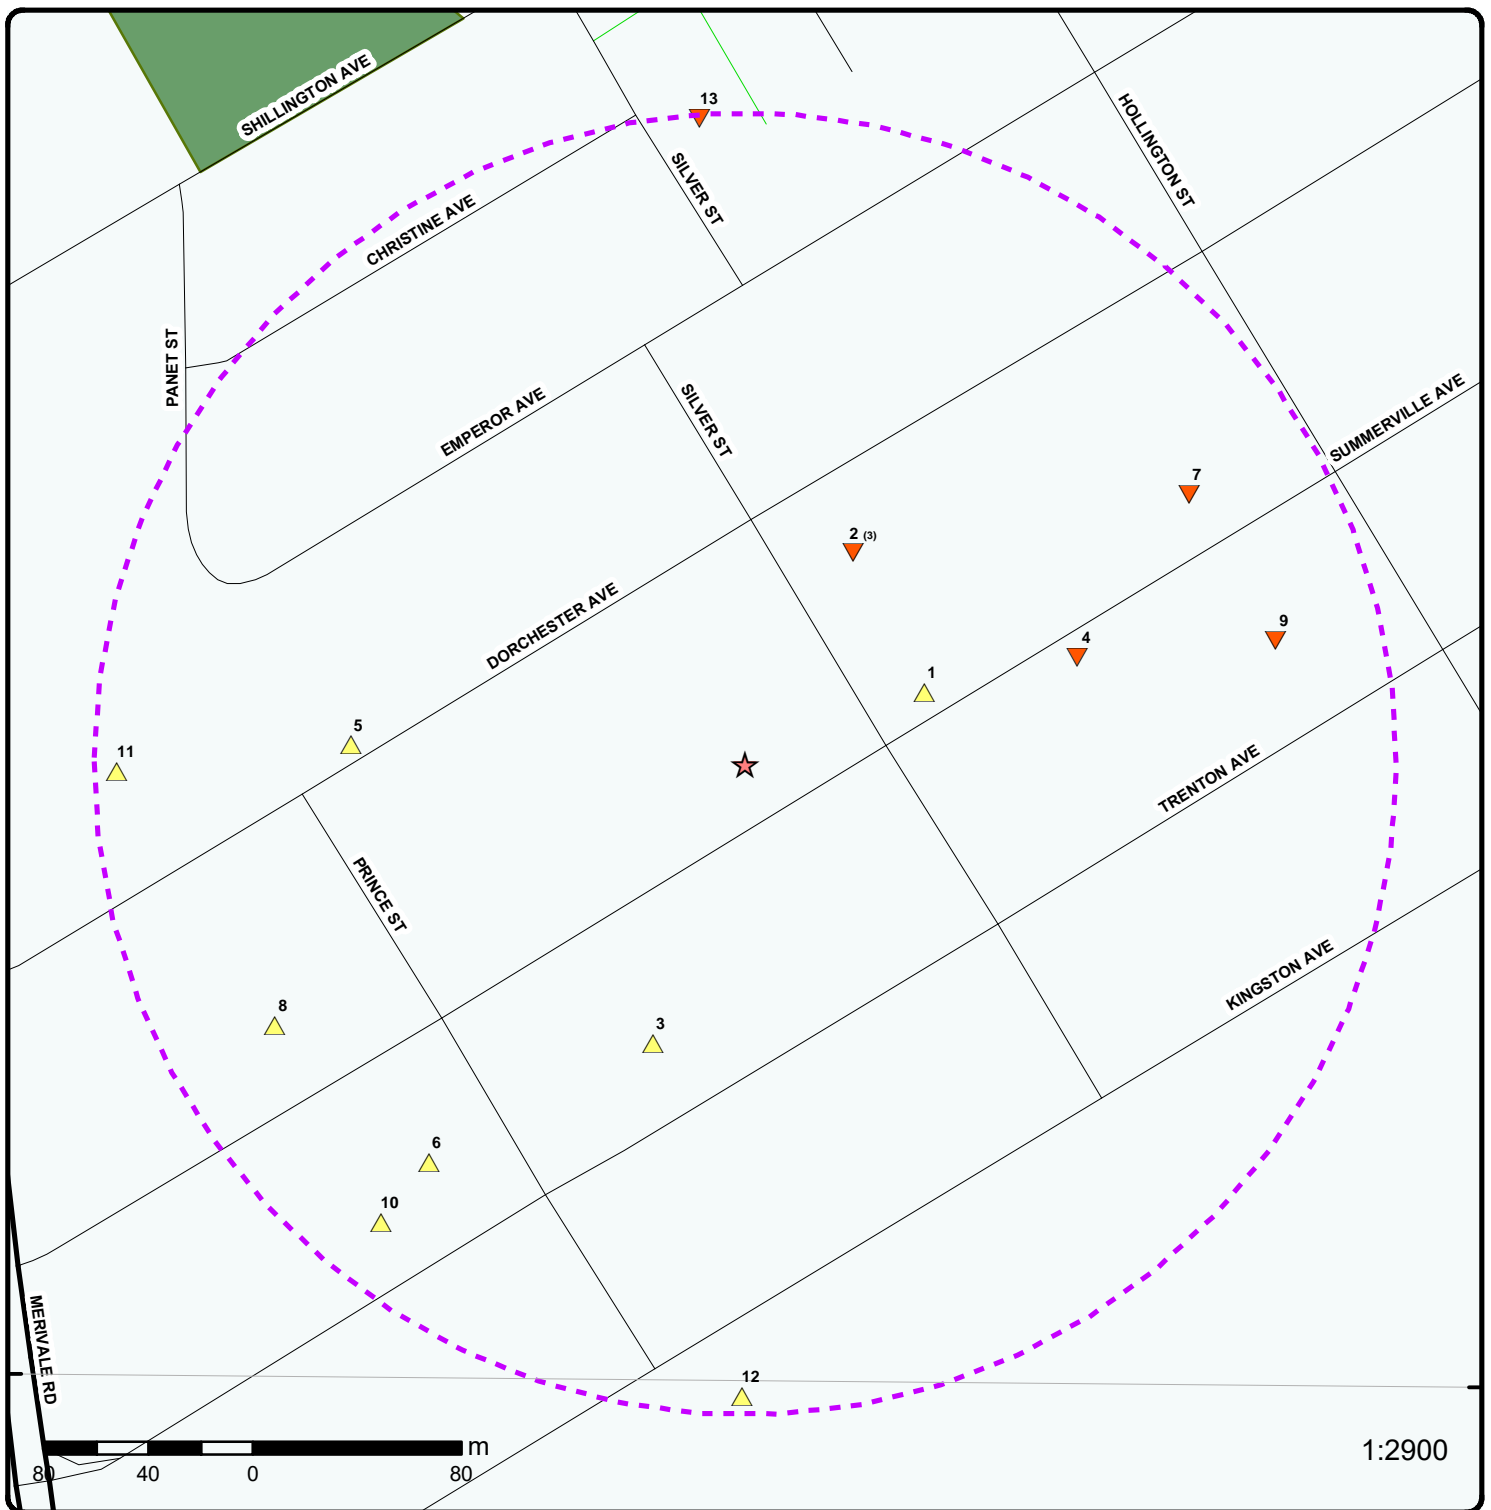
Map : 0.25 Kilometer Radius

<u>Equal/Higher Elevation</u>	<u>Address</u>	<u>Direction</u>	<u>Distance (m)</u>	<u>Map Key</u>
	ON <i>Well ID:</i> 1508490	SW	195.10	<u>6</u>
	lot 33 con 2 ON <i>Well ID:</i> 1510611	W	241.35	<u>11</u>

<u>Lower Elevation</u>	<u>Address</u>	<u>Direction</u>	<u>Distance (m)</u>	<u>Map Key</u>
	ON <i>Well ID:</i> 1508931	E	209.07	<u>9</u>
