Phase I – Environmental Site Assessment

83, 85, 87, 89 and 91 Sweetland Avenue
Ottawa, Ontario

Prepared for Upscale Homes

Report: PE6534-1R
January 30, 2025

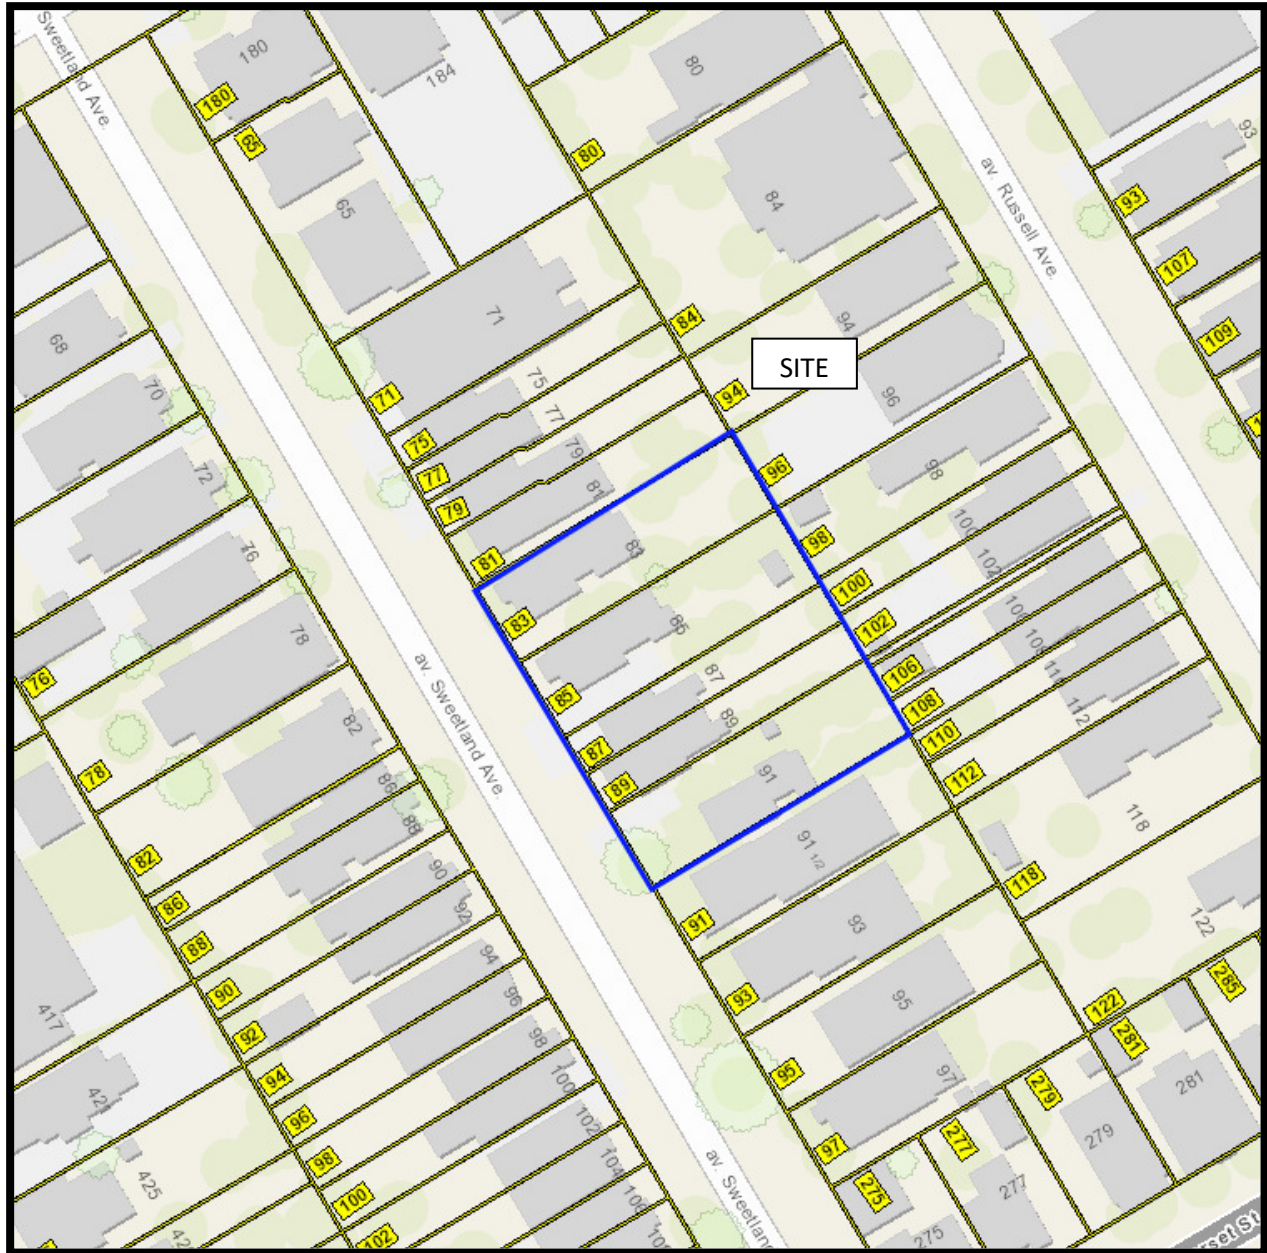
FIGURE 1
KEY PLAN

Location: The Phase I Property is situated on the east side of Sweetland Avenue, approximately 75m north of the intersection of Somerset Street East and Sweetland Avenue, in the City of Ottawa, Ontario. For the purposes of this report, Sweetland Avenue runs in a north-south orientation. Refer to Figure 1 – Key Plan, for the site location context.

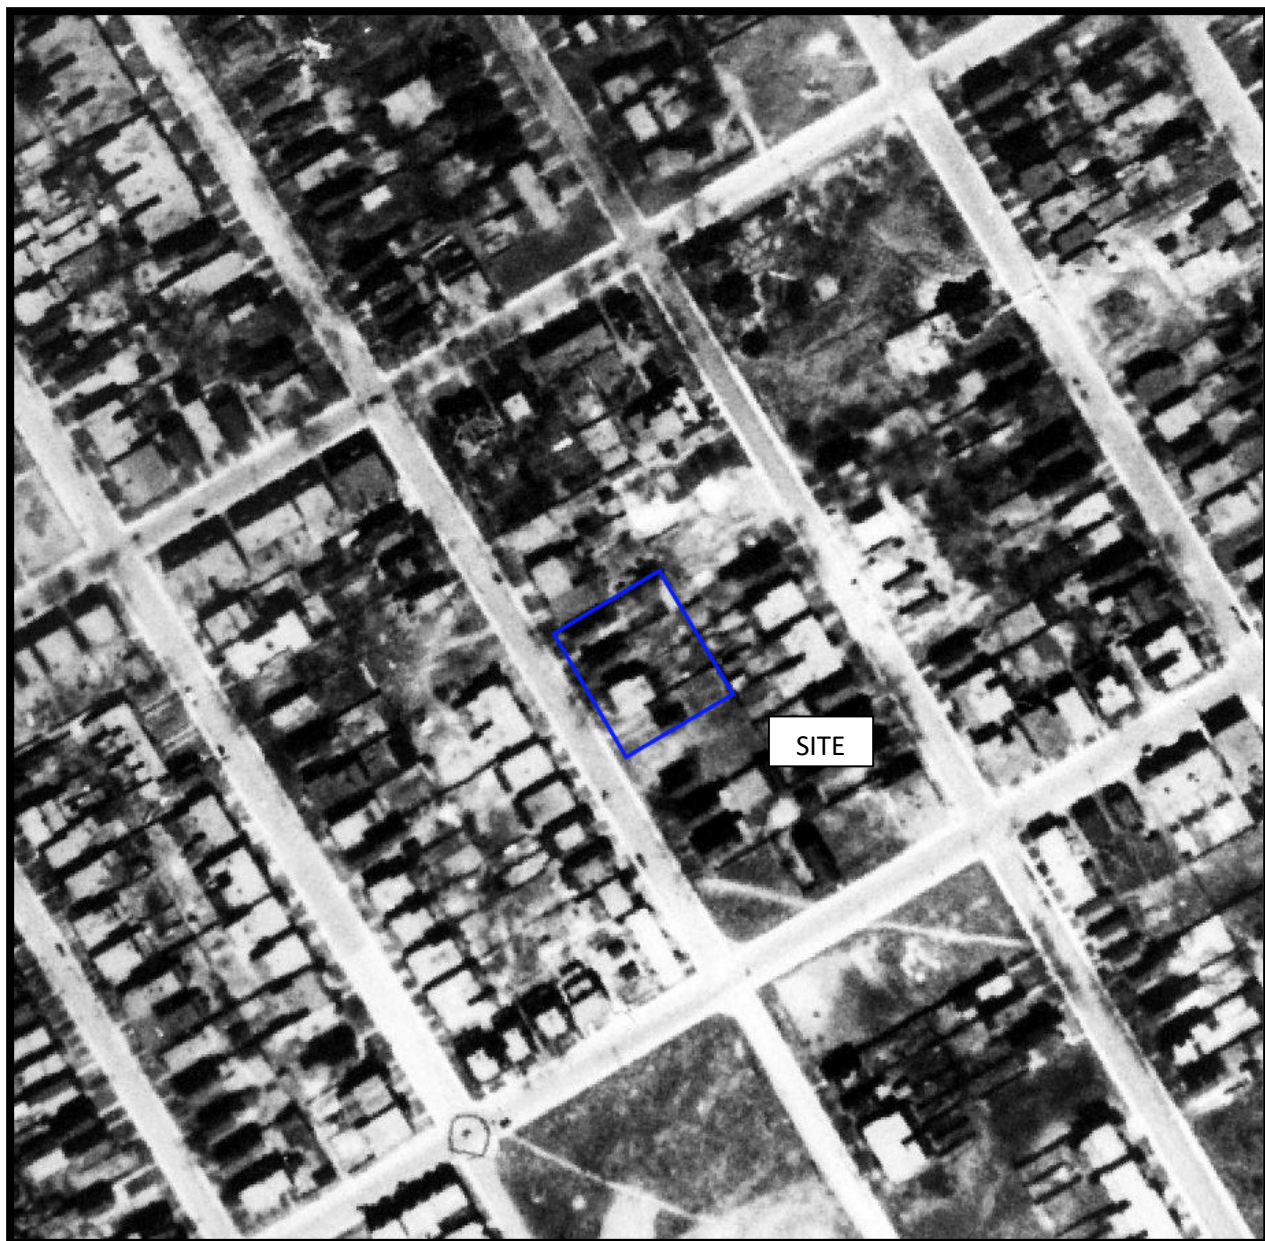
AERIAL PHOTOGRAPH
1928

| 1928 | (Poor Quality, geoOttawa) The Phase I Property is occupied by several single-family dwellings. The neighbouring properties are for the majority occupied by residential dwellings. Some vacant land can be observed to the south along Somerset Street East. |

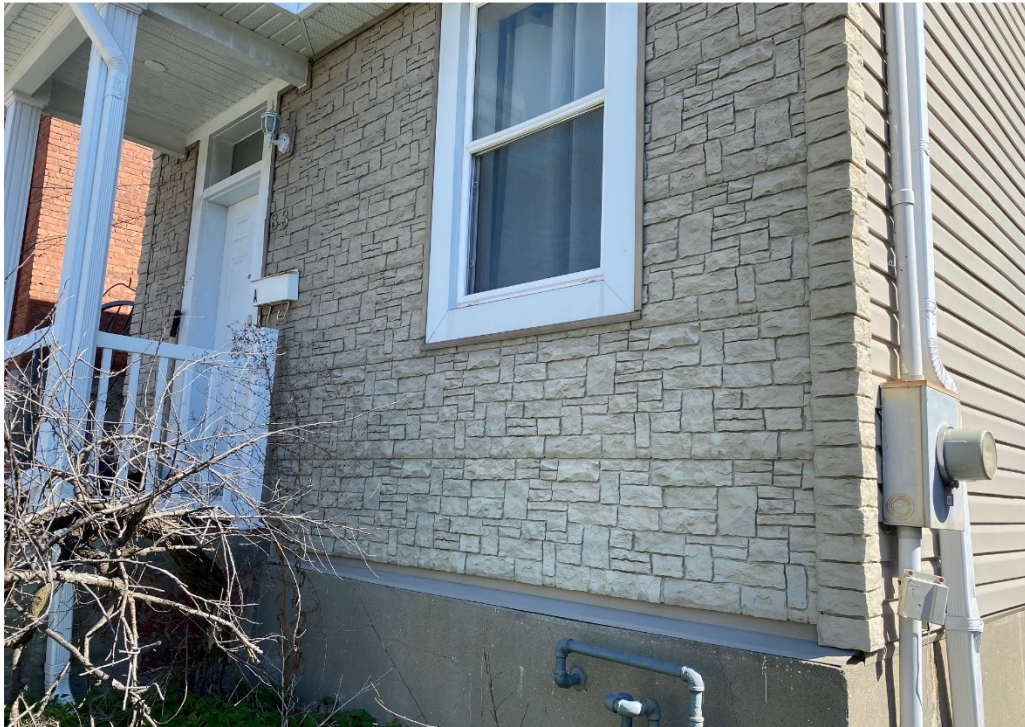
The property addressed 83 is occupied with a two-storey residential dwelling, with one full basement level. Built sometime circa 1912, the residence is constructed with a parging over stone foundation and is finished on the exterior with bricks and vinyl siding along the sides. The building has a sloped, shingled roof. The building is currently heated via a natural gas-fired furnace, located in the basement.

Photograph 1: View looking east at the front of 83 Sweetland Avenue.

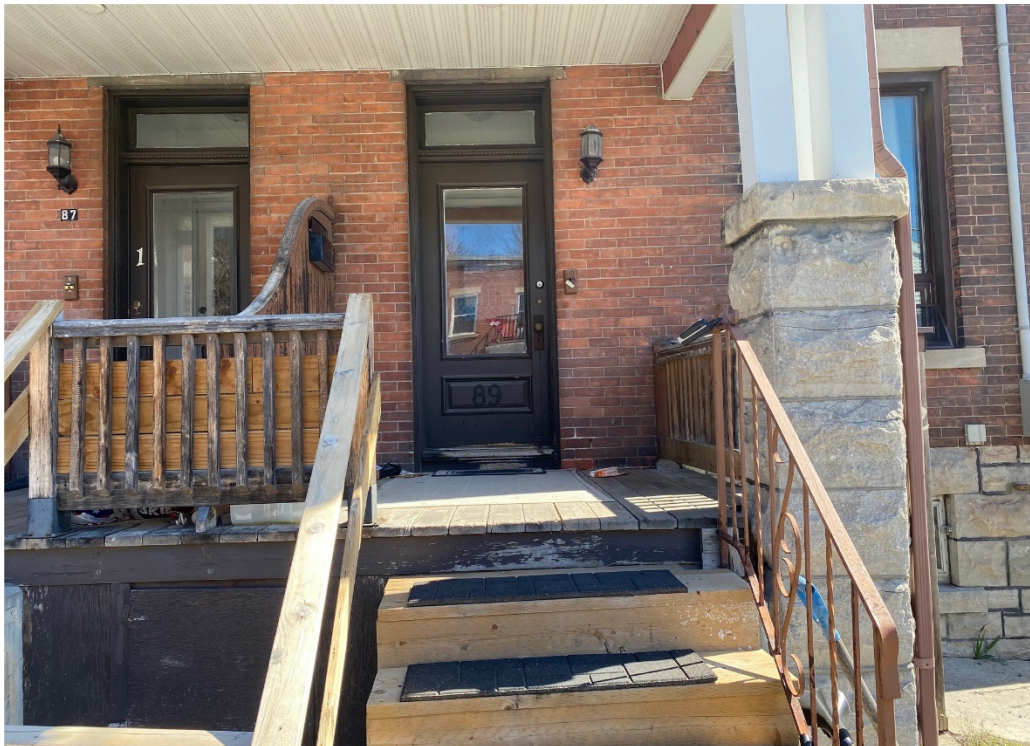
The property addressed 87 Sweetland Avenue is occupied with a two-storey residential dwelling, with one full basement level. Built sometime circa 1912, the residence is constructed with a concrete block foundation and is finished on the exterior with bricks. The building has a flat modified bitumen roof. The building is currently heated via a natural gas-fired furnace, located in the basement.

The property addressed 89 Sweetland Avenue is occupied a two-storey residential dwelling, with one full basement level. Built sometime circa 1912, the residence is constructed with a concrete block foundation and is finished on the exterior with bricks. The building has a flat modified bitumen roof. The building is currently heated via a natural gas-fired furnace, located in the basement.

Photograph 2: View looking east at the front of 87 and 89 Sweetland Avenue.

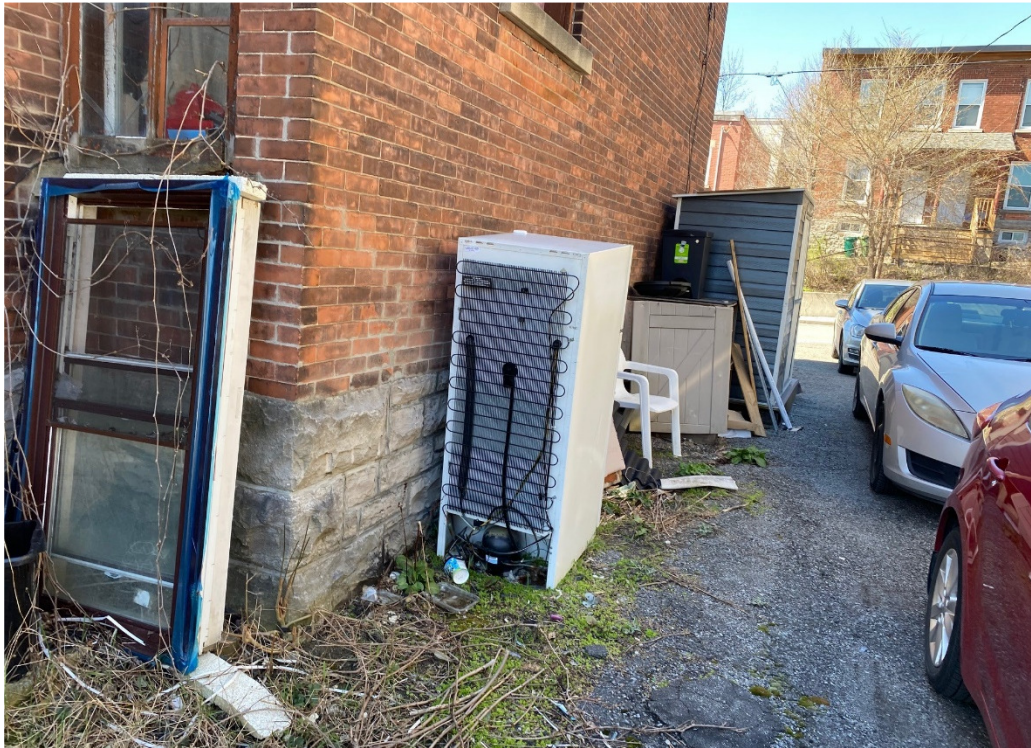
Photograph 3: View looking west, from 87 Sweetland towards Sweetland Avenue.

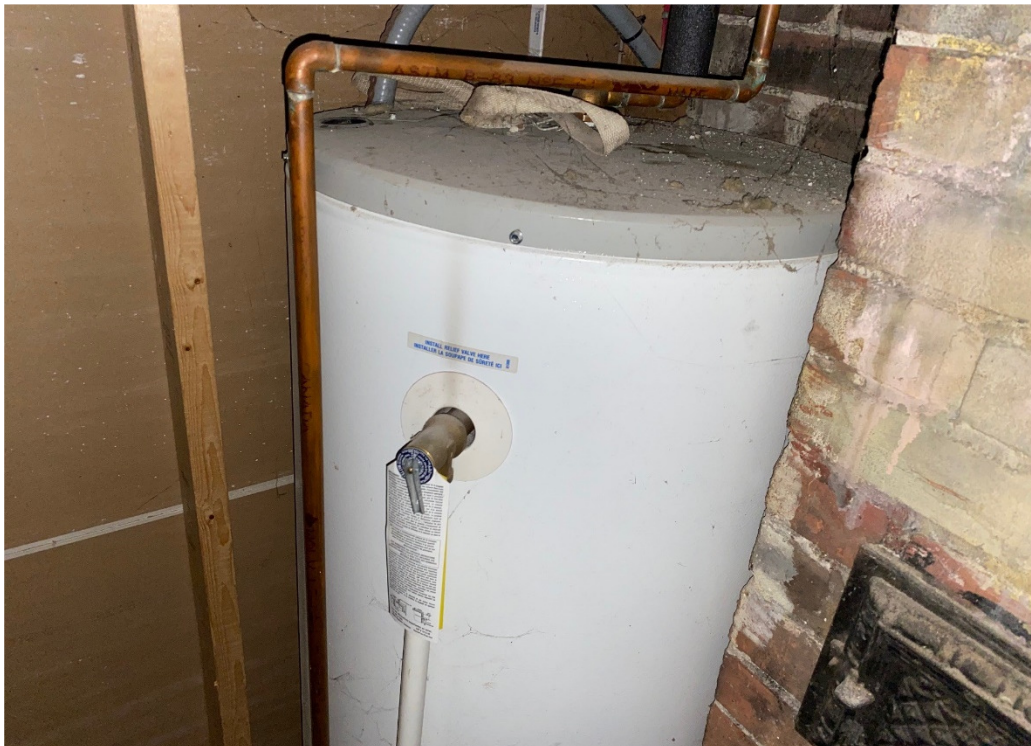
No vent and fill pipes, aboveground fuel storage tanks, or evidence indicating the presence of any underground fuel storage tanks were observed within the subject buildings at the time of the site inspection. A former coal chute access in the basement wall of 87/89 Sweetland Avenue was observed along the western wall of the building. The floor slab at the location of the former coal chute was in good condition and no staining was observed at the time of the site inspection.

Photograph 4: View of the former heating source in 89 Sweetland.

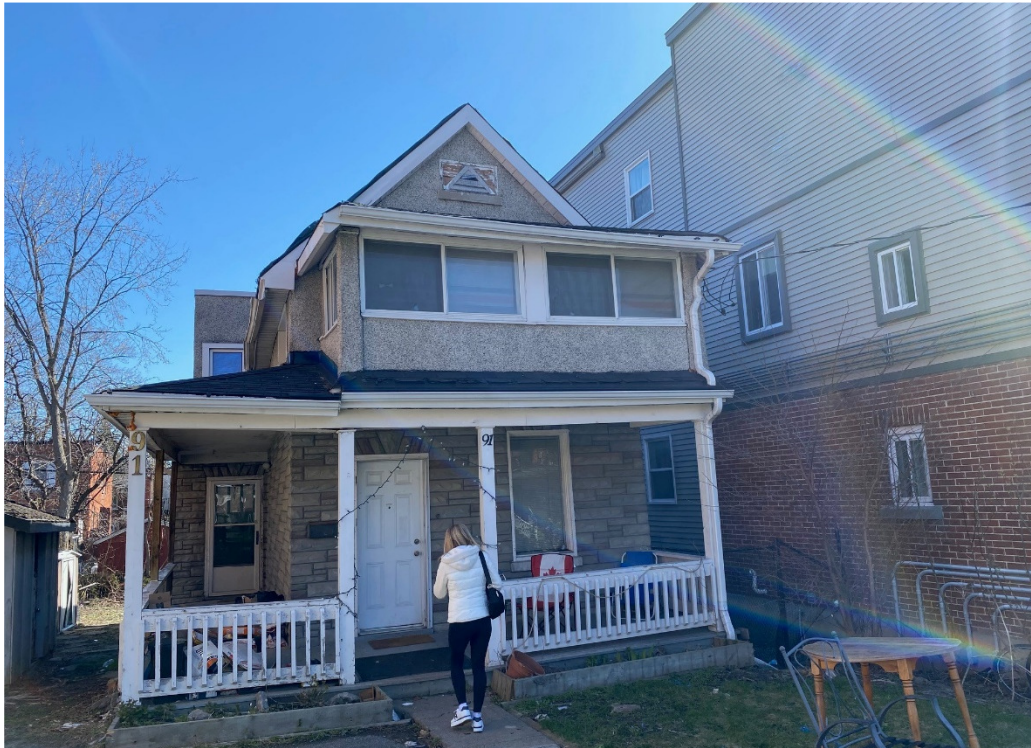
The property addressed 91 Sweetland Avenue is occupied by a two-storey residential dwelling, with one full basement level. Built sometime circa 1912, the residence is constructed with a poured concrete foundation and is finished on the

Photograph 5: View looking east at the front of 91 Sweetland Avenue.

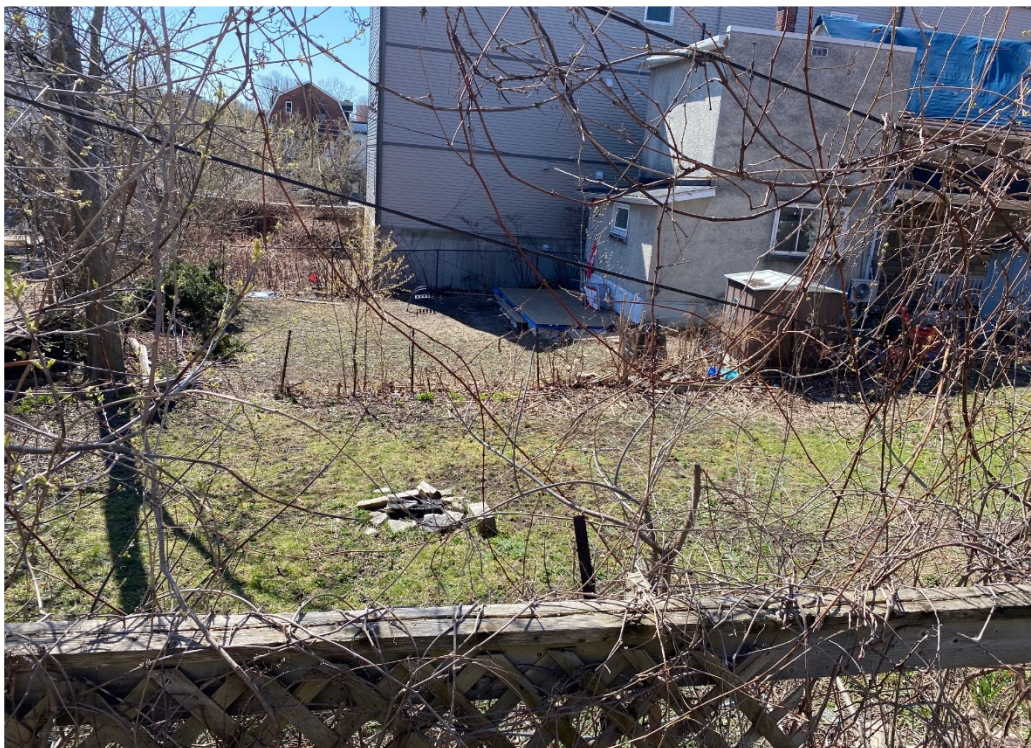
Photograph 6: View looking south 89 Sweetland Avenue, towards the rear of 91 Sweetland Avenue.
