Environmental Impact Study (EIS) & Tree Conservation Report

151-159 Wescar Lane,

Part of Lot 6, Concession 3, City of Ottawa

February 18, 2025

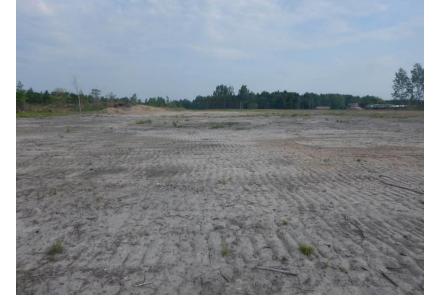
Photo 1: Cleared Area (June 2, 2023).

The entirety of the subject lands have been cleared which also extends into the adjacent lands (cleared prior to the site visit). Remnant patches of grasses, sedges, clovers, horsetail and bladder campion were present. Within the northern portion of the subject lands the area was cleared in a previous year and revegetation has commenced. This area had approximately 20% woody vegetation (1-2m tall) represented by trembling aspen and balsam poplar. Ground cover (90%) consisted of white sweet-clover, reed canary grass and common dandelion. Additionally, there is a small windrow running along the entirety of the subject lands western border. The windrow consisted of 30-50% woody vegetation (1-3m tall) dominated by trembling aspen followed by prickly-ash, wild red raspberry, hawthorn, American elm, and white spruce. Ground cover (60-90%) was dominated by grasses followed by grass-leaved goldenrod, sedges and wild carrot. Piles of logs were noted within the adjacent lands.

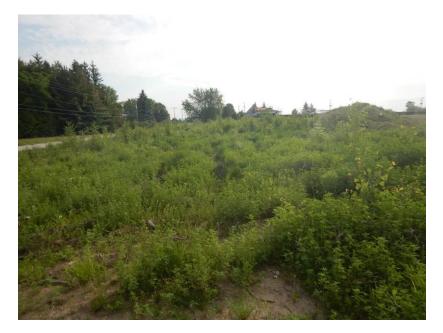
Photo 2: Northern Cleared Area (June 2, 2023).

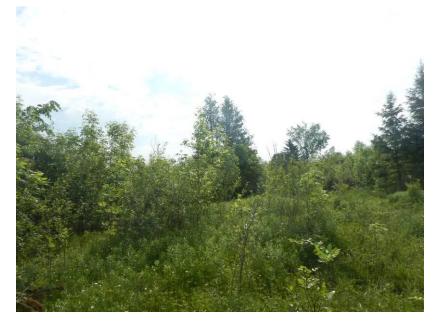
Photo 3: Cultural Thicket (June 2, 2023).

This community was present within the southern adjacent lands and was highly disturbed, evidence of cutting, previous farm activity and beaver dam removal. Woody vegetation provided 60-90% cover (1-3m tall) and was dominated by white ash followed by prickly-ash, tartarian honeysuckle, common buckthorn and glossy buckthorn. The occasional white spruce (5m tall) was dispersed throughout this community. Ground cover (100% cover) consisted of grasses, Canada anemone and goldenrods.

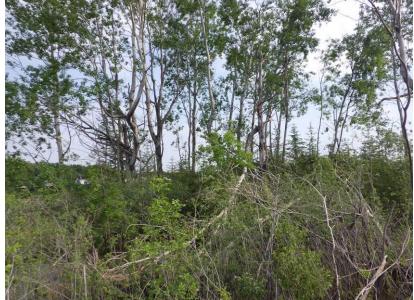
Photo 4: Fresh-Moist Poplar Deciduous Forest (June 2, 2023).

This community is present within the northern adjacent lands between the current subject lands and the commercial development. This area consisted of a small clump of deciduous tree with an average tree diameter of 25cm. The canopy was the dominant layer. The canopy (12-14m tall; 80% cover) was dominated exclusively by trembling aspen. There was no sub-canopy. The understory (3-6m tall; 60-80% cover) consisted of common buckthorn, white spruce, trembling aspen and white ash. Ground cover (100% cover) consisted of grasses. A small portion within the western edge contained standing water (common buckthorn provided 60% cover in this area), this area was isolated and did not represent fish habitat. Frogs were noted within this area.

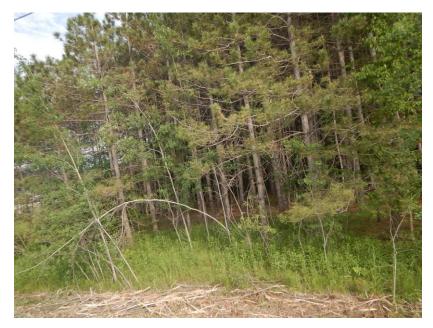
Photo 5: Coniferous Plantation (June 2, 2023).

Within the northern adjacent lands north of Canamore Road there were coniferous plantations consisting of white pine and white spruce.

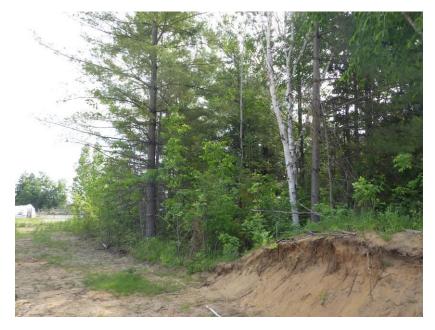
Photo 6: Windrow (June 2, 2023).

A small deciduous windrow was present within the south eastern subject lands/adjacent lands. The average tree diameter of 20cm. The canopy was the dominant layer. The canopy (10-12m tall; 70-80% cover) consisted of white pine, white birch, American elm, Freeman's maple and one butternut. There was no sub-canopy. The understory (2-4m tall; 50-70% cover) consisted of white ash, nannyberry, white spruce and American elm. Ground cover (70-90% cover) consisted of grasses, common dandelion, smooth bedstraw, field horsetail, and goldenrods.

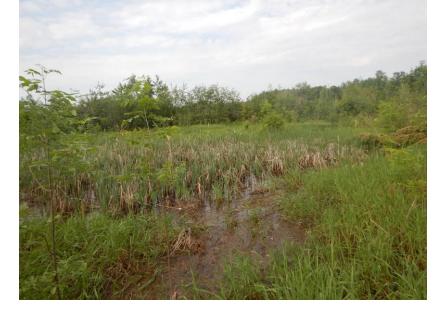
Photo 7: Isolated Pond / Narrow-leaved Emergent Swamp (June 2, 2023).

This community is present in the western adjacent lands. This small narrow-leaved cattail pond is isolated (not hydraulically connected to anything). This community consists entirely of robust emergent (narrowleaf cattail) and is bordered by a 1m buffer of speckled alder, tartarian honeysuckle, American elm, and green ash. Water was present. This area did not contain fish habitat and unlikely to be used by turtles due to size. Frogs were noted.

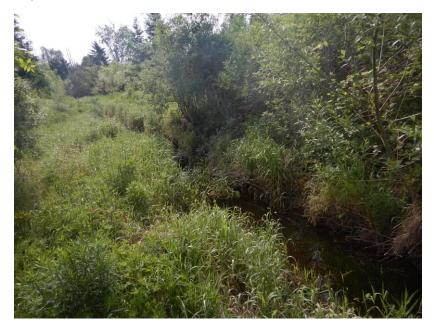
Photo 8: Tributaries to Huntley Creek (June 2, 2023).

A tributary to Huntley Creek was present within the western and southern adjacent lands, this feature represented fish habitat. Bank vegetation was represented by prickly-ash, common buckthorn, speckled alder, tartarian honeysuckle and willows.

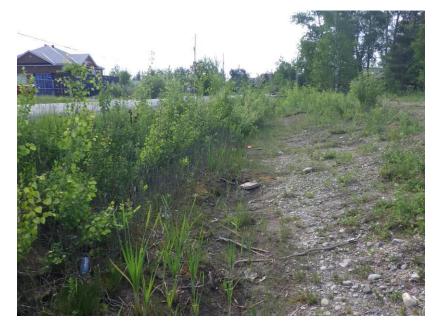
Photo 9: Roadside Ditches (June 2, 2023).

Roadside ditches were present along Westcar Lane and Cavanmore Road. During all field visits these ditches were dry. Channel width was 2m, some signs of erosion were noted. Vegetation was limited (due to clearing activities) and consisted of smooth bedstraw, grasses, water horsetail, purple loosestrife, trembling aspen and willows. These roadside ditches did not represent fish habitat.

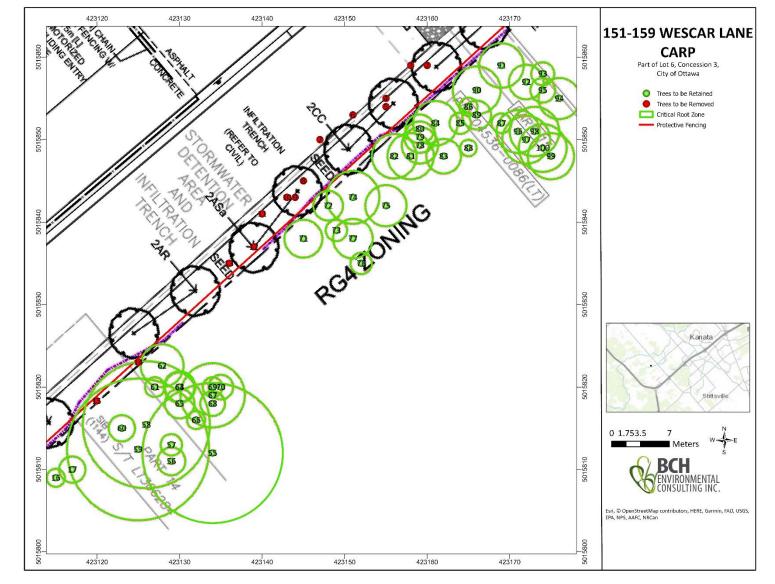
FIGURE 4: TREE CONSERVATION – ZOOMED IN (SOUTH EAST)
