**Roger Grenon
Greely Car Wash**

**Phase I Environmental Site Assessment
1386 Greely Lane
Greely, Ontario**

ER1015

January 24, 2023

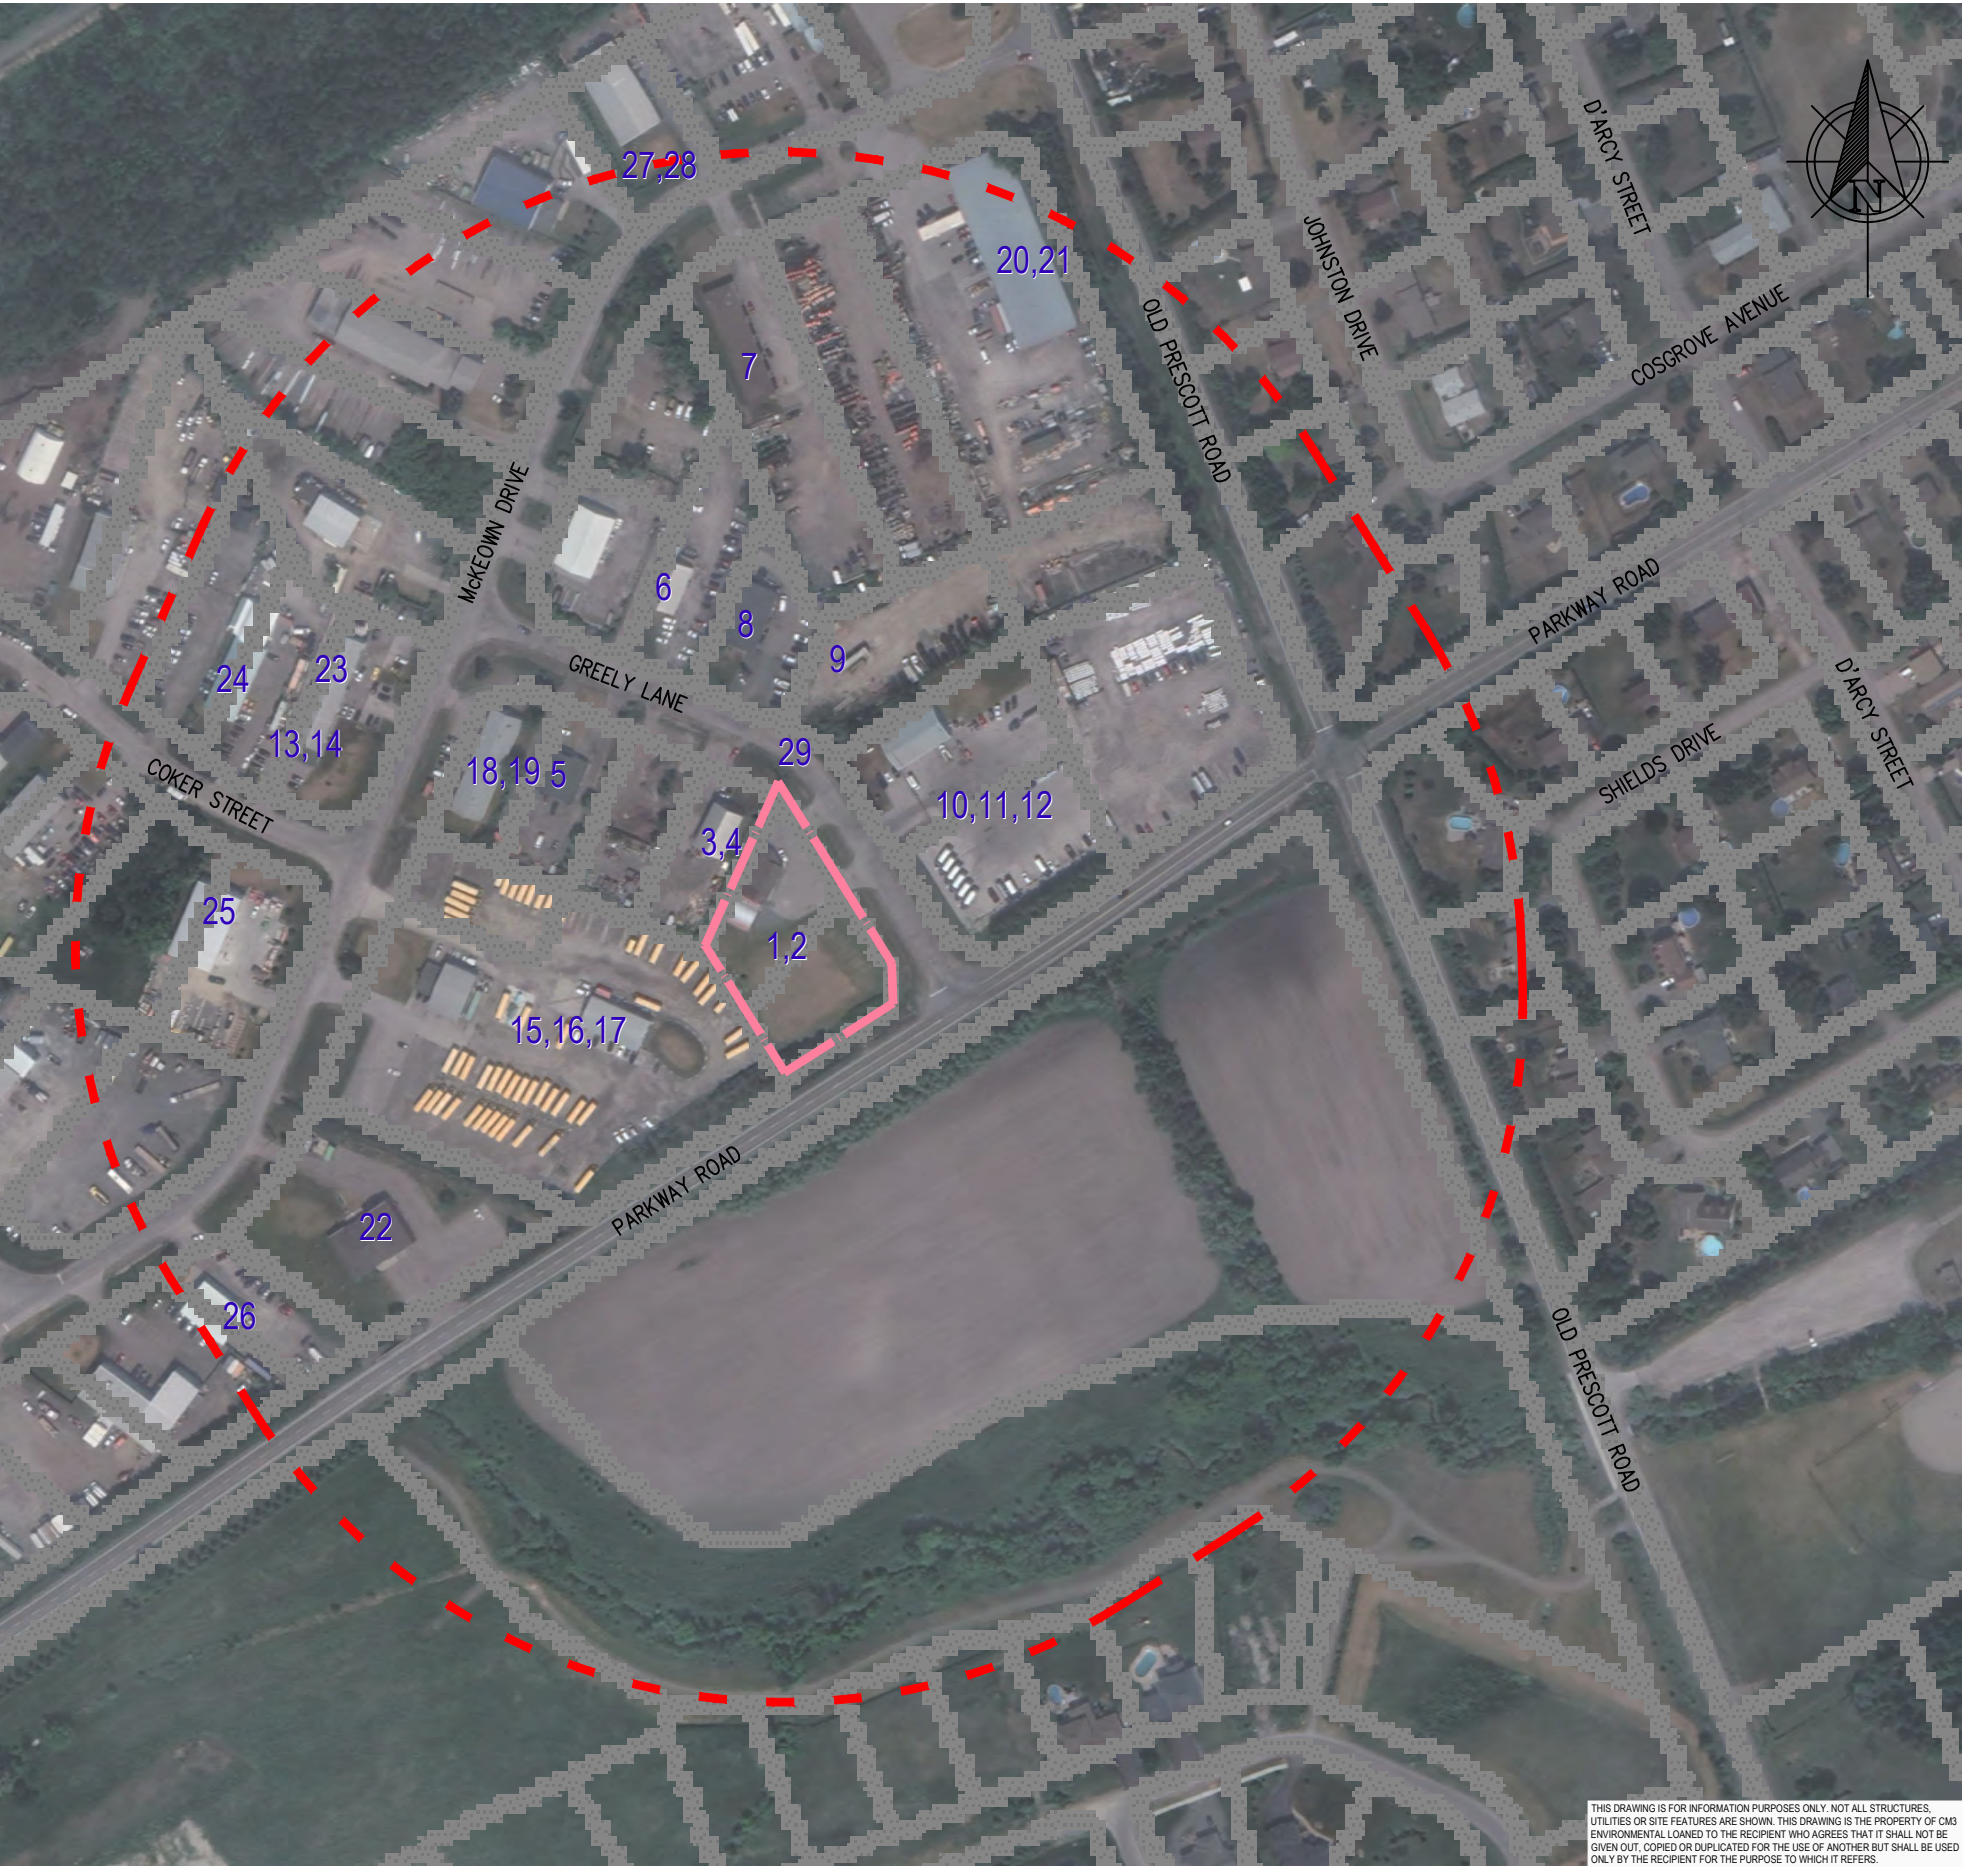
- 28
- 6933 MCKEOWN DRIVE (NOT LISTED): ONTARIO IRON WORKS LTD. GENERATOR OF VARIOUS PETROLEUM HYDROCARBON WASTES, PAINT RESIDUES, ETC.
- 29
- 1375, 1386 GREELY LANE: OFF-SITE TO THE EAST (ITEM 55): TRANSFORMER USE. POLE MOUNTED TRANSFORMERS

- 30
- PHASE I STUDY AREA (ITEM 30): IMPORTATION OF FILL MATERIALS DURING DEVELOPMENT (NOT SHOWN)

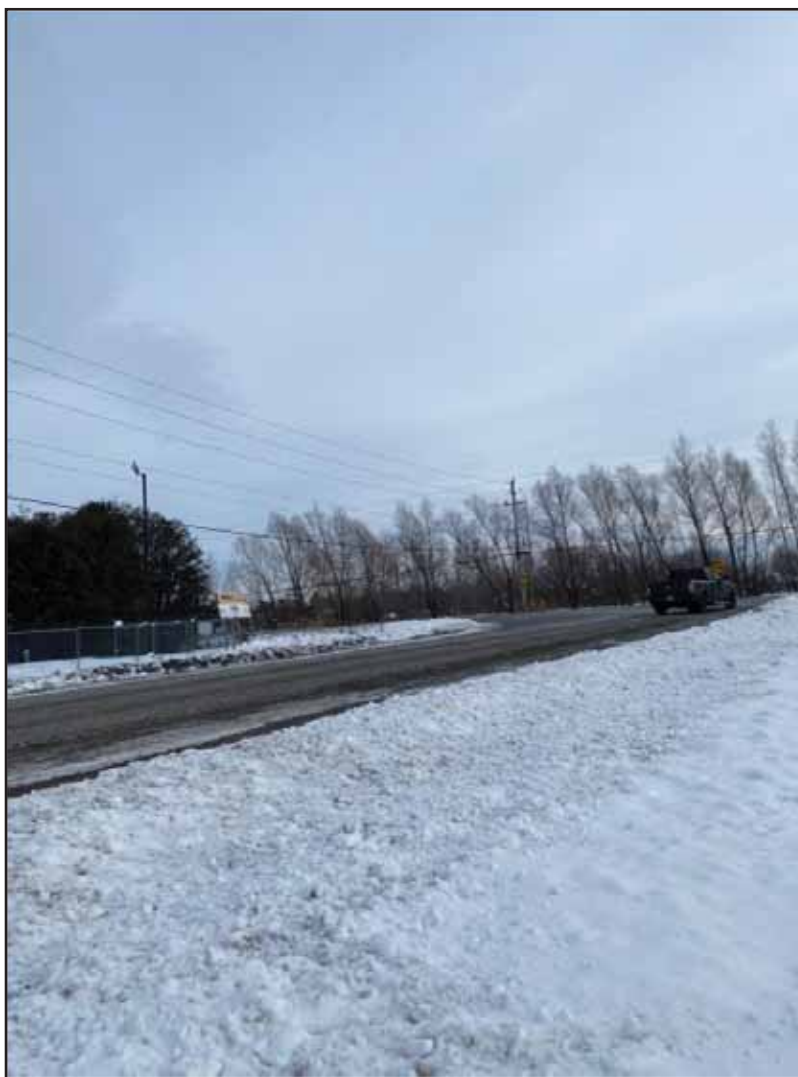
Photograph 2: Looking east from the subject property at the intersection of Greely Lane and Parkway Road, the snow-covered drainage ditch is in view.

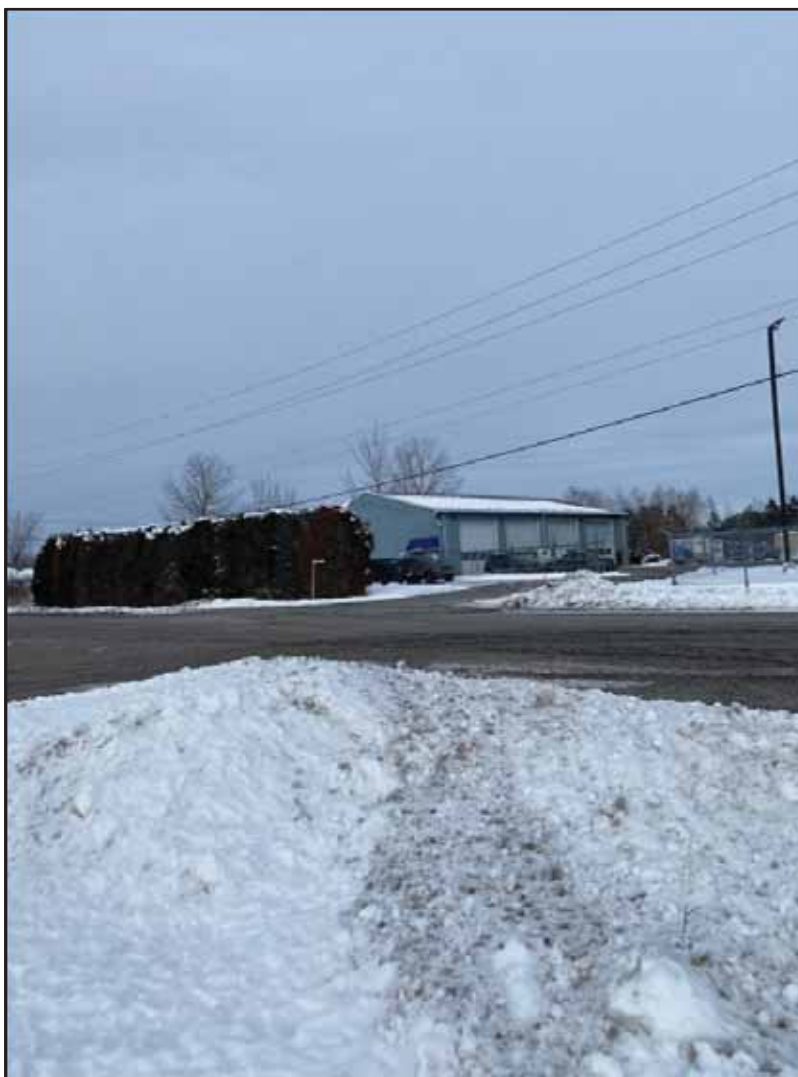
CM3 observed above ground fuel storage tanks (ASTs) at the properties to the east and west of the subject property at 1387 Greely Lane and 6906 McKeown Drive. Equipment and/or vehicle storage was observed on the properties immediately adjacent to the north and west of the subject property.

Photograph 3: Looking north at the adjacent property used for a commercial fuel delivery fleet at 1387 Greely Lane.

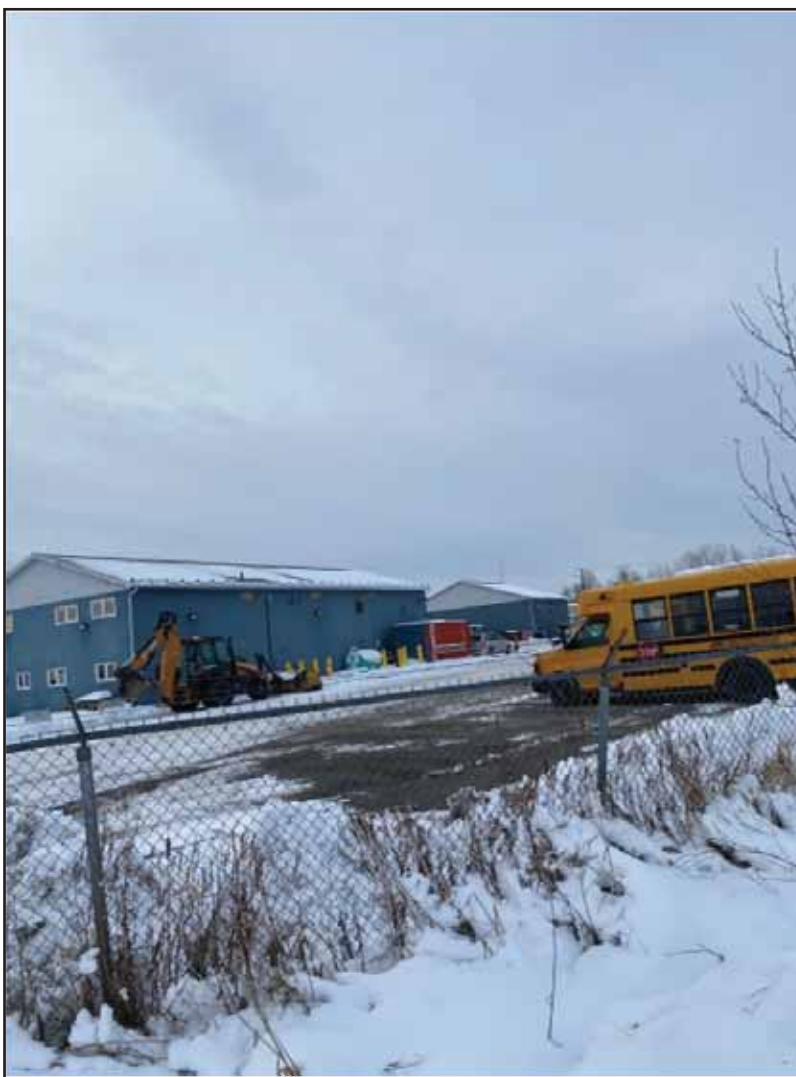
Photograph 4: Looking south-west at the adjacent property used for a commercial bus fleet.

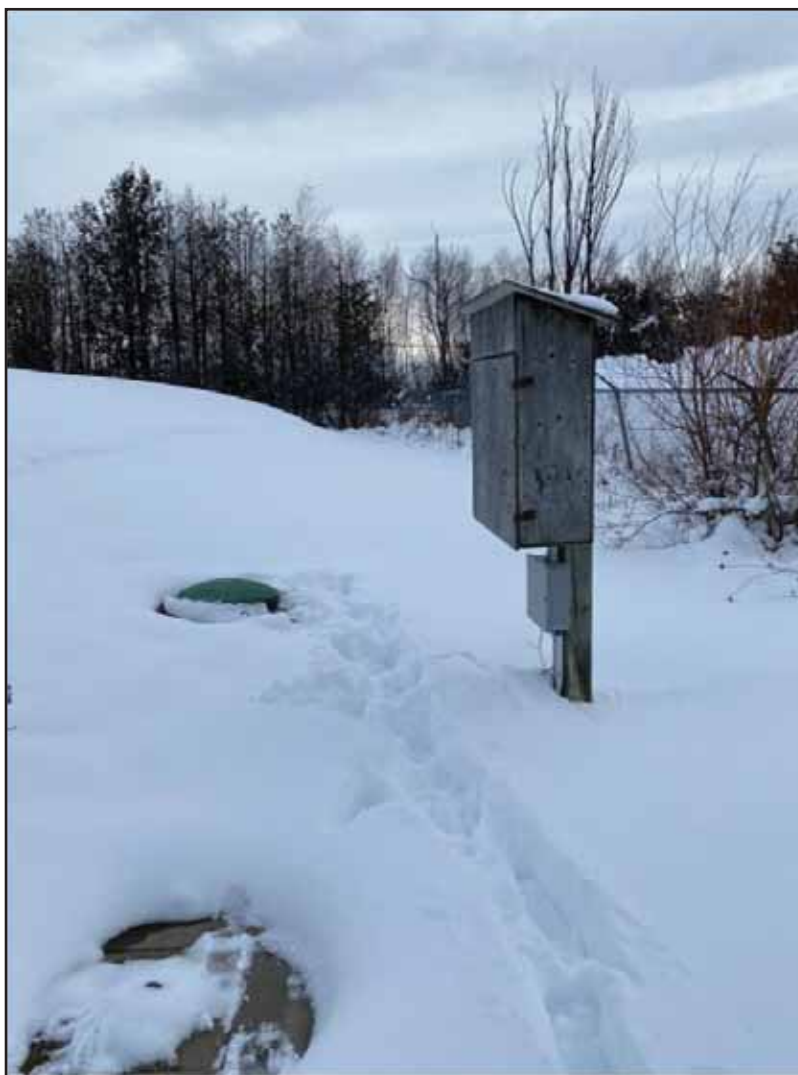
Photograph 5: View of access hatches and electrical systems associated with the septic system located on the south property boundary.

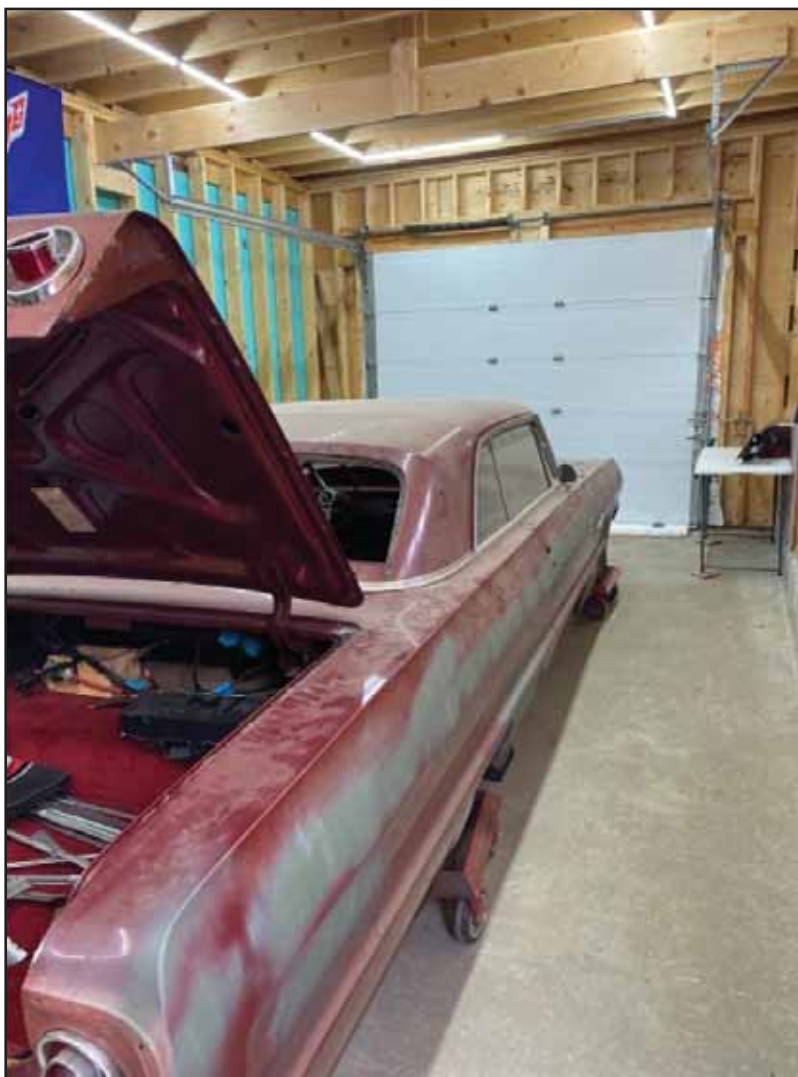
Photograph 8: Interior view of the addition on the car wash building. A vehicle is pictured. A channel drain is located under the vehicle.

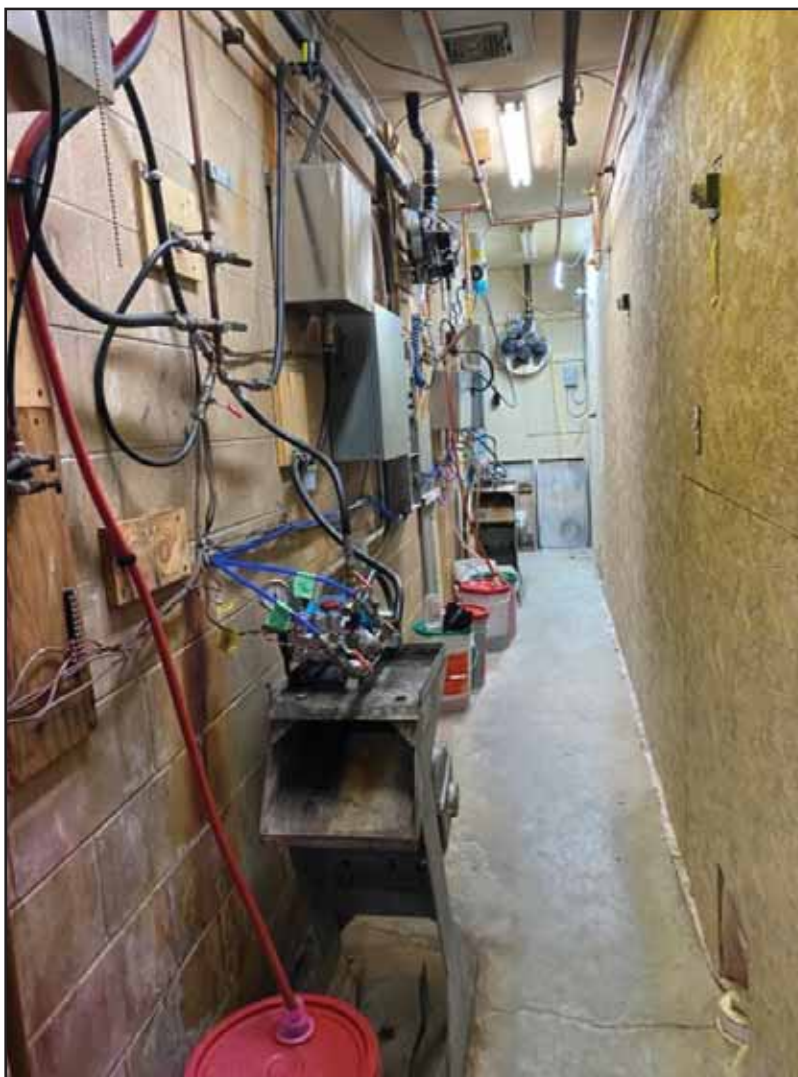
Photograph 10: Interior view of the car wash. Mechanical systems for the car wash are pictured.

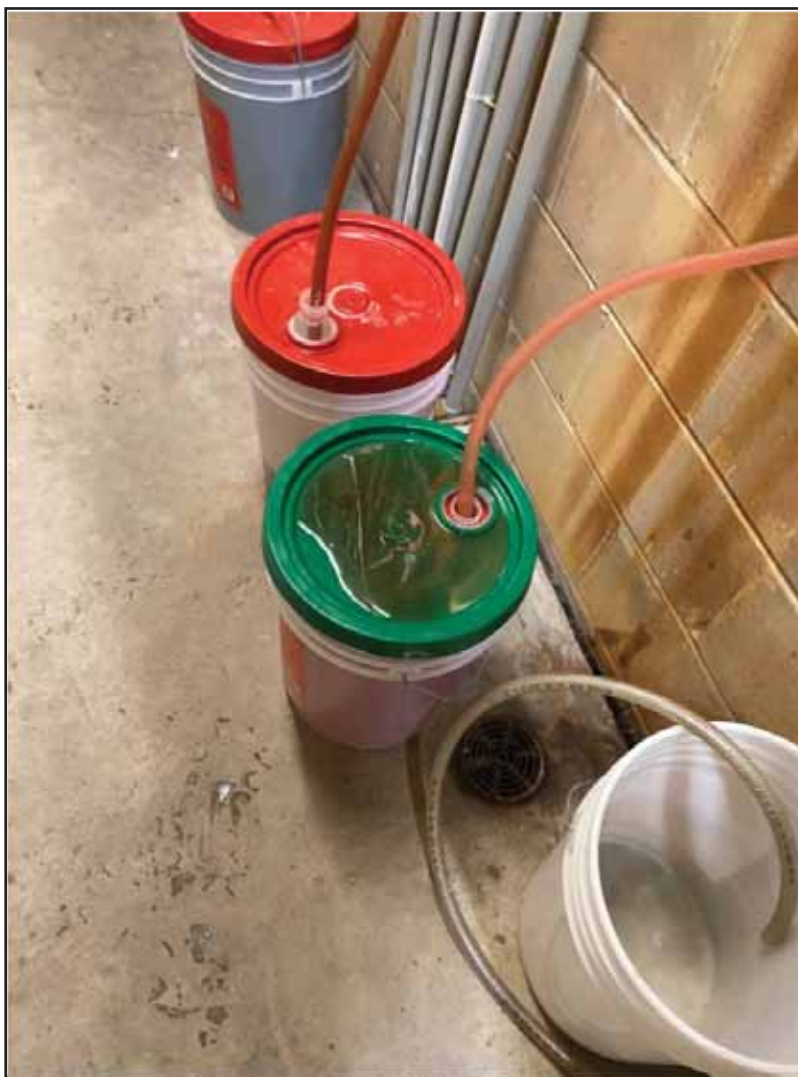
Floor drains were observed in the car wash bays. It was reported that the floor drains are used to collect the wash water and discharge to the septic holding tank southwest of the building. Two additional floor drains were observed on the north interior side of the car wash. Minor staining relating to mud from vehicles and cleaning agents were observed around the floor drains.

Photograph 11: View of concentrated cleaning liquids for the car wash. A floor drain is pictured.

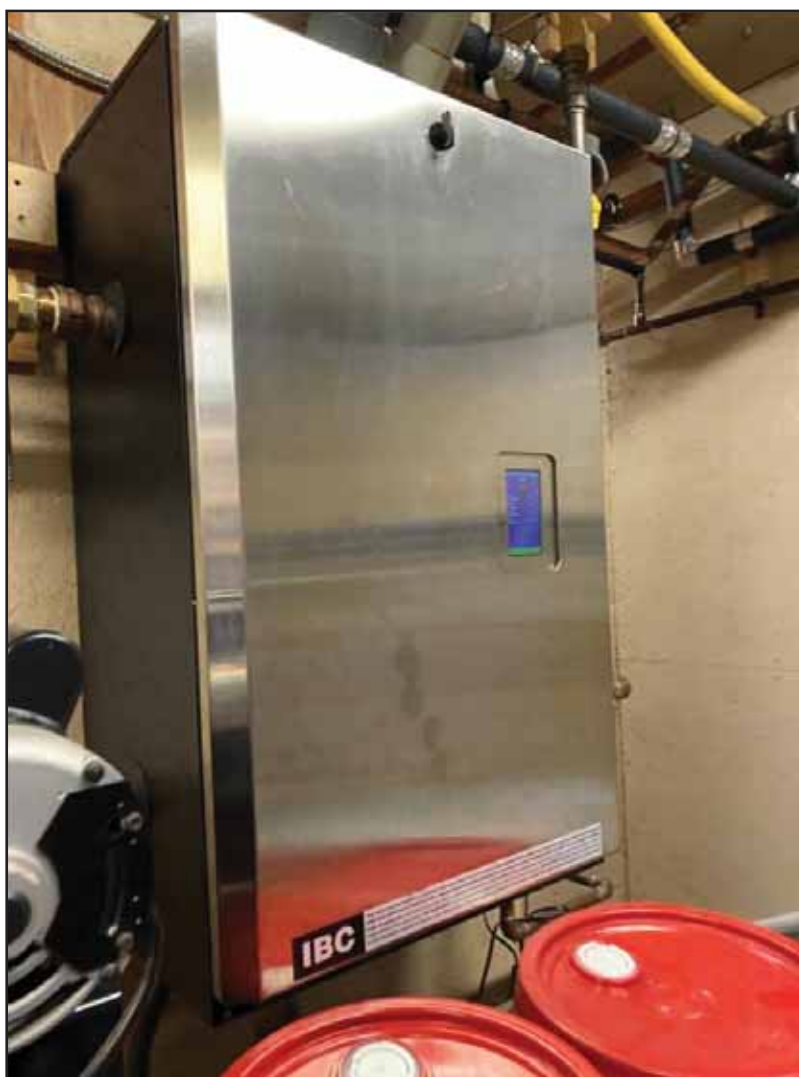
The car wash building is heated by a natural gas boiler and in-floor radiant heating. The addition and vehicle storage building were not heated. The on-site buildings were not air conditioned.

Photograph 13: View of car wash heating system.

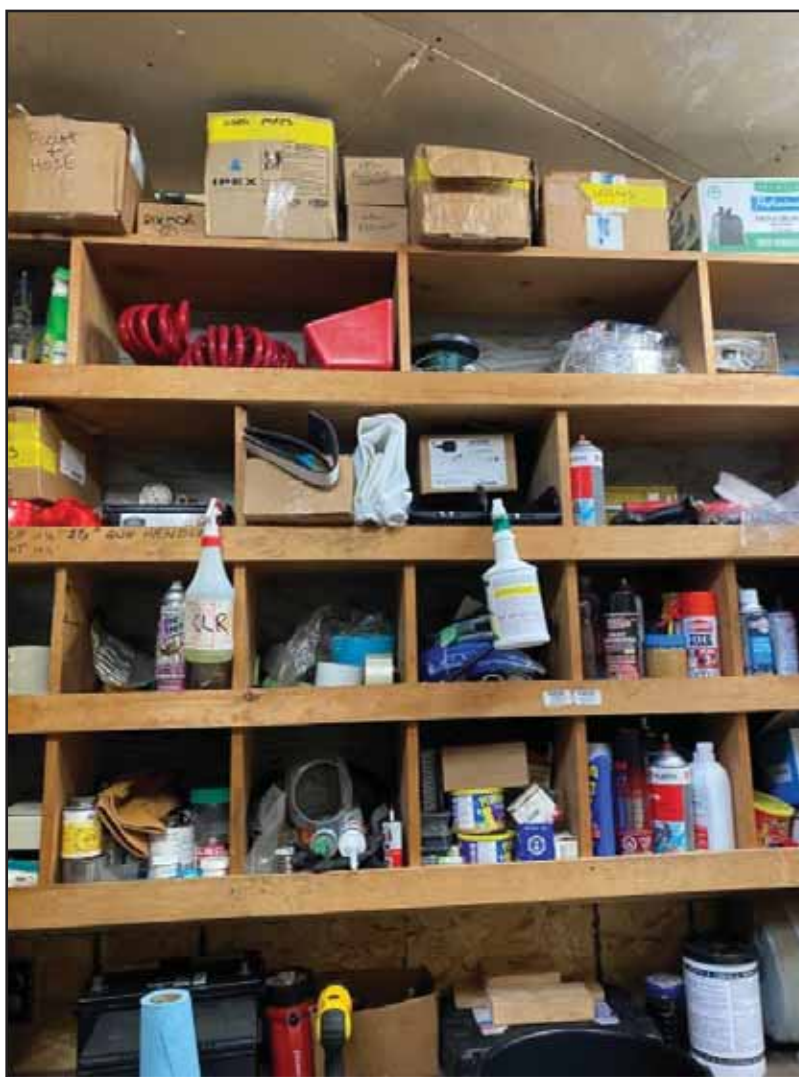
All containers observed on-site were labeled. Containers of unidentified substances were not observed at the subject property.

Photograph 15: View of various cleaning supplies, paint, oils, lubricants, etc.

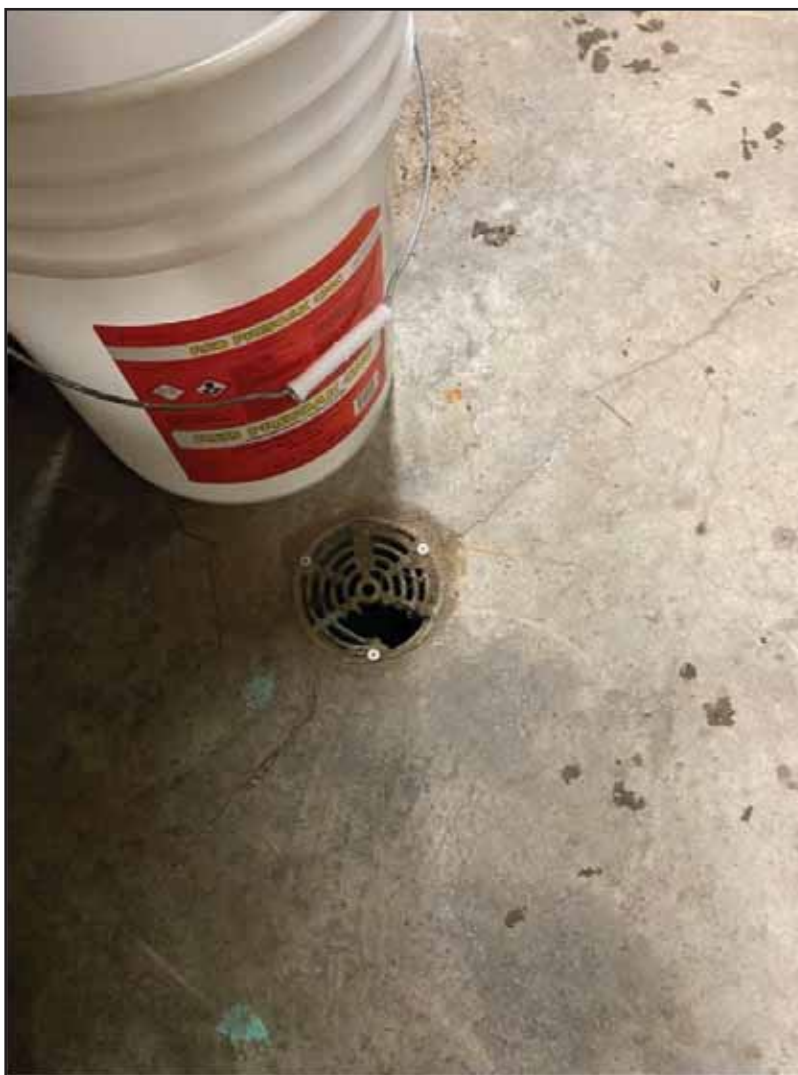
Photograph 16: View of floor drain near the entrance to the car wash.
