Phase One Environmental Site Assessment

506 Kent Street
Ottawa, Ontario

Prepared for:
11034936 Canada Inc.

LOP25-038A

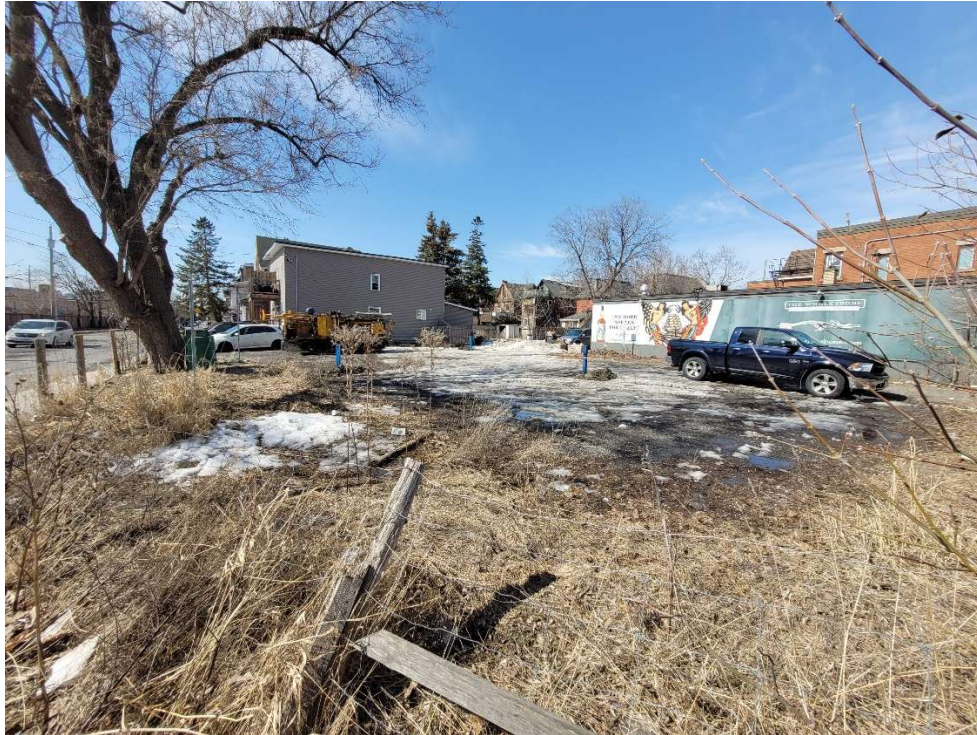
Photograph 1: View of the of the south portion of the Phase One Property looking west. View shows monitoring wells from recent (2025) Phase Two ESA.

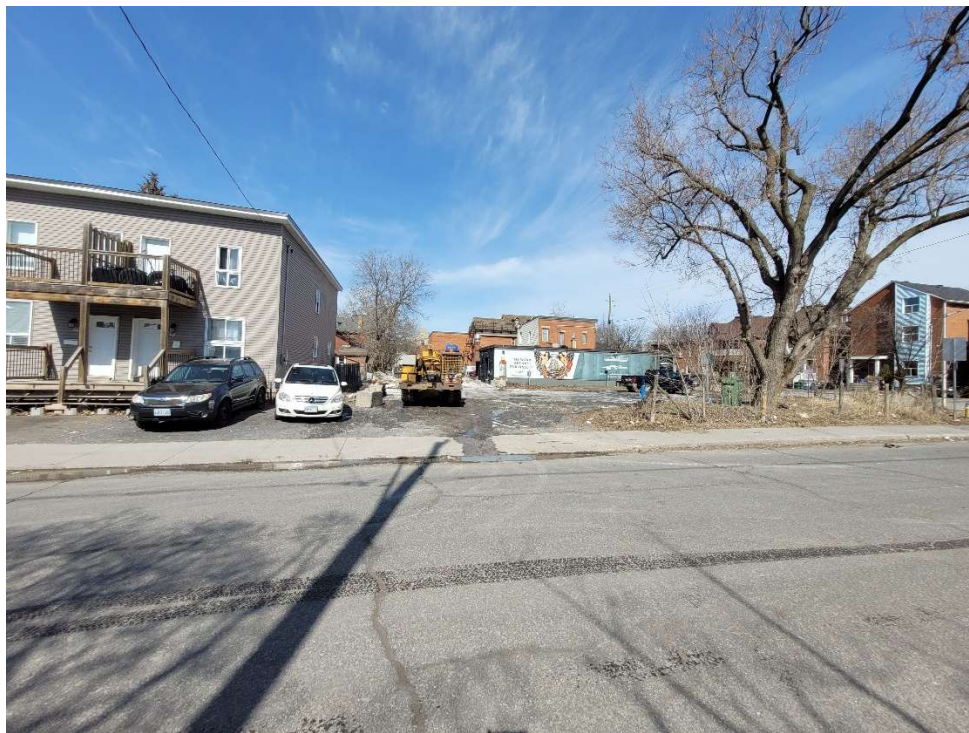
Photograph 2: View of the of the west portion of the Phase One Property looking north. View shows drill rig and monitoring wells from recent (2025) Phase Two ESA and access to the Site from Arlington Avenue to the south.

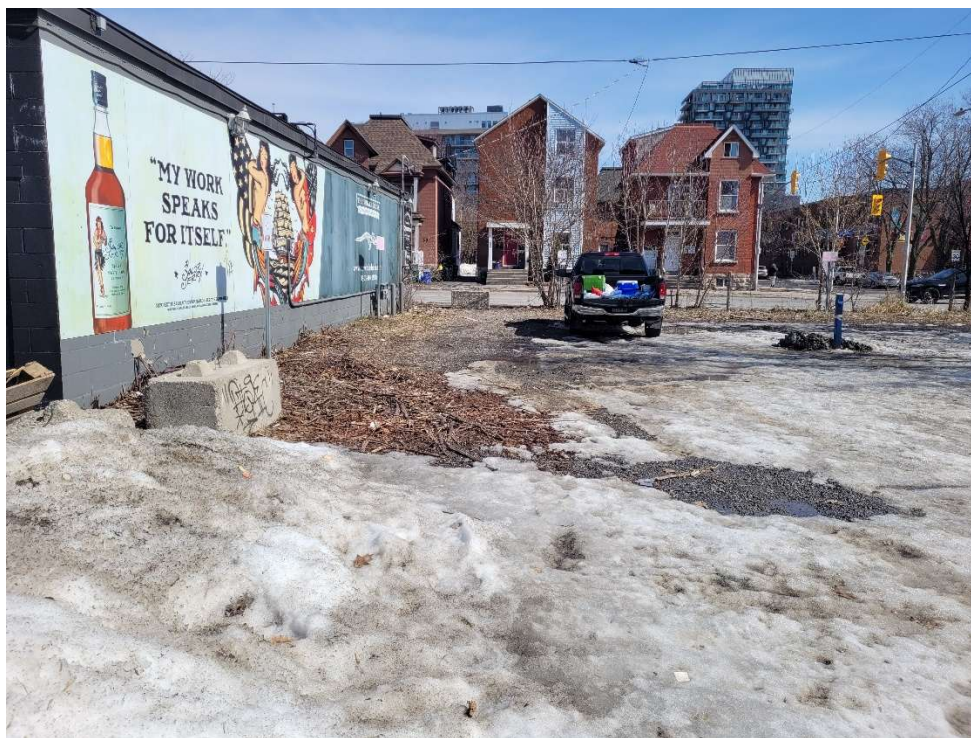
Photograph 3: View of the of the north portion of the Phase One Property looking east. View shows monitoring wells from recent (2025) Phase Two ESA and adjacent commercial building to the north.

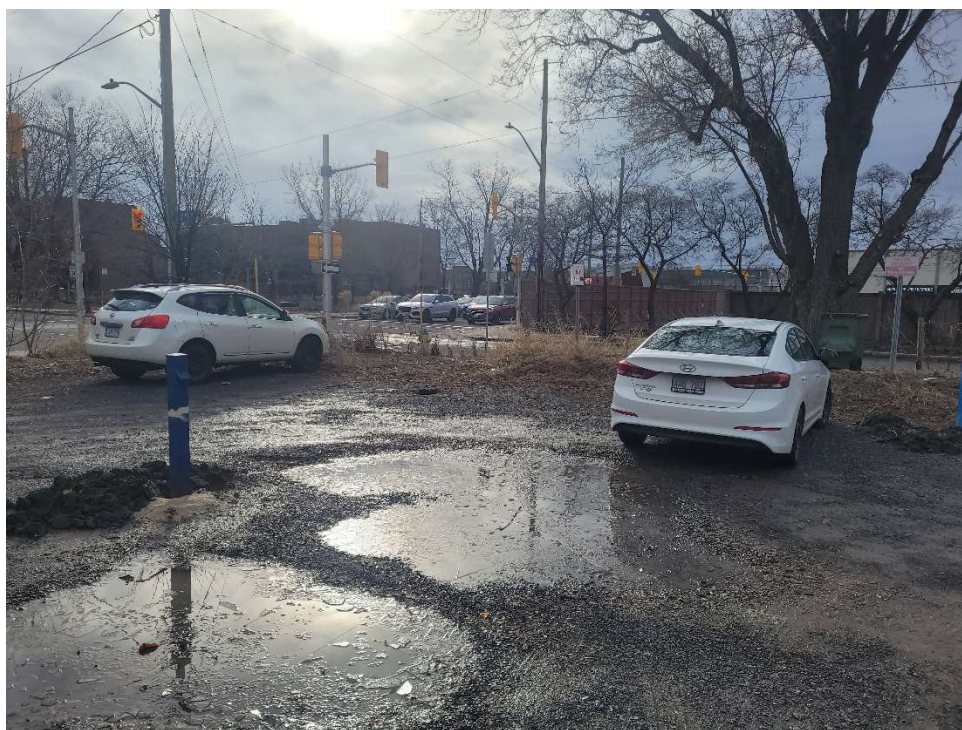
Photograph 4: View of the of the south portion of the Phase One Property looking southeast. View shows monitoring wells from recent (2025) Phase Two ESA and generally gravel surfaced parking.
