ENVIRONMENTAL IMPACT STUDY UPDATE

100 STEACIE DRIVE, OTTAWA, ONTARIO

CIMA+ file number: A001489  
July 11, 2025 – Review 002

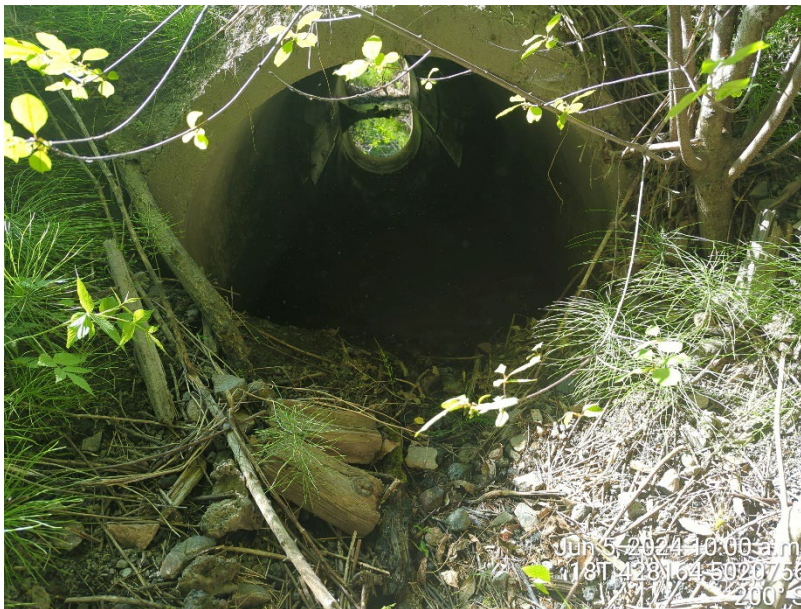
The origin of the channel was about 10 m upstream of the concrete culvert under the railroad and the entire channel was poorly defined, with an uneven gradient. The areas was also fully vegetated. There was some pooling of water in the concrete culvert and further downstream. Outside of the pools, there was no water. Just downstream of the concrete culvert, trees growing in the channel resulted in soil accumulation and created a step in the gradient (step height of 22 cm) which would represent a barrier to fish movement if fish were able to enter the ditch. However, the presence of rip rap at the connection with Kizell Drain is also a barrier to fish. There was no indication (i.e., water lines, vegetation etc.) to suggest that this barrier is overtopped in the spring.

Photo 2: Culvert under the Railroad (June 5, 2024)

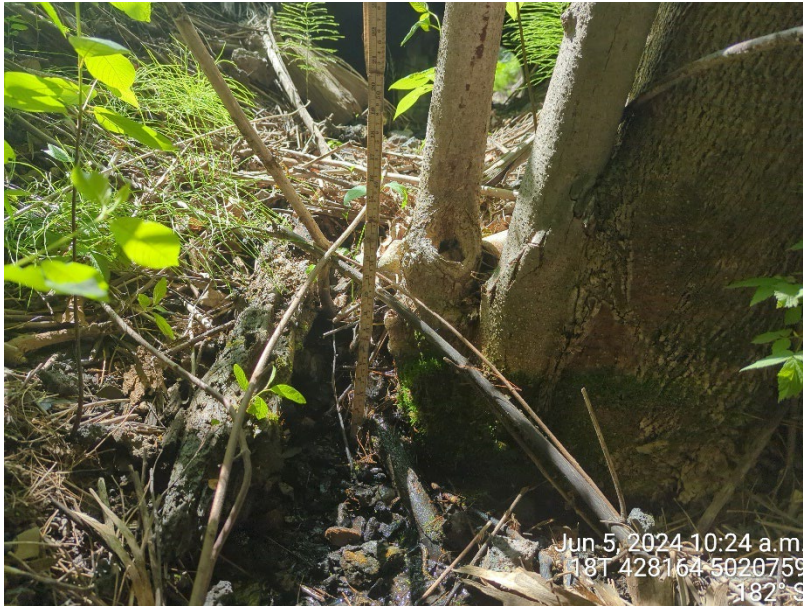
Photo 3: Tree in the channel resulting in steep of 22cm, downstream end of the culvert (June 5, 2024)

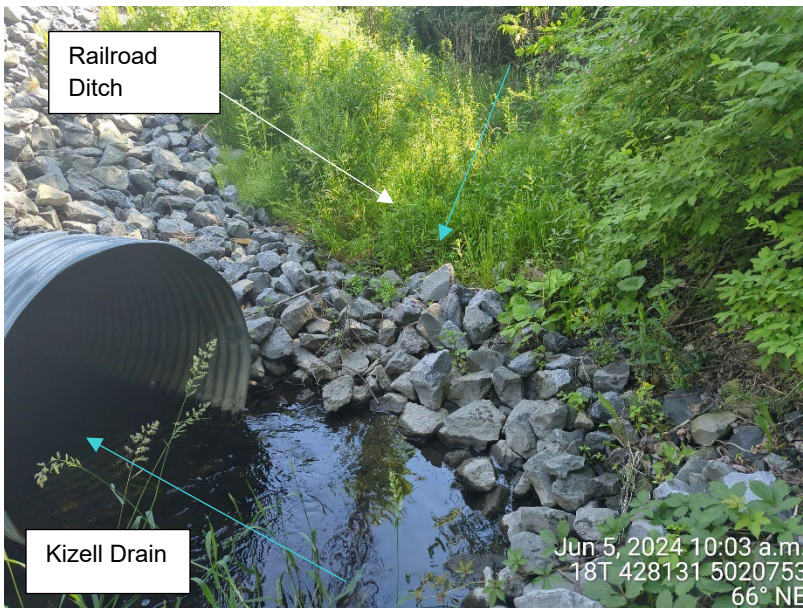
Photo 4: Rip rap at Kizell Drain creating a barrier at the downstream end of the ditch (June 5, 2024)

The railroad ditch has been assessed as indirect fish habitat due to the presence of a fish barrier at its confluence (rip rap), and poorly defined channel. It is understood that the flow being contributed to this ditch from the development is small (83.4 L/s in a 100 year event). This ditch is considered to be indirect fish habitat.

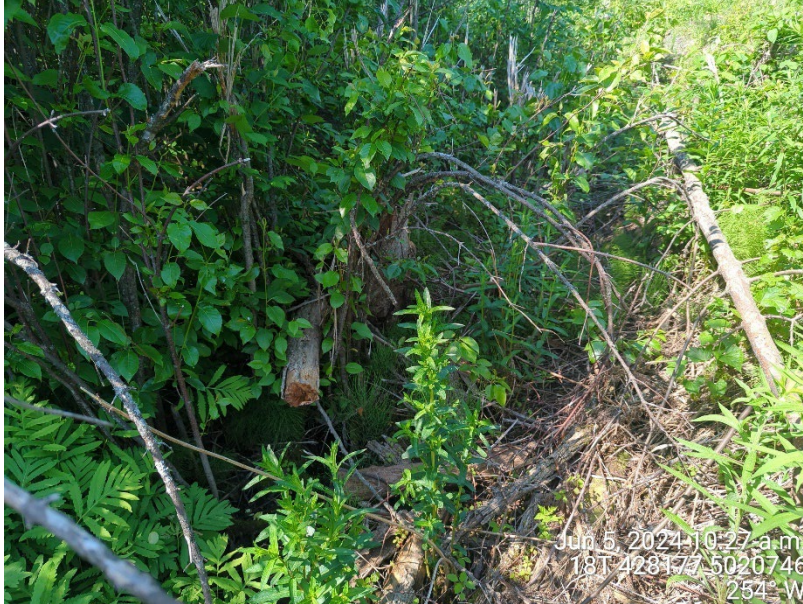
As noted above, there poorly defined channel started roughly 10 m upstream of the concrete culvert. This area was described with Station B (**Figure 3**). The average channel width and bankfull height were 1.8 m and 6 cm (range: 4-9 cm). The average wetted width and depths in the spring were 0.7 m and 1 cm (range: 0-2 cm), respectively. This portion of the channel also had an uneven grade and was poorly defined. The habitat within the station was a shallow pool.

Photo 7: Looking at the downstream end of Station B (June 5, 2024)

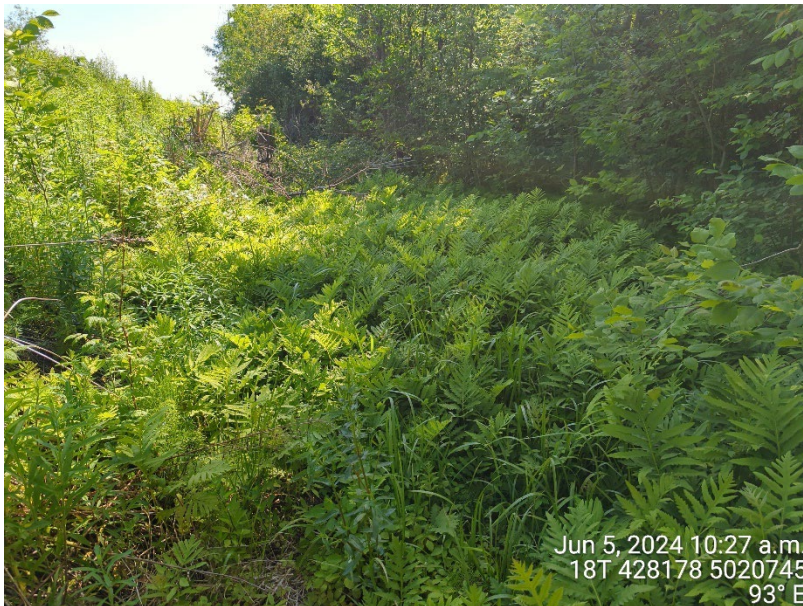
The substrate consisted of fines. The in-water cover was provided by vegetation (sensitive fern and horsetails), and small woody debris. No signs of erosion were noted. The top of the left bank was fully vegetated with herbaceous vegetation and woody species; the right bank was the railroad. The most common herbaceous species were sensitive fern, horsetails, grasses, and spotted jewelweed. The most common woody species were nannyberry and dogwoods. Both the woody and herbaceous vegetation provided little shading.

Photo 8: Looking at the upstream end of Station B (June 5, 2024)
