# TREE CONSERVATION REPORT

4405-4409 Innes rd

Tree Conservation Report submitted as Partial  
Requirements for a Site Plan Control Application,  
July 15, 2025

Dendron Forestry Services

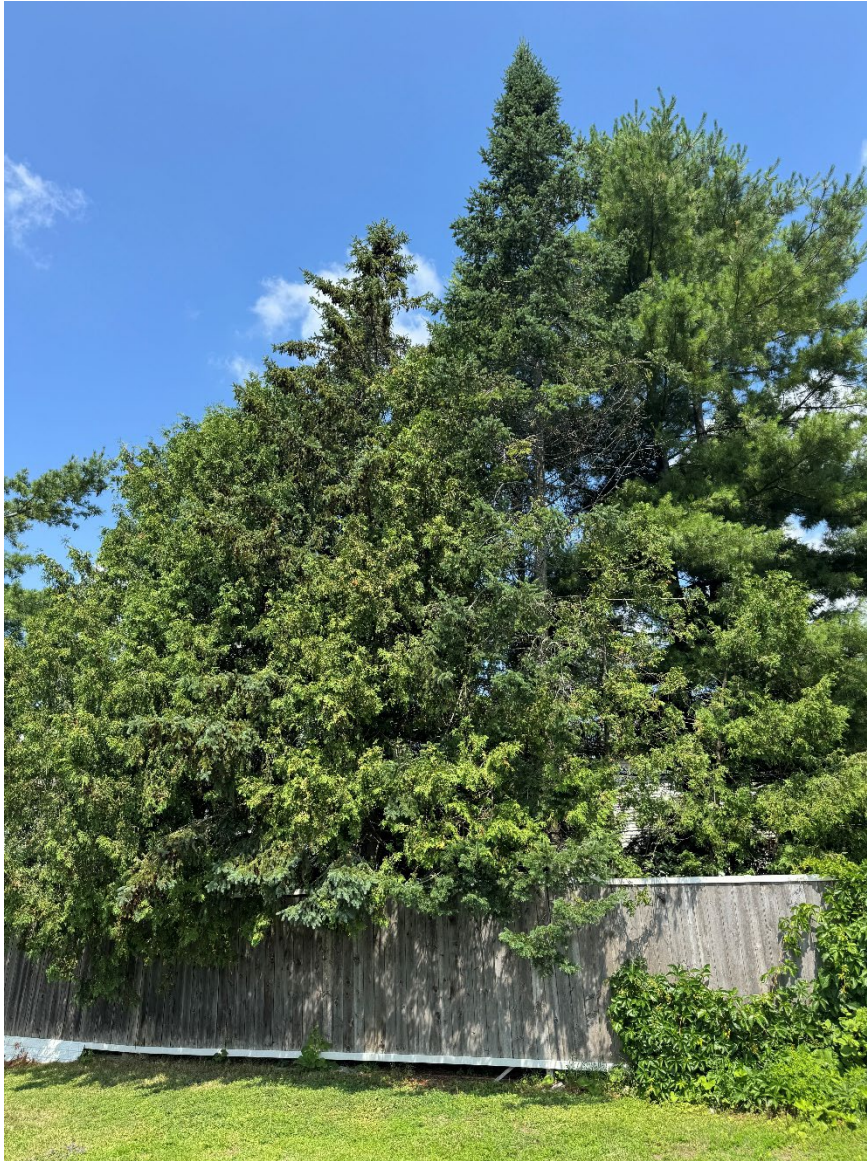
| Tree <sup>1,4</sup> | Species | DBH (cm) | Ownership <sup>2</sup> | Tree Condition | Forester recommendation |
|---|---|---|---|---|---|
| 1 <sup>4</sup> | White spruce ( <i>Picea glauca</i> ) | 16 | Adjacent property at 436 Grassland Terrace | Good | Retain and protect |
| 2 <sup>4</sup> | Eastern white cedar ( <i>Thuja occidentalis</i> ) | 15 | Adjacent property at 436 Grassland Terrace | Good | Retain and protect |
| 3 <sup>4</sup> | White spruce ( <i>Picea glauca</i> ) | 16 | Adjacent property at 436 Grassland Terrace | Good | Retain and protect |
| 4 <sup>4</sup> | Eastern white cedar ( <i>Thuja occidentalis</i> ) | 13 | Adjacent property at 436 Grassland Terrace | Good | Retain and protect |
| 5 <sup>4</sup> | Eastern white cedar ( <i>Thuja occidentalis</i> ) | 13 | Adjacent property at 436 Grassland Terrace | Good | Retain and protect |

Figure 1: Trees 1-5 on adjacent property to the north, to be protected

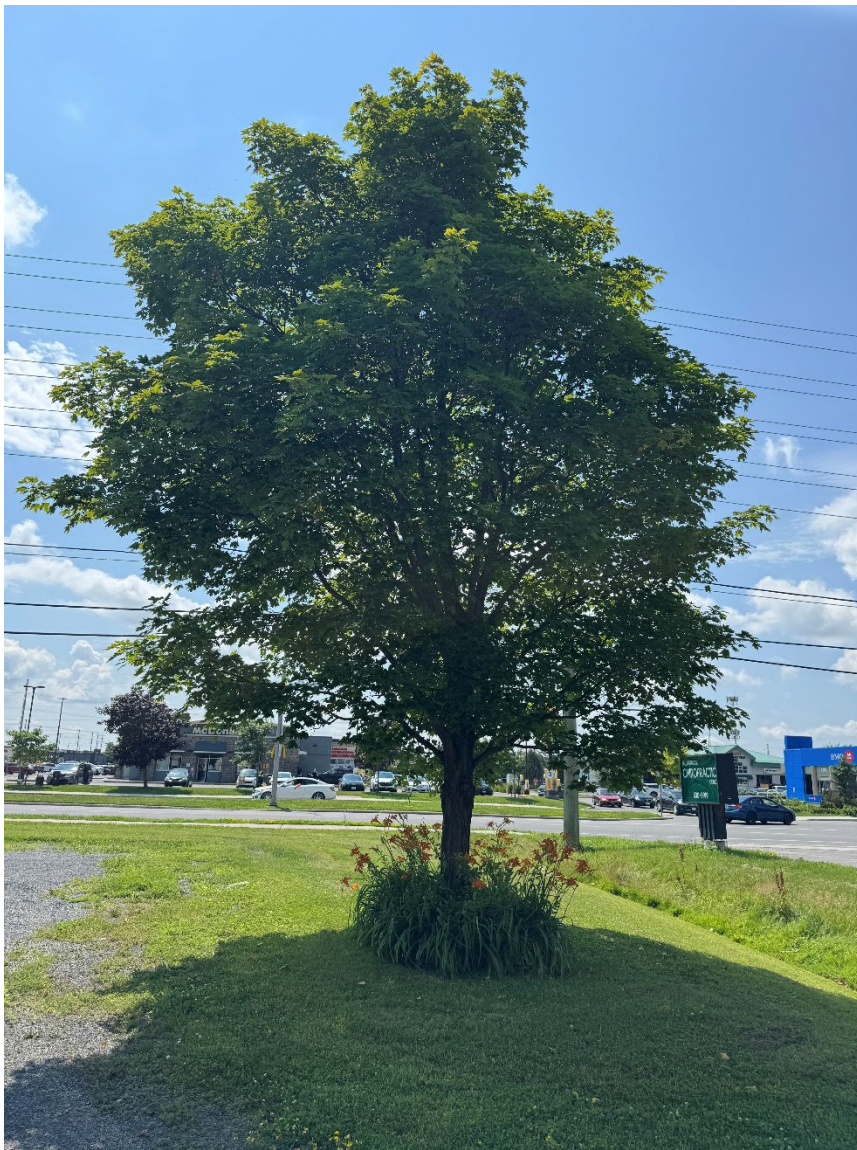
| Tree <sup>1,4</sup> | Species | DBH (cm) | Ownership <sup>2</sup> | Tree Condition | Forester recommendation |
|---|---|---|---|---|---|
| 7 | Sugar maple ( <i>Acer saccharum</i> ) | 30 | Subject property | Good | Remove; in conflict with proposed laneway; <b>Tree Permit required</b> |

Figure 3: Tree 7, sugar maple to be removed

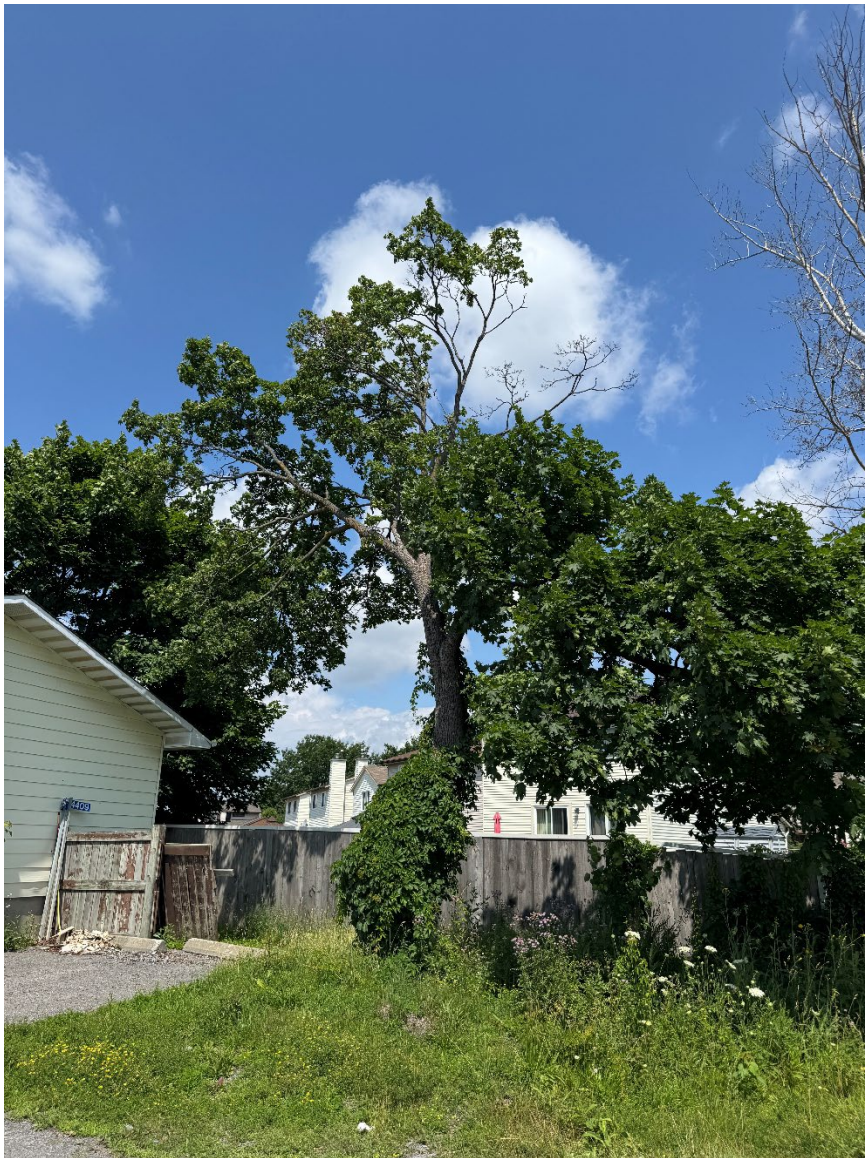
| Tree <sup>1,4</sup> | Species | DBH (cm) | Ownership <sup>2</sup> | Tree Condition | Forester recommendation |
|---|---|---|---|---|---|
| 8 | Norway maple ( <i>Acer platanoides</i> ) | 53 | Subject property | Poor; lost main stem, significant decay | Remove; in conflict with proposed laneway; <b>Tree Permit required</b> |

Figure 4: tree 8, Norway maple to be removed

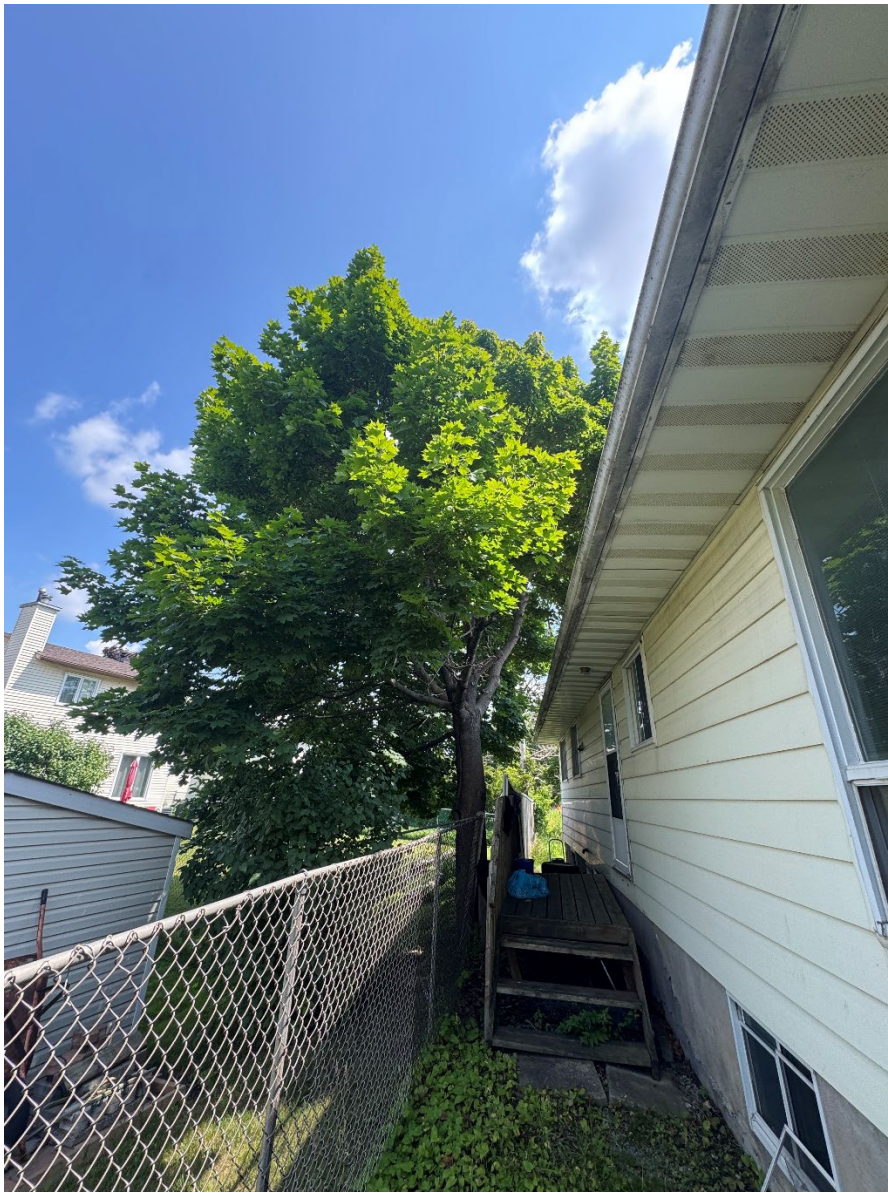
| Tree <sup>1,4</sup> | Species | DBH (cm) | Ownership <sup>2</sup> | Tree Condition | Forester recommendation |
|---|---|---|---|---|---|
| 9 | Norway maple ( <i>Acer platanoides</i> ) | 45 (est) | Jointly owned with 428 Grassland Terrace | Fair; poor pruning practices on branches leaning over fence | Retain and protect |

Figure 5: Tree 9, jointly owned Norway maple to be retained
