PH5075-LET.01

Subject: **Hydrogeological Assessment and Terrain Analysis**
Proposed Industrial Development
301 Somme Street, Ottawa, Ontario

INTRODUCTION

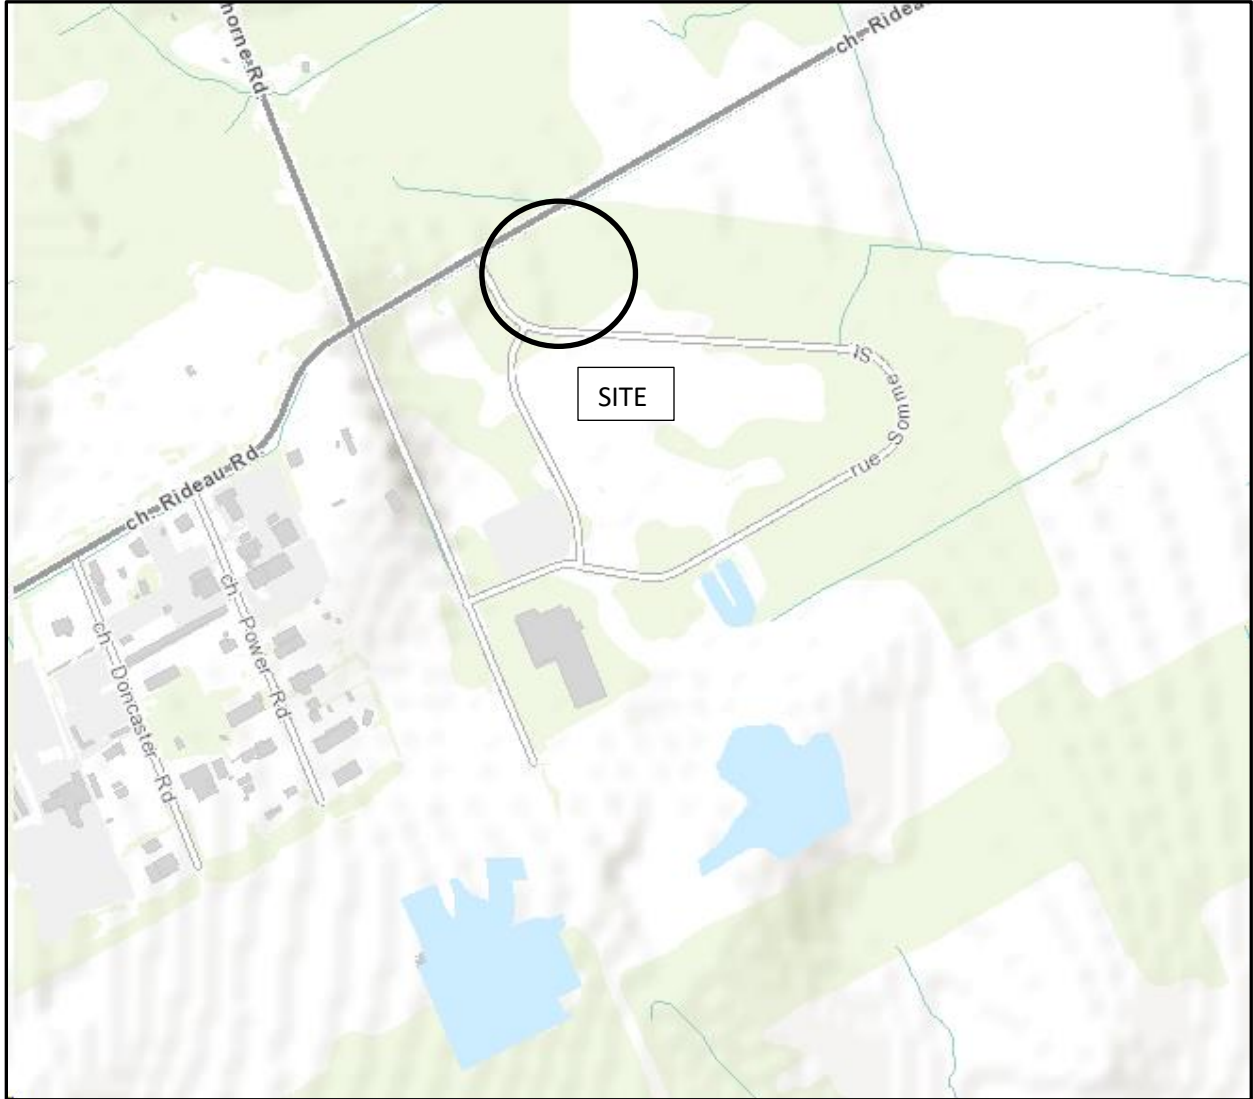
FIGURE 1

KEY PLAN

Further to your request, Paterson has conducted a Hydrogeological Assessment and Terrain Analysis in support of a Site Plan Control Application (hereby referred to as a Site Plan application) for the proposed industrial development located at 301 Somme Street in Ottawa. Please refer to the Figure 1 - Key Plan attached for the approximate site location.

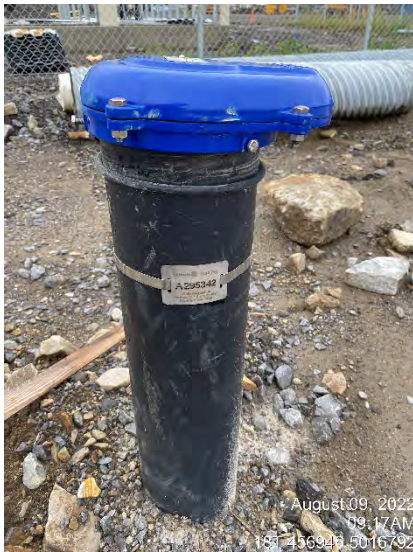
Photo 5 - Observation well (ID A295342) used during pumping test for monitoring of potential interference effects.
