# Phase One Environmental Site Assessment

2025 and 2035 Othello Avenue  
Ottawa, Ontario

July 6, 2021

Pinchin File: 290064.001

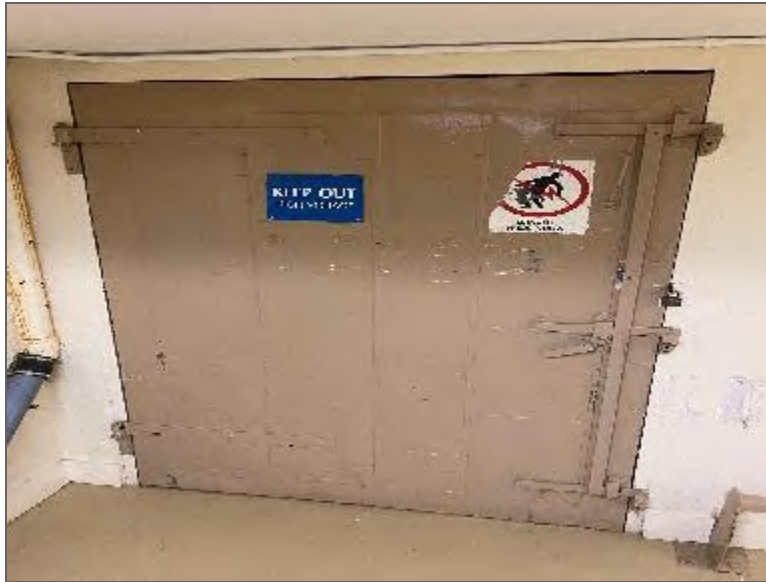
Photo 3 – Hydro vault within the basement level of Site Building A (PCA).

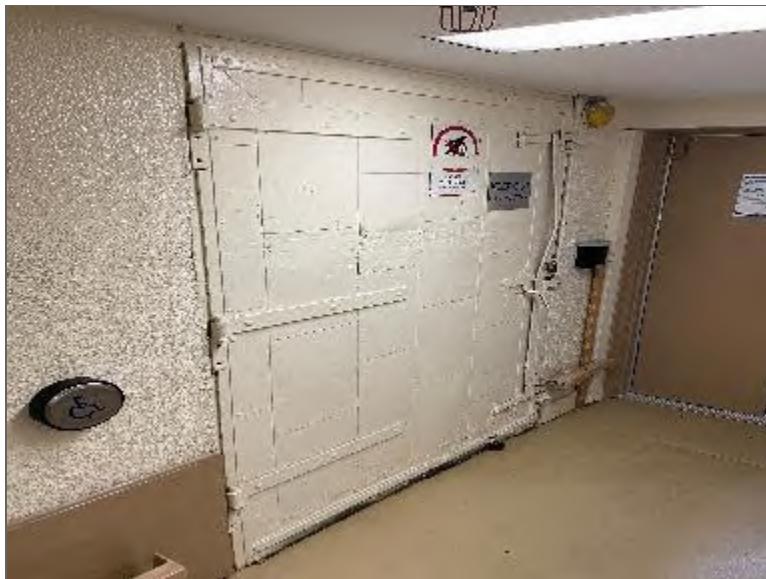
Photo 6 – Hydro vault within the basement level of Site Building B (PCA).

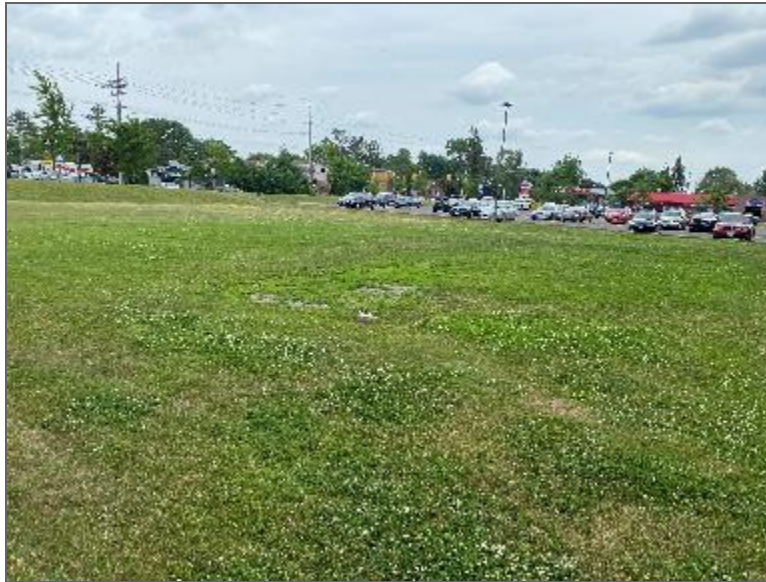
Photo 7 – General location of former in-ground pool, which was backfilled with fill material of unknown quality (PCA).

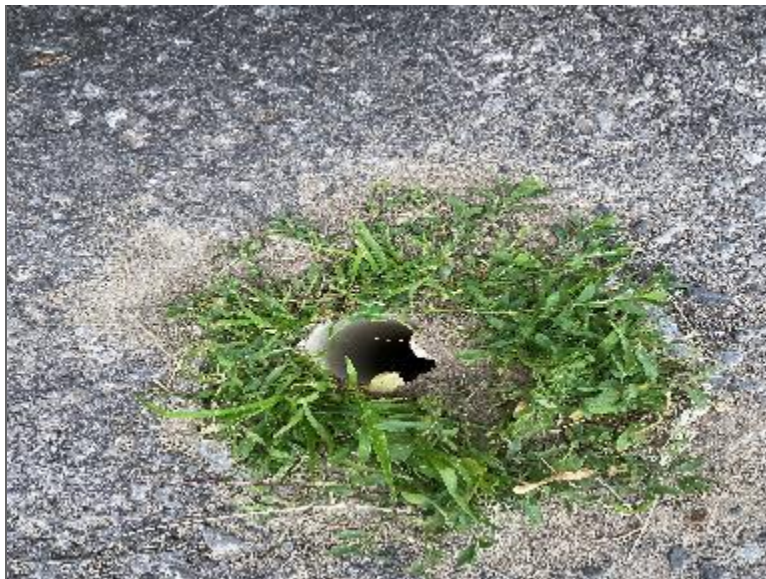
No water supply or groundwater monitoring wells were observed to be on or within the Phase One Property, with the exception of two groundwater monitoring wells located near the east boundary of the Phase One Property. The groundwater monitoring wells were installed as part of the 2000 AGRA Phase II ESA Report and were observed to be damaged and in poor condition.

Photo 8 – Groundwater monitoring well (damaged) identified along the east boundary of the Phase One Property. Fill material of unknown quality identified here (PCA).

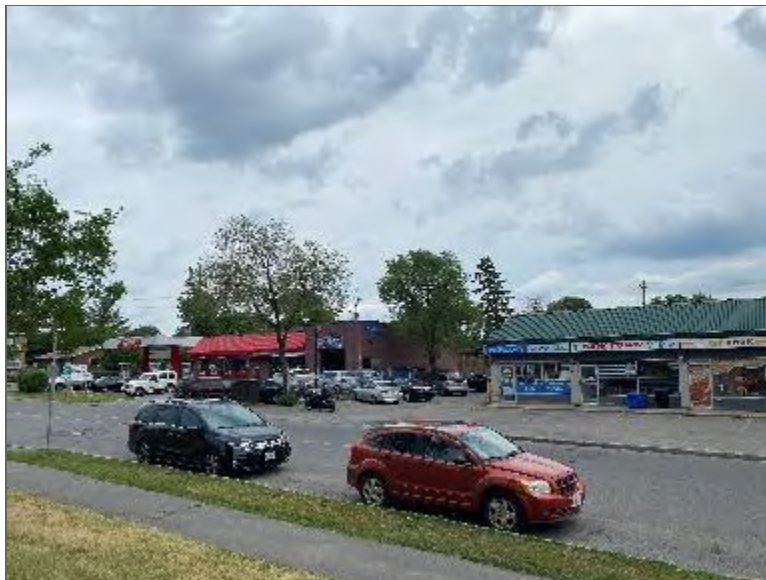
- An RFO was evident approximately 15 m south of the Phase One Property; and
- An automotive repair/servicing operation was evident approximately 20 m east of the Phase One Property.

Photo 10 – Properties located south of the Phase One Property, including an automotive repair/servicing operation and RFO (PCAs).

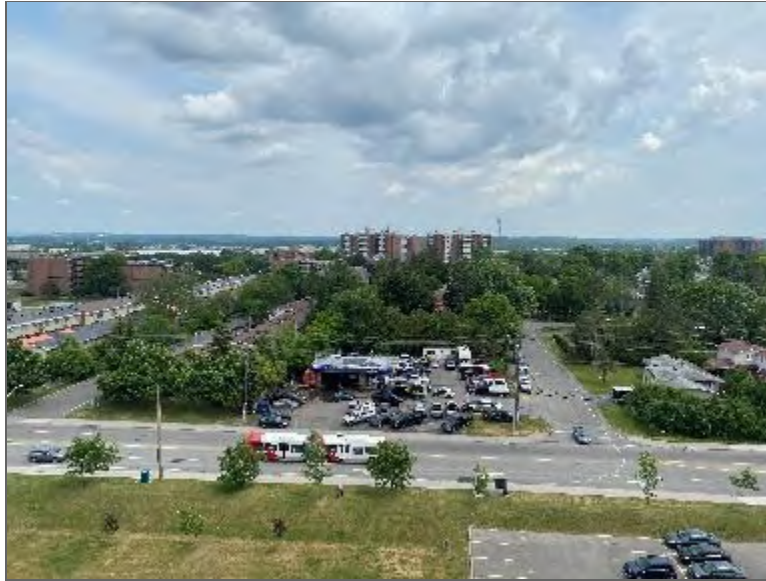
- An automotive repair/servicing facility and RFO were listed at 2013 St. Laurent Boulevard from 1964 until 2010. This property is located approximately 20 m east of the Site and is situated hydraulically upgradient to the Site in relation to the inferred groundwater flow direction. Based on the close proximity to the Site, the inferred groundwater flow direction, and the nature/duration of operations at this property, it is Pinchin's opinion that the above-noted PCAs represent APECs for the Phase One Property;

Photo 9 – Properties located east of the Phase One Property, including 2013 St. Laurent Boulevard (current automotive repair/servicing operation and former RFO (PCAs)).
