# PATERSON GROUP

September 19, 2025  
File: PE6827-LET.02R

Subject: **Phase I-Environmental Site Assessment Update  
4405 and 4409 Innes Road  
Ottawa, Ontario**

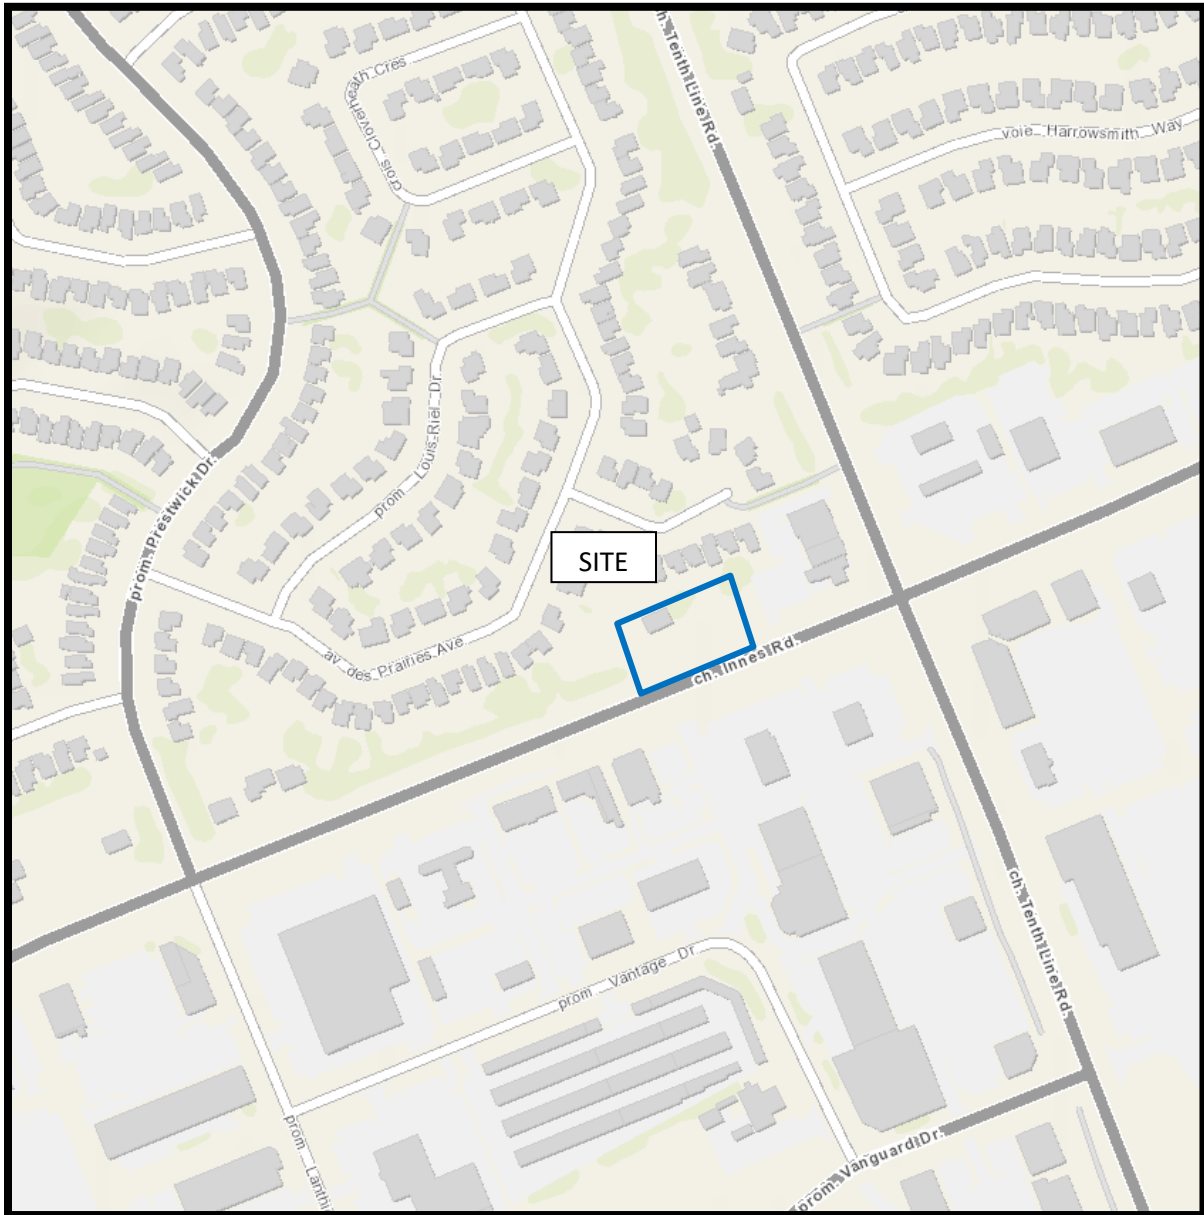
FIGURE 1

## KEY PLAN

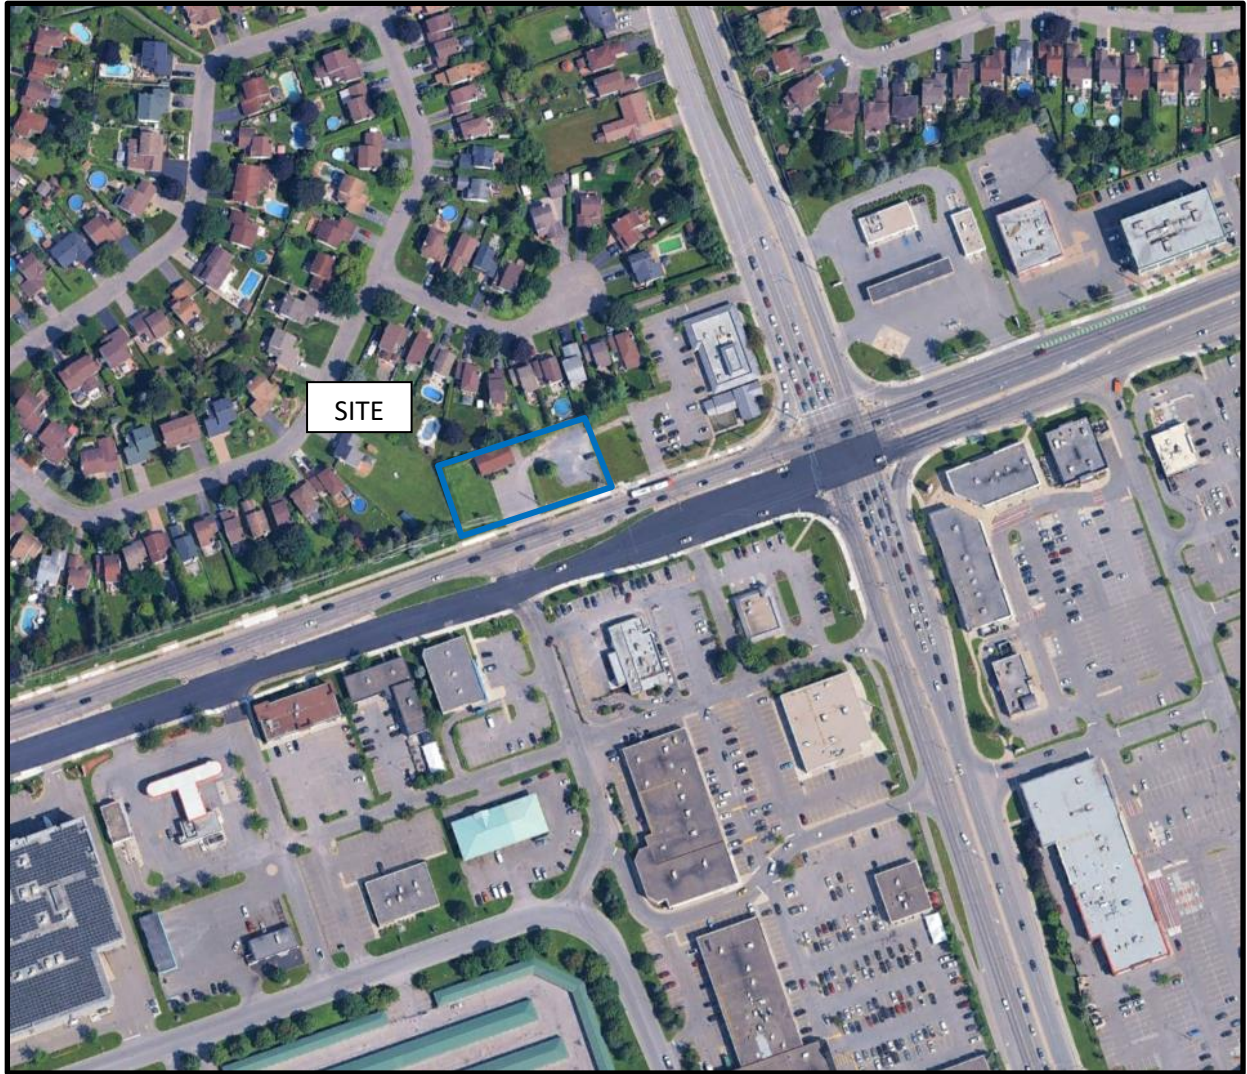
AERIAL PHOTOGRAPH  
2025

The latest aerial image in the 2015 Phase I ESA report was from 2011. An aerial image from 2025 (Google Earth) was reviewed as part of this update. Based on the more recent aerial imagery, the residential dwelling addressed as 4409 Innes Road has been demolished and has been replaced with a gravel parking lot. East of the site, the properties addressed as 1992 Tenth Line Road, 2000 Tenth Line Road, and 4419 Innes Road have merged to form one property, occupied by the Orleans Veterinary Hospital, the Orleans Pet Spa, and an associated parking lot. Further east, the vacant land addressed as 4471 Innes Road has been developed into a commercial fast-food restaurant. No other significant changes can be observed with the Phase I Study area. A copy of the 2025 aerial imagery is appended to this letter.
