September 25, 2025  
File: PE6214-LET.05

Subject: **Phase I - Environmental Site Assessment Update**  
**2506 Innes Road**  
**Ottawa, Ontario**

CONCORDE PROPERTIES  
PHASE I - ENVIRONMENTAL SITE ASSESSMENT  
2506 INNES ROAD

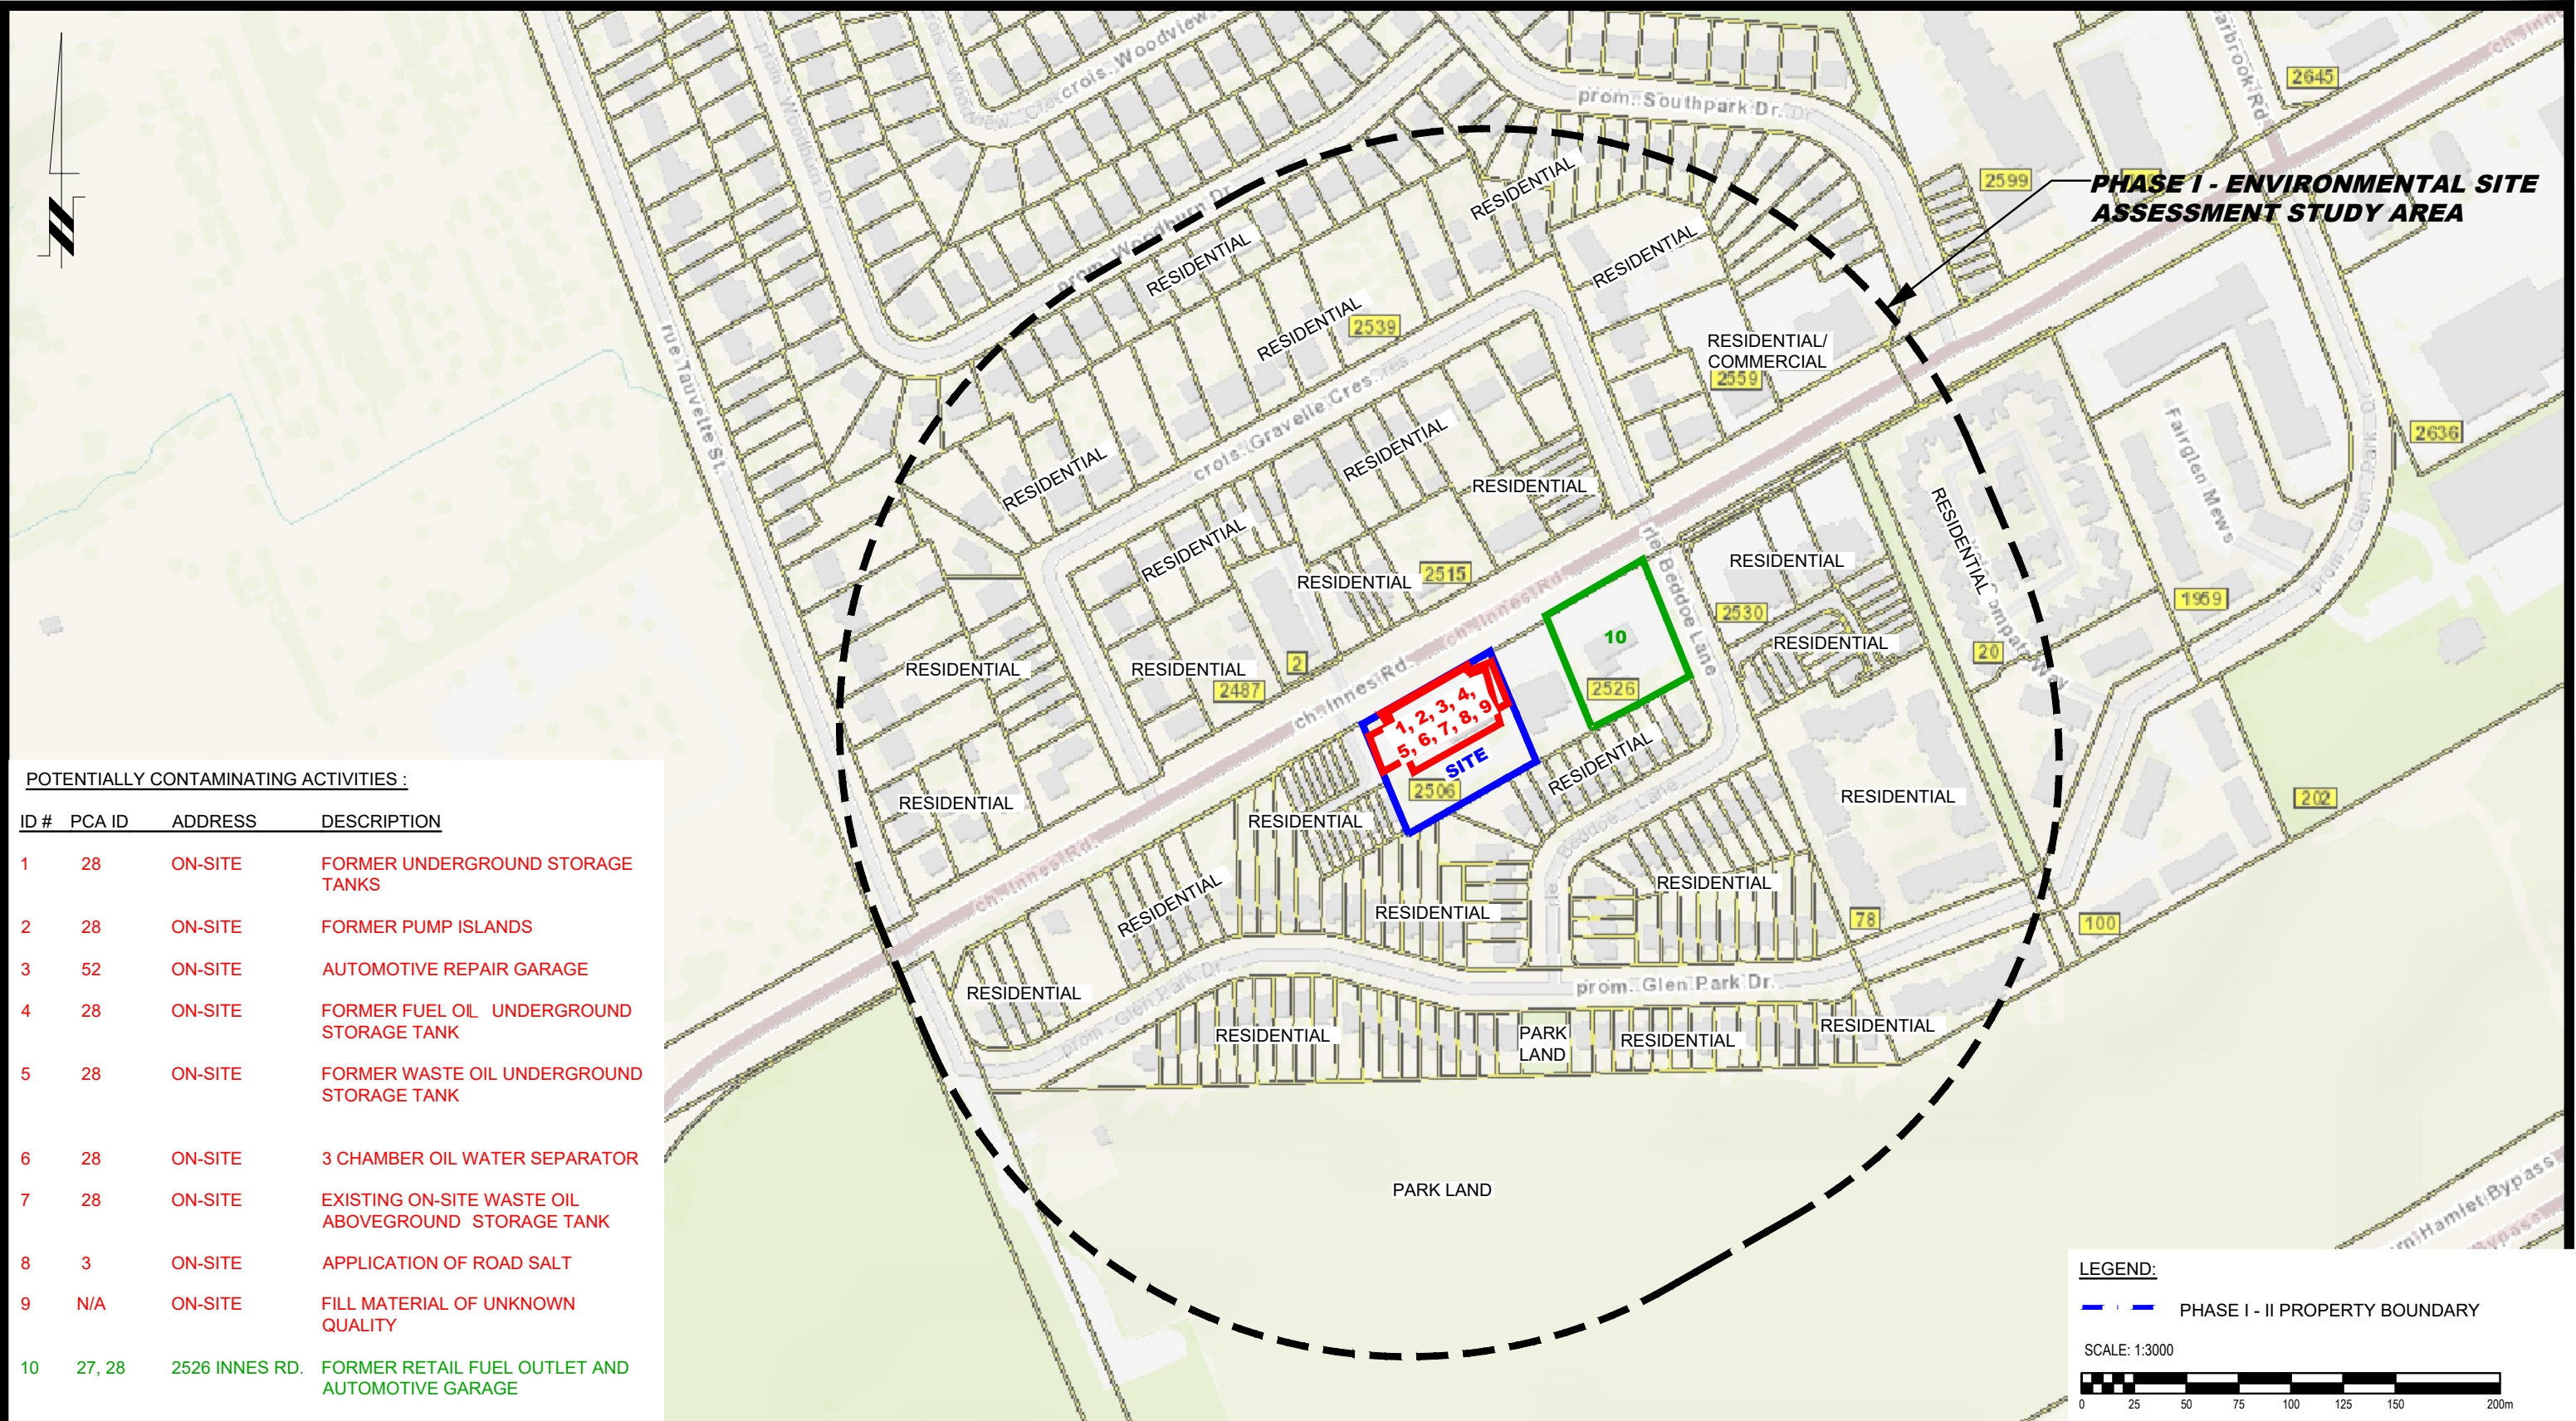
Title: SURROUNDING LAND USE PLAN

Neighbouring land use in the Phase I Study Area consists primarily of residential with some commercial land use along Innes Road, east of the Phase I Property. No new existing off-site PCAs were identified within the Phase I Study Area.
