**RESIDENTIAL PROPERTIES  
245 - 267 ROCHESTER STREET,  
27 & 29 BALSAM STREET  
OTTAWA, ONTARIO  
K1R 7M9**

**Phase II  
Environmental Site Assessment**

Rubicon Job Number • R63048.10

Report Date • March 29, 2023

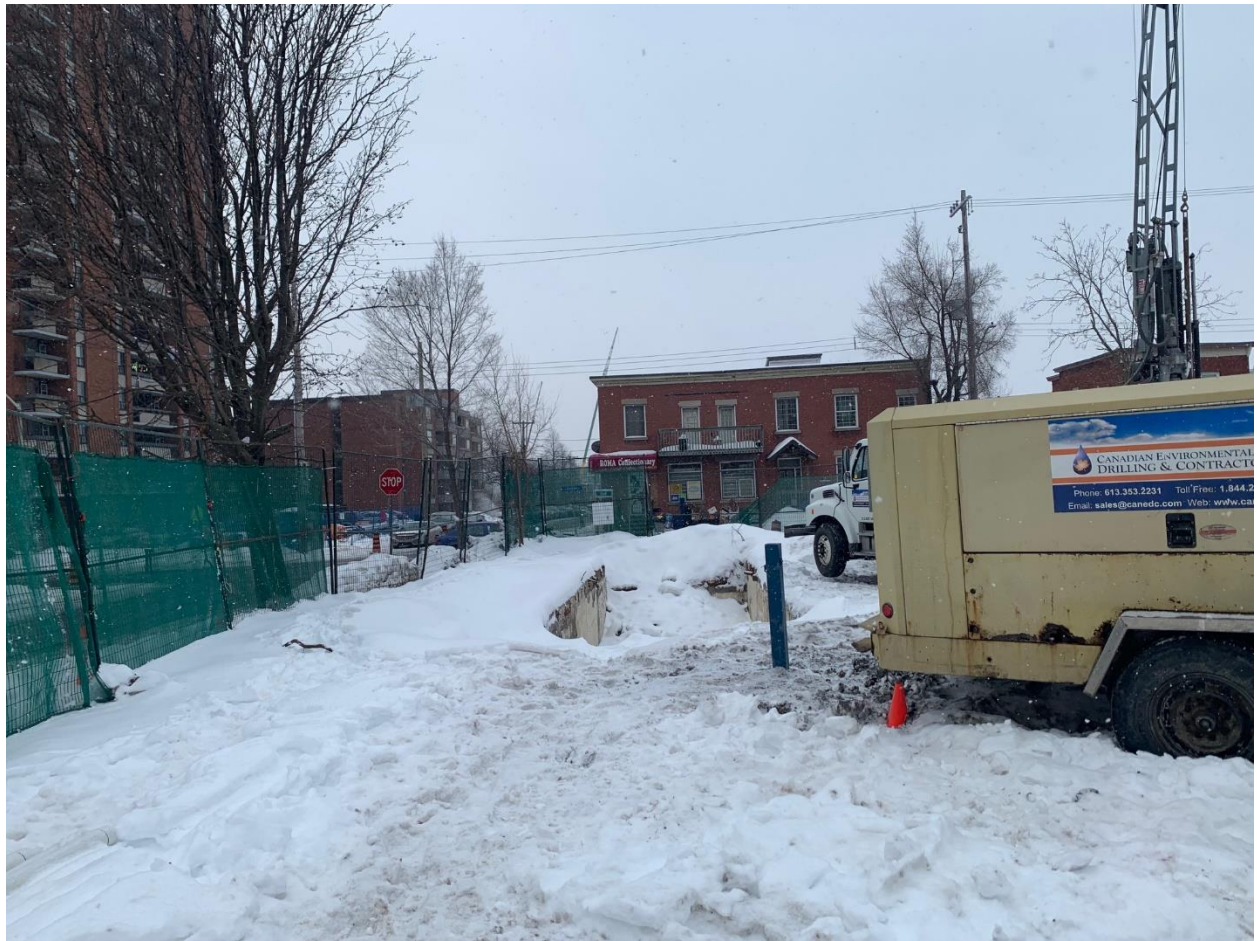
*Image 1 – Monitoring Well 4, facing west (later decommissioned)*

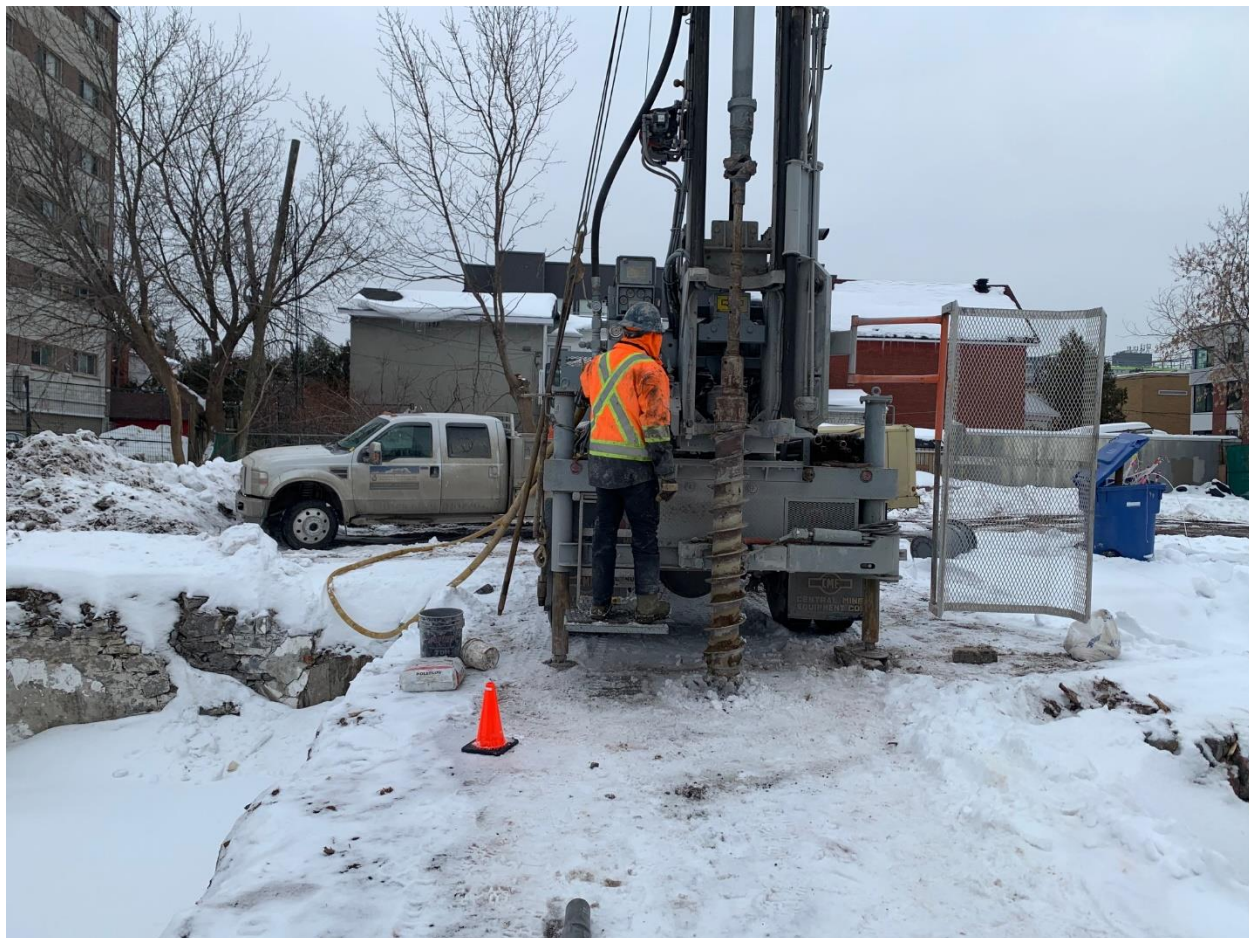
*Image 2 – Monitoring Well 1, facing east (later decommissioned)*

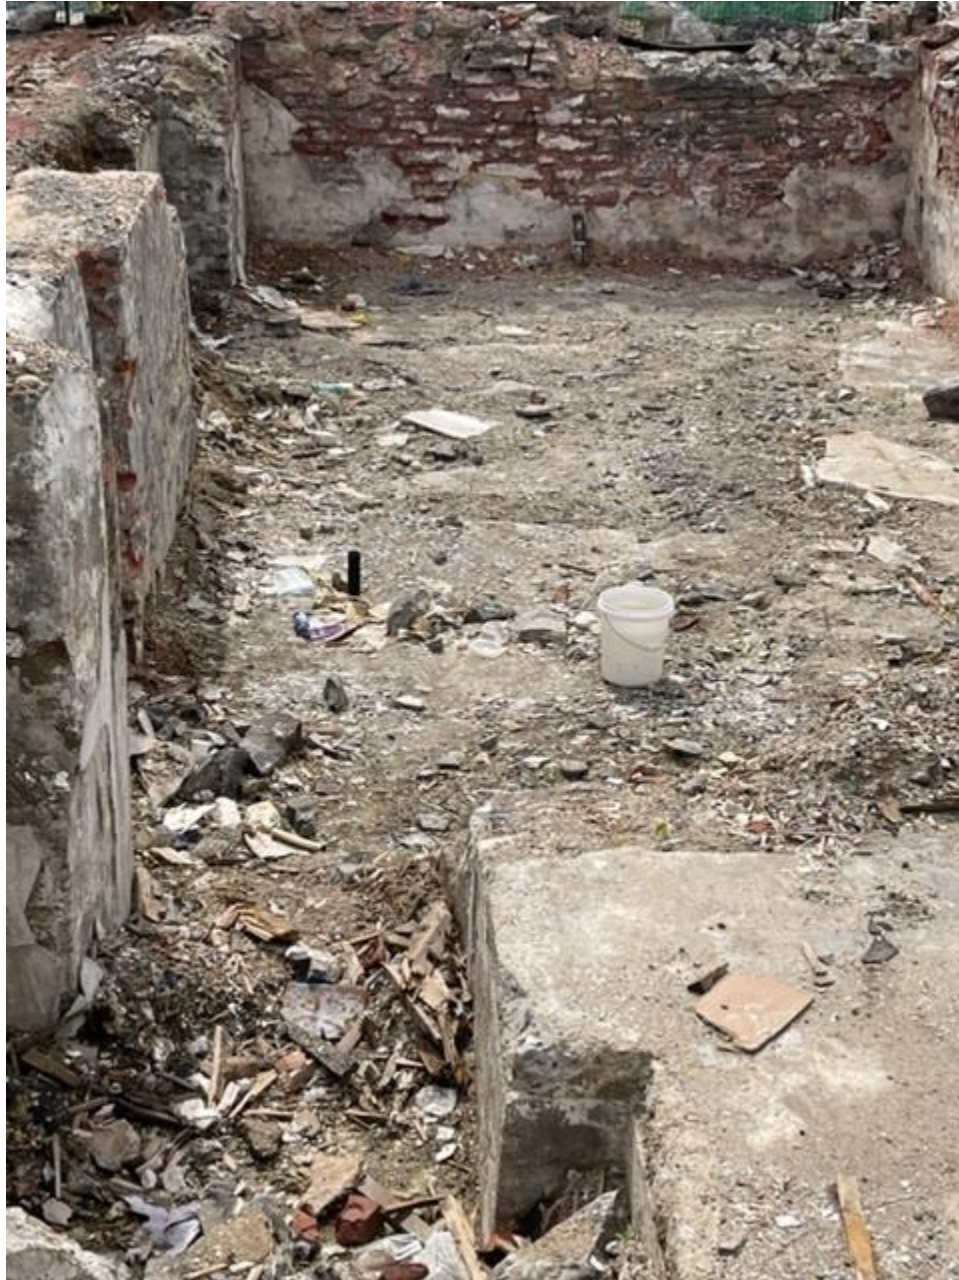
| SAMPLE ID | COMMENTS |
|---|---|
| EX-MW2 | <ul style="list-style-type: none"> <li>Located within APEC #1-2</li> <li>Sampled on October 3, 2022</li> <li>No petroleum odours staining present</li> <li>VOC reading using field instruments (&lt; 5 ppm)</li> <li>Soil sample analysed for VOCs, PHC and BTEX.</li> </ul> |

*Image 3 - EXMW2 within the basement foundation*

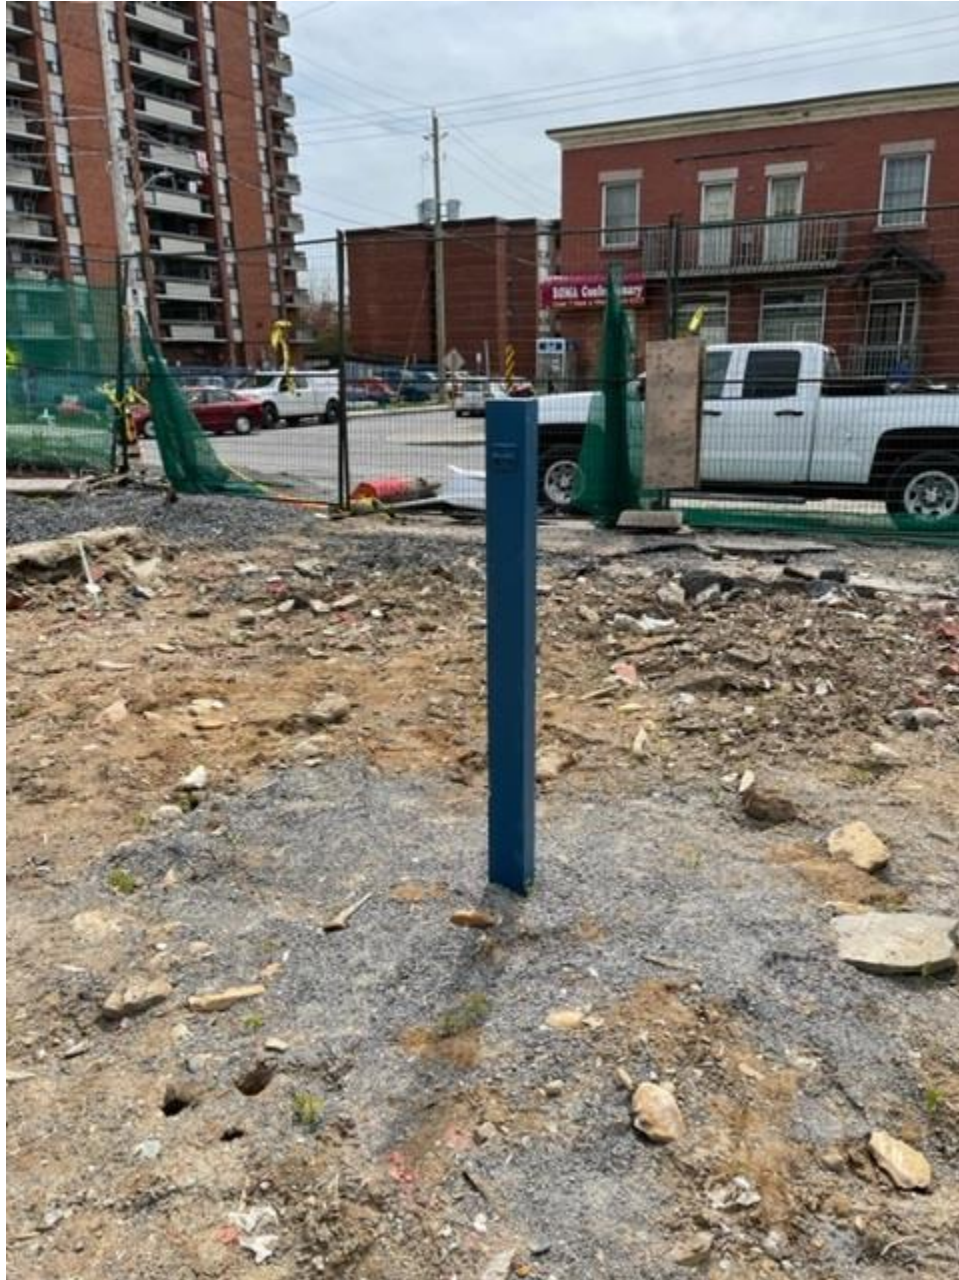
| SAMPLE ID | COMMENTS |
|---|---|
| MW3 | <ul style="list-style-type: none"> <li>Located within APEC #1-2</li> <li>Sampled on October 3, 2022</li> <li>No petroleum odours staining present</li> <li>VOC reading using field instruments (&lt; 5 ppm)</li> <li>Soil sample analysed for VOCs, PHC and BTEX.</li> </ul> |

*Image 4 – MW3 stick southwest of the subject property*

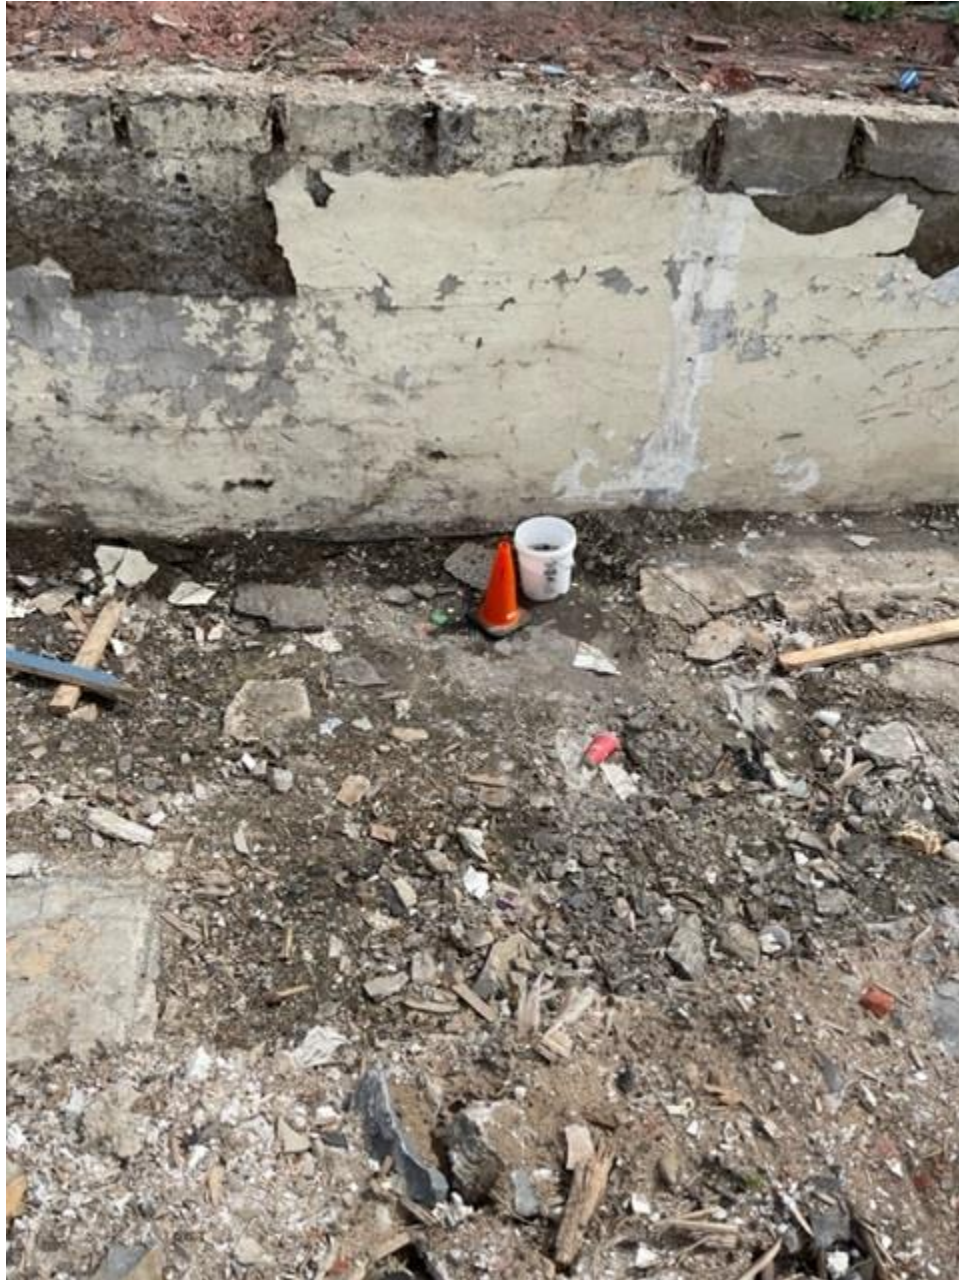
| SAMPLE ID | COMMENTS |
|---|---|
| EX-MW1 | <ul style="list-style-type: none"> <li>Located within APEC #1-2</li> <li>Sampled on October 3, 2022</li> <li>No petroleum odours staining present</li> <li>VOC reading using field instruments (&lt; 5 ppm)</li> <li>Soil sample analysed for VOCs, PHC and BTEX.</li> </ul> |

*Image 5 – EX-MW1 within basement foundation southwest of the subject property*

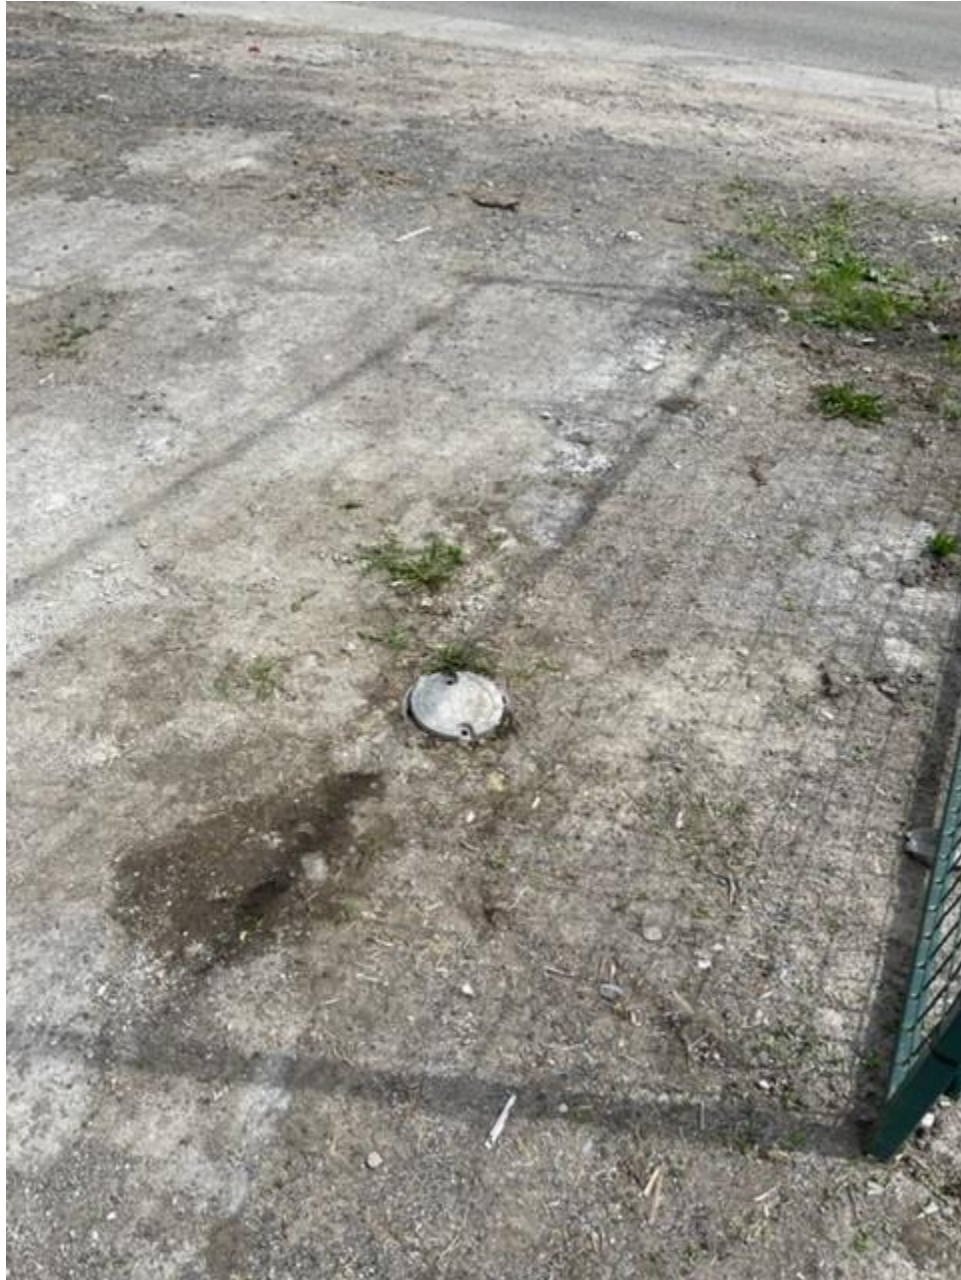
| SAMPLE ID | COMMENTS |
|---|---|
| EX-MW5 | <ul style="list-style-type: none"> <li>Located within APEC #1-2</li> <li>Sampled on October 3, 2022</li> <li>No petroleum odours staining present</li> <li>VOC reading using field instruments (&lt; 5 ppm)</li> <li>Soil sample analysed for VOCs, PHC and BTEX.</li> </ul> |

*Image 6 – EX-MW5 south of the subject property*

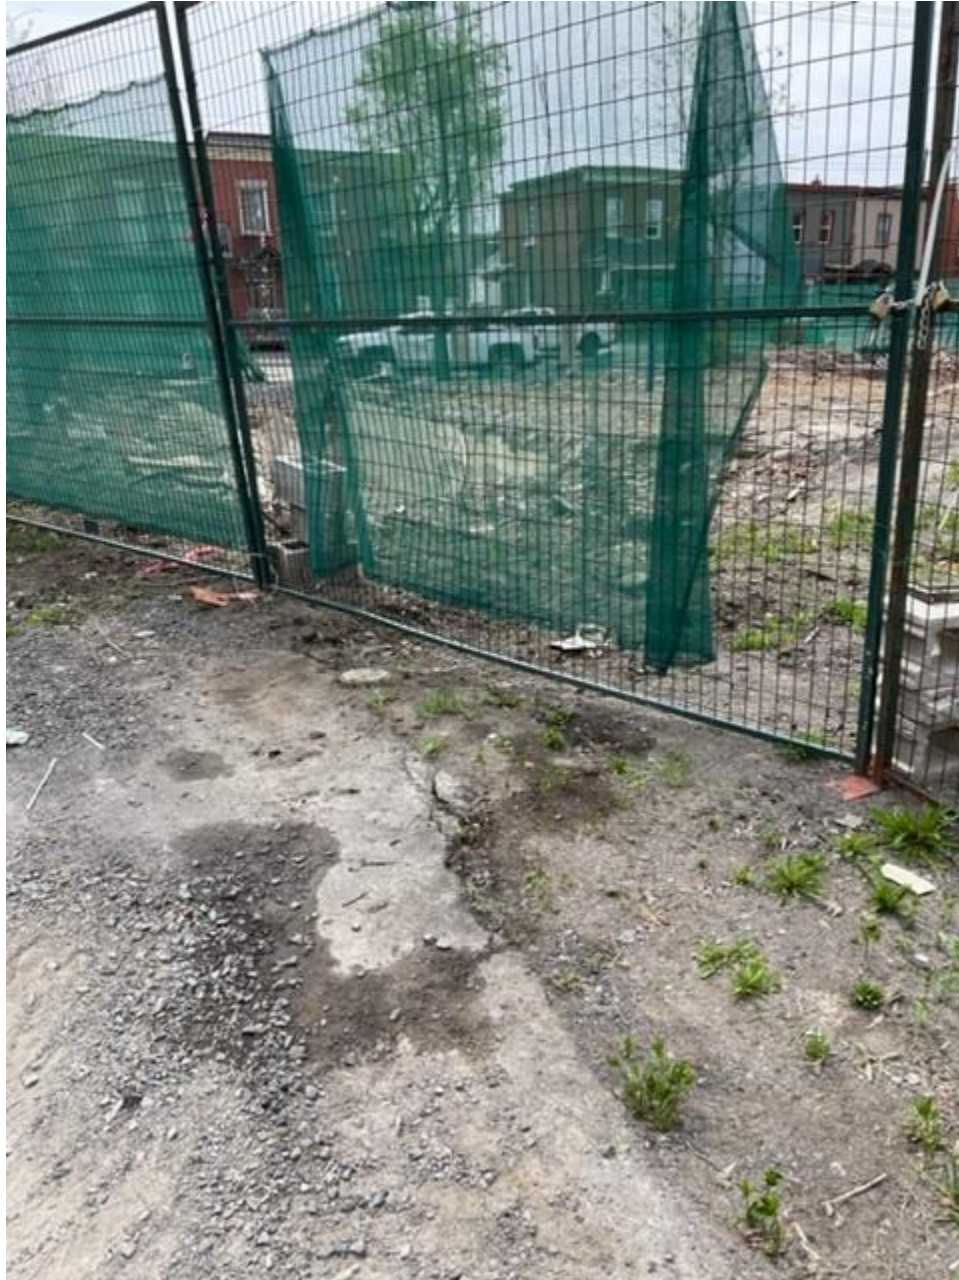
| SAMPLE ID | COMMENTS |
|---|---|
| EX-MW7 | <ul style="list-style-type: none"> <li>Located within APEC #1-2</li> <li>Sampled on October 3, 2022</li> <li>No petroleum odours staining present</li> <li>VOC reading using field instruments (&lt; 5 ppm)</li> <li>Soil sample analysed for VOCs, PHC and BTEX.</li> </ul> |

*Image 7 – EX-MW7 southwest on the property bounds*

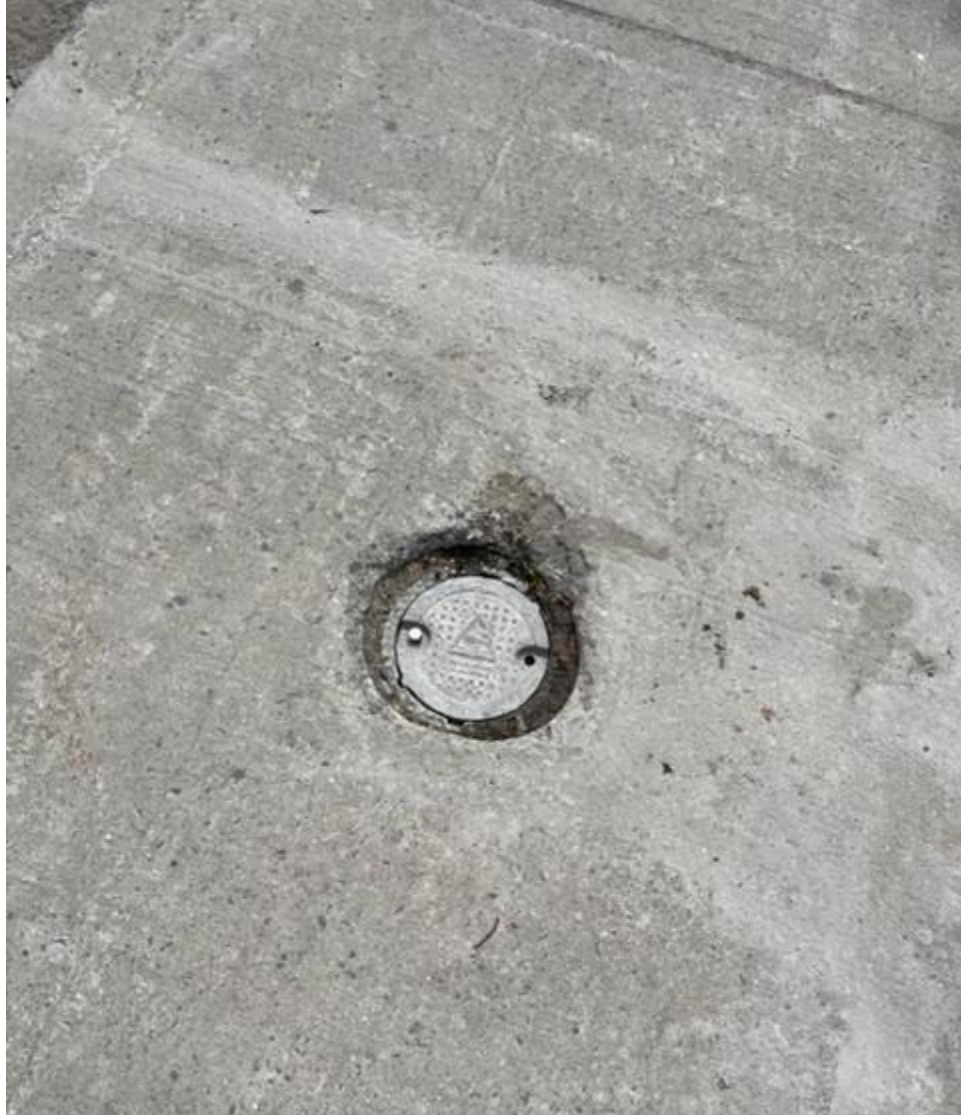
| SAMPLE ID | COMMENTS |
|---|---|
| EX-MW6 | <ul style="list-style-type: none"> <li>Located within APEC #1</li> <li>Sampled on October 3, 2022</li> <li>No petroleum odours or soil staining present</li> <li>VOC reading using field instruments (&lt; 5 ppm)</li> <li>Soil sample analysed for VOCs, PHC and BTEX.</li> </ul> |

*Image 8 – EX-MW6 offsite monitoring well*

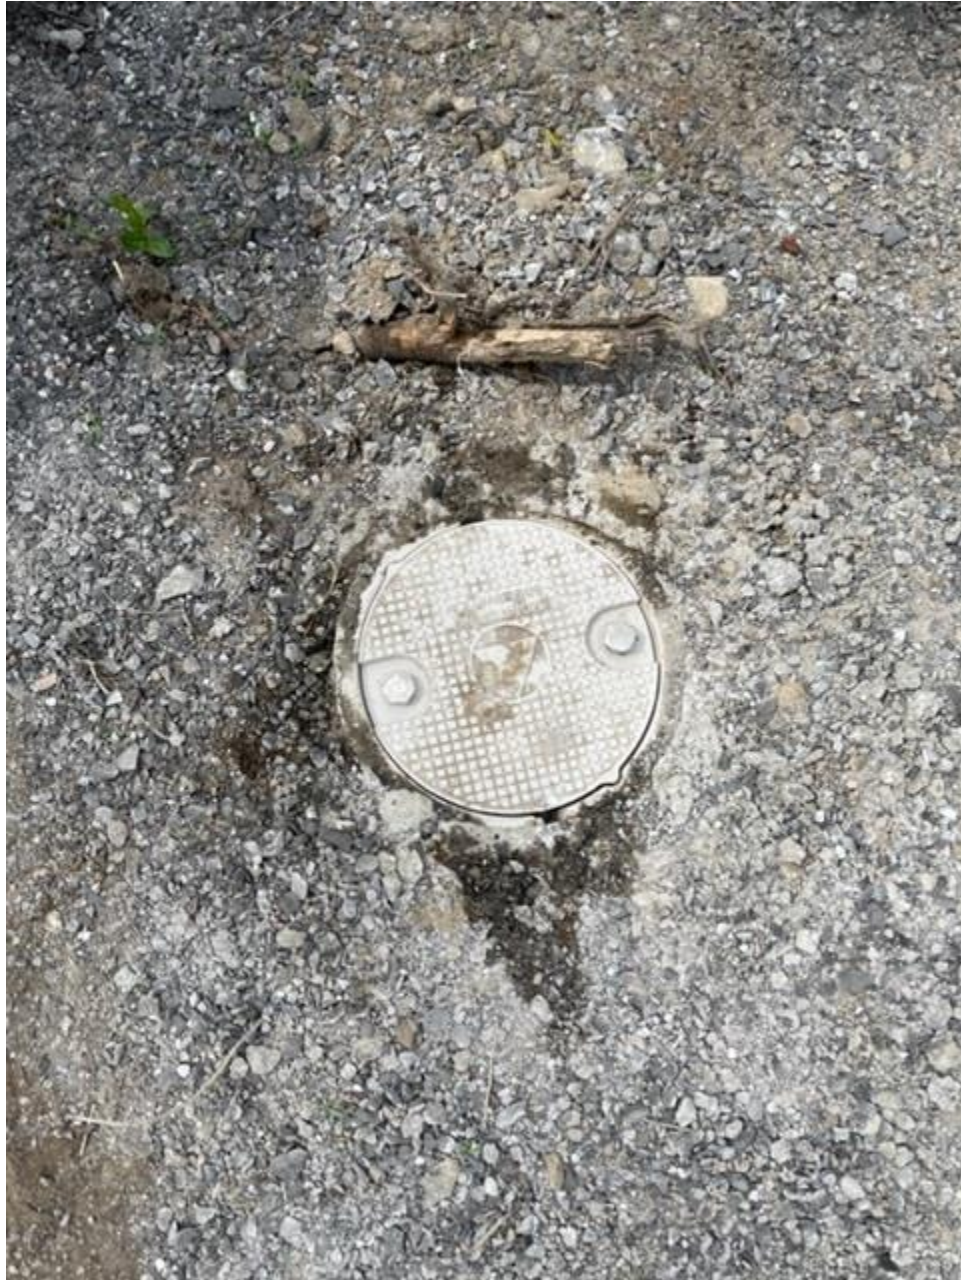
| SAMPLE ID | COMMENTS |
|---|---|
| MW5 | <ul style="list-style-type: none"> <li>Located on the south perimeter line of the subject property, northeast of EX-MW1, in order to investigate the groundwater in the groundwater flow direction.</li> <li>Sampled on October 3, 2022</li> <li>No petroleum odours staining present</li> <li>VOC reading using field instruments (&lt; 5 ppm)</li> <li>Soil sample analysed for VOCs, PHC, and BTEX.</li> </ul> |

*Image 9 – MW5 on the subject property*
