## Phase I - Environmental Site Assessment

Vacant Land, Strandherd Drive at Kennevale Drive  
Ottawa, Ontario

### Paterson Group Inc.

Report: PE2785-1

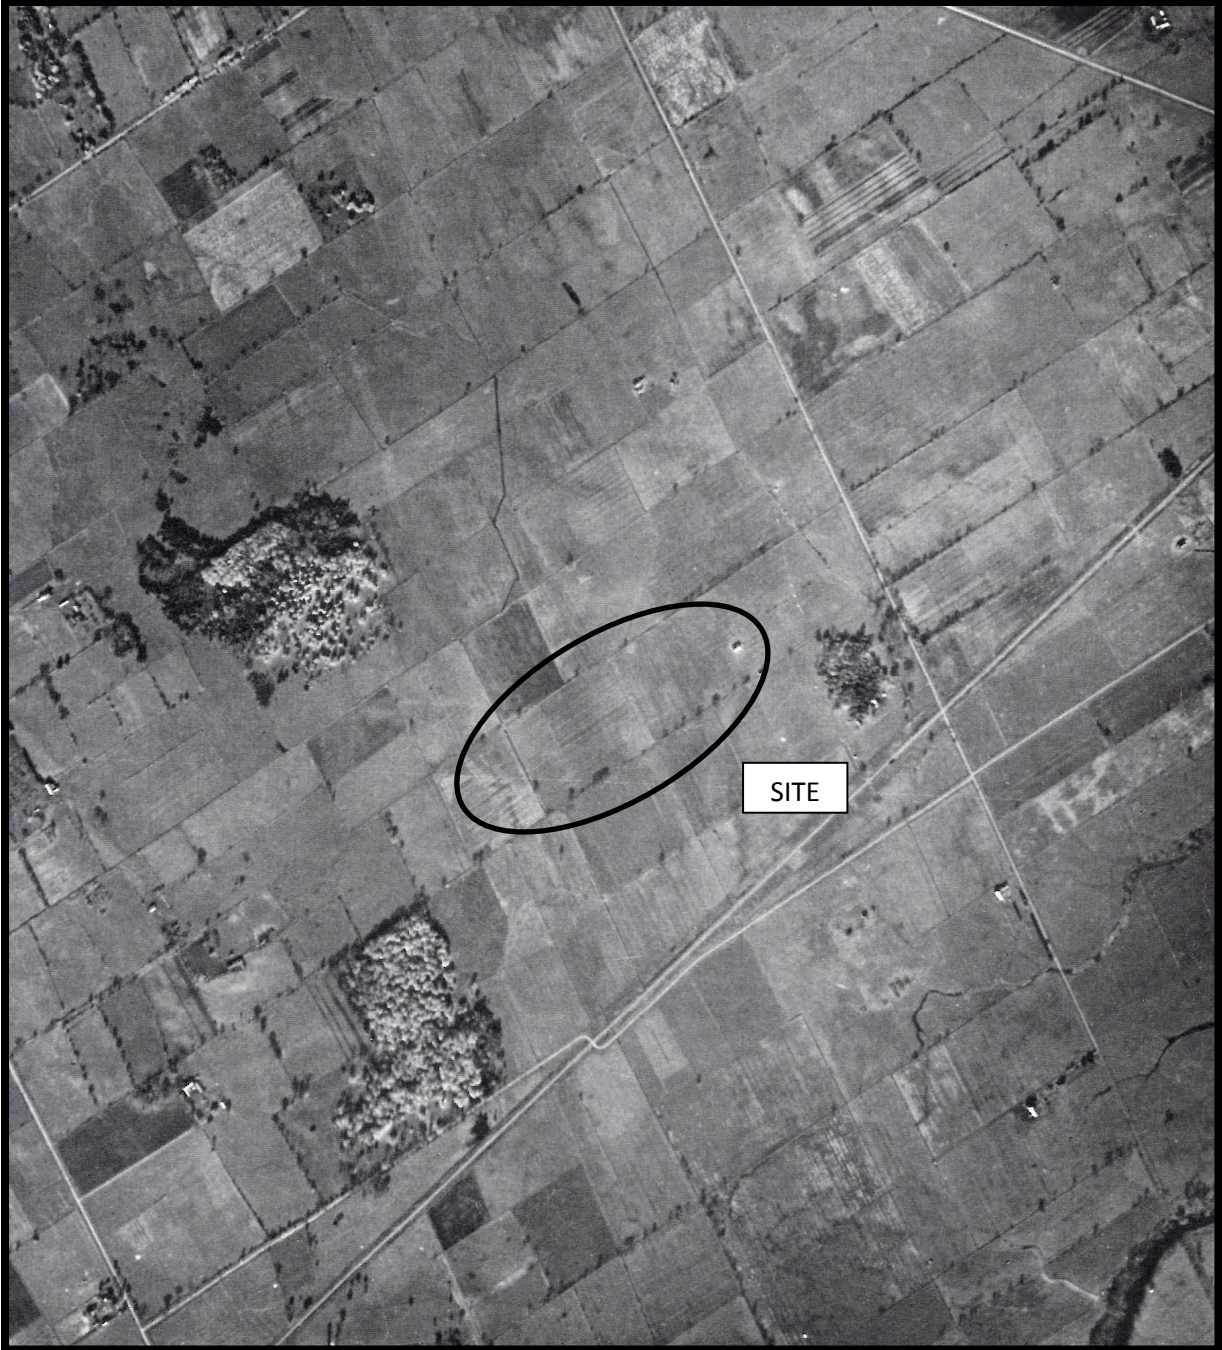
AERIAL PHOTOGRAPH  
1945

- 1945 The subject site and adjacent properties are vacant agricultural land. A rail line is present further to the south.
- 1963 No significant changes have been made to the subject site or surrounding properties.
