**Hydrogeology Assessment
Metcalf Agricultural Society
2821 8th Line Road, Metcalfe, Ontario**

Final Report

Prepared for:
Metcalf Agricultural Society

Prepared by:
Stantec Consulting Ltd.

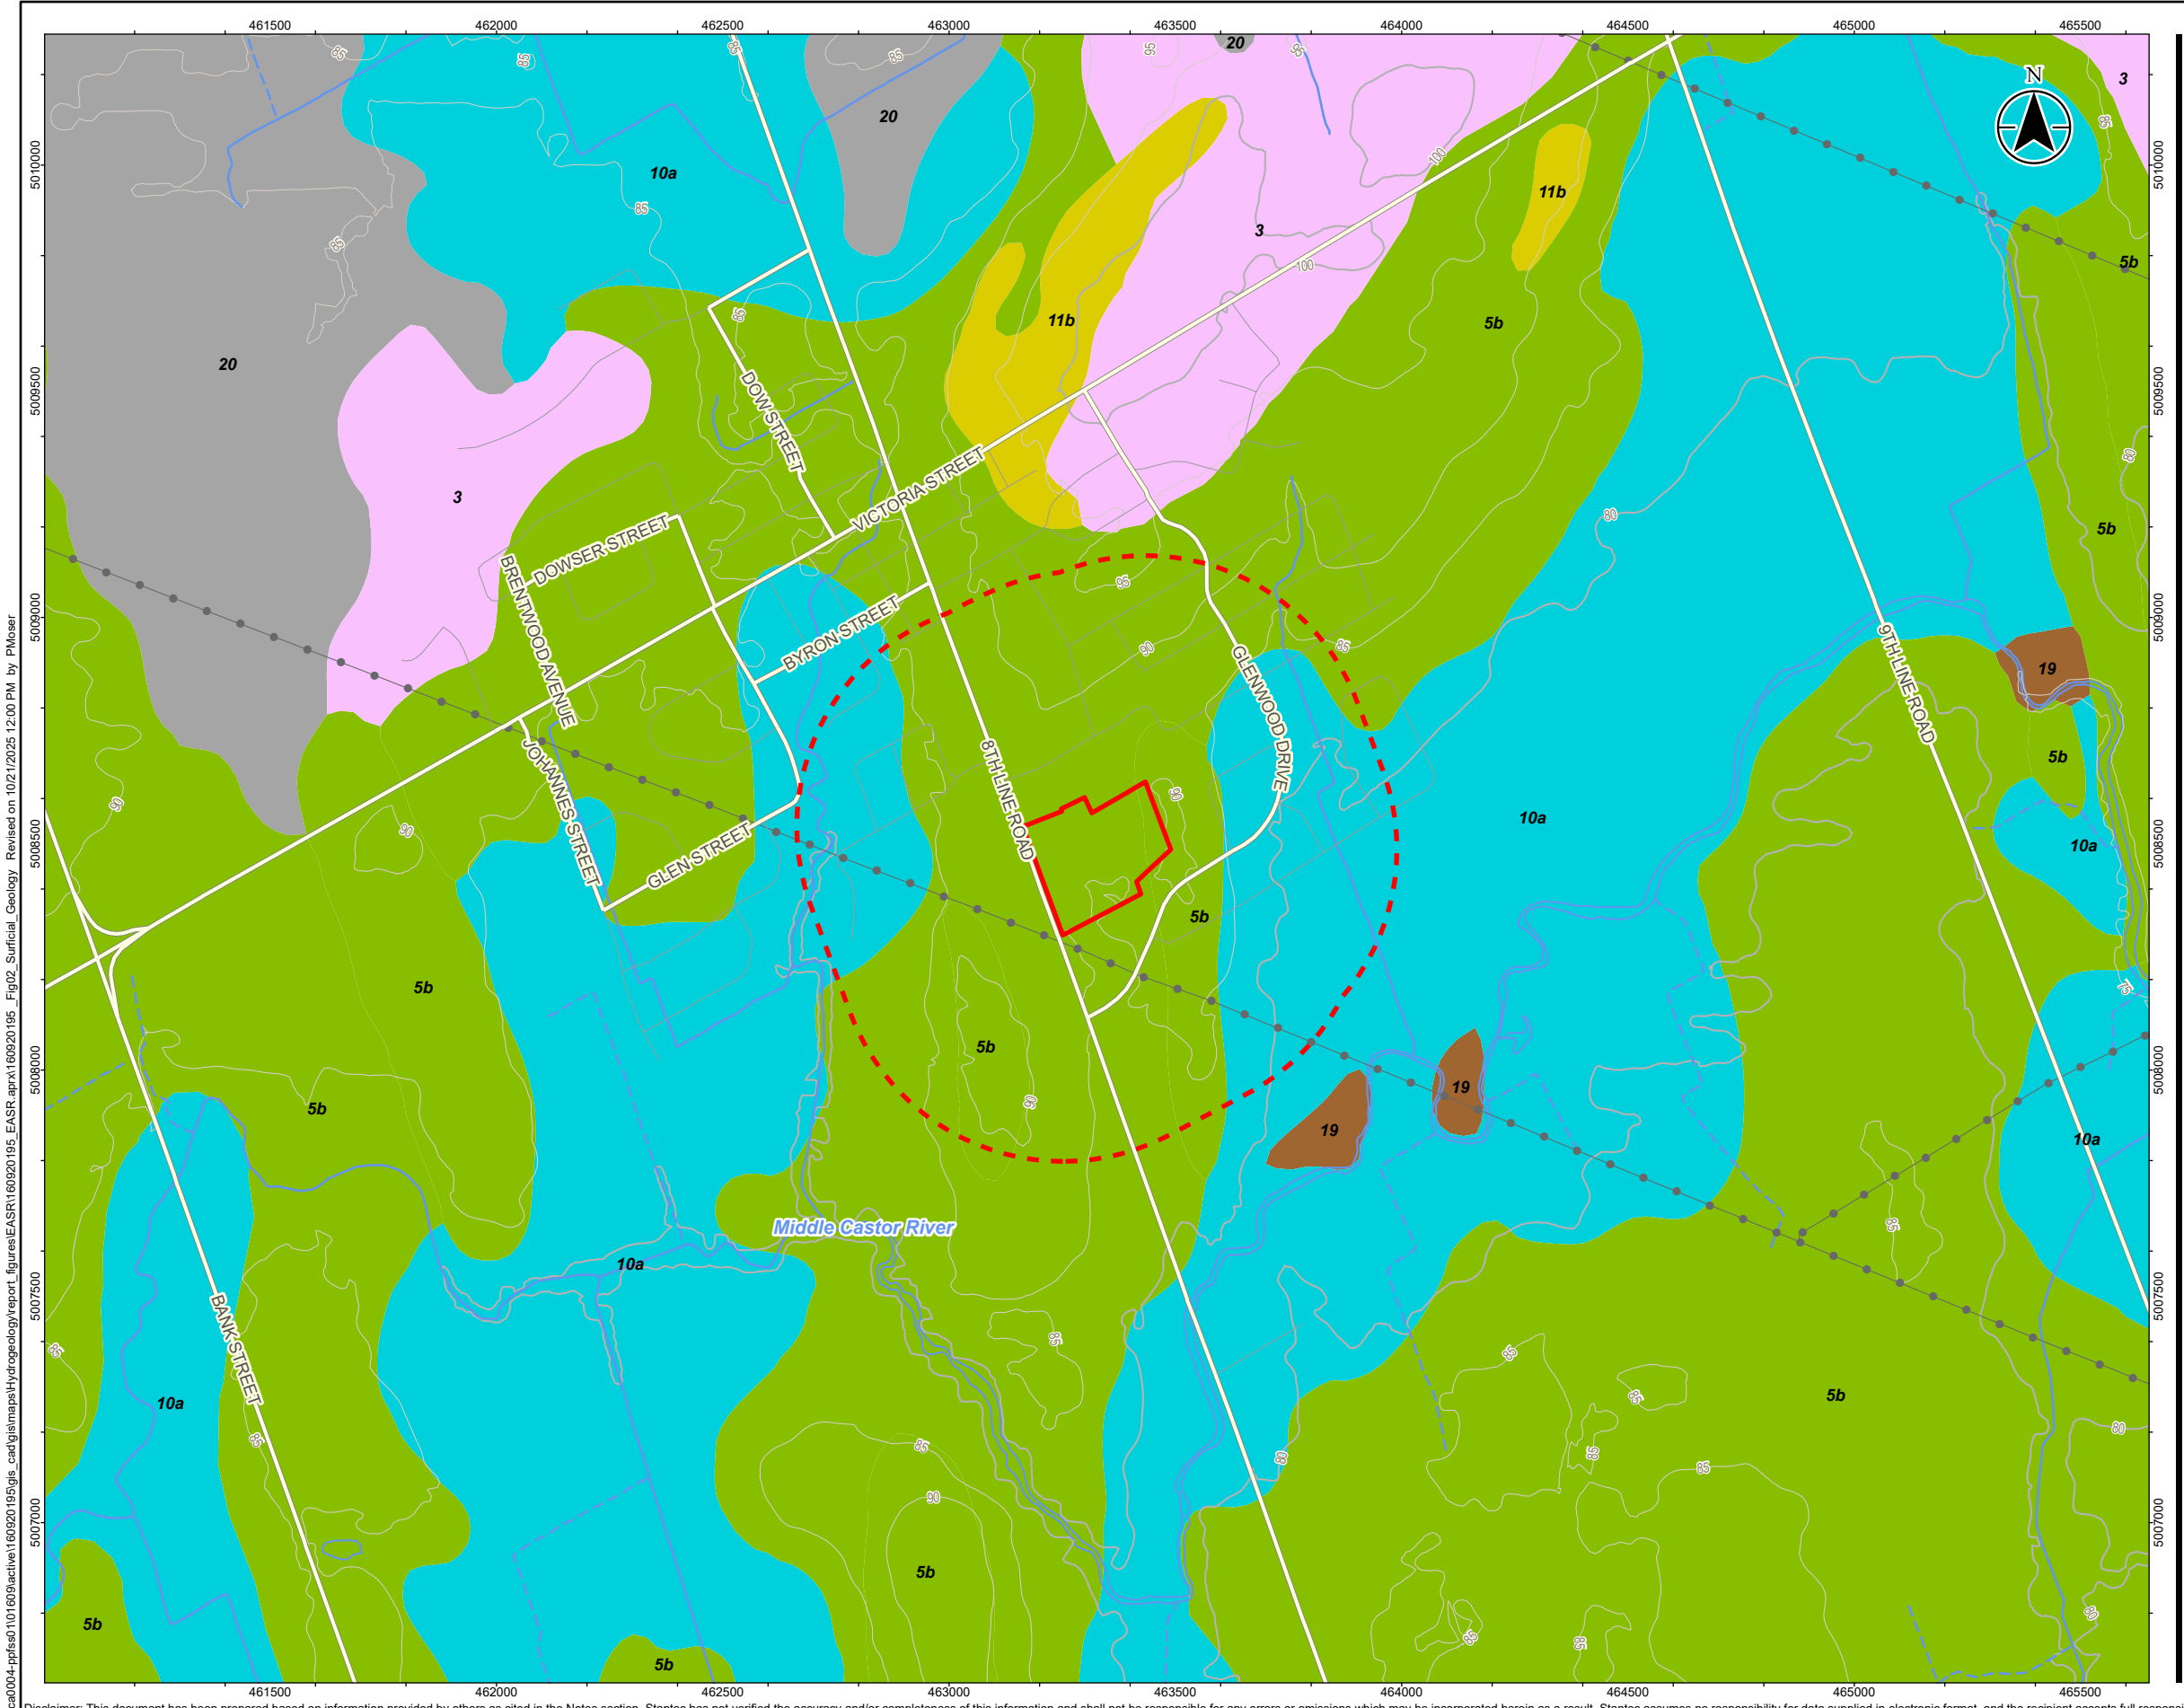
Figure No.
2
Title
Surficial Geology

Surficial geology and bedrock mapping by the Ontario Geological Survey (OGS 2010) are presented on Figure 2 and Figure 3, respectively. As shown on Figure 2, the Site is mapped in an area characterized by silty to sandy till deposits. Areas surrounding the Site are mapped as fine textured glaciomarine deposits. Bedrock near the Site is described by Armstrong and Dodge (2007) as dolostone and sandstone of the Oxford Formation, part of the Beekmantown Group ((Figure 3). Bedrock beneath the Site consists of limestone and was confirmed during coring completed as part of Stantec's geotechnical investigation (2025) at depths between 0.9 m and 0.8 m below ground surface (BGS).
