Roof Maintenance Solutions Inc.

Phase II Environmental Site Assessment  
Revision 2.0 Remediation  
3210 Albion Road South  
Ottawa, Ontario

SDC1023

J uly 23, 2025

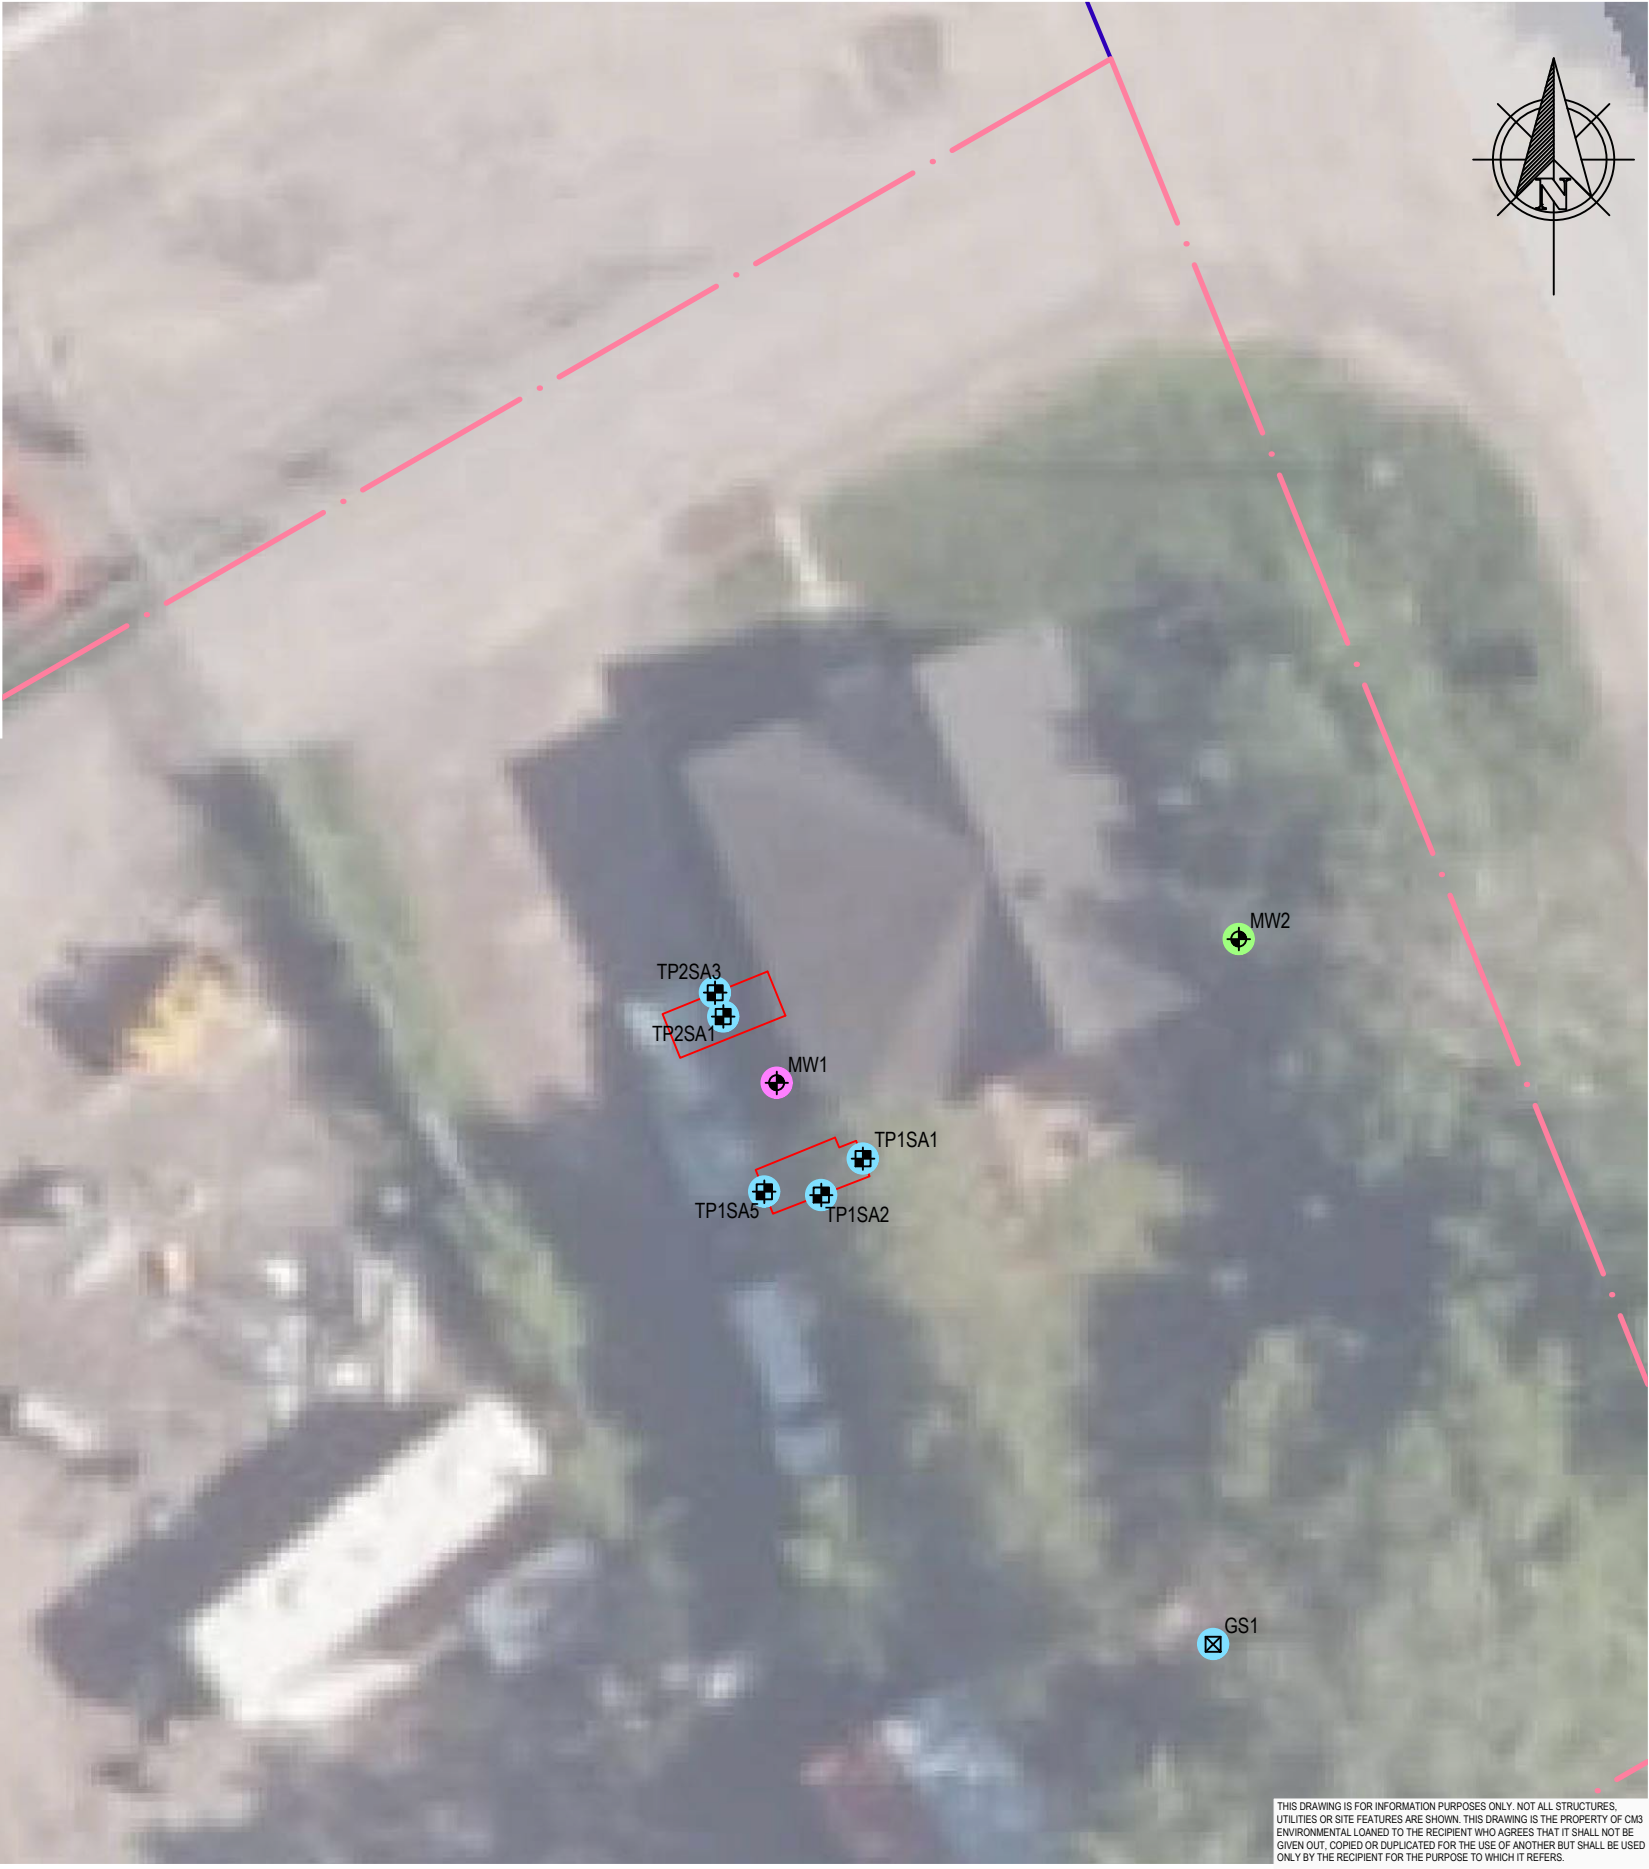
| Scale: | 1:200 | Figure: | 3 |

One borehole (MW1) and two test pits (TP1 and TP2) were completed at APEC 2 and seven soil sample were analysed for PHCs in the F1 to F4 fractions. The results were either non-detectable or had concentration of BTEX and/or PHCs in the F1 to F4 fractions that comply with the Table 3 SCS except for one sample, (MW1SA3). The soil sample MW1SA3 had detectable levels of PHCs in the F1 to F3 fraction with the F2 fraction exceeding the Table 3 SCS. All other parameters in soil sample MW1SA3 were non-detectable.

The soil sample analytical results for the boreholes and test pits are summarized in Table 2. The soil sample analytical results for the soil pile sample are summarized in Table 3. The monitoring well, test pit and soil pile locations and soil quality are provided on Figure 3. The soil sample laboratory reports are provided in Appendix B.

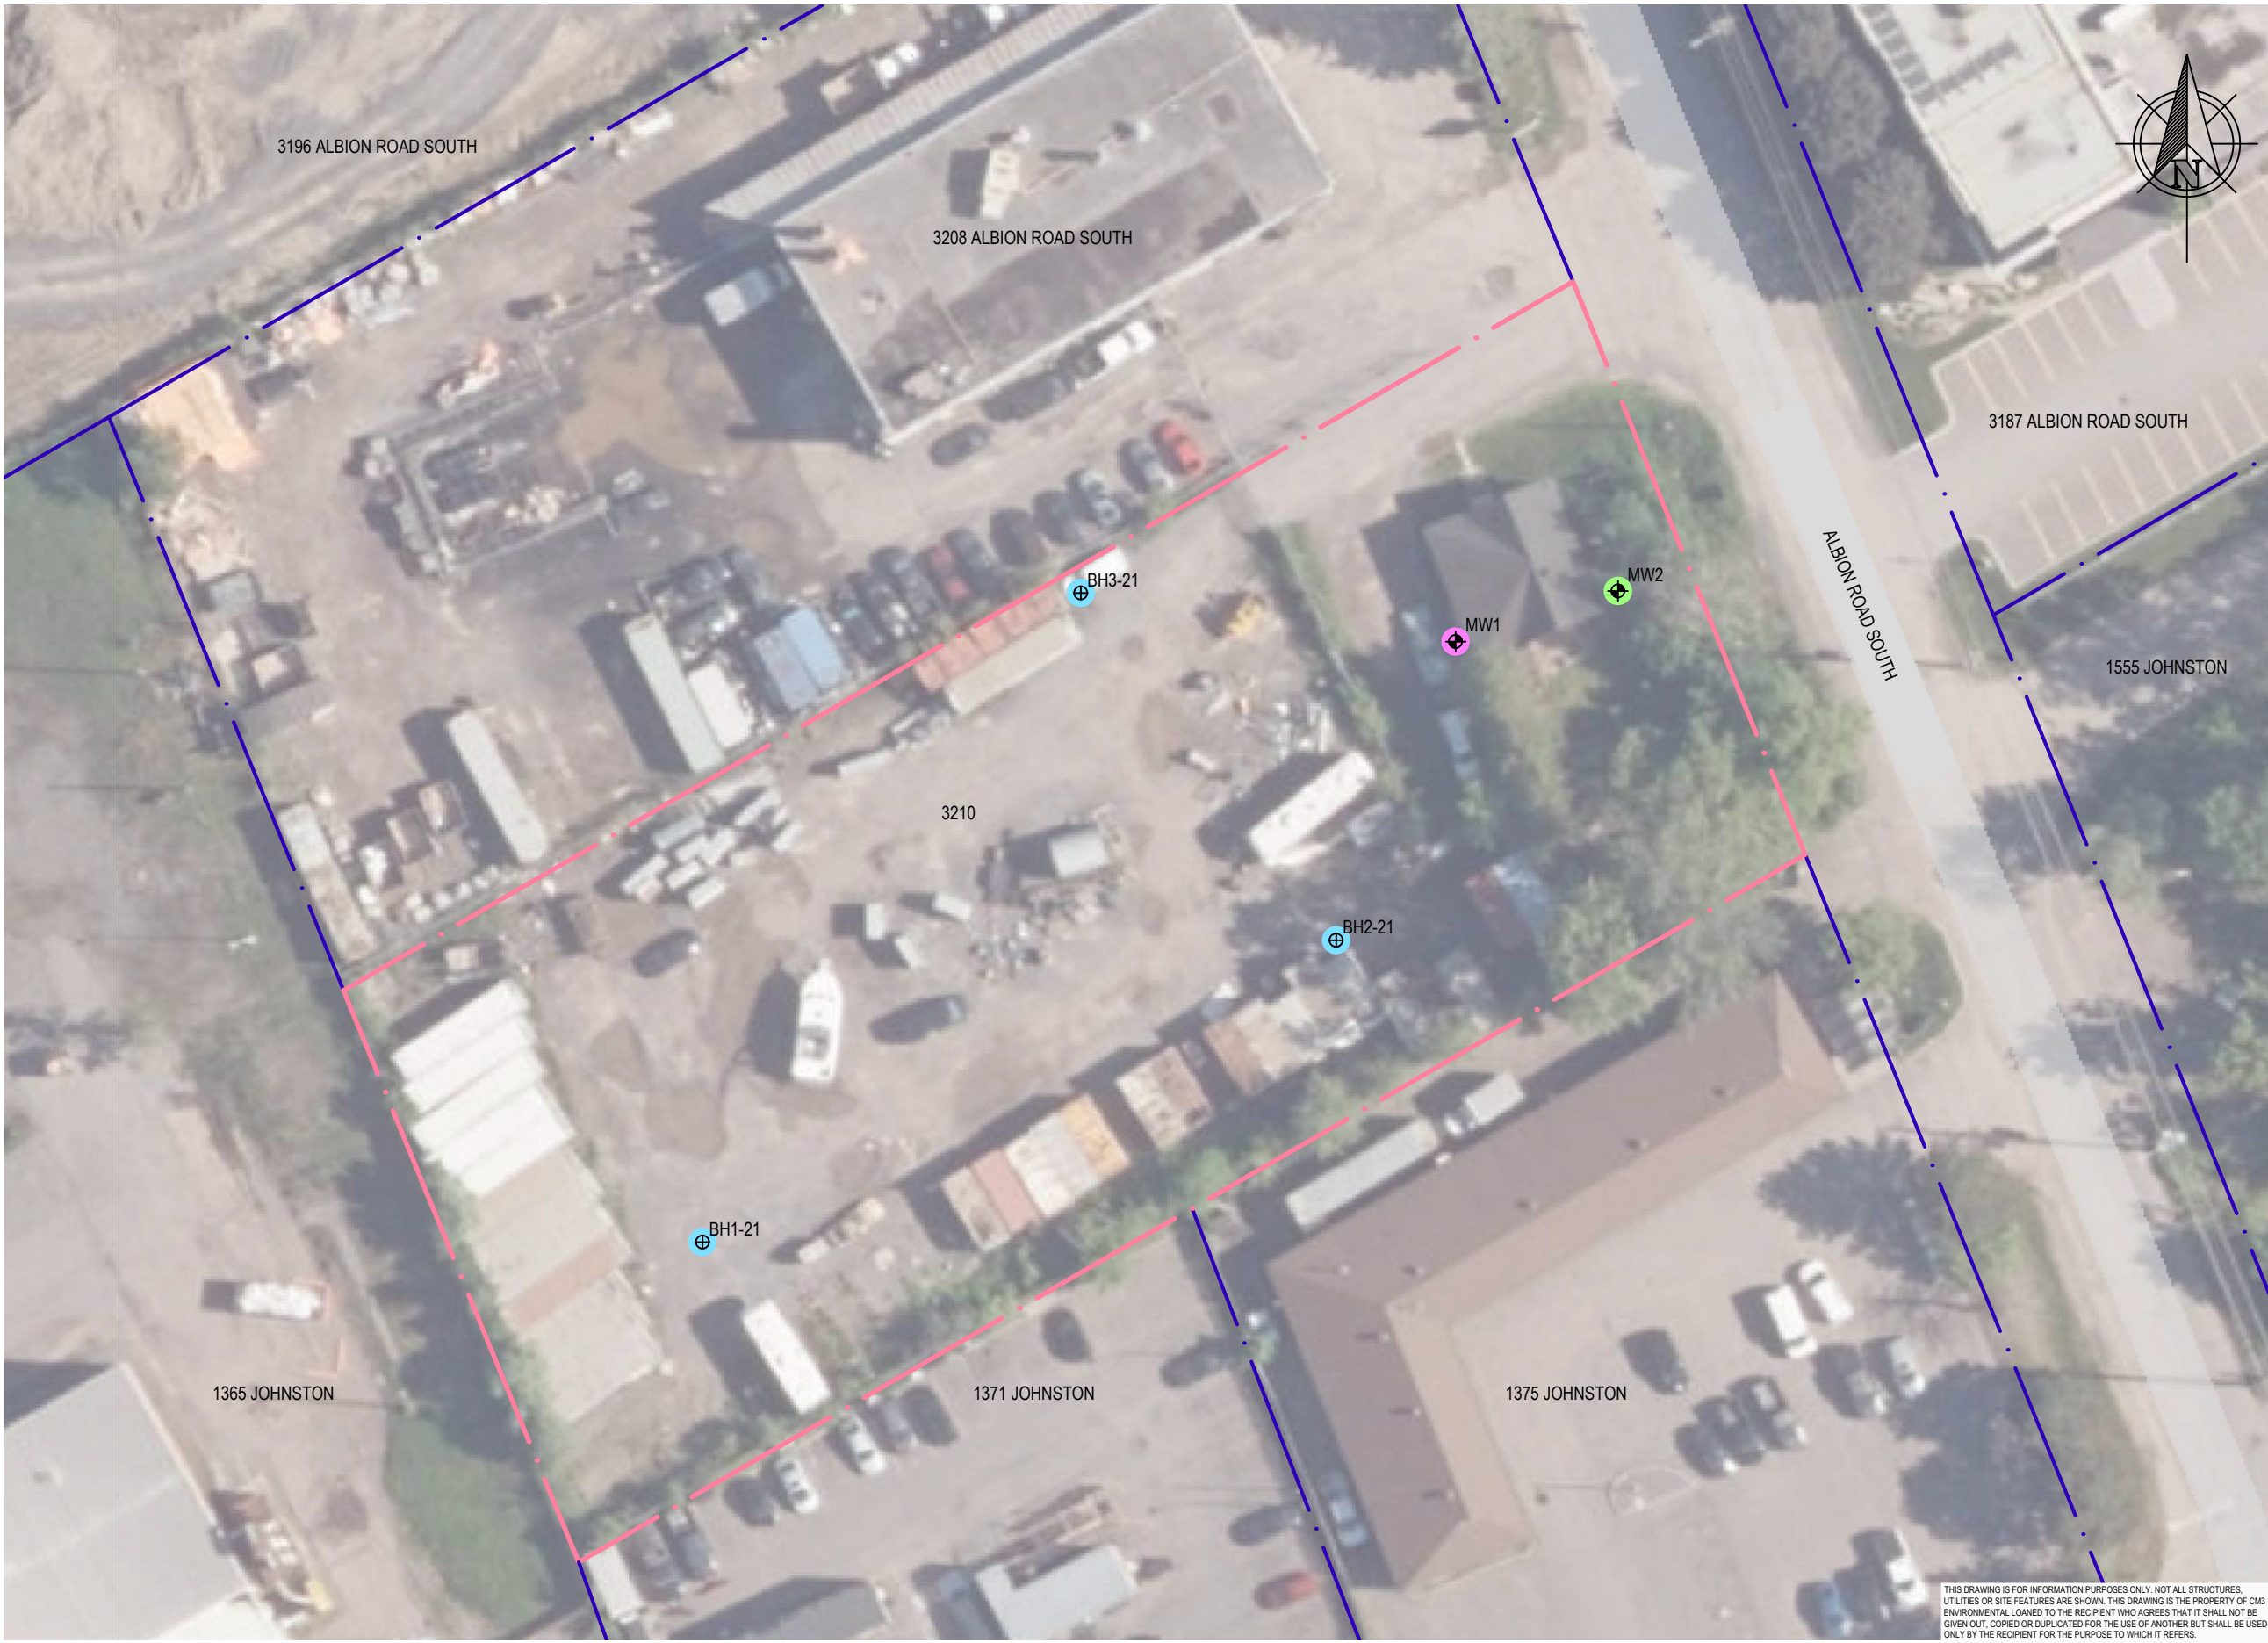
| Scale: | 1:500 | Figure: | 4 |

One monitoring well (MW1) was installed at APEC 2 and one groundwater sample was analysed for COCs including PHCs and BTEX. Laboratory results indicated that groundwater sample 'MW2\_ did not have detectable concentrations of BTEX or PHCs in the F1 and F4 fractions but did have

detectable levels of PHCs in the F2 and F3 fractions. The concentrations of PHCs in the F2 and F3 fractions exceeded the Table 3 SCS.

The three existing monitoring wells BH1-21 to BH3-21 were sampled for PHCs F1-F4, VOCs, PAHs, metals. The results were either non-detectable or had concentrations of PHCs F1-F4, VOCs, PAHs, and metals that comply with the Table 3 SCS

The groundwater sample analytical results are summarized in Table 4. The monitoring well locations and groundwater quality are provided on Figure 4. The groundwater sample laboratory reports are provided in Appendix B.
