Muncaster
Environmental
Planning Inc.

September 12, 2025

**RE: 2726 Moodie Drive – Proposed Commercial Development
Environmental Impact Study and Tree Conservation Report - Updated**

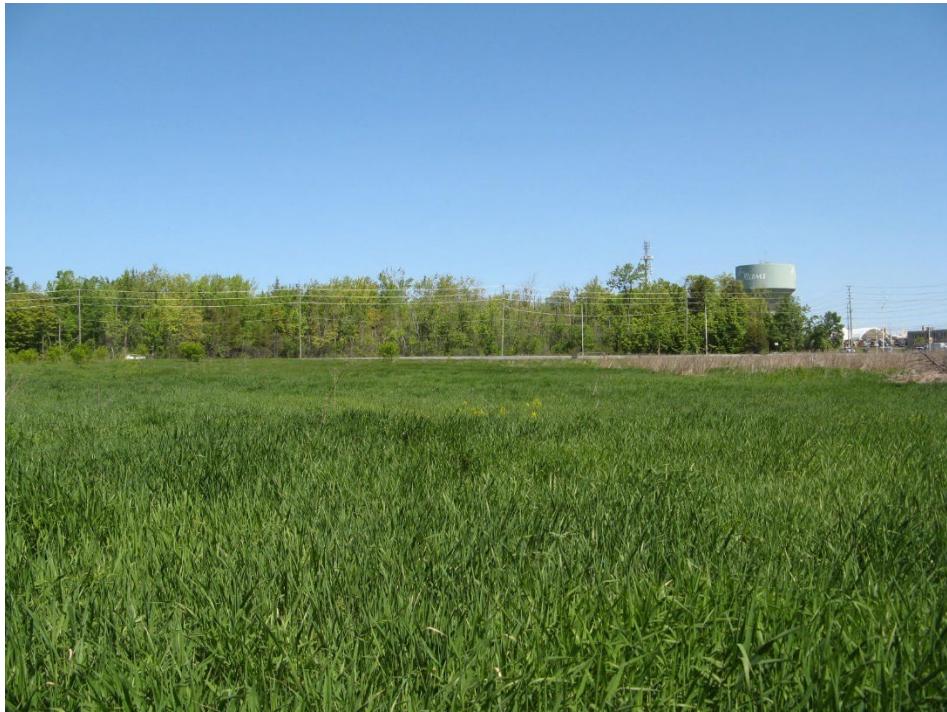
*Photo 1 – Site looking north from the south-central edge.
Note Monahan Forest in the background, on the north side of Fallowfield Road*

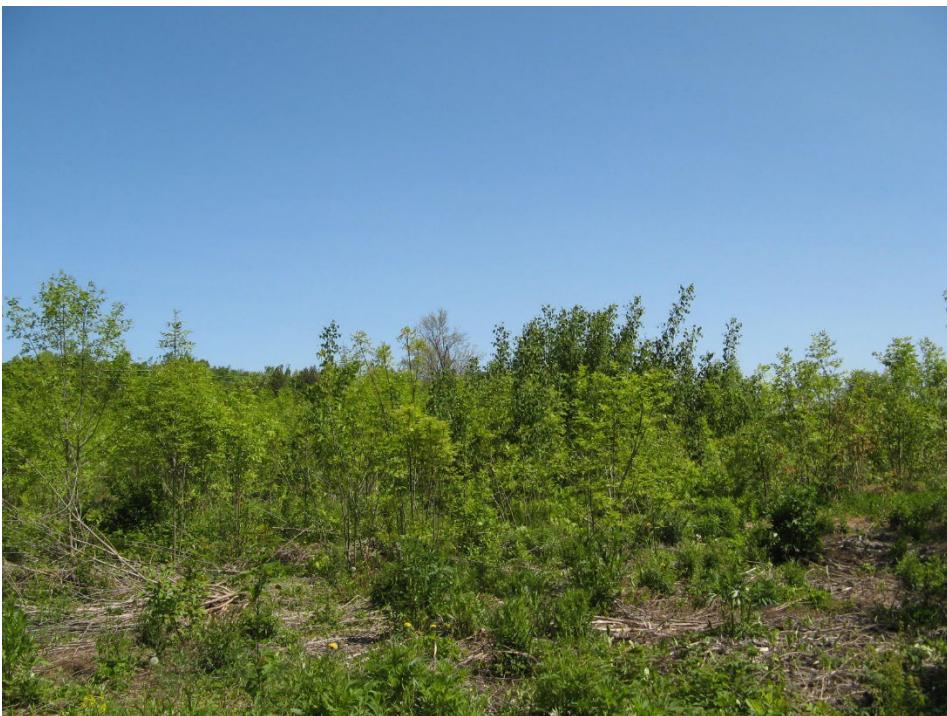
Photo 2 – Cultural thicket in the west portion of the site. View looking northeast.

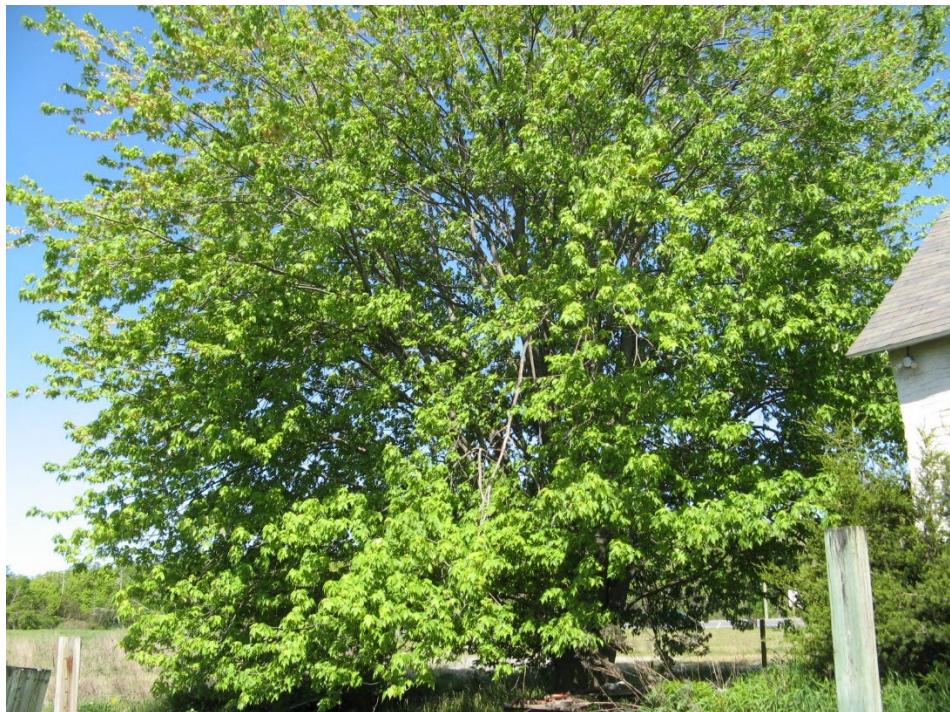
*Photo 3 – Red maple, Tree 'A' on Map 1, to the east of Moodie Drive. View looking north.
Tree now removed*

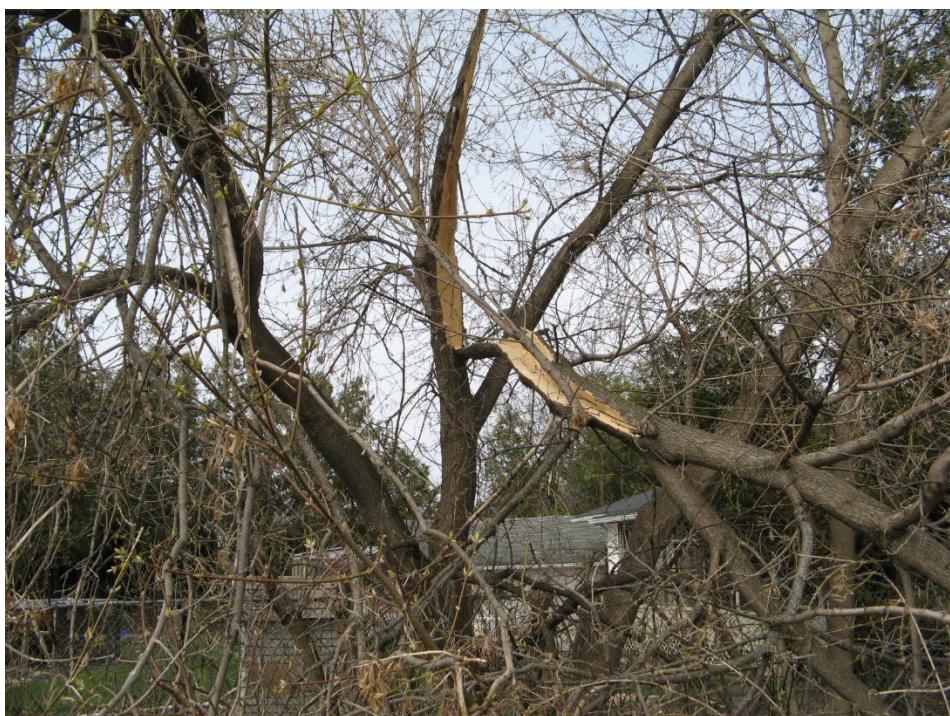
A deciduous hedgerow dominated by Manitoba maple (Trees 'C' on Map 1) was along the northwest property line shared with 4644 Fallowfield Road, south of Moodie Drive. In addition to extensive wind damage, there was major trunk damage on the maples (Photo 4). Most of the Manitoba maple were coppice, with the largest individual stems up to 35cm dbh. Other trees in the deciduous hedgerow included green ash and basswood up to 25cm and 20cm dbh, respectively (Trees 'D' on Map 1) and regenerating stems of Manitoba maple and white cedar.

Photo 4 – Extensive damage on the Manitoba maples, Trees 'C' on Map 1, along the northwest site boundary. View looking northwest. Tree now removed

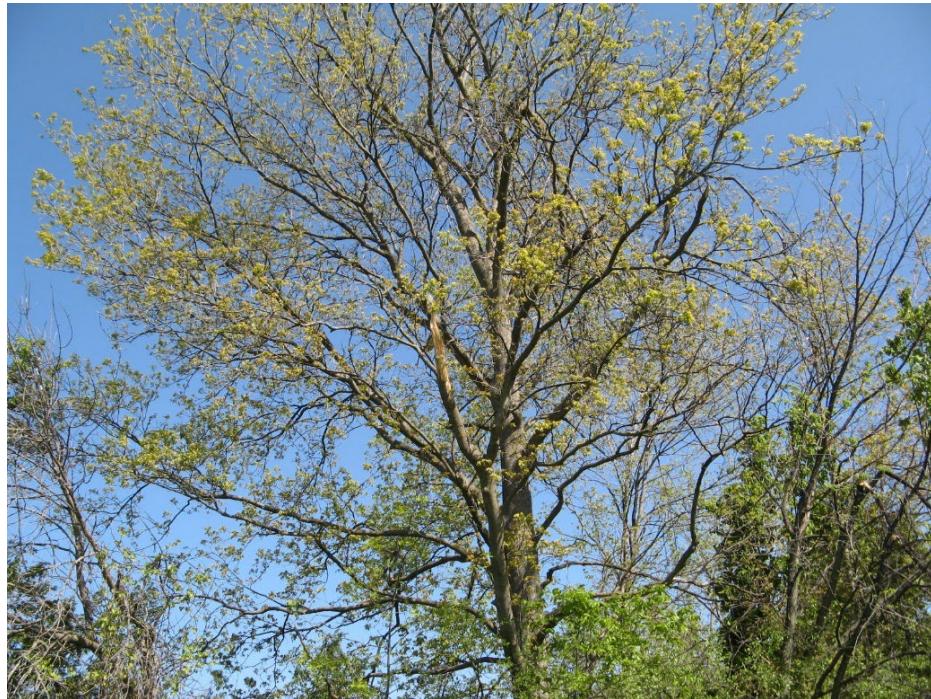
An intermittent deciduous hedgerow was along the north property line shared with the rear of 4644 to 4670 Fallowfield Road. A mature Manitoba maple (approximately 75cm dbh and Tree 'E' on Map 1) was just north of the property line (Photo 5). Wind damage was common on this tree, as it was on a 24cm dbh white elm to the east of the large Manitoba maple. Green ash and white cedars up to 20cm dbh and common buckthorn shrubs were also along and just north of the property line in this area. Wild grape coverage was common on the lower portions of these trees and many of the ash and elm had poor leaf-out. Further to the west, along the west portion of the property line with the rear of 4658 Fallowfield Road, was a 32cm dbh black walnut (Tree 'F' on Map 1, Photo 6). This tree was in poor condition, with many dead branches. This black walnut was told from butternut by the lack of a developed terminal leaflet, terminal buds that are as long as broad, and notched, non-hairy leaf scars. Thicket creeper growth was common on the lower branches. To the west of this tree regenerating Manitoba maple and ash stems have wind damage. Slender willow shrubs are also very common in this area. Along the property line with 4664 Fallowfield Road, five Norway maples are between 25cm and 48cm dbh (Trees 'G' on Map 1). The trees appeared to be in generally good condition, with some pruning. The property line at the rear of 4664 Fallowfield Road was not easily identified in this area. Regenerating ash stems are common at the rear of 4670 Fallowfield Road. All of these stems are less than 20cm dbh.

Photo 5 – Mature Manitoba maple, Tree 'E' on Map 1, immediately north of the northwest portion of the site. View looking north. Tree now removed

The outer portions of the critical root zones of Trees 'E' and 'G' along the north boundary in the west portion of the site may be impacted by the construction as the critical root zones extend onto the site up to 7 metres and 4.8 metres for Trees 'E' and 'G', respectively. Tree 'E' has been removed. If the adjacent landowner for the row of maples (Trees 'G') chooses to retain these trees in lieu of new plantings of native species, excavations within the outer critical root zones of adjacent trees to the north are to be completed by hand where feasible. Exposed roots either should be kept moist and protected until they can be backfilled, or as advised by a certified arborist, the roots cut cleanly at a proper angle to facilitate healing.

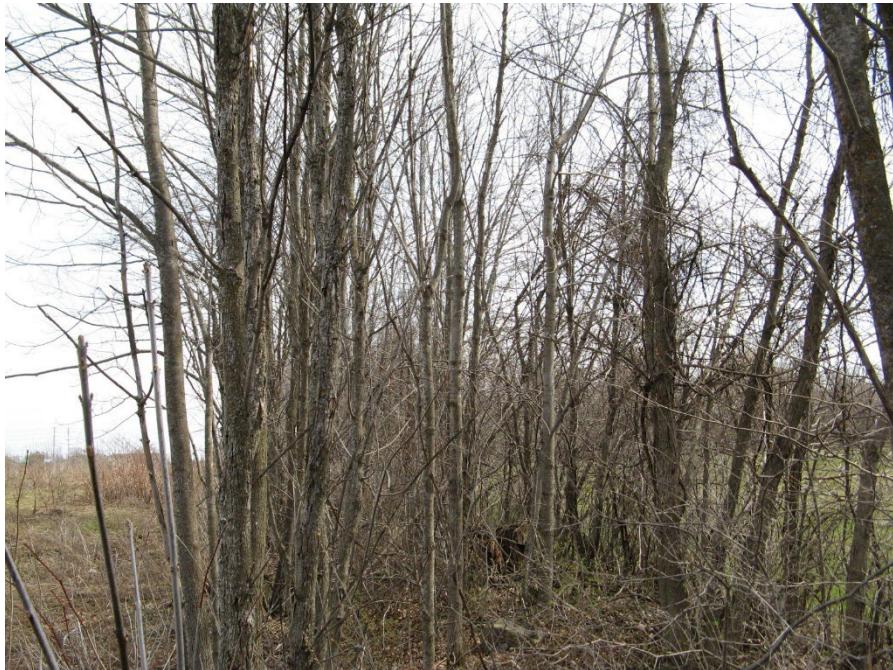
In the west portion of the south property line, a deciduous hedgerow begins immediately north of the property line and extends onto the site by up to five metres (Trees 'H' on Map 1, Photo 7).

There are no trees along or south of the property line. Basswood up to 25cm dbh are dominant, with black cherry and trembling aspen up to 28cm dbh and smaller green ash, red maple, Manitoba maple, and white elm also present. These trees have some wind damage but generally appear to be in good condition. Common buckthorn, prickly ash, staghorn sumac, black currant, tartarian honeysuckle, common lilac, slender willow, and red raspberry shrubs are among the hedgerow trees, along with regenerating basswood, Manitoba maple, cherry, and ash stems. Ground cover includes the highly invasive lamium, along with common mullein, wild carrot, evening primrose, thicket creeper, common strawberry and blue violet. White trillium, wild ginger, Canada mayflower, and trout lily are likely remnants from former forested conditions.

Photo 7 – Deciduous hedgerow, Trees 'H' on Map 1, immediately to the north of the south property line. View looking east

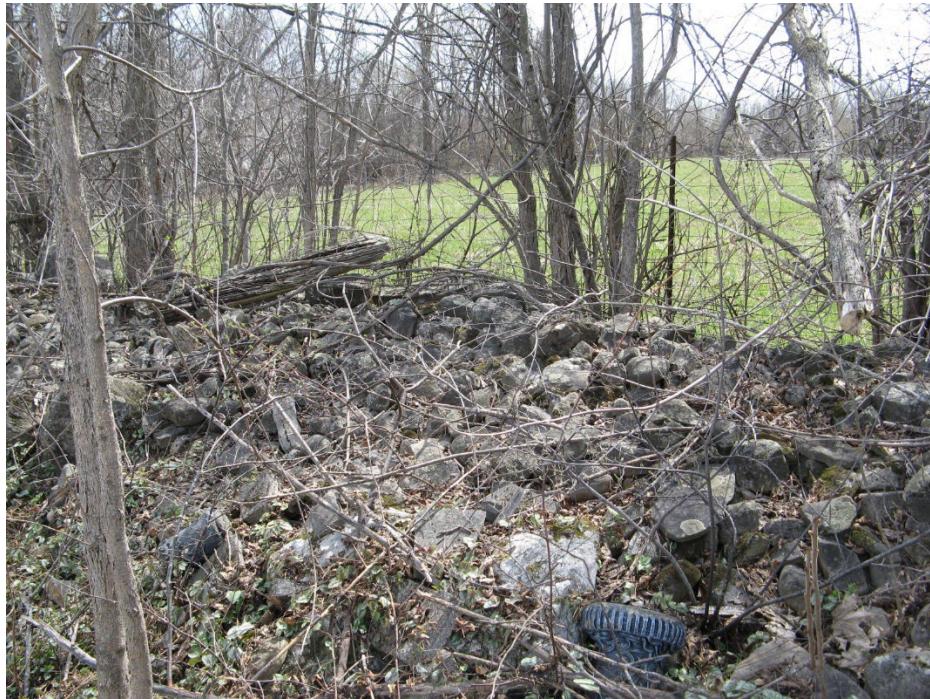
*Photo 9 – Stone piles immediately north of the west portion of the south property line.
View looking southeast*

observed on or adjacent to the site. No evidence of raptor utilization was observed. Stone piles along the west portion of the south property line could provide over-wintering habitat for snakes and other wildlife.

6. The stone piles along the west portion of the south property line are not anticipated to be impacted. If these piles need to be altered, the disturbance is to take place between April and October to minimize the potential for impacts to reptile hibernaculum or other over-wintering wildlife;

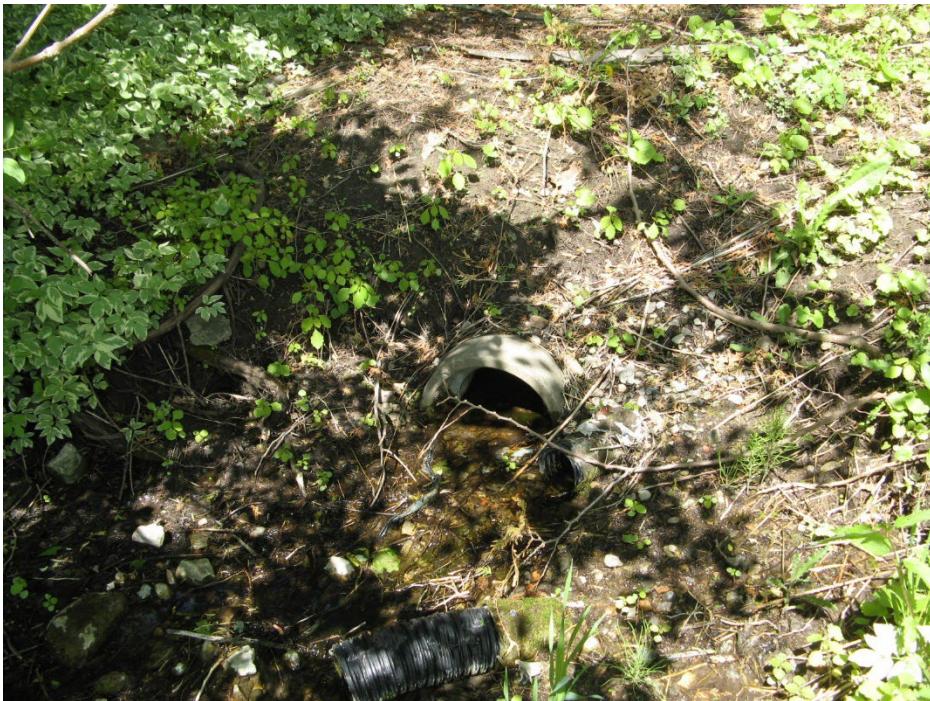
with potential habitat upstream and downstream of the site. The ditch is fed by a culvert and two drain outlets in the northwest corner of the site (Photo 10). There is no channel present to the north of the site, with a poorly defined scratch swale to the southwest. Some standing water, up to two cm deep, was present in the ditch on April 21st and May 25th (Photo 11). No fish were observed in the clear, very shallow water during either survey.

*Photo 10 – Culvert and drain outlets entering the ditch along the west property line.
View looking northeast*

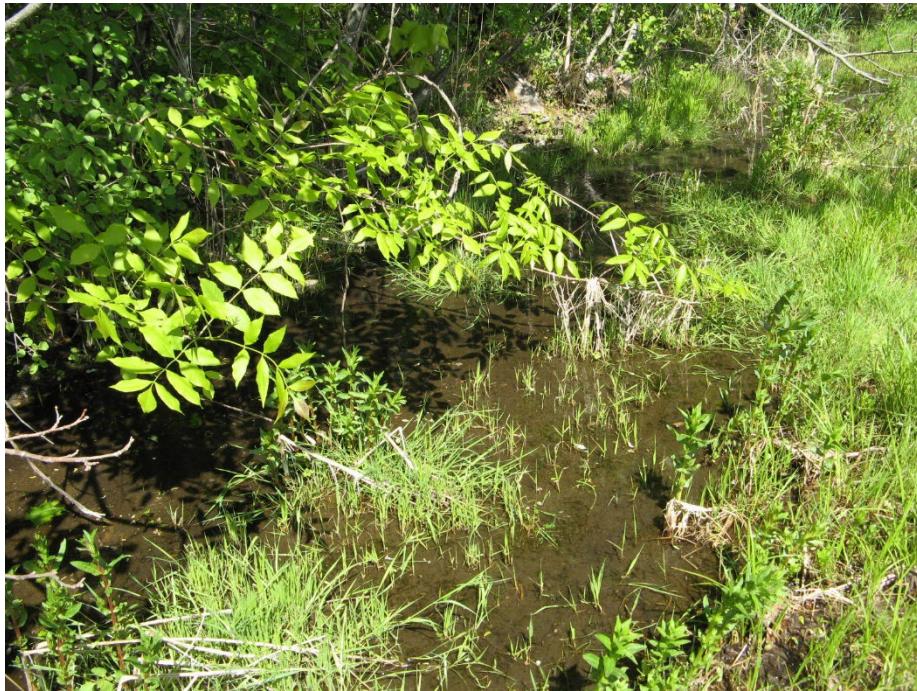
*Photo 11 – A wider section of standing water up to 2cm deep in the ditch on May 25th, 2023.
View looking north*

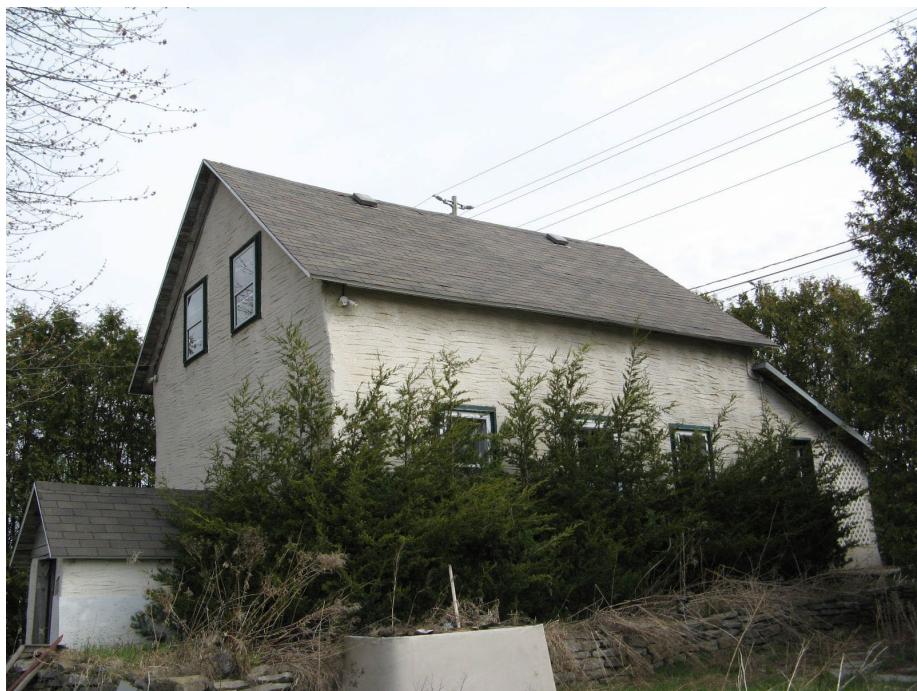
*Photo 12 –Residence, now removed, on the east side of Moodie Drive.
View looking northeast*

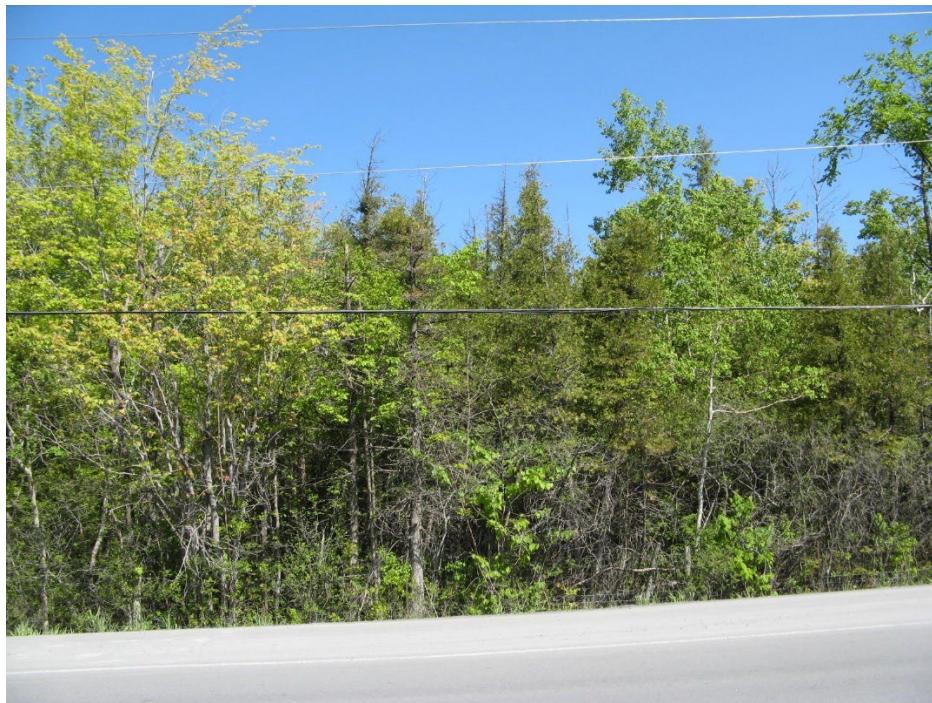
Sugar maple, red maple, white cedar, trembling aspen, and basswood are well represented in the portion of the Monahan Forest closest to the site, north of Fallowfield Road (Photo 13). The largest trees in proximity to the south portion of the forest are up to 40cm dbh, with most trees in the 15cm to 25cm dbh range. As the south edge of the forest trees are approximately 25 metres north of the site, there is no potential for critical root zones of these trees extending south onto the site.

*Photo 13 – Monahan Forest to the north of the site, north of Fallowfield Road.
View looking north*

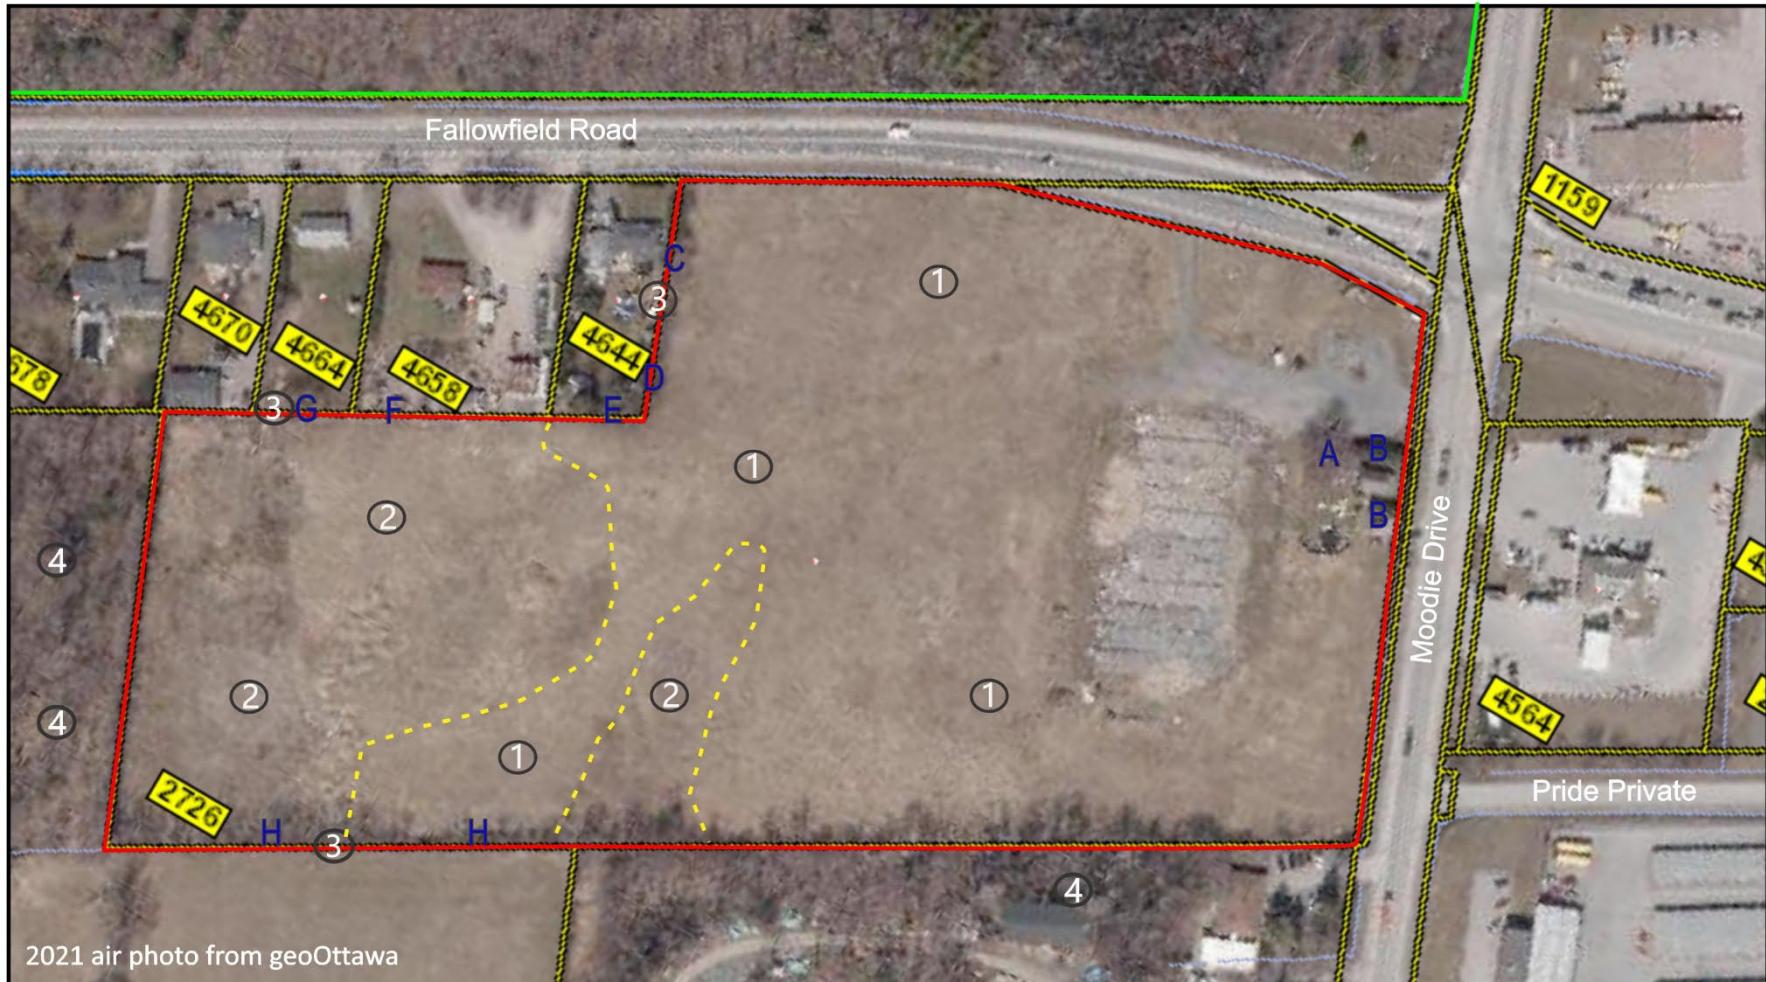
Ground vegetation and shrubs have regenerated on the site. Map 1 shows the west portion of the site as cultural thicket as the extent of woody vegetation is greater than 25 percent. The common ground flora generally reflects the past site disturbances. In areas orchard grass, reed canary grass, and Canada goldenrod are dominant (Photo 1). Other ground flora includes curled dock, colt's-foot, bull thistle, Canada thistle, wild carrot, evening primrose, common burdock, awnless brome grass, June meadow grass, barnyard grass, field sow-thistle, Canada thistle, common mugwort, tall buttercup, wormseed mustard, field mustard, white bedstraw, field horsetail, Canada goldenrod, heart-leaved aster, white-sweet clover, common mullein, blueweed, hoary alyssum, wild grape, common milkweed, wild parsnip, common dandelion, and ox-eye daisy, with trout lily and sensitive fern also observed. A small area of broad-leaved cattail is among goldenrod and field horsetail in the northwest corner of the site, adjacent to the north portion of the ditch described above. Spotted jewelweed is also along portions of the ditch edge.

EXISTING CONDITIONS - EIS & TCR

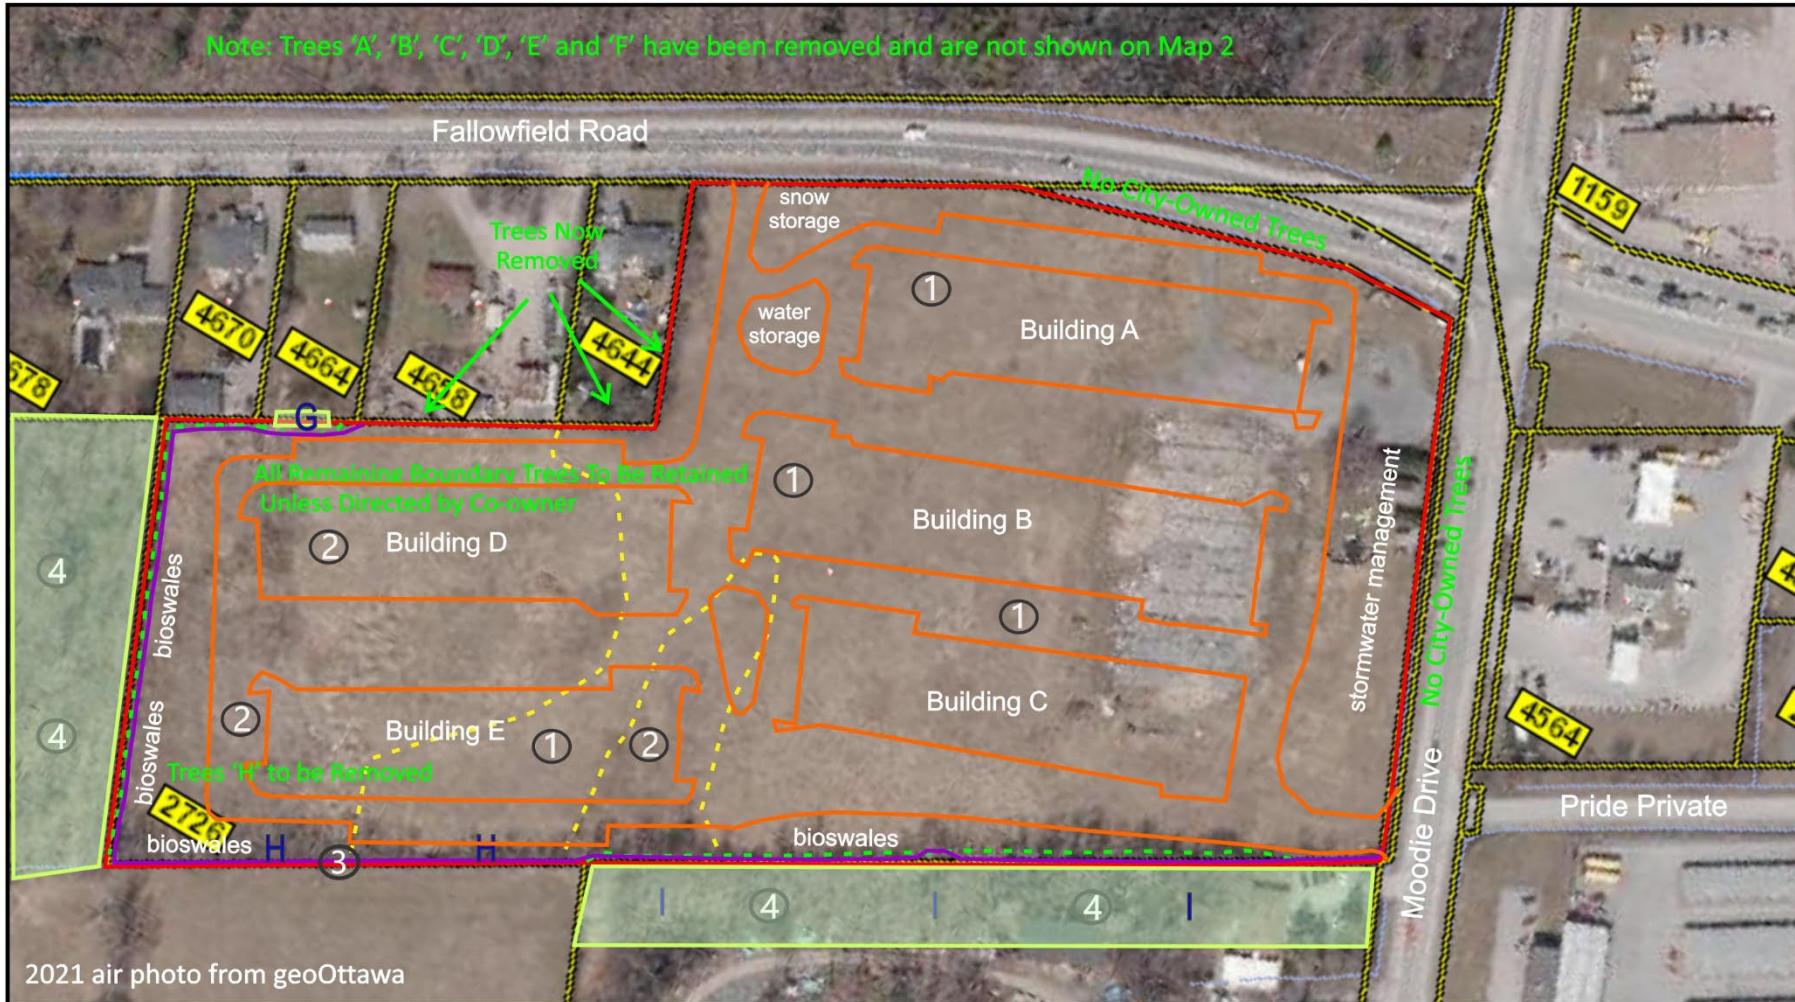
As indicated in Table 1 boundary trees are present on portions of the site periphery. The critical root zones of the boundary and adjacent trees are shown on Map 2. For the northwest boundary, including Trees 'C' and 'D', no impacts were anticipated on these trees and their critical root zones. The landowner to the west is the same as the Applicant and these trees have been removed.

PROPOSED CONSERVED VEGETATION - EIS & TCR

Tree protection fencing in the form of silt fencing is recommended along the outer edge of the critical root zones shown on Map 2 or the site boundary where critical root zones of adjacent trees to be retained area not present. In locations where the edge of construction will occur within the outer portions of the critical root zones, the temporary fencing is to be installed as
