**Hydrogeology Assessment  
Metcalf Agricultural Society  
2821 8<sup>th</sup> Line Road, Metcalfe, Ontario**

Final Report  
Version 2

Prepared for:  
Metcalf Agricultural Society

Prepared by:  
Stantec Consulting Ltd.

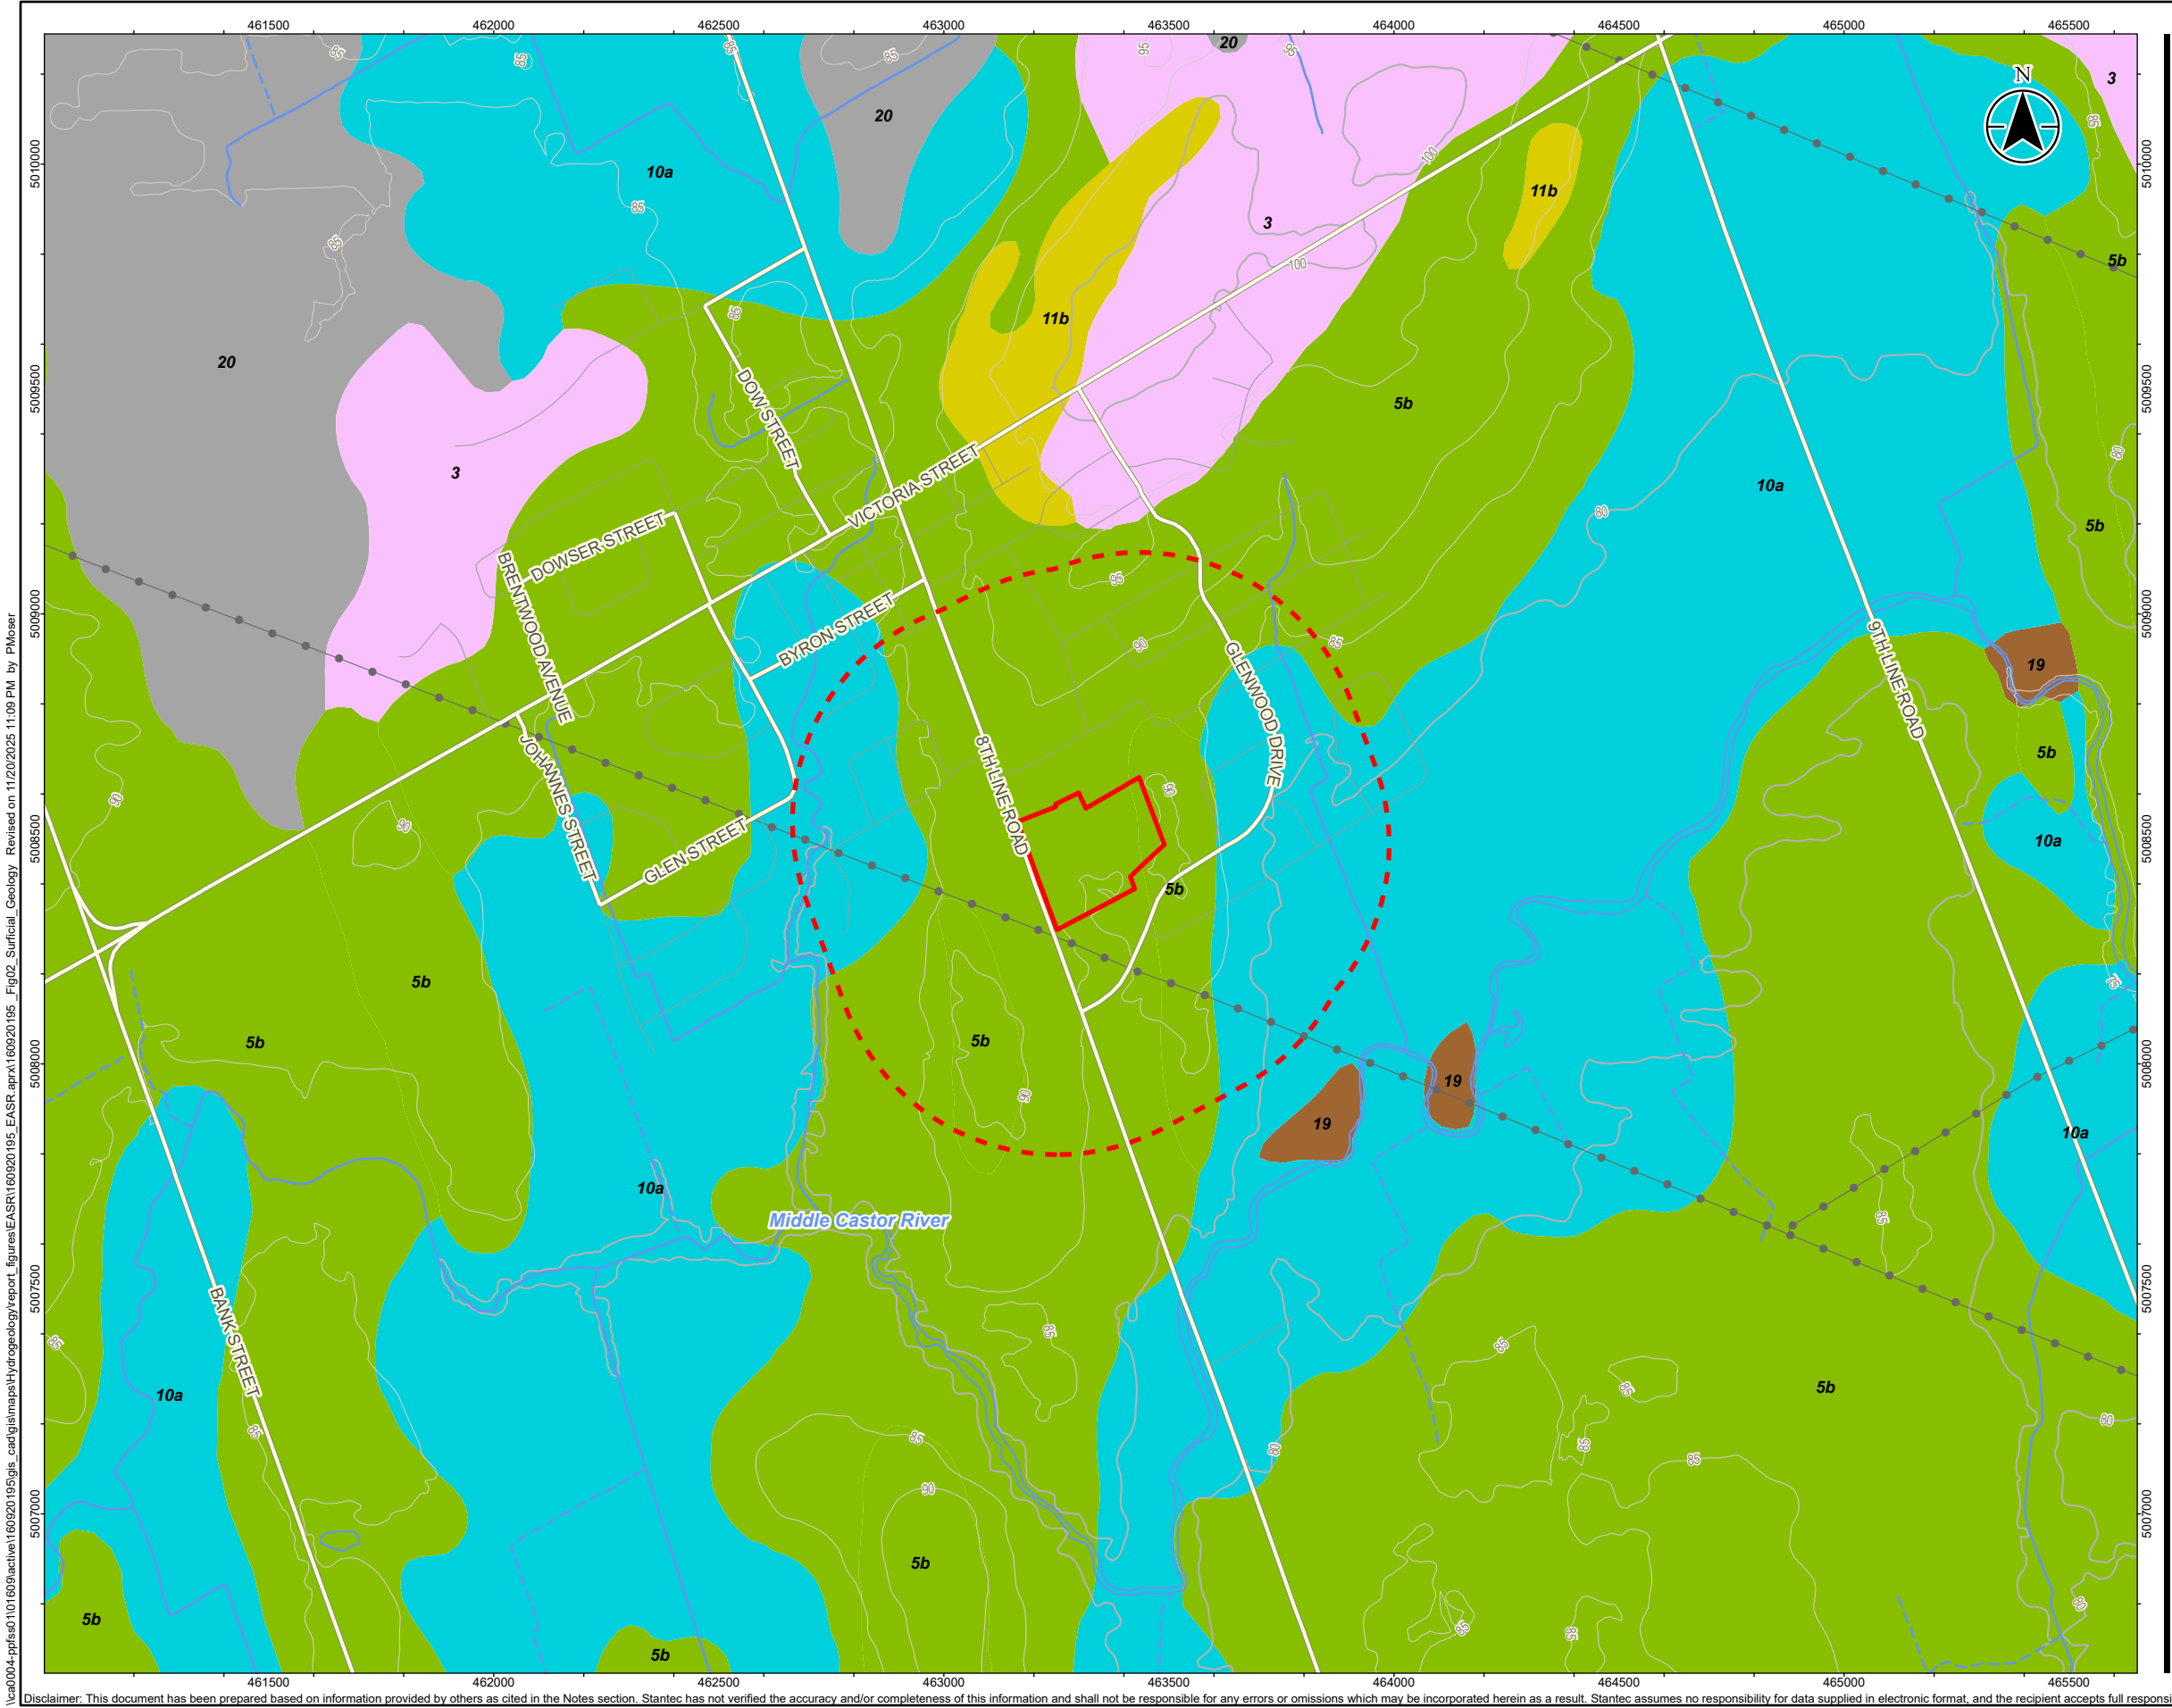
- Site Boundary
- Study Area (500m)
- Major Road
- Minor Road
- Hydro Line
- Contour (10 m Interval)
- Contour (5 m Interval)
- Watercourse (Intermittent)
- Watercourse (Permanent)
- Waterbody

On behalf of the Metcalfe Agricultural Society (the Client), Stantec Consulting Ltd. (Stantec) has completed a hydrogeology assessment to support the proposed development of a single-storey building and associated sewage treatment system (the Project), located at 2821 8<sup>th</sup> Line Road in Metcalfe, Ontario, herein referred to as the Site (Figure 1, Appendix A).

There is a second water supply well on the west side of the Hicks Building ('Existing Well', Figure 1), which supplies water to a livestock wash station.

The Stantec (2025) geotechnical investigation reported similar subsurface conditions to those described above for WWRs. The subsurface conditions encountered consisted of topsoil / fill extending from surface to approximately 1 m BGS followed by limestone bedrock (Stantec 2025). The geotechnical borehole locations are shown on Figure 1.

Lithology at the new water supply well (PW25-01) is described as gravel / broken rock from surface to 1.8 m BGS followed by blue limestone to 11 m BGS. Grey limestone was observed from 11 m BGS to the completion depth. It is noted trace white sandstone was observed between 55 m and 73 m BGS, suggesting potential transition zone from the Oxford / March to the Nepean Formation. The location of PW25-01 is shown on Figure 1 and a copy of the MECP well record is provided in Appendix C.
