Phase One Environmental Site Assessment
133 Forward Avenue, Ottawa, Ontario

Client:
In-Harmony Developments Inc.

Project Name:
Phase One Environmental Site Assessment

Project Number:
OTT-25011403-A0

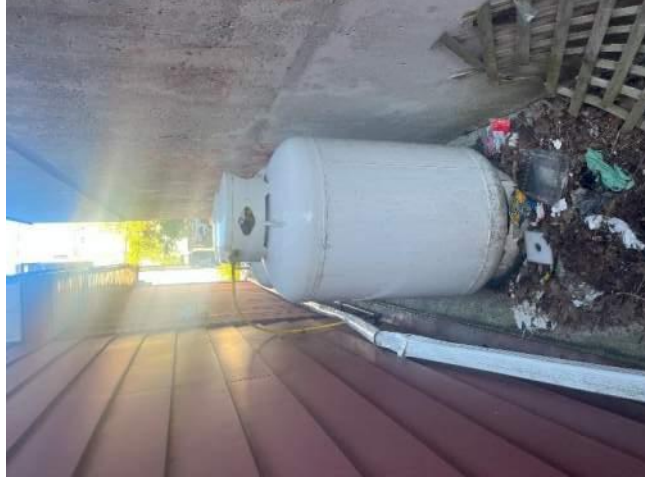
Photograph No. 4

EXP did observe two propane tanks on the north side of the residence. Due to the contents, these ASTs are not considered a concern. Historically, a heating oil AST was present in the southwest corner of the basement. No staining was observed on the concrete floor in this area.

View of the propane tanks on the north side of the residence.

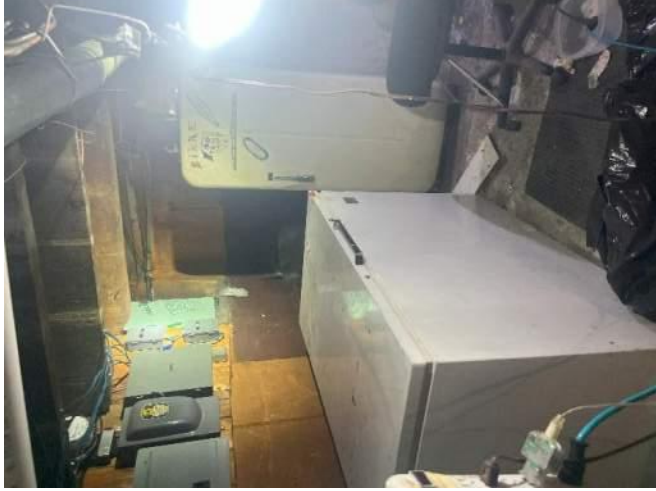
Photograph No. 5

The former on-site furnace oil AST, and the likely presence of fill material on the Phase One property is considered to contribute to APECs. Due to the proximity and inferred up-gradient direction from the Phase One property, the former repair

View of the location of the former furnace oil AST in the basement of the residence.

The Qualified Person who oversaw this work, Leah Wells, P.Eng. recommends that a Phase Two ESA be conducted to address the PCA that may have adversely affected the Phase One property.

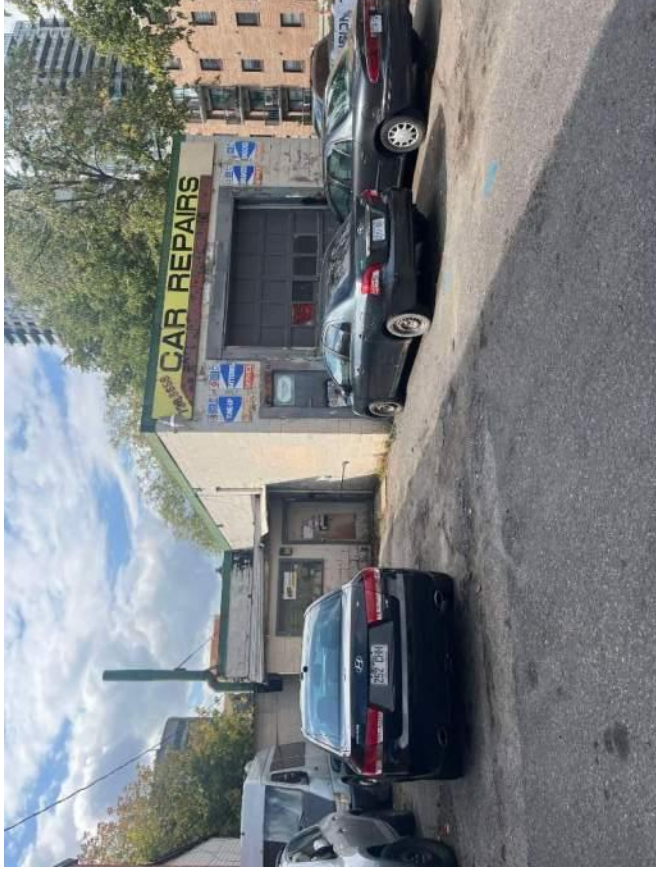
Photograph No. 8

The likely presence of fill material on the Phase One property is considered to contribute to an APEC. Due to the proximity and inferred up-gradient direction from the Phase One property, the former repair garage/gas station at 140 Hinchey Avenue and the furnace oil spill at 154 Hinchey Avenue result in an APEC. None of the other off-site PCAs were determined to contribute to APECs.

View of one of the garage at 140 Hinchey Street.
