Tree Conservation Report submitted as Partial Requirements for a Site Plan Control Application, November 28, 2025

TREE CONSERVATION REPORT V2.0

2055 Robertson Road, Ottawa

Tree Conservation Report 2.0

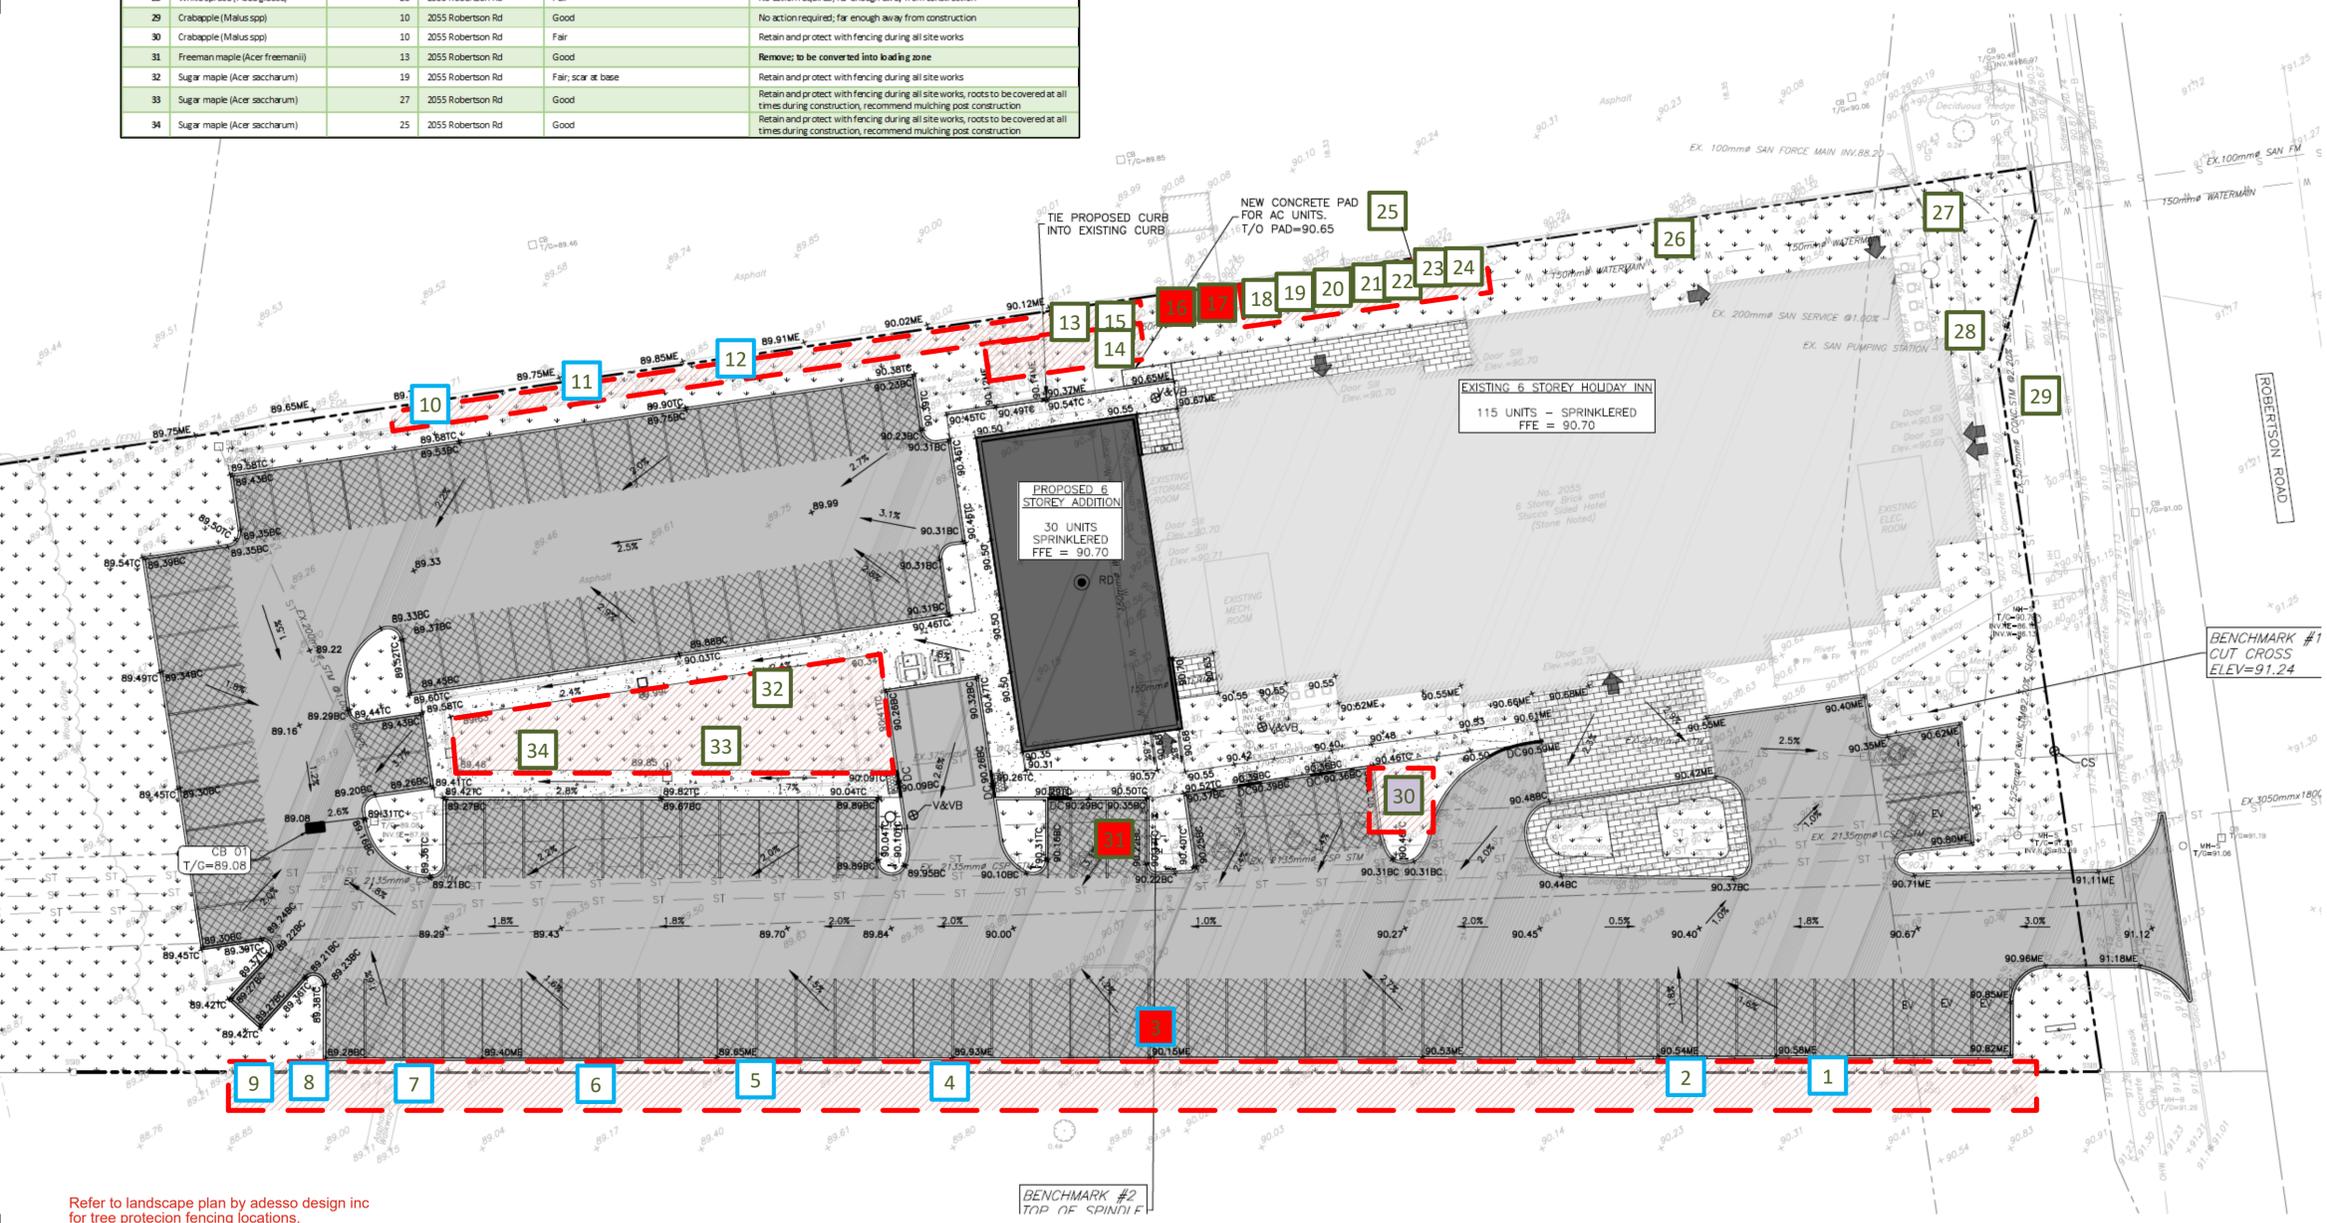
TCR Map#2: Proposed Development and Conserved Vegetation – 2055 Robertson Rd

The location of the parking area will shift slightly along the east property line that will result in an increase in soft surface. This will be of benefit to the trees 10-12 as their rooting area will increase. Along the west property line, there will be no change in the location of the parking lot and there should be no impact on the trees along here except for **tree 3** where the existing bulb out will be replaced with additional parking units. The remaining trees along this edge can be retained effectively if they are protected property and all equipment stays out of the grassy area. Any branches that are in the way of equipment should be pruned ahead of time by an arborist to avoid breakage.

There will be a shift to the loading zone which will result in the removal of **tree 31**. The current amenity area with picnic area will result in a decrease in soft scaping due to a new pathway adjacent to the parking area. This will impede within the critical root zones of **tree 32, 33 and 34**. Since they are still relatively young, they may be resilient enough to withstand the stresses of construction and rooting area loss. Protection of this entire area during the whole project will be key in ensuring their long-term viability. Additional mitigation measures are also recommended such as manual root pruning, watering and mulching.

Trees 16 and 17 are in direct conflict with proposed servicing as a new pipe is required to connect to the old water service (see site servicing plan).

Prior to any site works, protective fencing should be installed around the Tree Protection Area as indicated in *Map#2, Proposed Development and Conserved Vegetation* and maintained until all construction on site has been completed as per the City of Ottawa Tree Protection Specifications (March 2021).

The tree protection fencing must be 1.2 m in height and constructed of a rigid or framed material (e.g. modulus – steel, plywood hoarding, or snow fence on a 2"X4" wood frame) with posts 2.4 m apart such that the fence location cannot be altered. All supports must be placed outside of the CRZ and installation must minimize damage to existing roots.

If the fenced tree protection area must be reduced to facilitate construction, *one* of the following mitigation measures should be applied:

- Place a layer of 6-12 inches (15 to 30 cm) of woodchip mulch to the area
- Apply $\frac{3}{4}$ (2 cm) inch plywood, or road mats over a 4+ inch (10 cm) thick layer of the wood chip mulch
- Apply 4-6 inches (10 to 15 cm) of gravel over a taut, staked, geotextile fabric

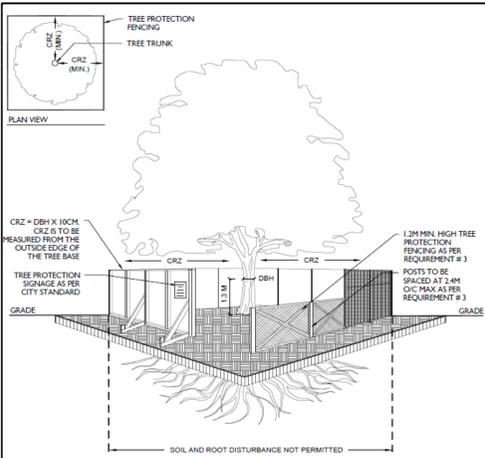
- DO NOT EXTEND HARD SURFACE OR SIGNIFICANTLY CHANGE LANDSCAPING
 - TREE PROTECTION FENCING MUST BE AT LEAST 1.2M IN HEIGHT, AND CONSTRUCTED OF RIGID OR FRAMED MATERIALS (E.G. MODULOC - STEEL, PLYWOOD HOARDING, OR SNOW FENCE ON A 2"x4" WOOD FRAME) WITH POSTS 2.4M APART, SUCH THAT THE FENCE LOCATION CANNOT BE ALTERED. ALL SUPPORTS AND BRACING MUST BE PLACED OUTSIDE OF THE CRZ, AND INSTALLATION MUST MINIMISE DAMAGE TO EXISTING ROOTS. (SEE DETAIL)
