To: City of Ottawa – Site Plan Control
Subject: Tree Removal Summary Memo – CEPEO Louise-Arbour

**Reference: 1010 Somerset Street West
Tree Assessment Investigation**

Client/Project
CITY OF OTTAWA
1010 SOMERSET STREET WEST
REZONING AND REDEVELOPMENT

OTTAWA, ONTARIO
Title
CURRENT VEGETATION PLAN

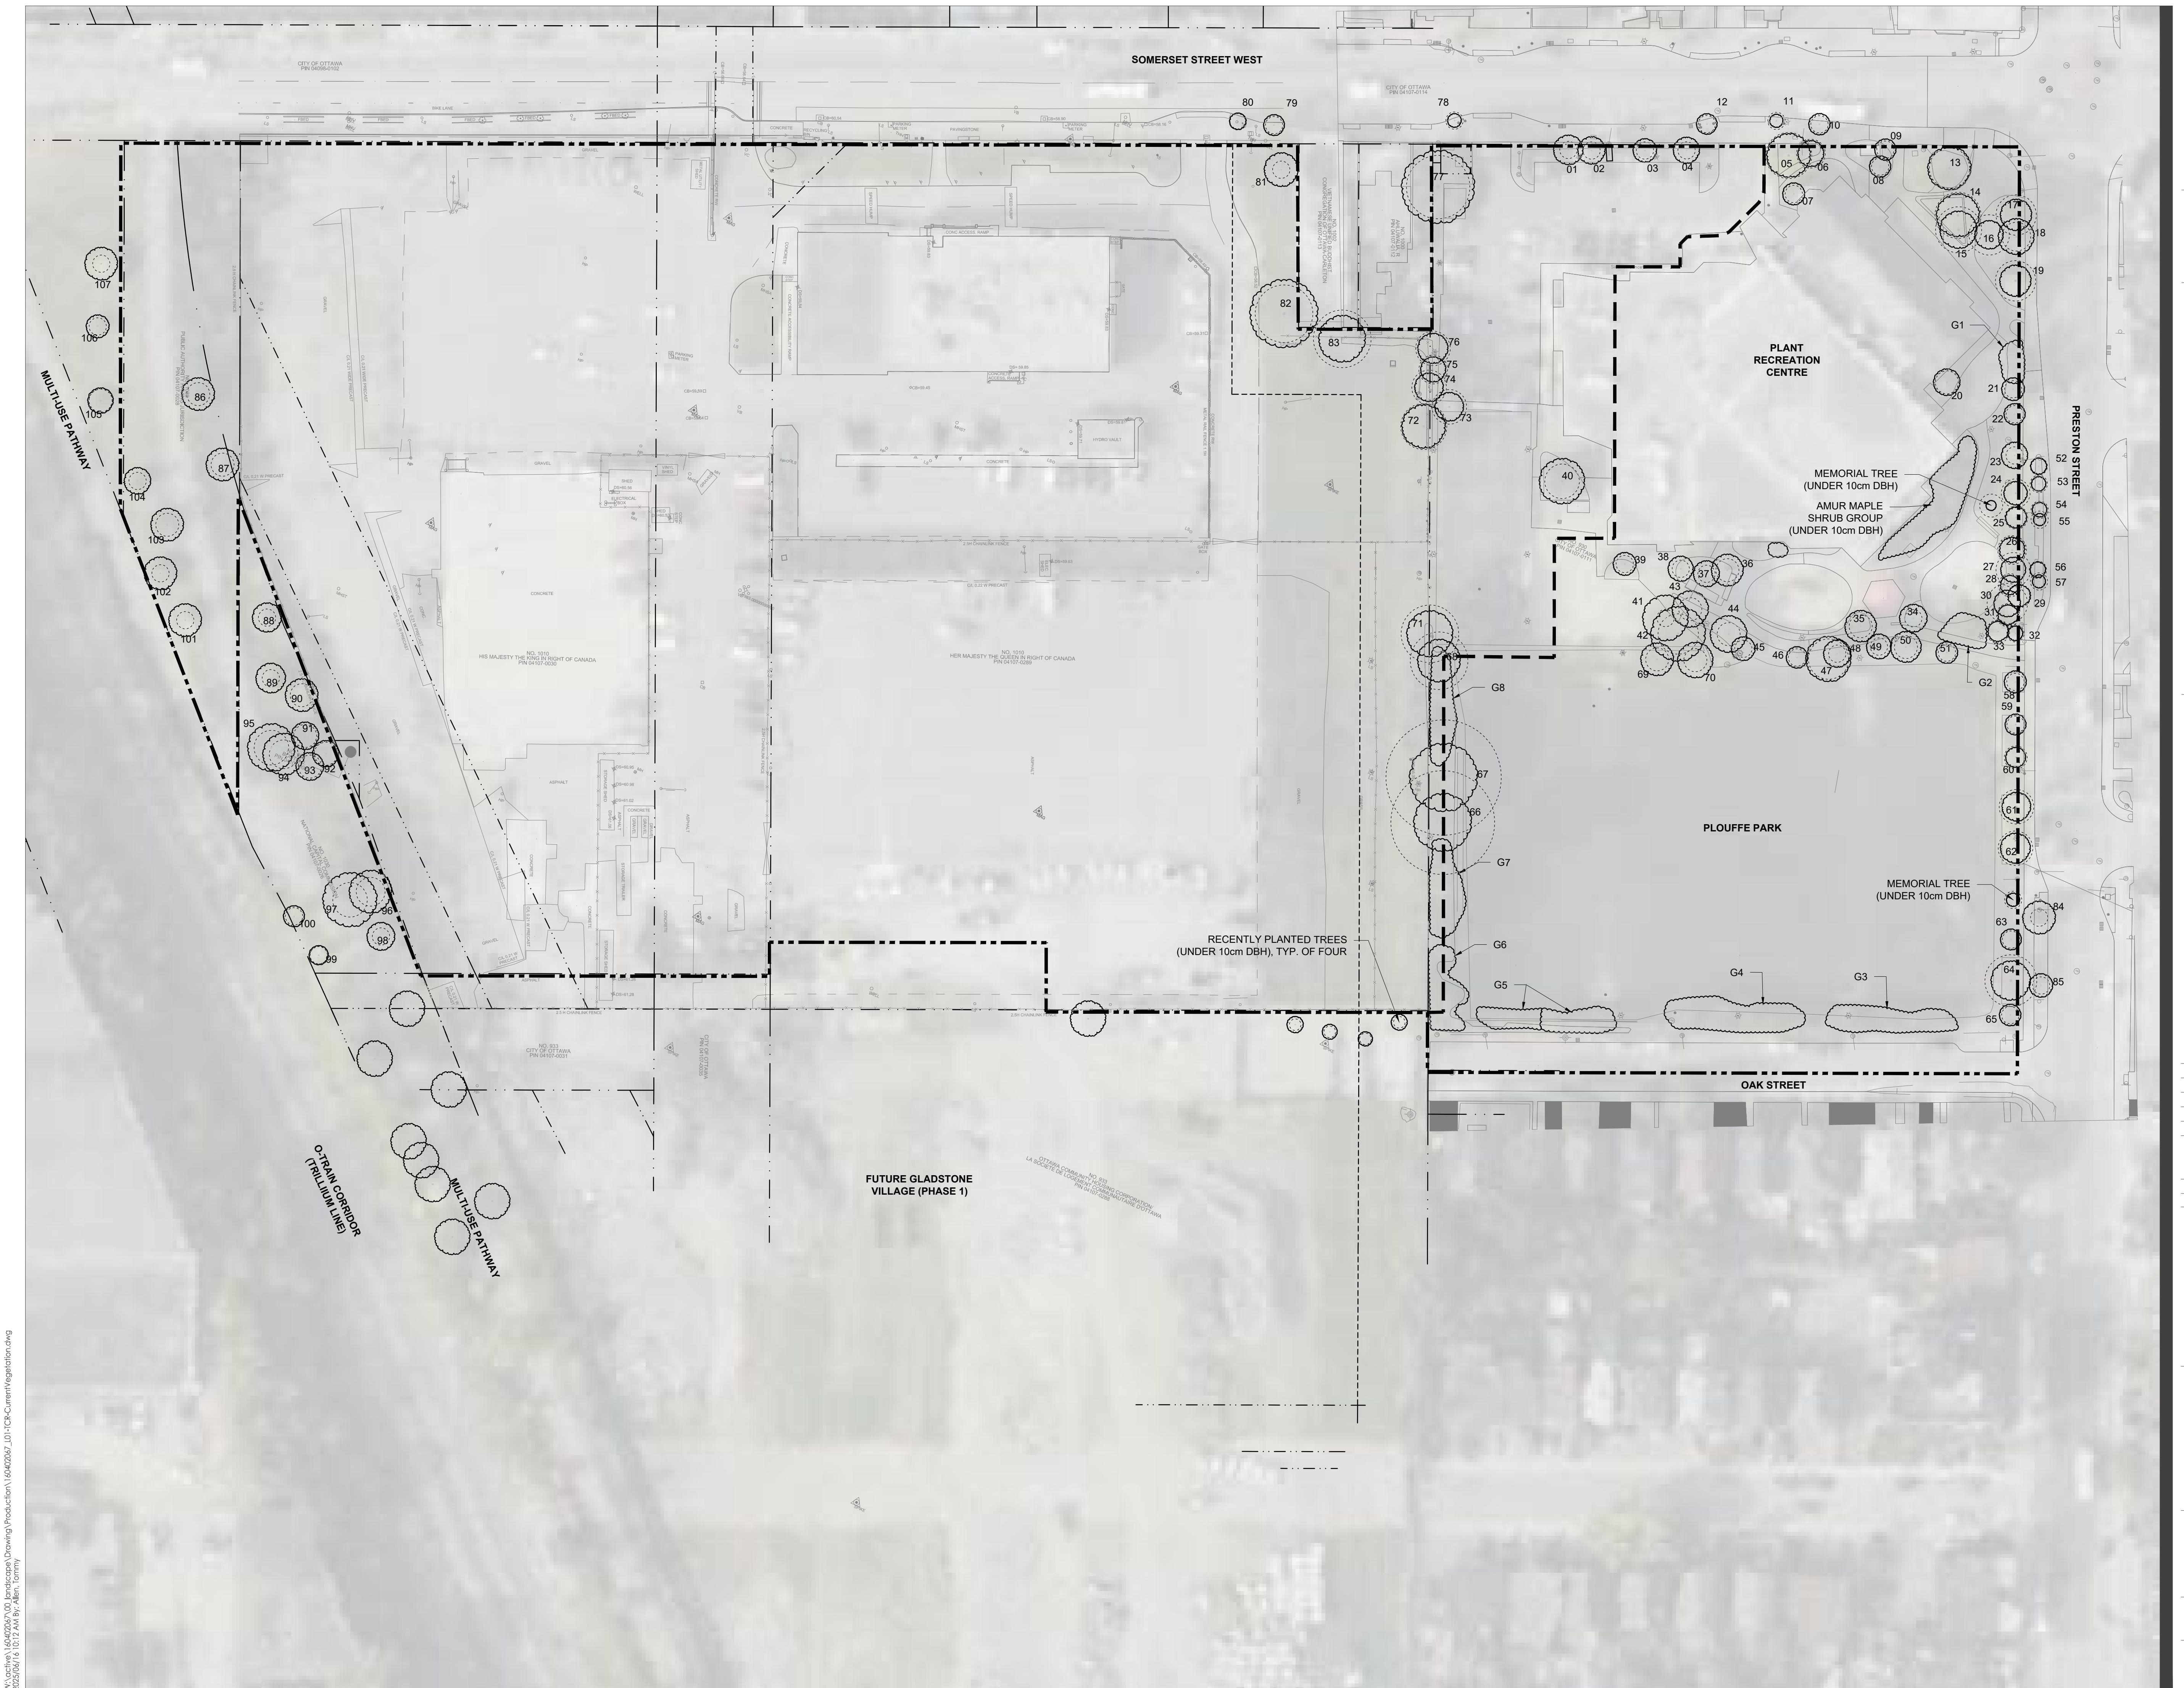
L01 1 of 2 2

Groupings of trees along Oak Street are growing in a row directly adjacent to the chain link fence indicating they were planted; groupings of trees along the western property line of Plouffe Park are growing naturally and include spontaneous / opportunistic species generally spreading through seeds. Drawing L01 in Appendix B provides location of all trees inventoried.

Based on current design drawings, it is anticipated that thirty-eight (38) trees will require removal to facilitate the redevelopment of this block. Anticipated tree removals are associated to the construction of the new Recreation and Cultural Facility, the expansion of the Plant Recreation Centre, and the new CEPEO school and adjacent roadway:

1. **Recreation and Cultural Facility** – new building
 - a. Eight (8) individual trees:
 - i. Trees 72 to 76 – Trees 72 and 73 are Siberian elms (non-native and opportunistic species); Trees 74 and 75 are Manitoba maples (non-native); and Tree 76 is a Norway maple (non-native and invasive species). Trees 72 to 74 are 30cm DBH or greater. All these trees are in fair conditions.

3. **CEPEO School and Adjacent Roadway** – new building and new roadway within Plouffe Park
 - a. Four (4) individual trees:
 - i. Trees 66 to 68 – Siberian elms (non-native and opportunistic species). All trees are more than 50cm DBH but generally in fair conditions.

- ii. Tree 71 – a significantly large American elm (native species) of 50cm DBH; it is in fair to good condition.
 - b. Three (3) groupings: groupings G6 to G8 (21 trees). All trees are less than 30cm DBH and generally in fair conditions.

- c. Up to two (2) trees in grouping G5. Trees are Amur maples with a DBH of less than 30cm and are generally in fair conditions.

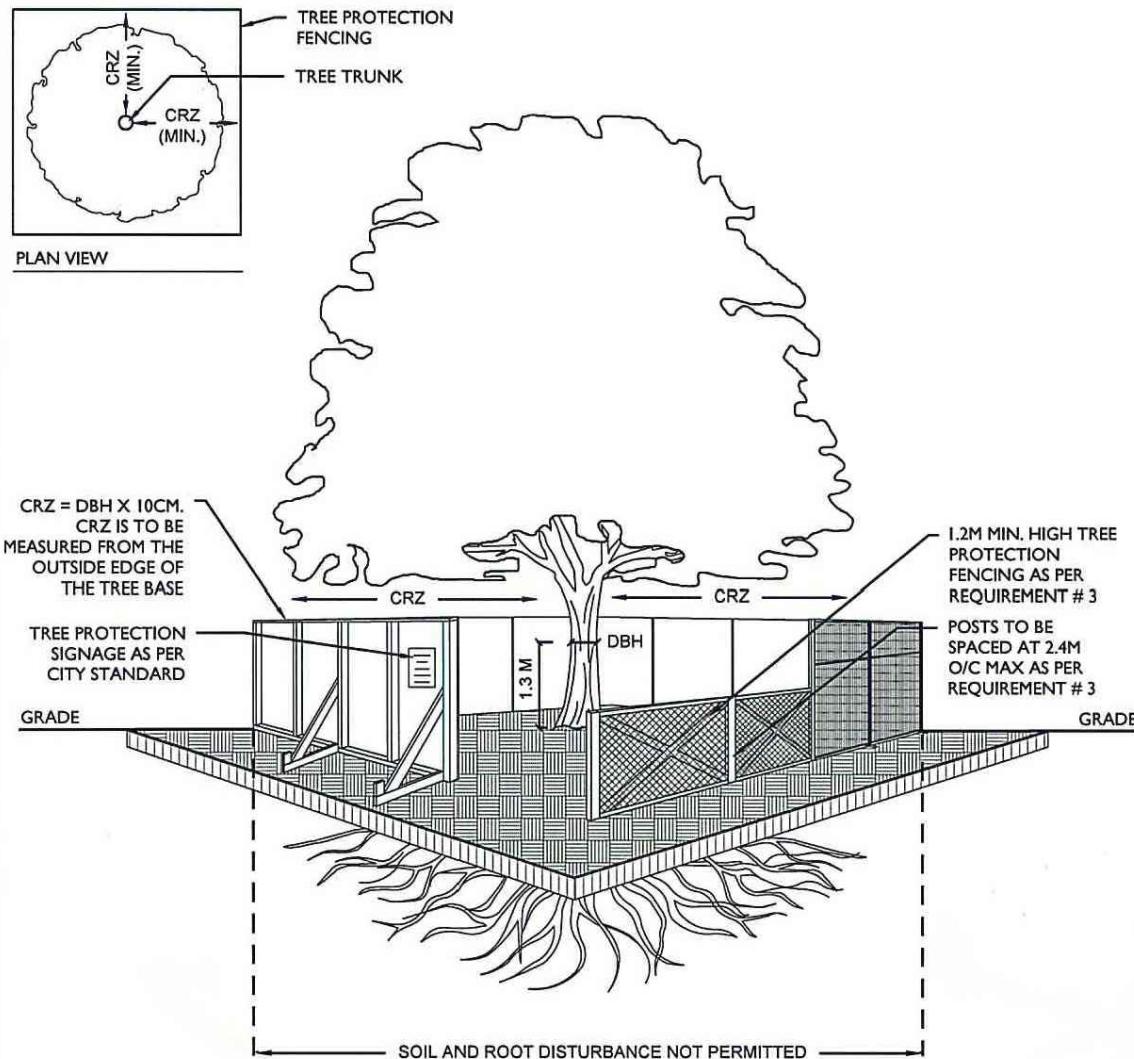
TREE PRESERVATION PROTECTION FENCE

1. PRIOR TO ANY WORK ACTIVITY WITHIN THE CRITICAL ROOT ZONE (CRZ = 10 X DIAMETER) OF A TREE, TREE PROTECTION FENCING MUST BE INSTALLED SURROUNDING THE CRITICAL ROOT ZONE, AND REMAIN IN PLACE UNTIL THE WORK IS COMPLETE.

- DO NOT EXTEND HARD SURFACE OR SIGNIFICANTLY CHANGE LANDSCAPING
3. TREE PROTECTION FENCING MUST BE AT LEAST 1.2M IN HEIGHT, AND CONSTRUCTED OF RIGID OR FRAMED MATERIALS (E.G. MODULOC - STEEL, PLYWOOD HOARDING, OR SNOW FENCE ON A 2"X4" WOOD FRAME) WITH POSTS 2.4M APART, SUCH THAT THE FENCE LOCATION CANNOT BE ALTERED. ALL SUPPORTS AND BRACING MUST BE PLACED OUTSIDE OF THE CRZ, AND INSTALLATION MUST MINIMISE DAMAGE TO EXISTING ROOTS. (SEE DETAIL)

Mitigation measures should be taken to limit physical damage to trees to remain including roots, overall structure, and soil conditions. All trees within the limit of construction not identified for removal shall be protected with the installation of a temporary tree protection fencing placed at or beyond the identified critical root zone as detailed on the City of Ottawa Standard Protection detail inserted as Appendix C. Additional site-specific measures to limit tree disturbance should be included during design development to adjust and refine the limits of grading and / or introducing tree well(s). Finally, measures should be taken to enhance the soil conditions of any disturbed trees to limit stress and promote continued long-term health.
