## **Phase Two Environmental Site Assessment**

5360 Bank Street  
Ottawa, Ontario

GEMTEC Project: 100227.101

October 2, 2023  
GEMTEC Project: 100227.101

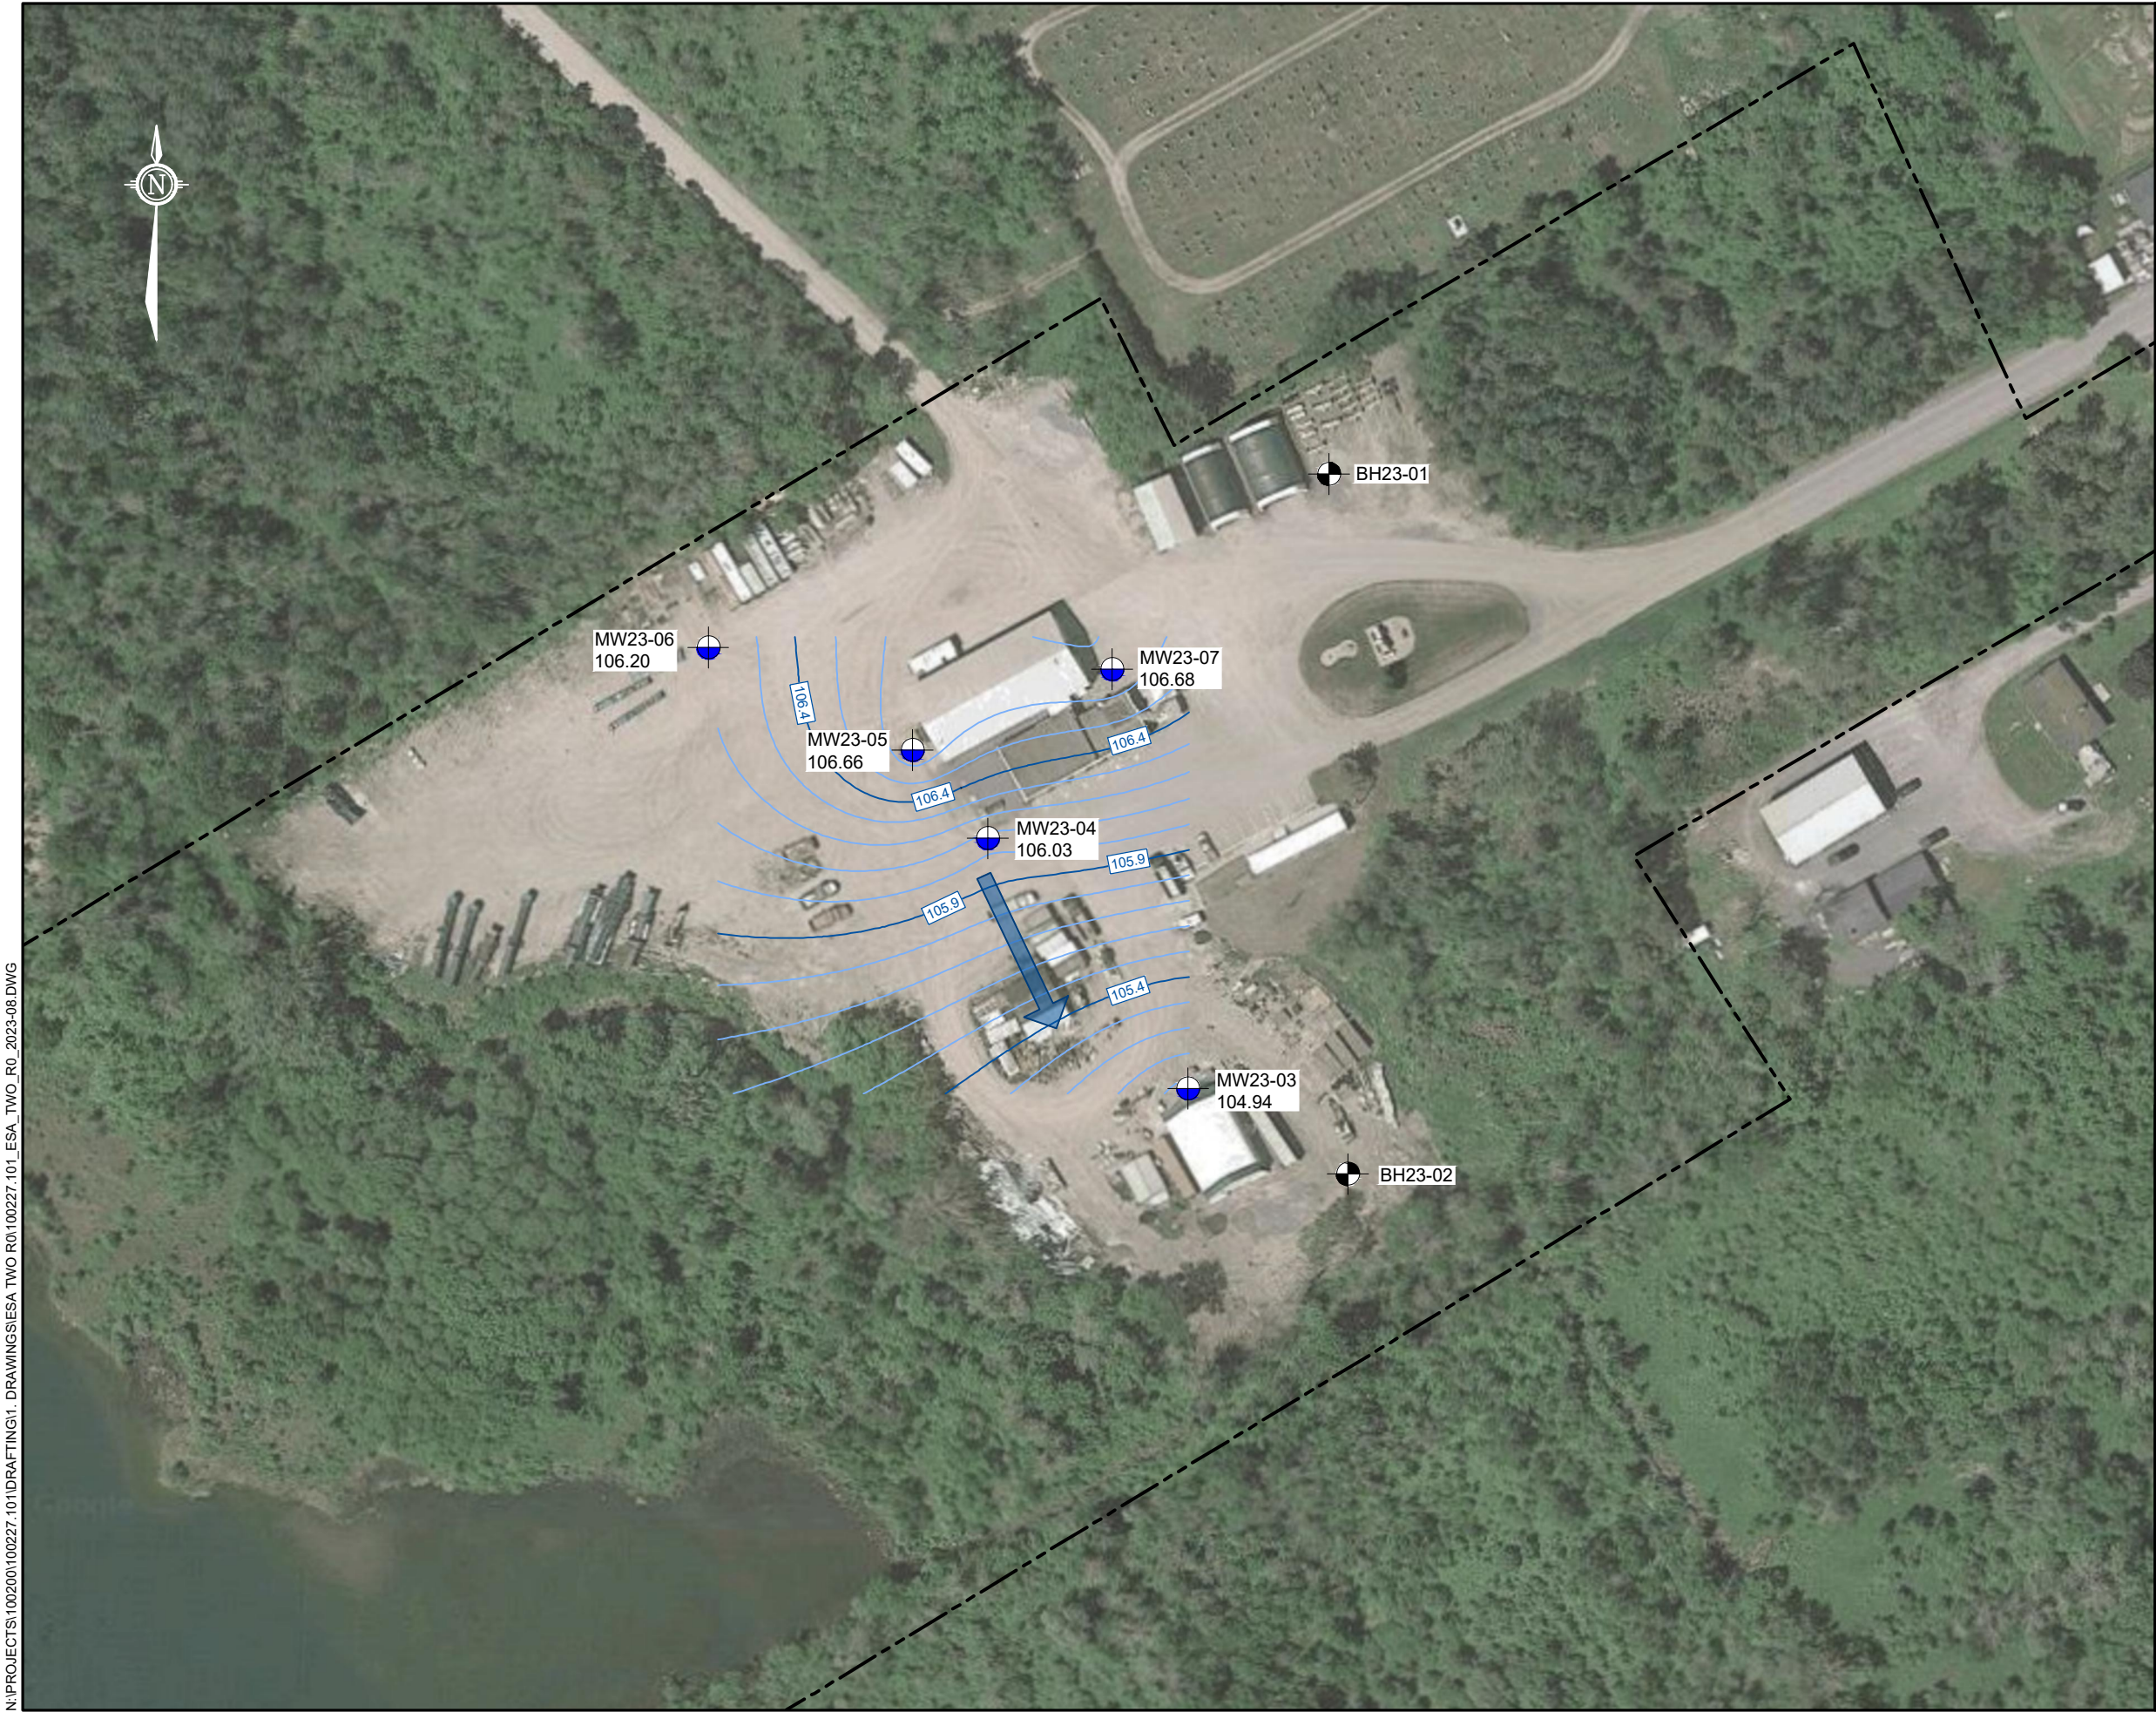
- BH/MW #** ——— BOREHOLE/ MONITORING WELL ID  
**XX.XX** ——— GROUND WATER ELEVATION (AUGUST 25, 2023), IN METRES, GEODETIC DATUM
-

The average horizontal hydraulic gradient for shallow groundwater conditions measured on August 25, 2023 was 0.022 m/m. Vertical hydraulic gradient for shallow groundwater conditions were not calculated as nesting monitoring wells were not installed at the Site.

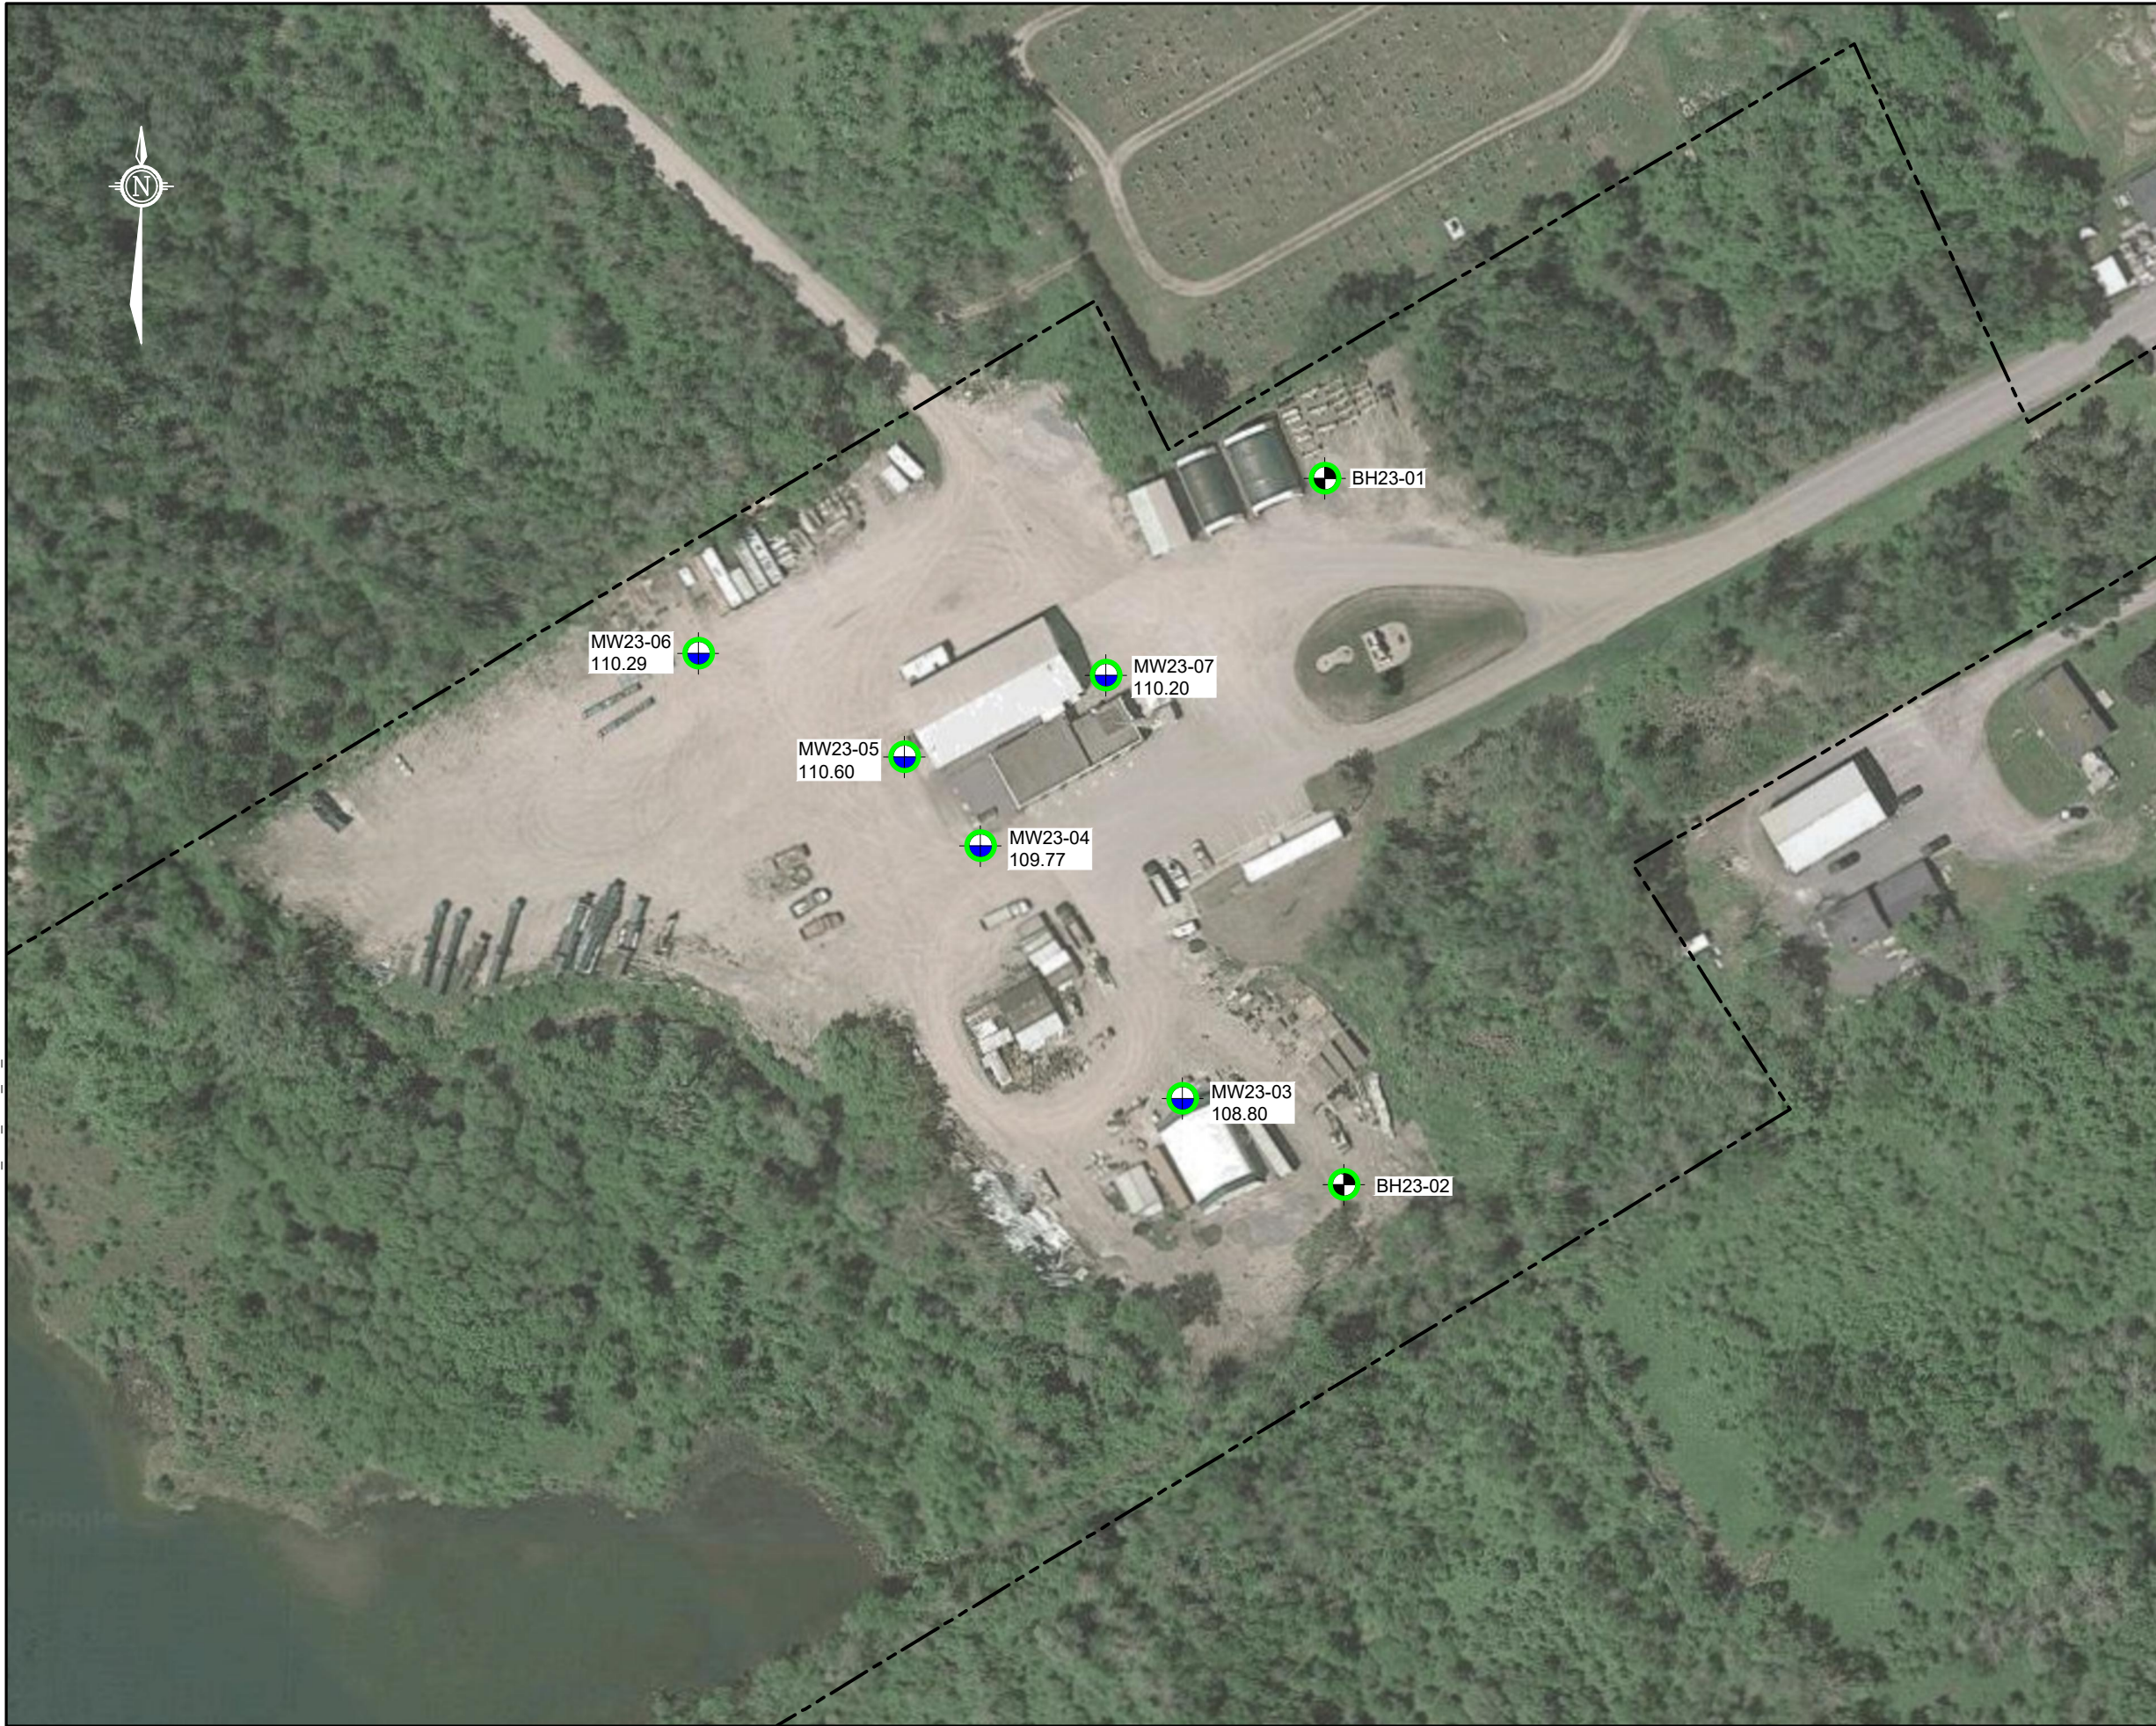
- BH/ MW #** ——— BOREHOLE/ MONITORING WELL ID  
**XX.XX** ——— GROUND SURFACE ELEVATION, IN METRES  
                    GEODETIC DATUM
- BOREHOLE LOCATION**  
(current investigation by GEMTEC)
- MONITORING LOCATION**  
(current investigation by GEMTEC)
- MEETS TABLE 2 SCS COARSE SOIL STANDARDS AND  
TABLE 8 SCS COARSE SOIL STANDARDS**
- EXCEEDS TABLE 2 SCS COARSE SOIL STANDARDS AND/ OR  
TABLE 8 SCS COARSE SOIL STANDARDS**

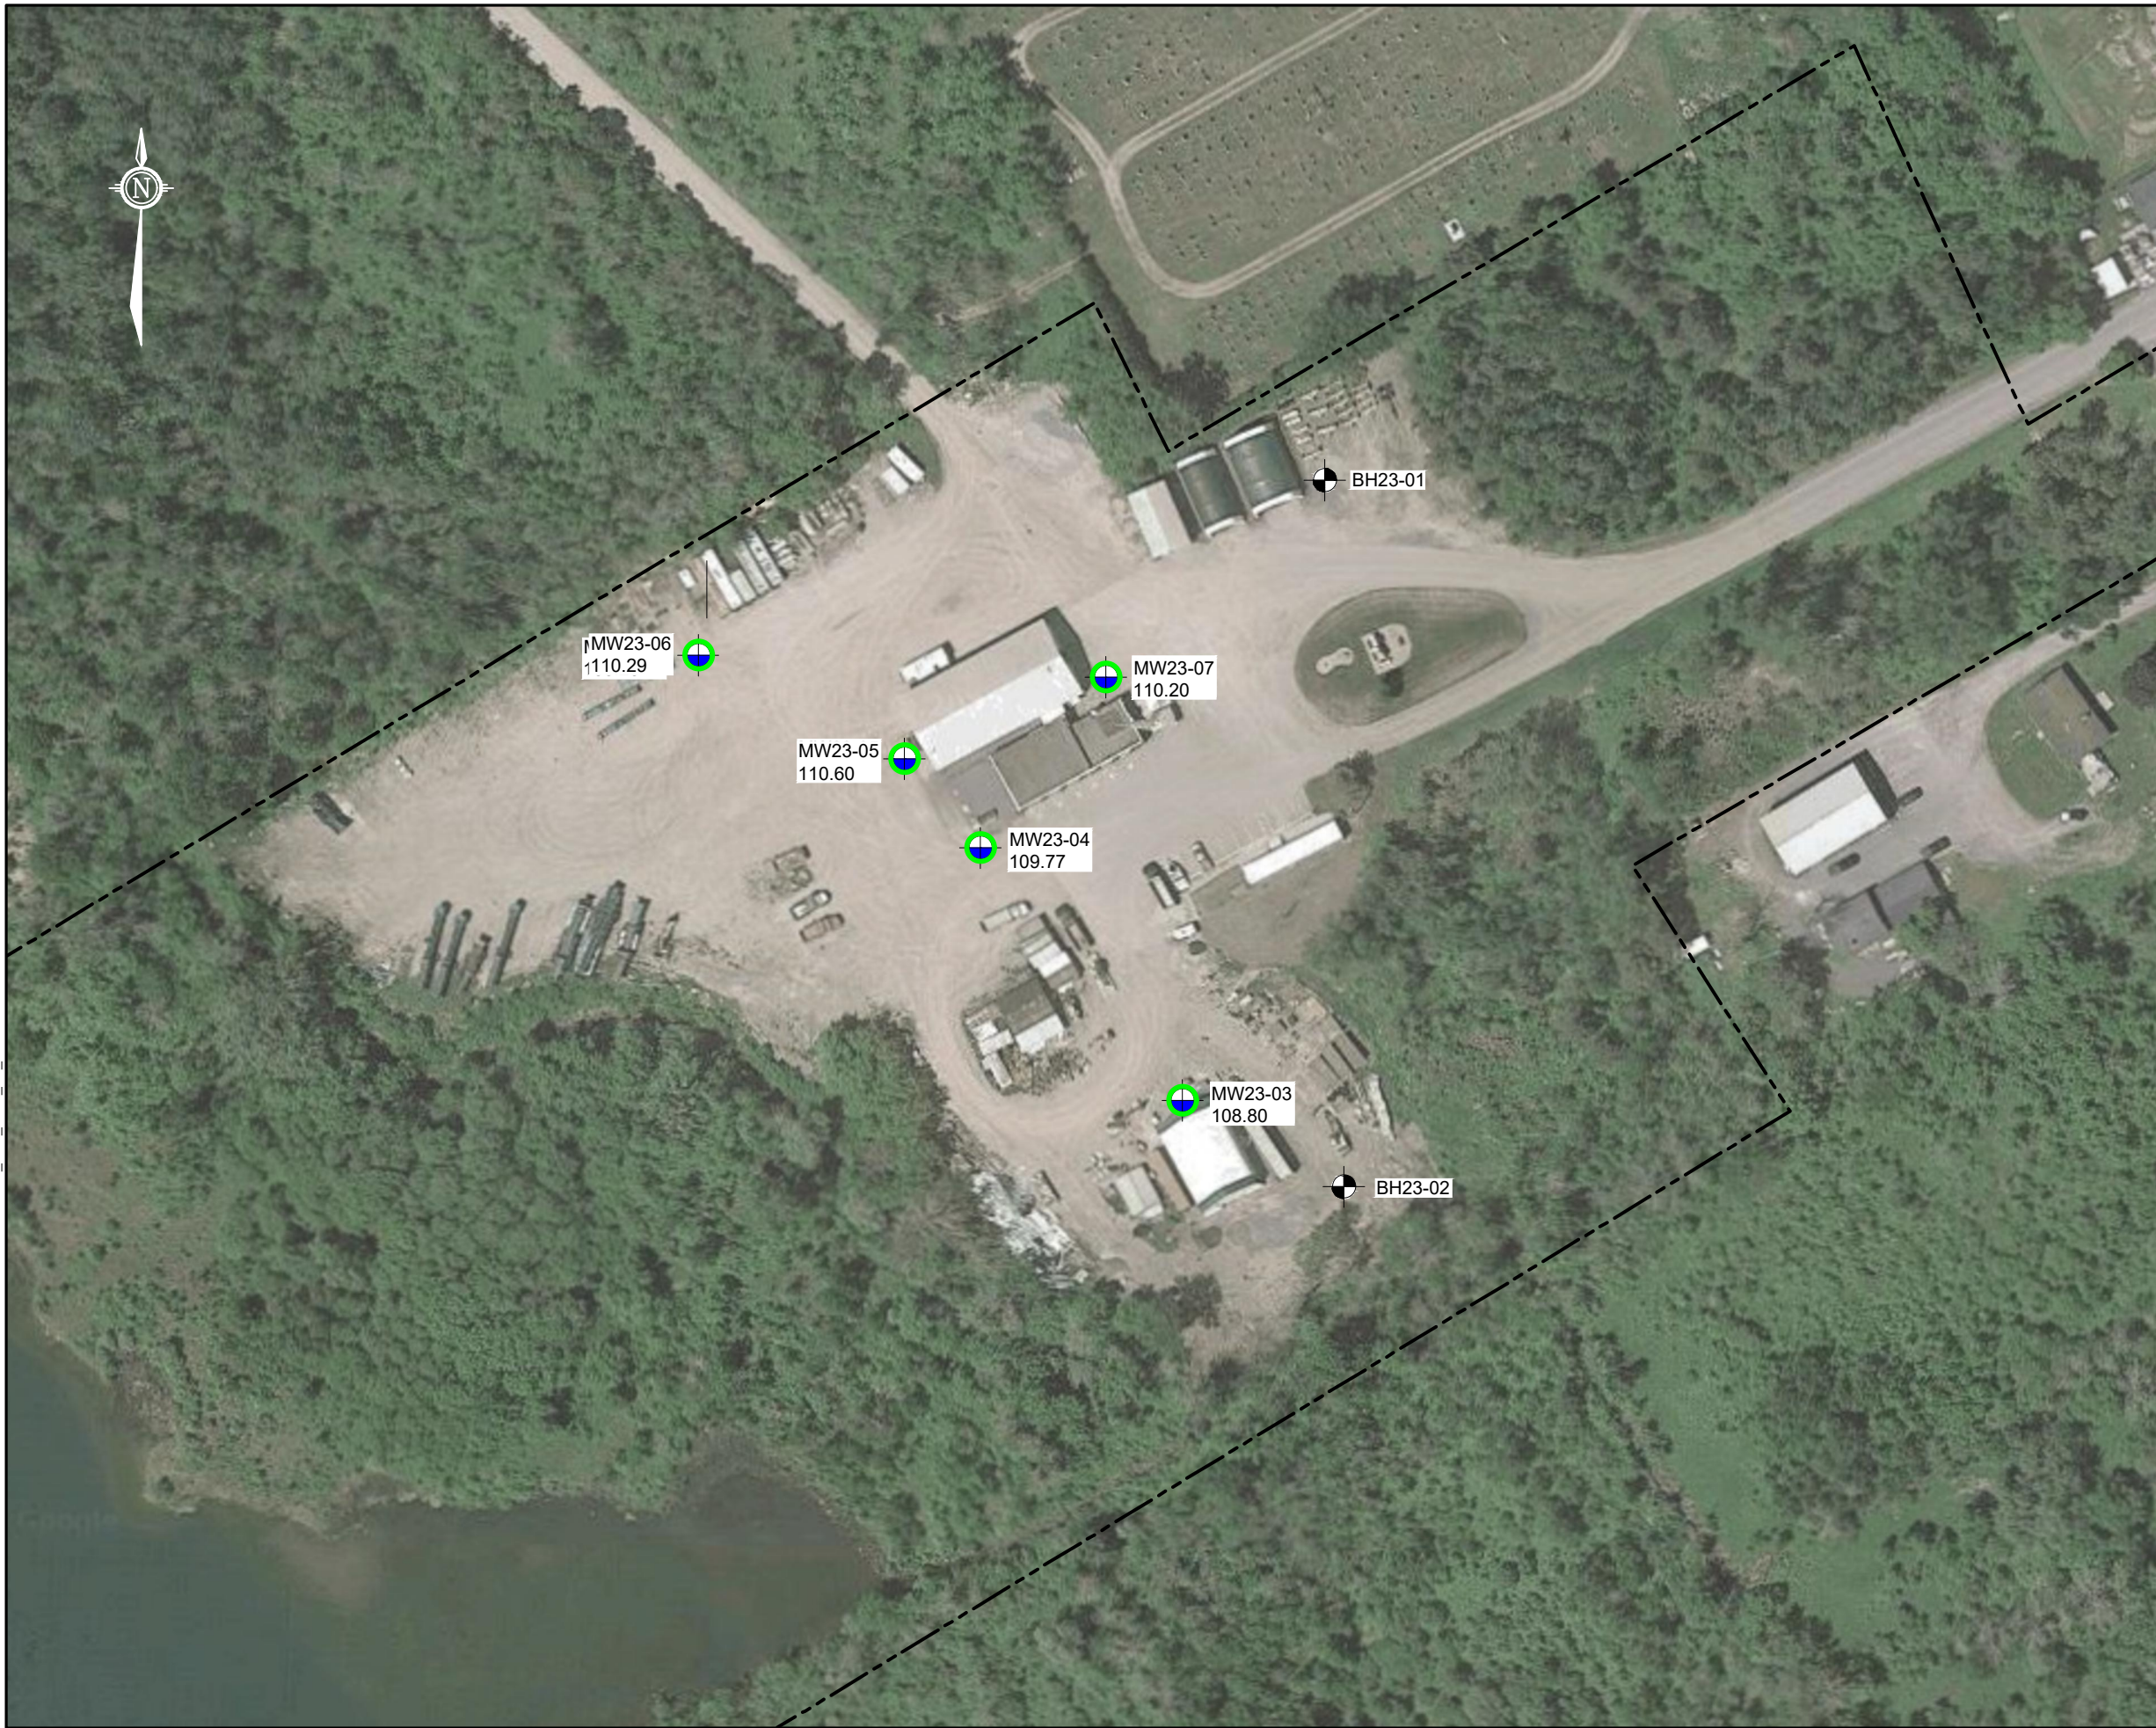
- BH/ MW #** ——— BOREHOLE/ MONITORING WELL ID  
**XX.XX** ——— GROUND SURFACE ELEVATION, IN METRES  
                    GEODETIC DATUM
-
