**REPORT ON  
GEOTECHNICAL INVESTIGATION  
WEST OF CAMBRIAN ROAD AND GREENBANK ROAD  
(3845 CAMBRIAN ROAD - SOUTH PARCEL)  
BARRHAVEN, ONTARIO**

**REPORT NO.: 4817-18-G-LPL-A  
REPORT DATE: AUGUST 5, 2025  
REVISION NO.: 02**

**PREPARED FOR  
LOBLAW REAL ESTATE  
1 PRESIDENT'S CHOICE CIRCLE  
MISSISSAUGA, ONTARIO  
L6Y 5S5**

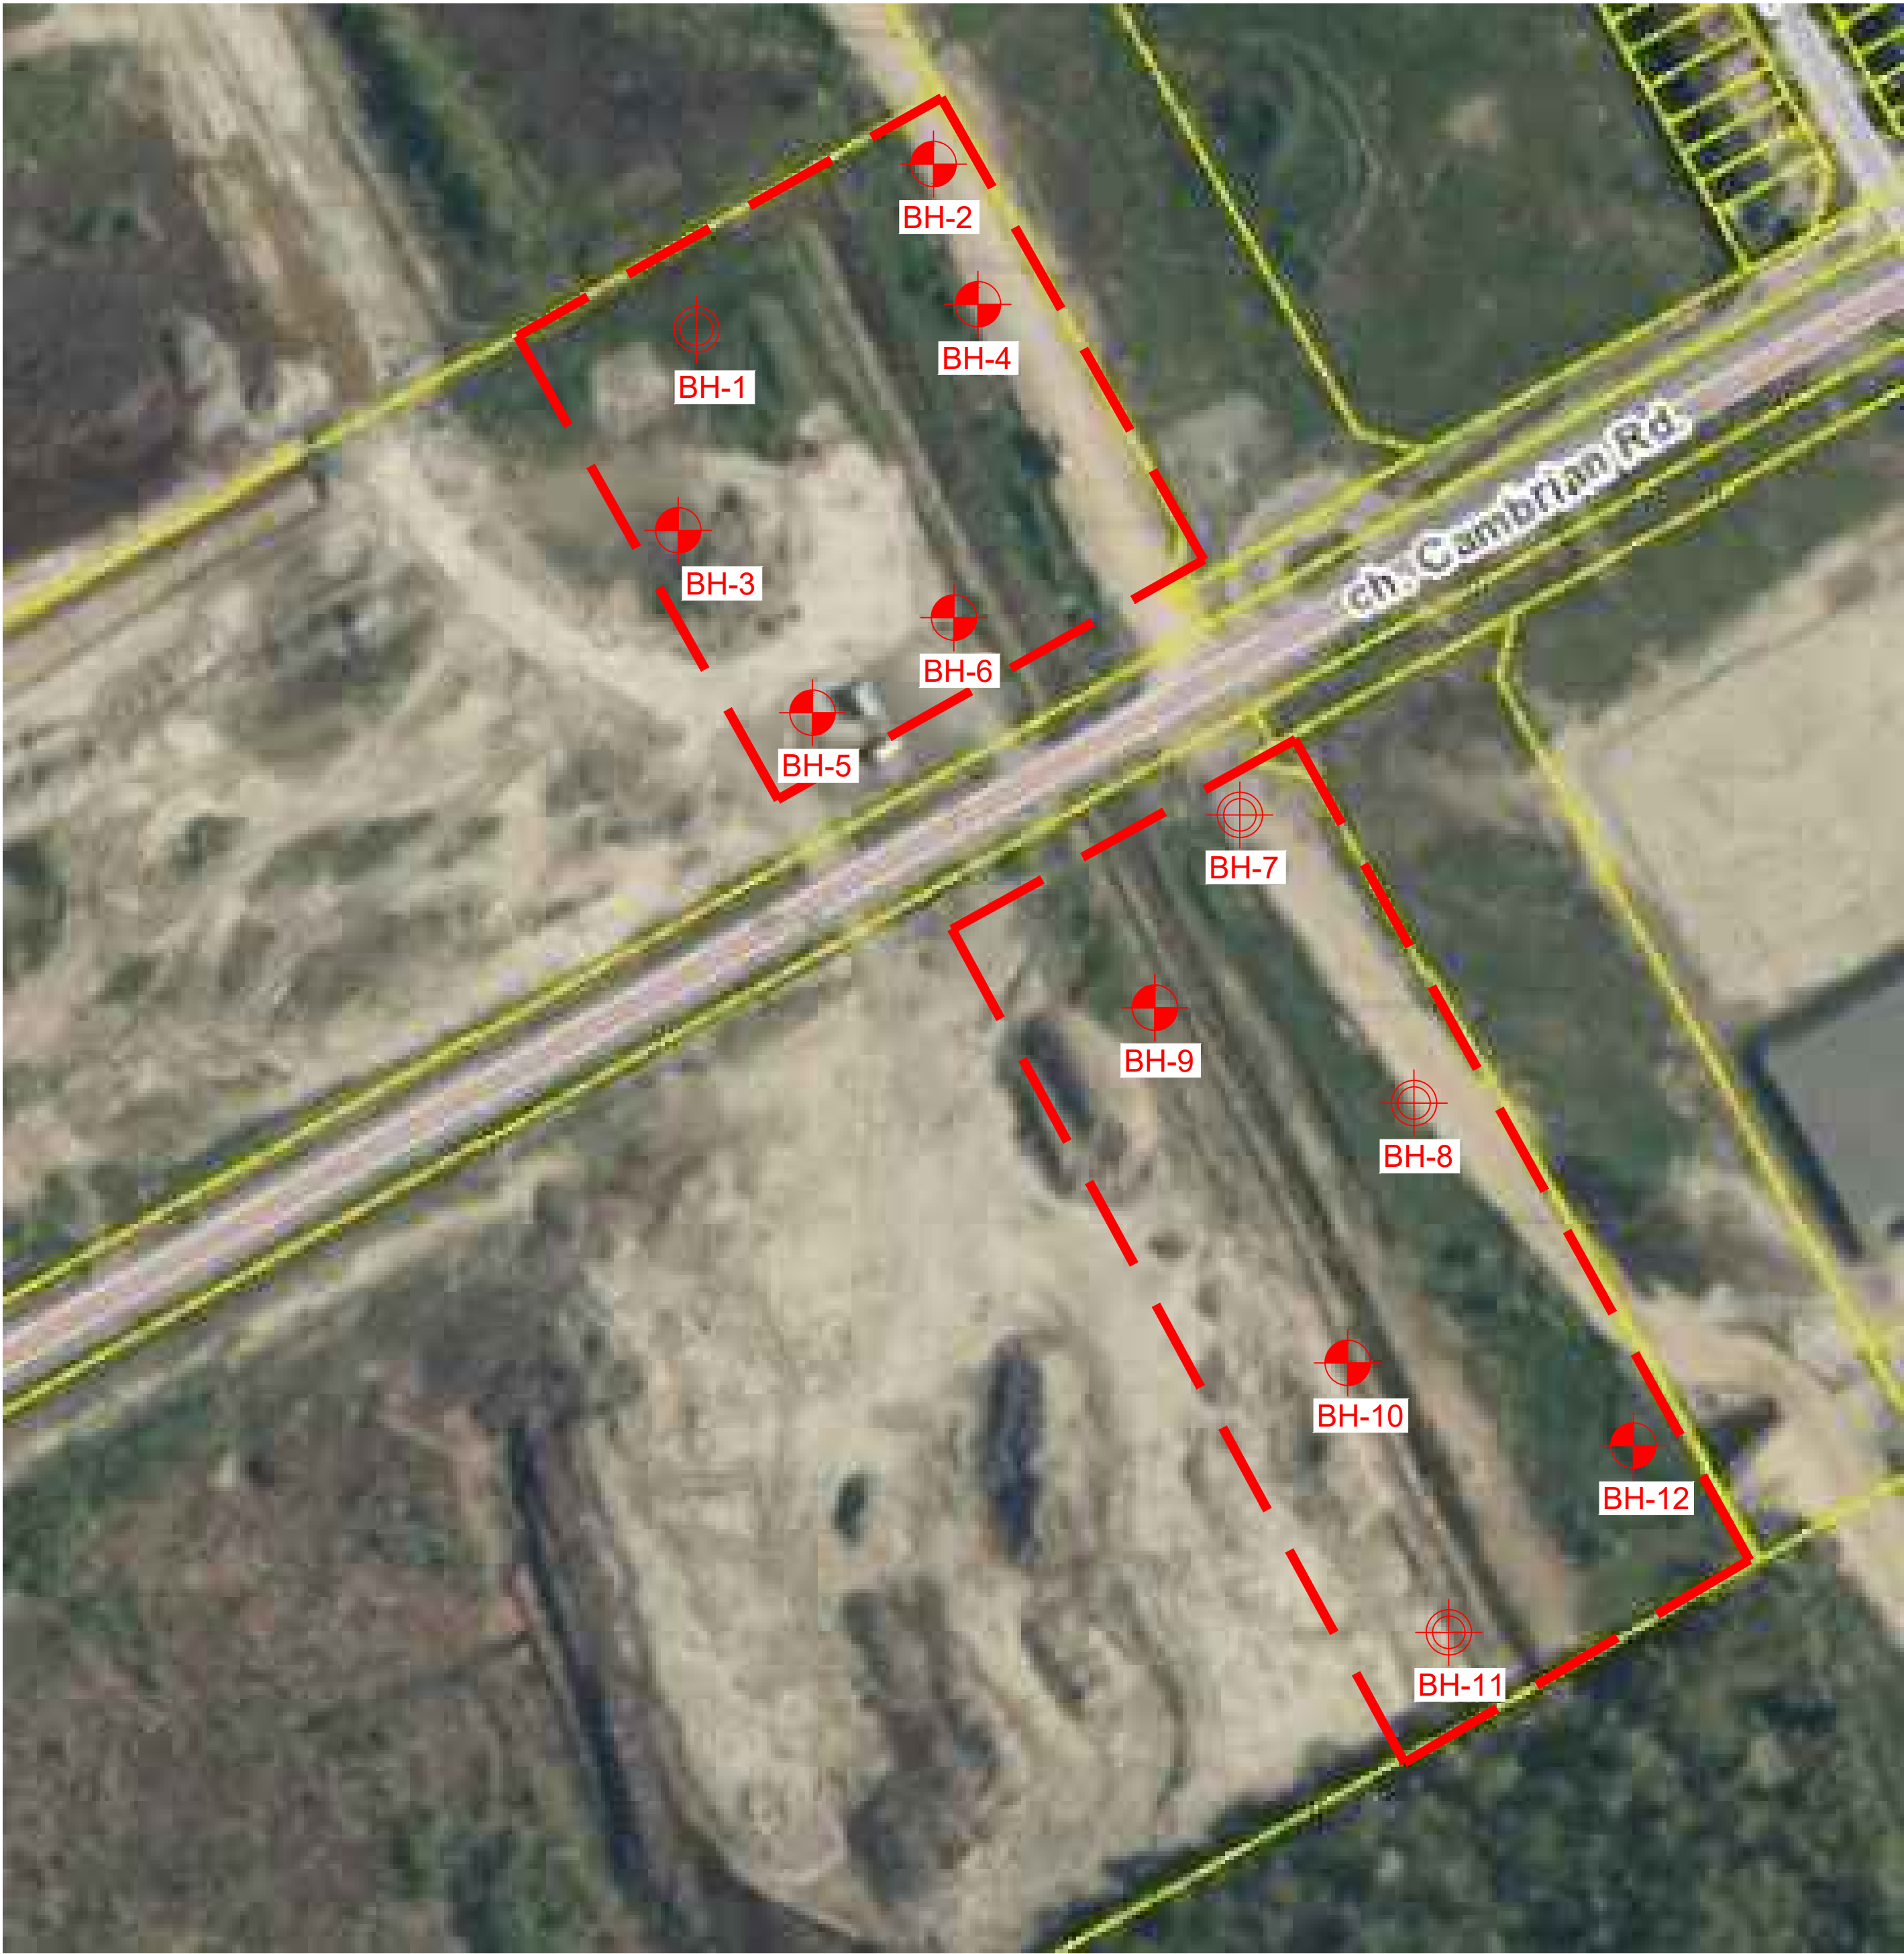
**DRAWINGS**  
**Borehole Location Plan**  
**Logs of Boreholes**

- Approximate Site Boundary
- ⊕/⊗ Borehole / Monitoring Well Location

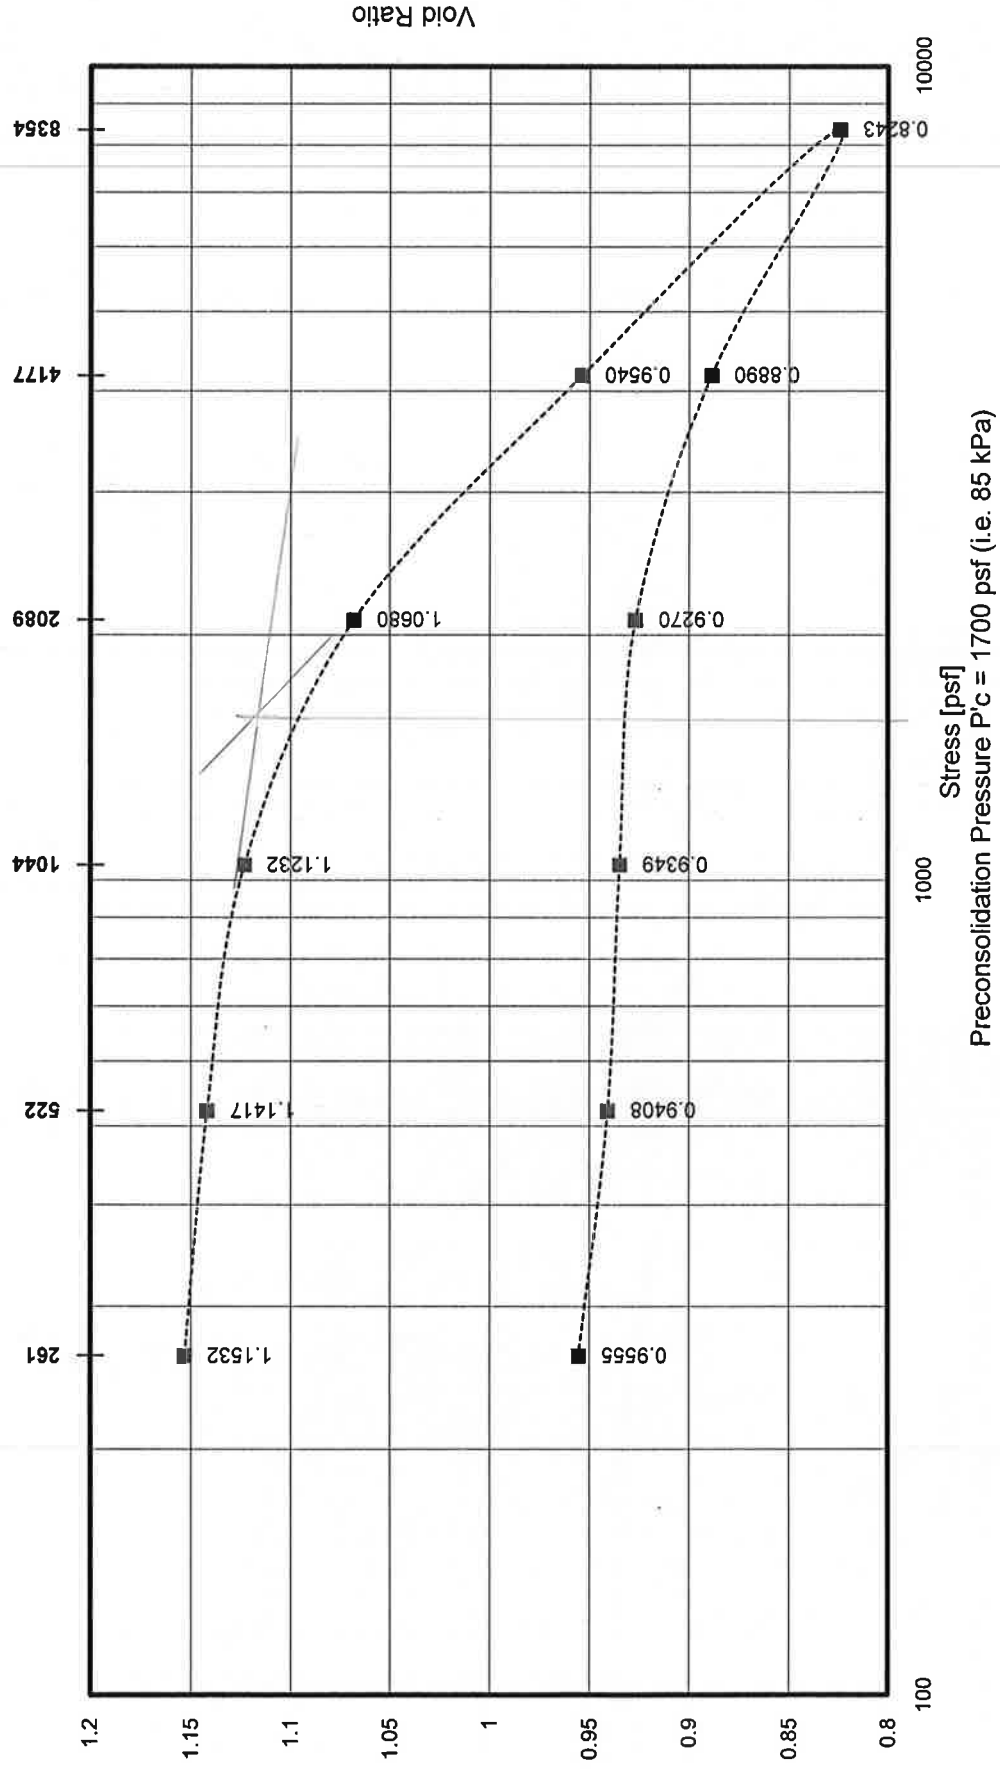
**Figure No. 3 - Void Ratio vs Log Pressure**

Project : Proposed Retail Buildings  
 Location : NW-Cambrian Road and Greenbank Road, Barrhaven, Ontario  
 Sample Description : Silty Clay / Clayey Silt, BH-4, at a depth of 6.6m (20.5')

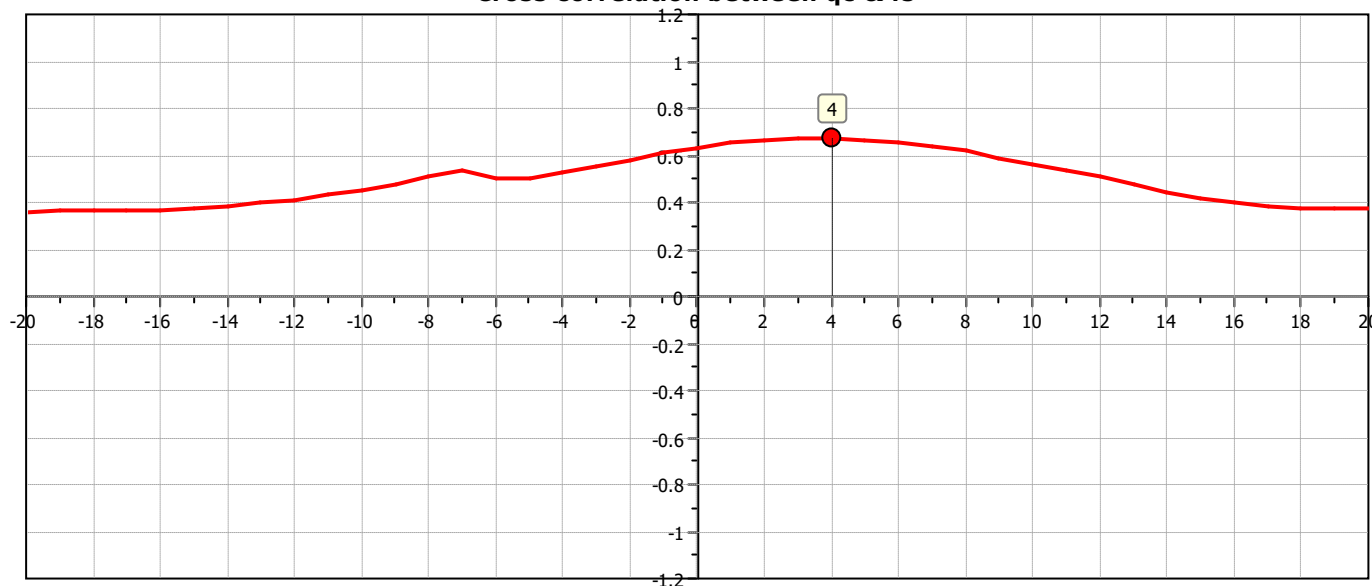
**Cross correlation between  $q_c$  &  $f_s$**

The plot below presents the cross correlation coefficient between the raw  $q_c$  and  $f_s$  values (as measured on the field). X axes presents the lag distance (one lag is the distance between two successive CPT measurements).
