**1440 Prince of Wales Drive,
Ottawa, Ontario**

Shell Canada Products

January 12, 2024

FINAL - Phase One Environmental Site Assessment

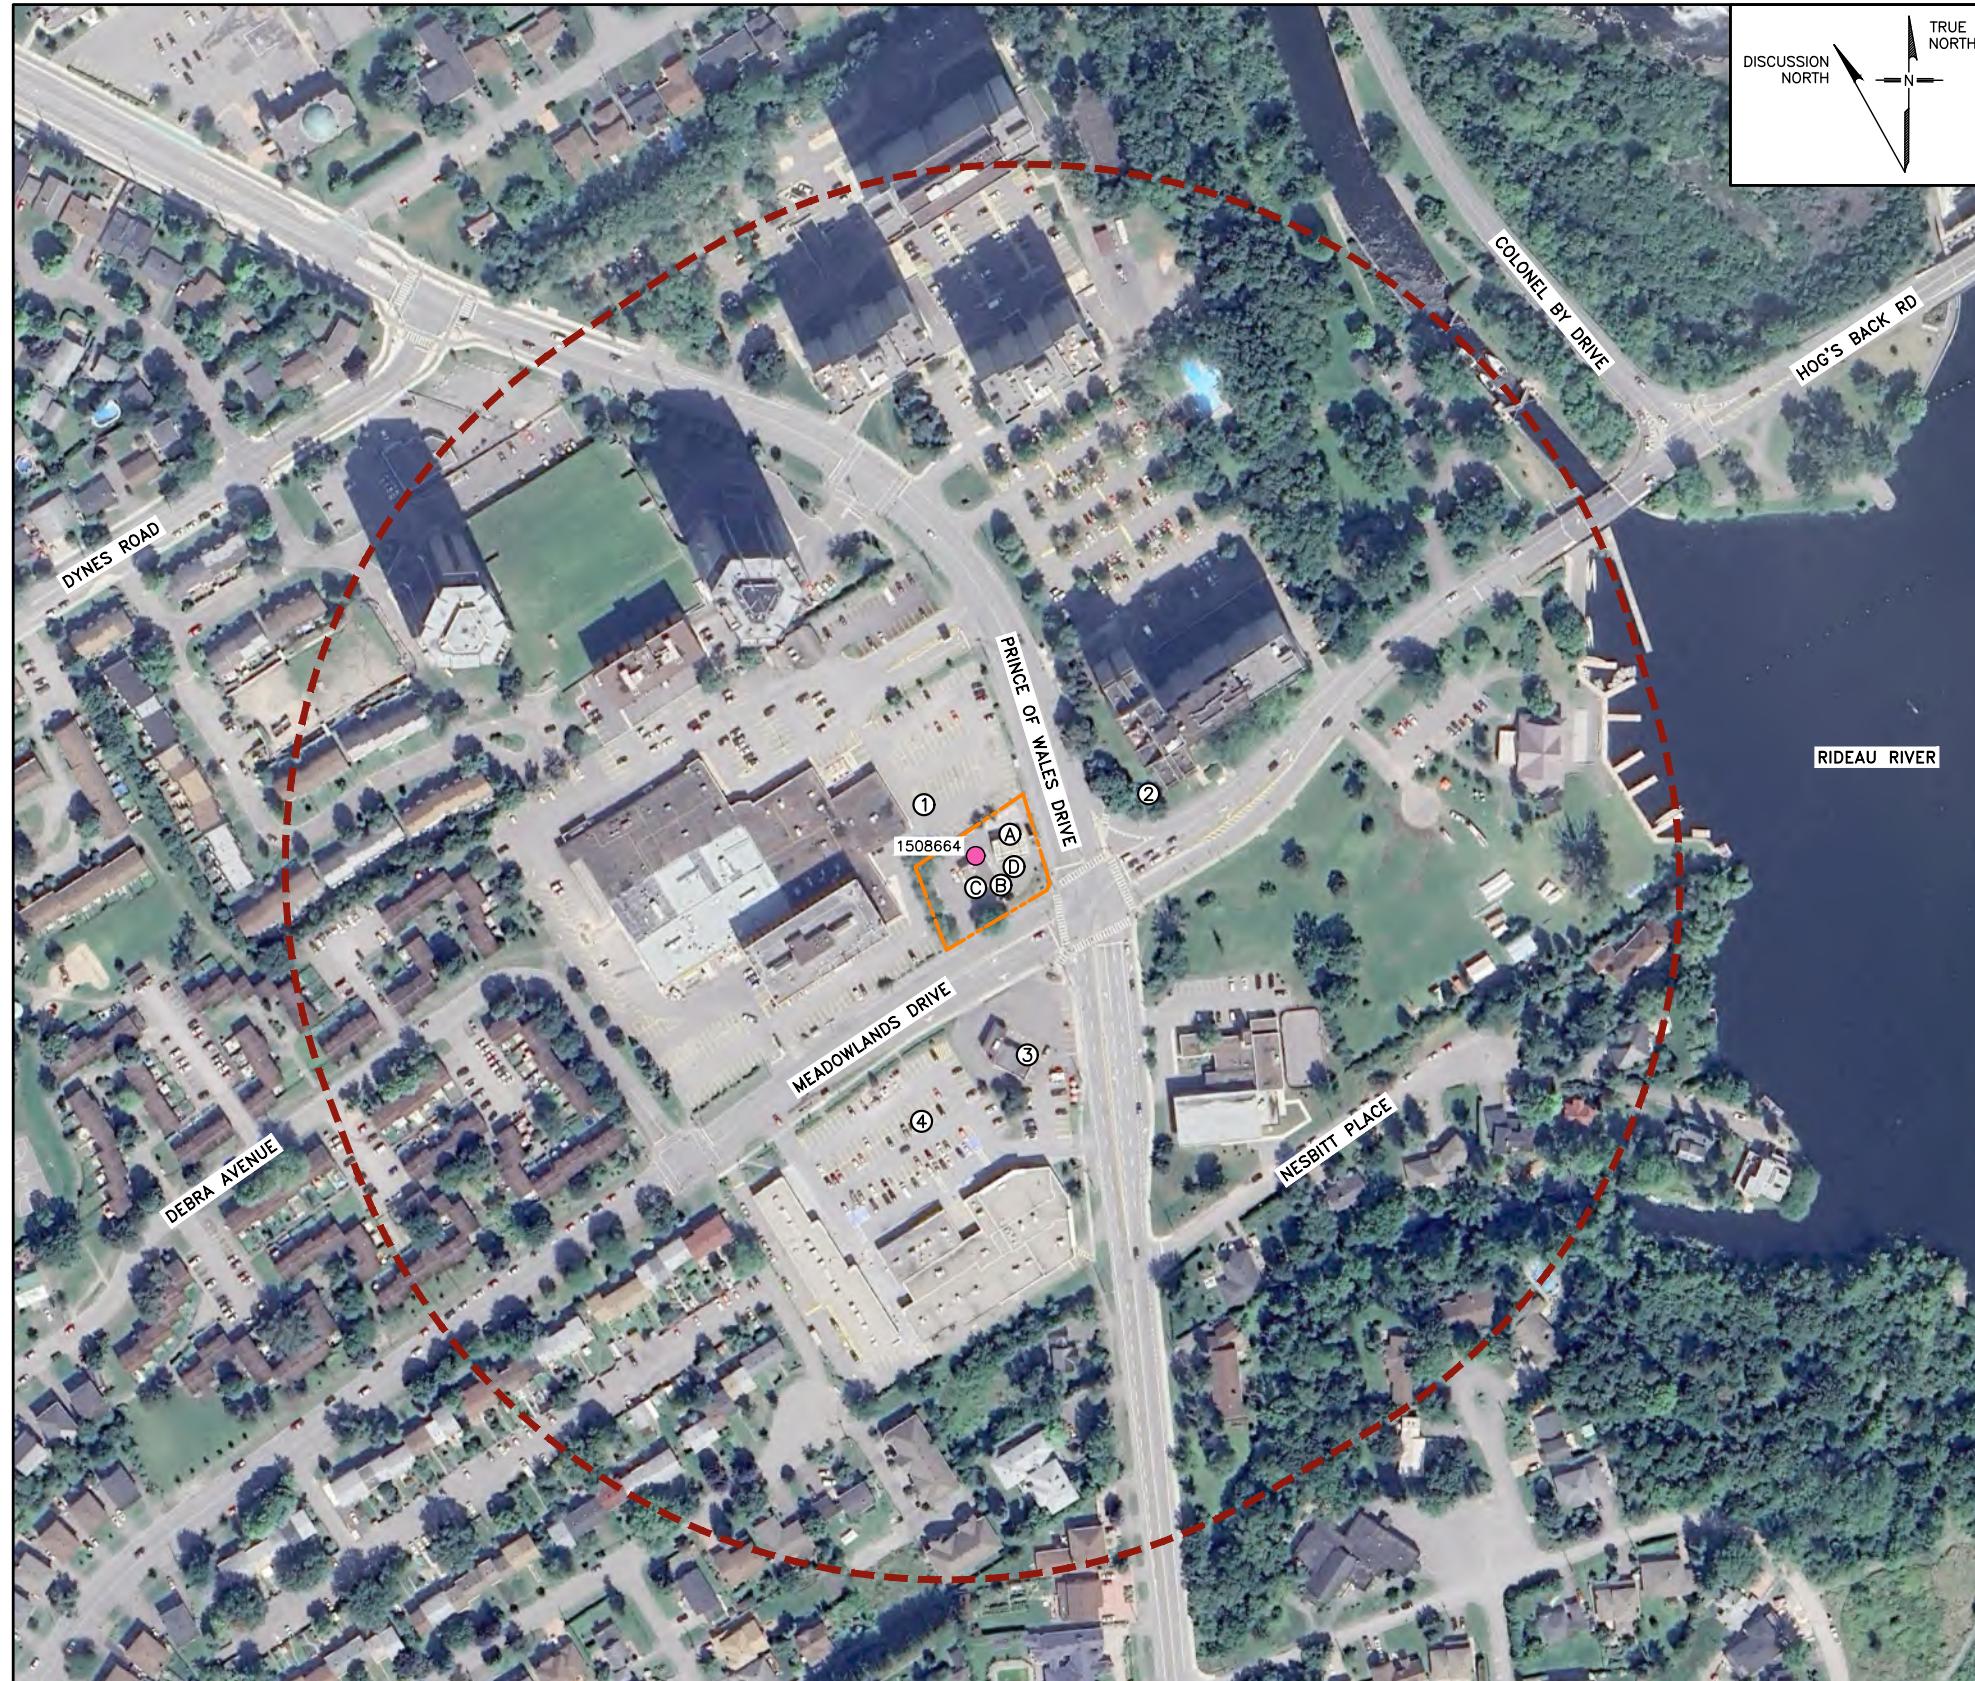
ON PHASE ONE STUDY PROPERTY ARE THERE?		
ROADS	YES	SEE FIGURE
WATER WELLS	YES	1- COMMERCIAL WATER SUPPLY WELL. CONSTRUCTED IN 1959; POSSIBLY ABANDONED. THE PHASE ONE PROPERTY IS CONNECTED TO MUNICIPAL WATER SUPPLY. SEE FIGURE
IN PHASE ONE STUDY AREA ARE THERE?		
ROADS	YES	SEE FIGURE
WATER BODIES	NO	
AREA OF NATURAL SIGNIFICANCE	NO

ON-SITE LOCATION	PCA No.	POTENTIALLY CONTAMINATING ACTIVITY TYPE	DESCRIPTION
A	28	GASOLINE AND ASSOCIATED PRODUCTS STORAGE IN FIXED TANKS	UNDER GROUND STORAGE TANKS WITHIN TANK NEST AND PUMP ISLANDS
B	52	STORAGE, MAINTENANCE, FUELING AND REPAIR OF EQUIPMENT, VEHICLES AND MATERIALS USED TO MAINTAIN TRANSPORTATION SYSTEMS	FORMER WASTE OIL TANK
C	52	STORAGE, MAINTENANCE, FUELING AND REPAIR OF EQUIPMENT, VEHICLES AND MATERIALS USED TO MAINTAIN TRANSPORTATION SYSTEMS	TWO FORMER MOTOR OIL STORAGE TANKS
D	30	IMPORTATION OF FILL MATERIAL OF UNKNOWN QUALITY	FILL MATERIAL OF UNKNOWN QUALITY IDENTIFIED AT PHASE ONE PROPERTY DURING PREVIOUS INVESTIGATION
OFF-SITE LOCATION	PCA No.	POTENTIALLY CONTAMINATING ACTIVITY TYPE	DESCRIPTION
1	28	GASOLINE AND ASSOCIATED PRODUCTS STORAGE IN FIXED TANKS	LOCATED IN AN INFERRED HYDRAULICALLY UPGRADIENT POSITION FROM THE PHASE ONE PROPERTY
	37	OPERATION OF DRY CLEANING EQUIPMENT

2	28	GASOLINE AND ASSOCIATED PRODUCTS STORAGE IN FIXED TANKS	LOCATED IN AN INFERRED HYDRAULICALLY DOWNGRADIENT POSITION FROM THE PHASE ONE PROPERTY IN CLOSE PROXIMITY TO THE PHASE ONE PROPERTY
3	28	GASOLINE AND ASSOCIATED PRODUCTS STORAGE IN FIXED TANKS	LOCATED IN AN INFERRED HYDRAULICALLY CROSS-GRADIENT POSITION FROM THE PHASE ONE PROPERTY
	52	STORAGE, MAINTENANCE, FUELING AND REPAIR OF EQUIPMENT, VEHICLES AND MATERIALS USED TO MAINTAIN TRANSPORTATION SYSTEMS	
4	37	OPERATION OF DRY CLEANING EQUIPMENT	LOCATED IN AN INFERRED HYDRAULICALLY CROSS-GRADIENT POSITION FROM THE PHASE ONE PROPERTY

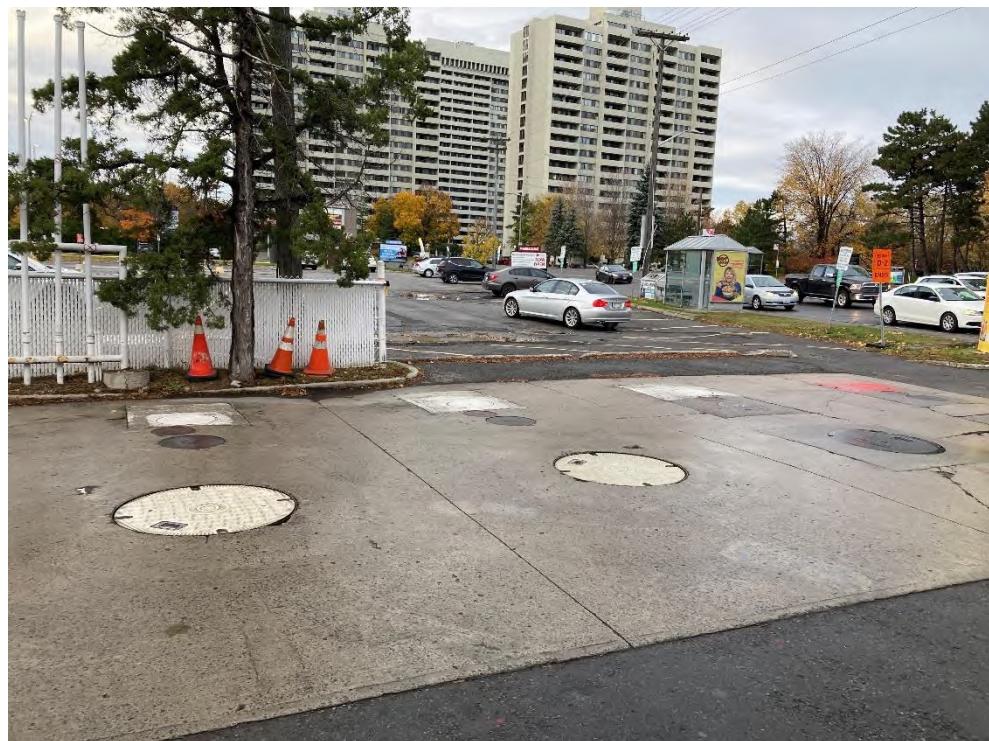
Photograph 2: View of the tank nest located by the northern portion of the Phase One Property looking north

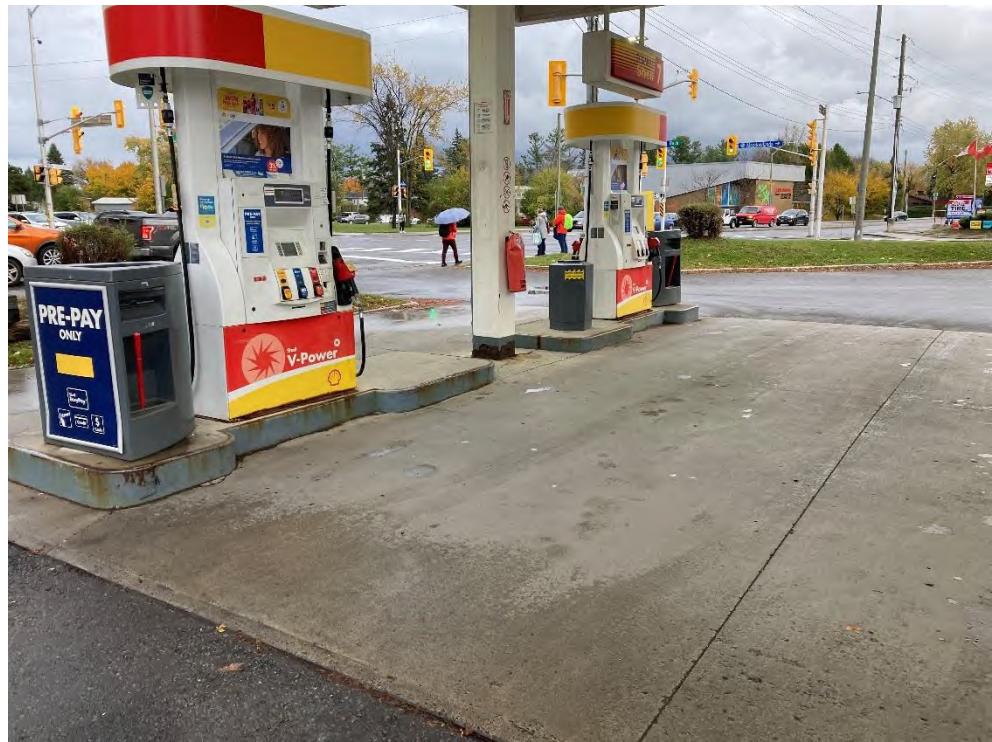
Photograph 3: View of the pump island on the Phase One Property – looking southeast

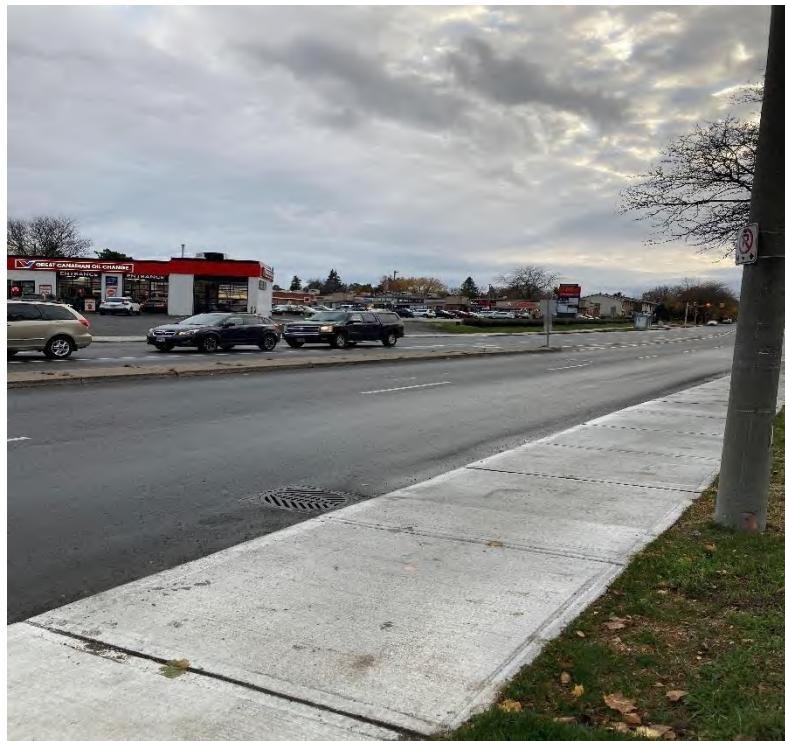
Photograph 8: View of Oil Changing facility at 1488 Prince of Wales Drive (located south/southeast of the Phase One Property) – looking south/southeast.
