South March Battery Energy Storage System (BESS) Fluvial Geomorphology Assessment

H375142-0000-2B0-066-0001

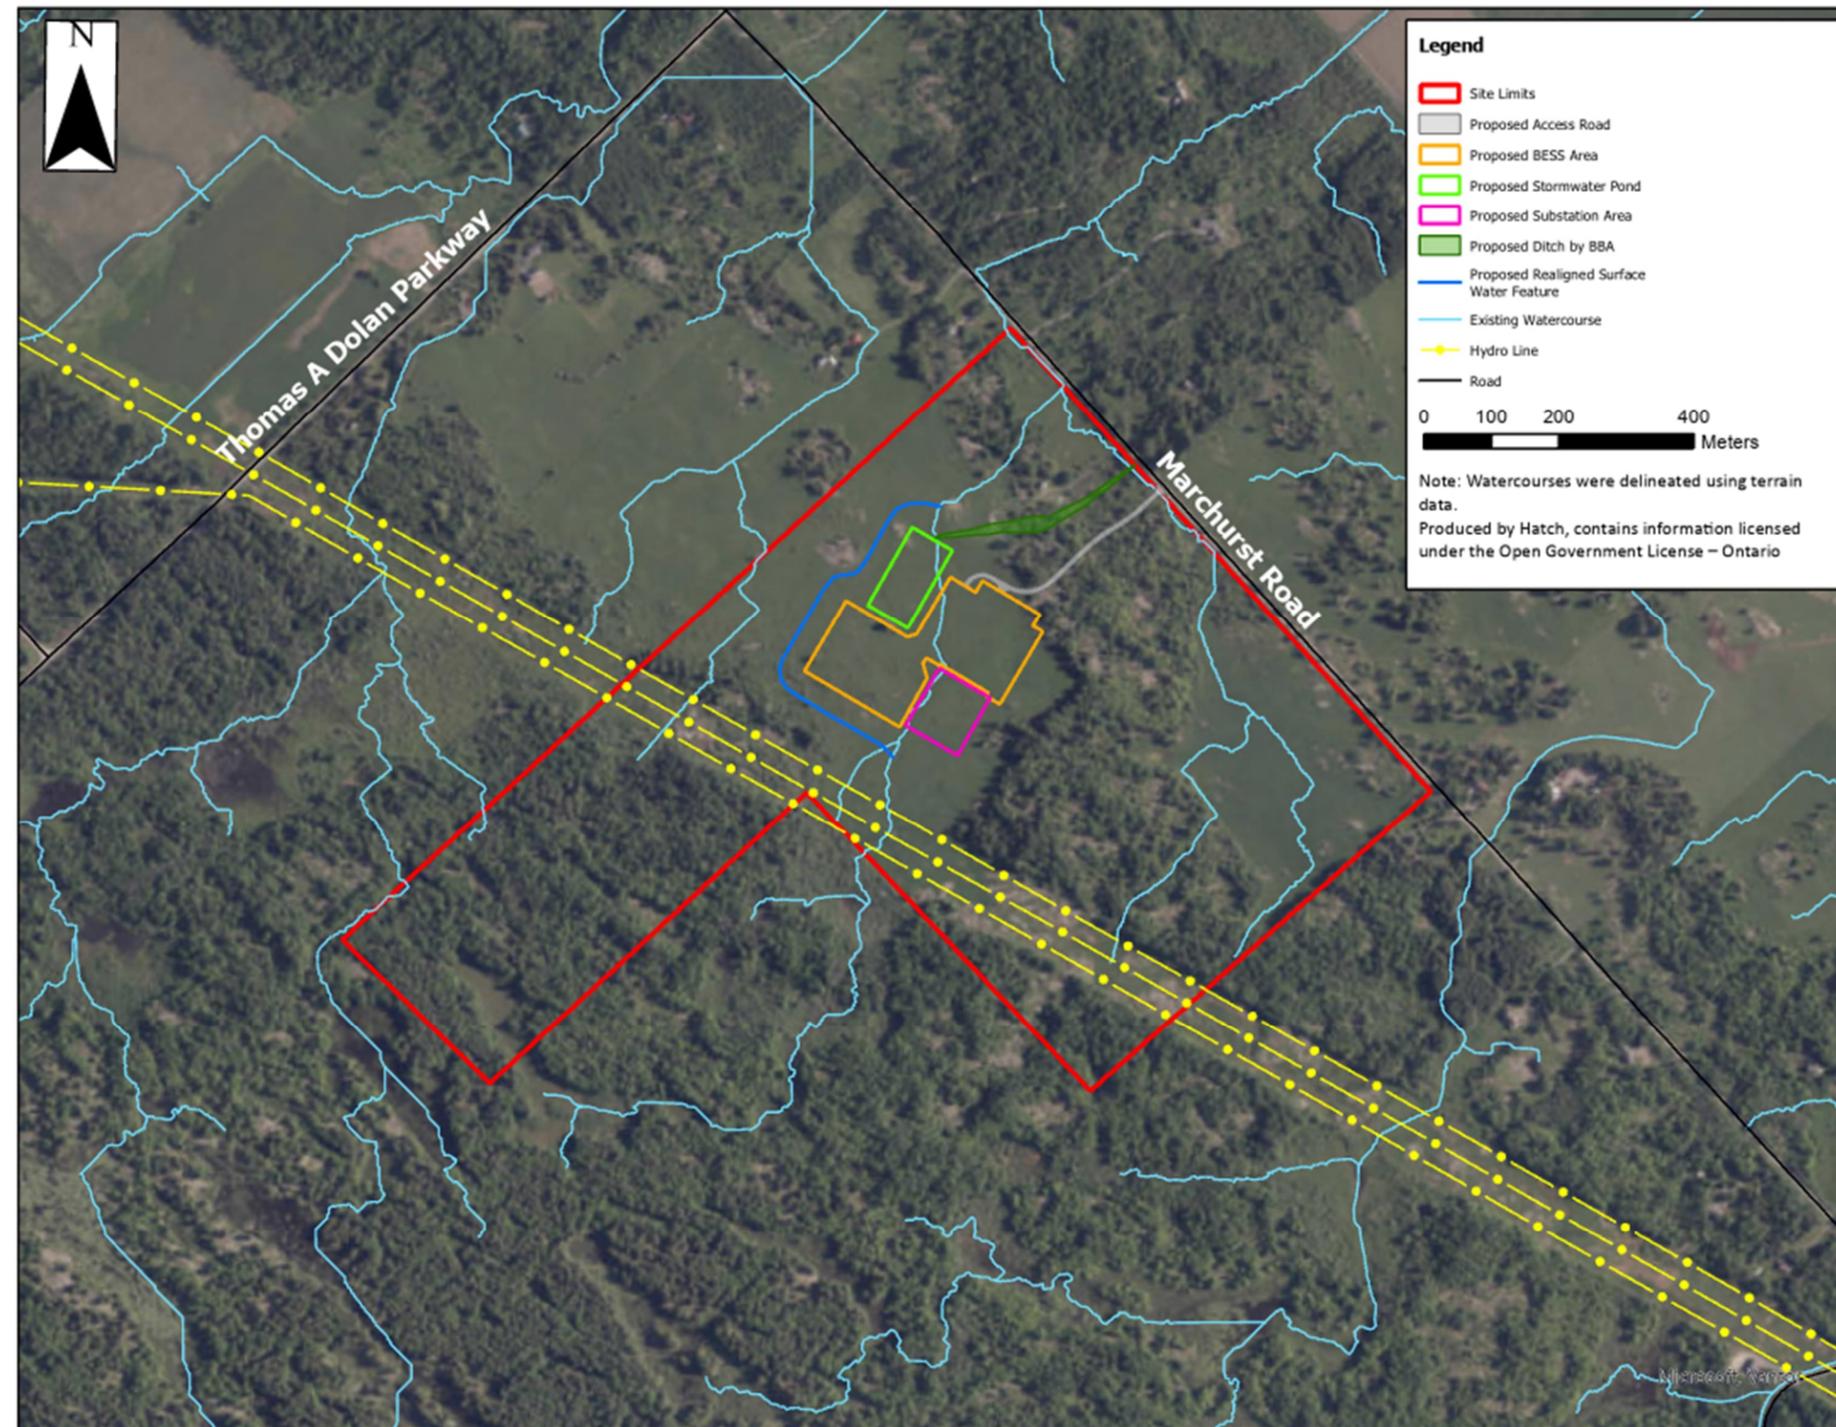
Figure 1-1: Overview of the South March BESS Project Limits

Brookfield is proposing to develop approximately 9.0 hectares of 84.5 hectares of property at 2555 and 2625 Marchurst Road in Ottawa, Ontario. The Project will consist of battery energy storage containers, a substation, access roads and associated electrical infrastructure. A key plan outlining the site location is shown on Figure 1-1.

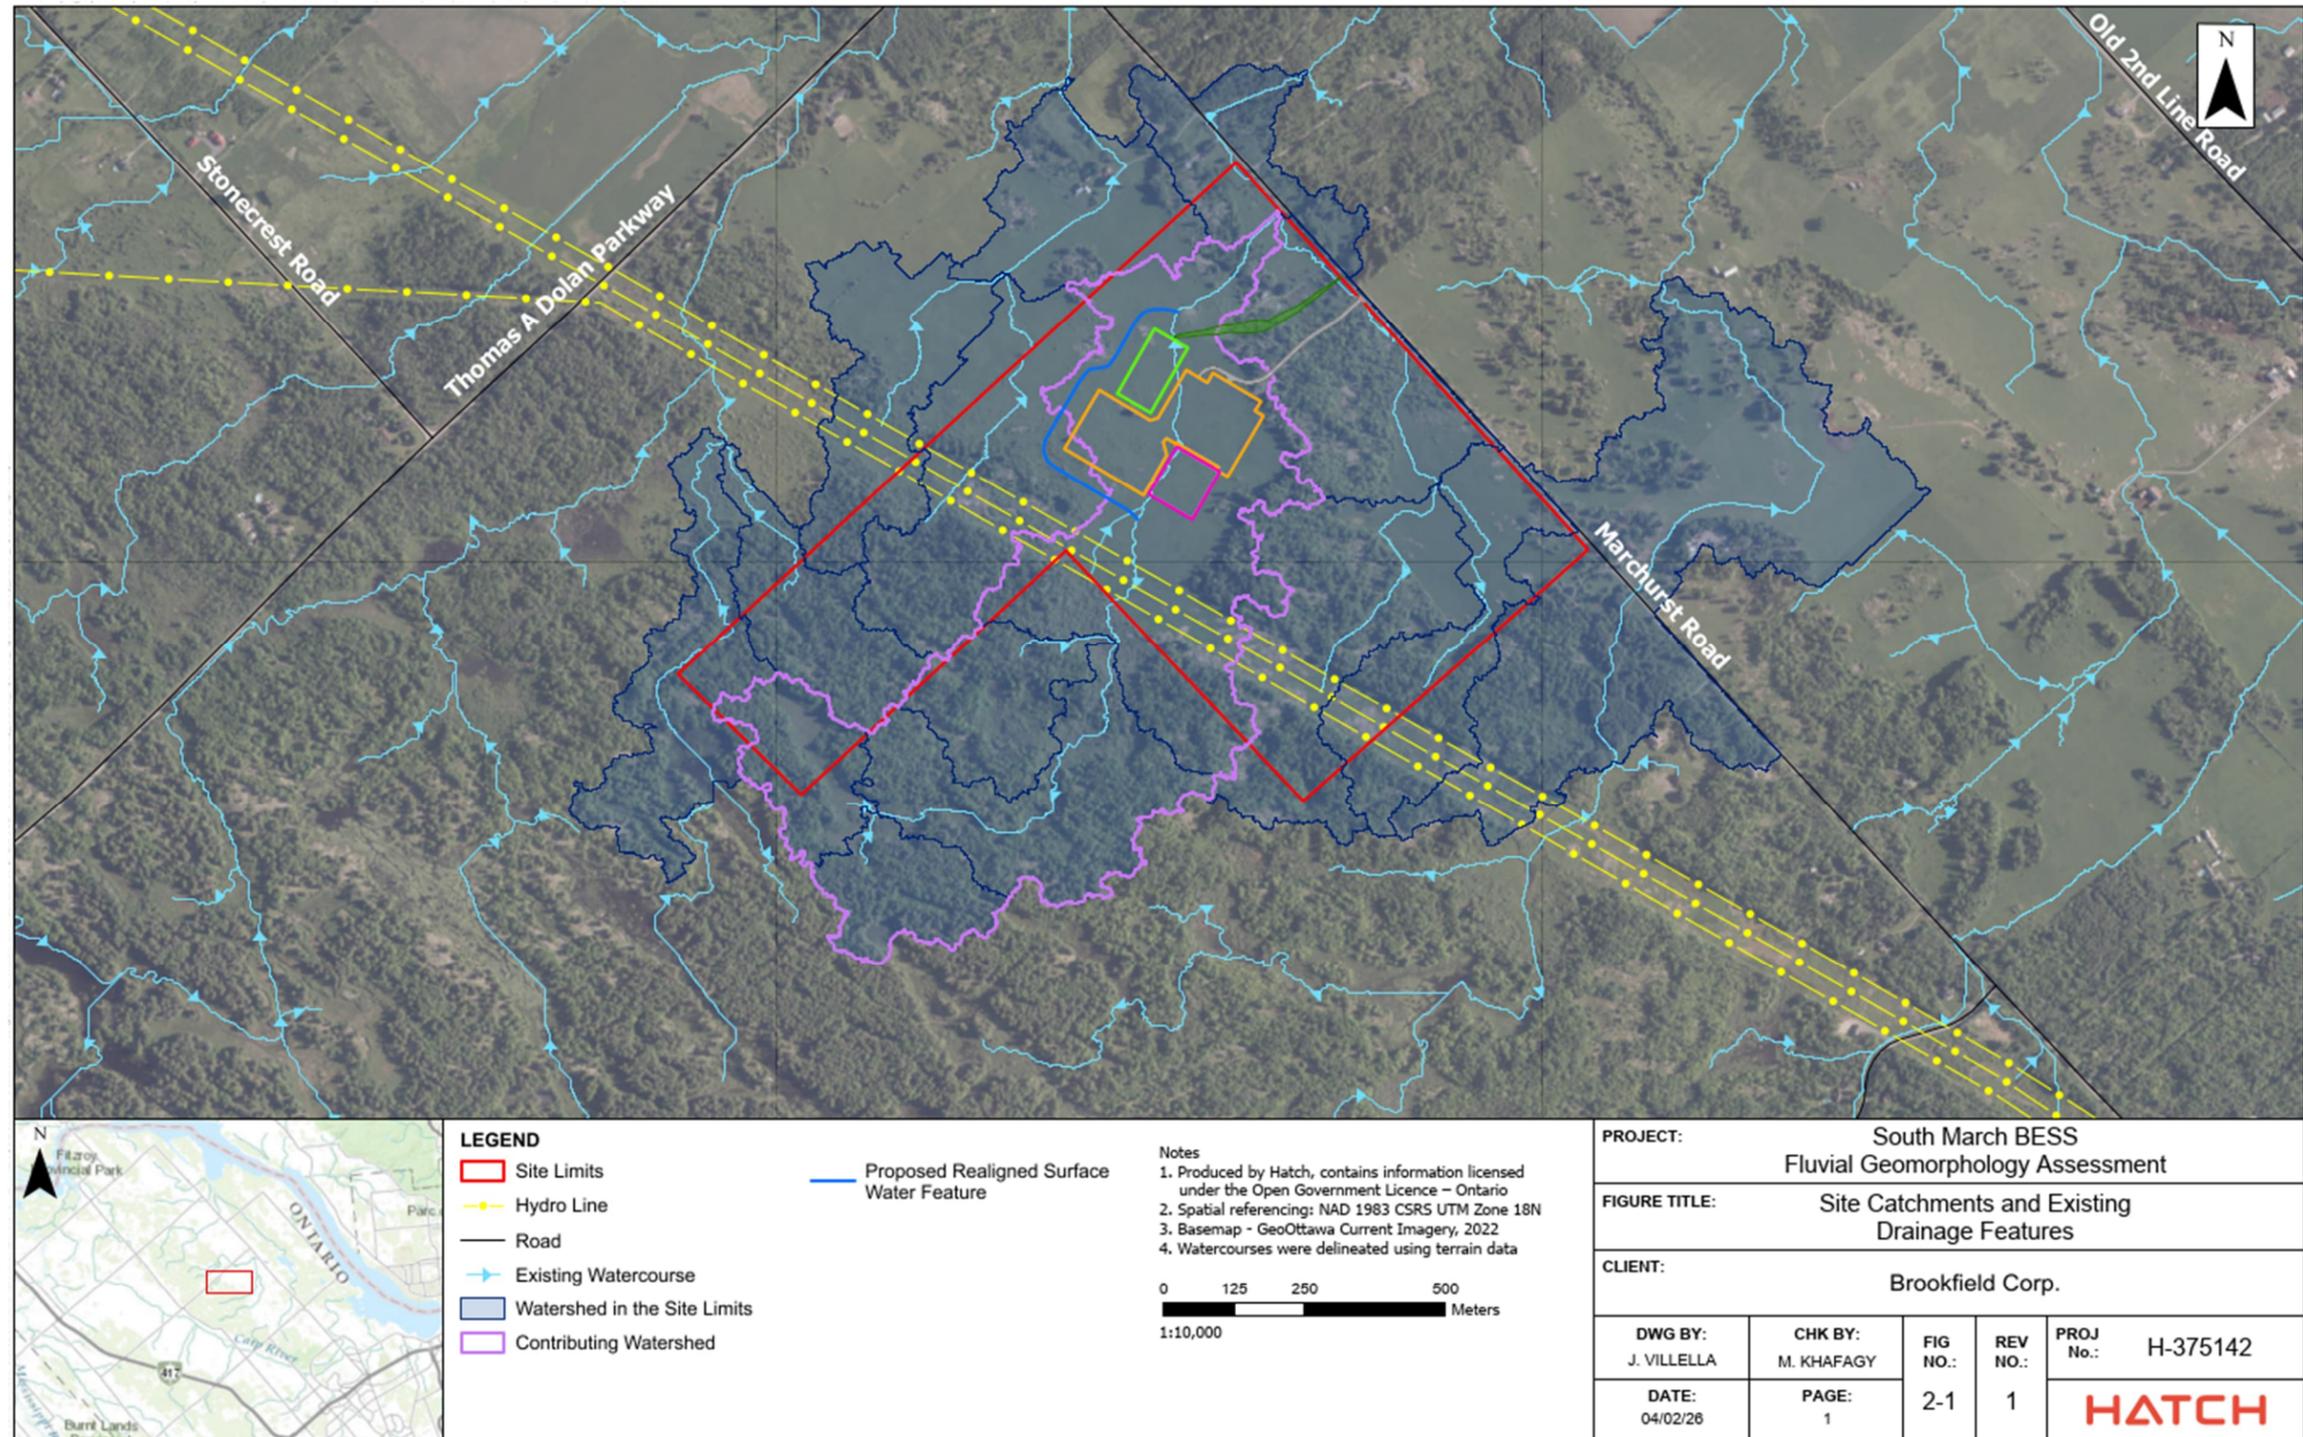
Figure 2-1: Catchments Within the Study Area with Existing Drainage Features and General Drainage Patterns

Hydrological analysis, including catchment and stream delineation, was performed using ArcGIS to assess surface flow directions. Figure 2-1 shows the drainage patterns within the study area using the topographic data.

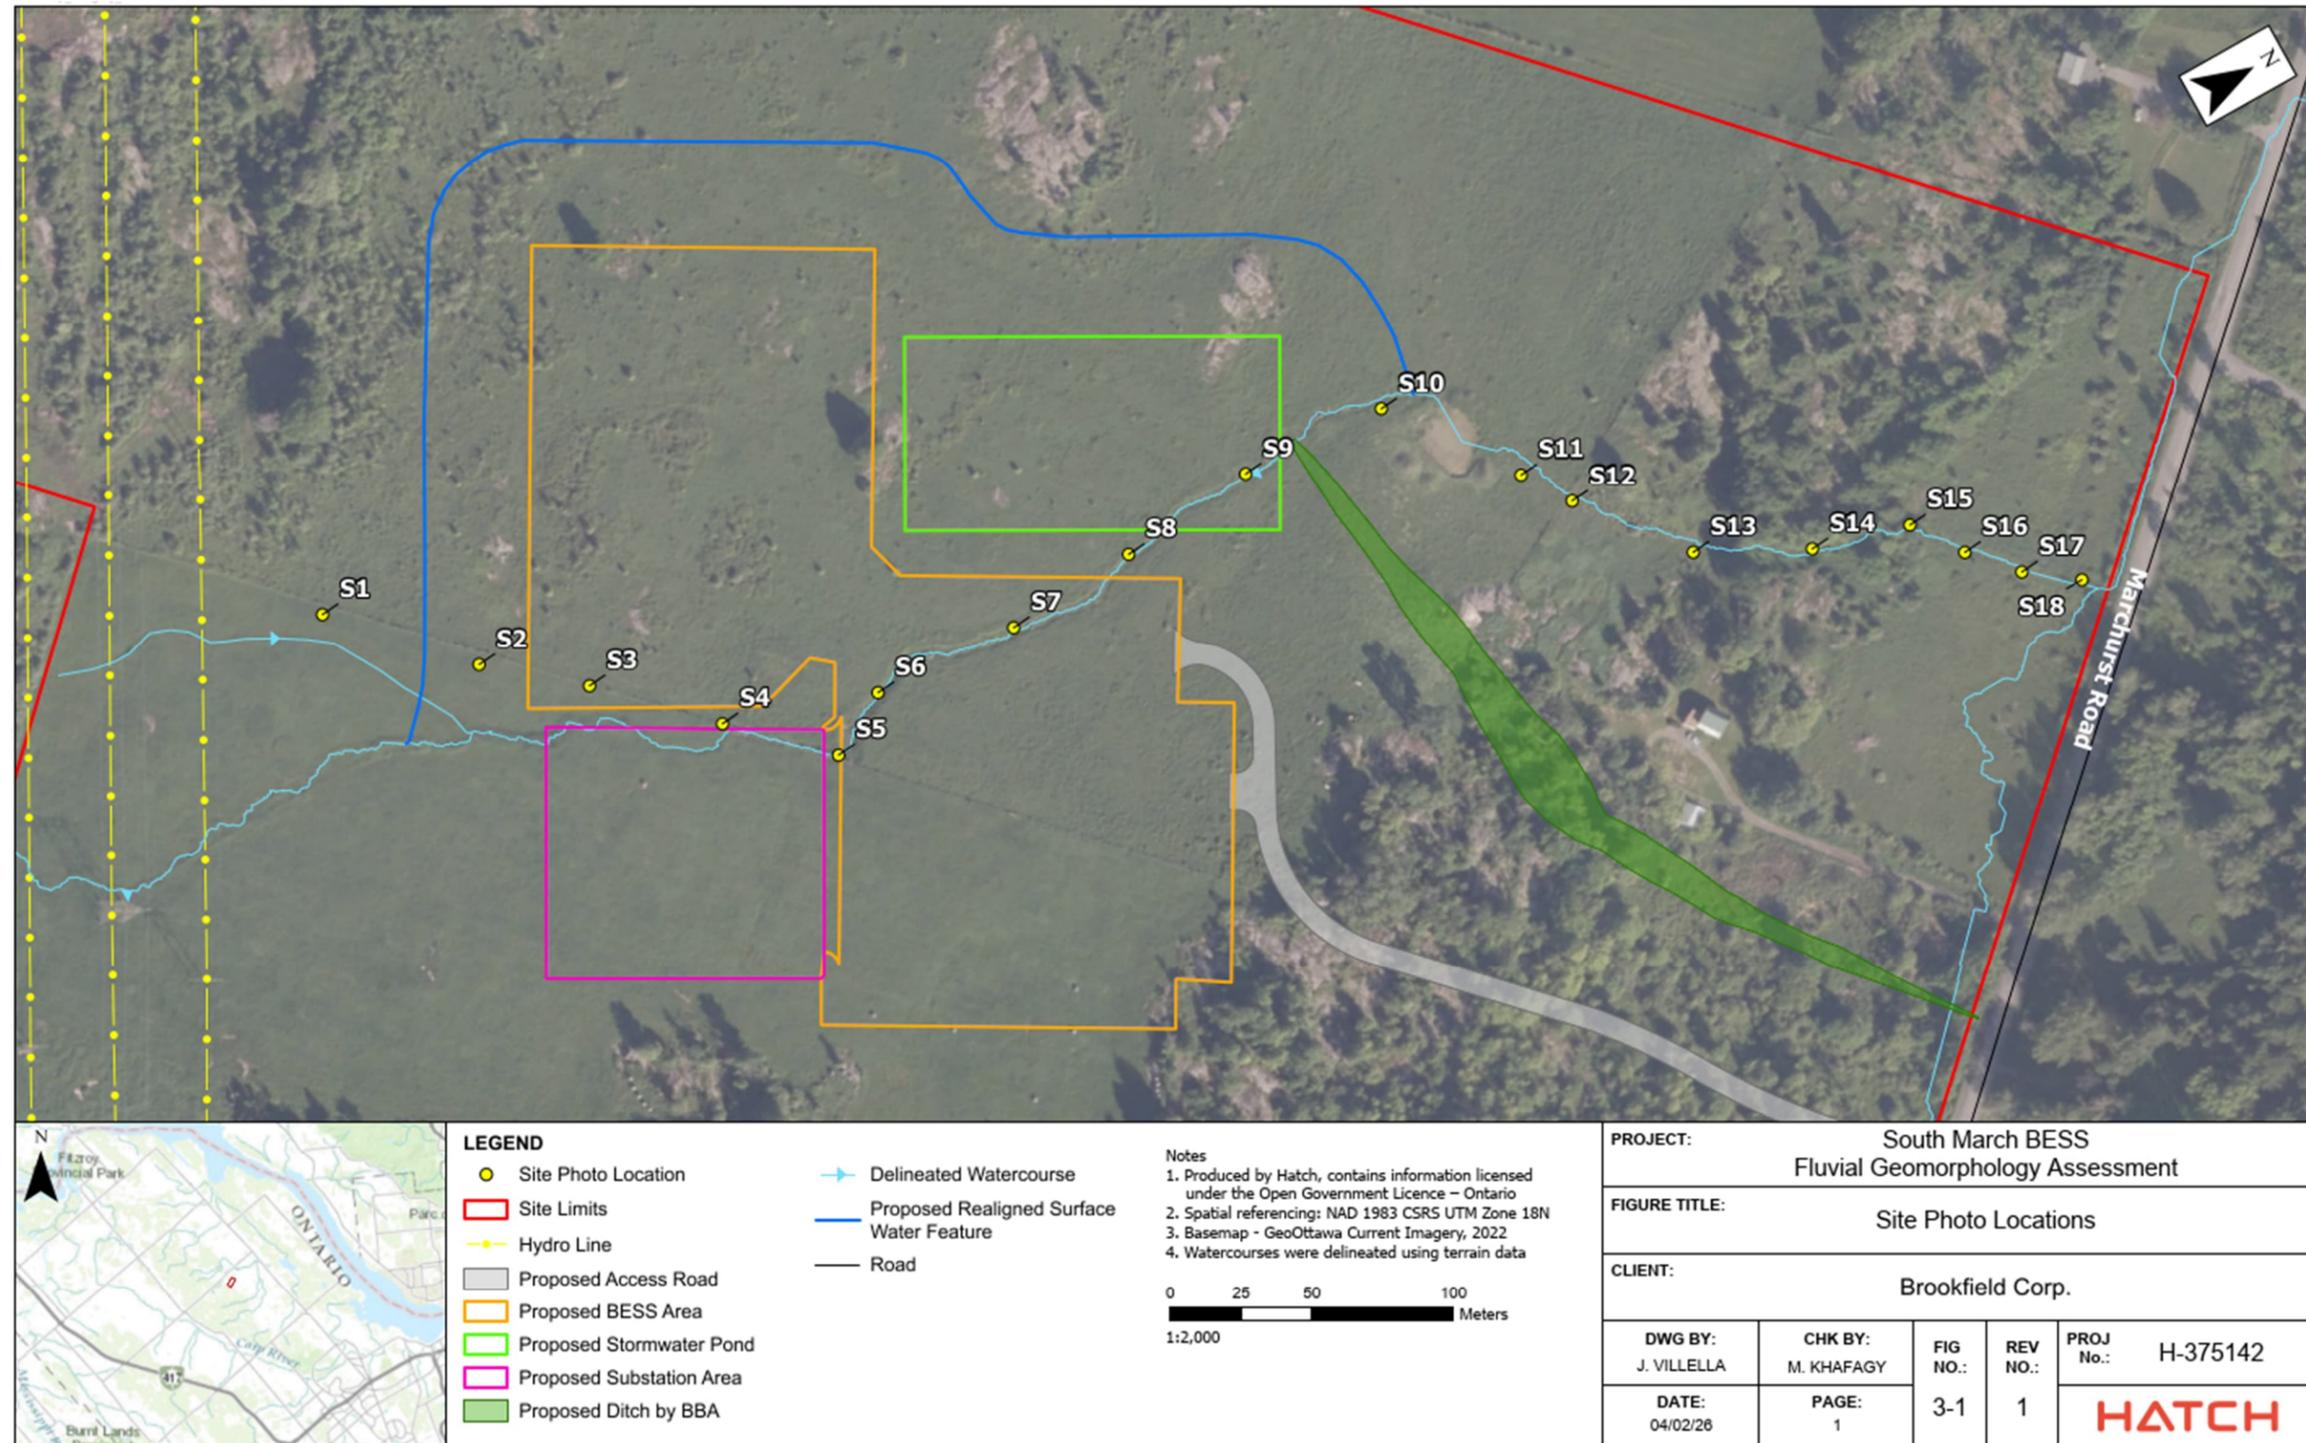
Figure 3-1: Locations of Field Photographs

Field observations are supplemented by representative photographs (Photos 1 to 27), the geographic locations of which are shown in Figure 3-1, and included in Appendix B.

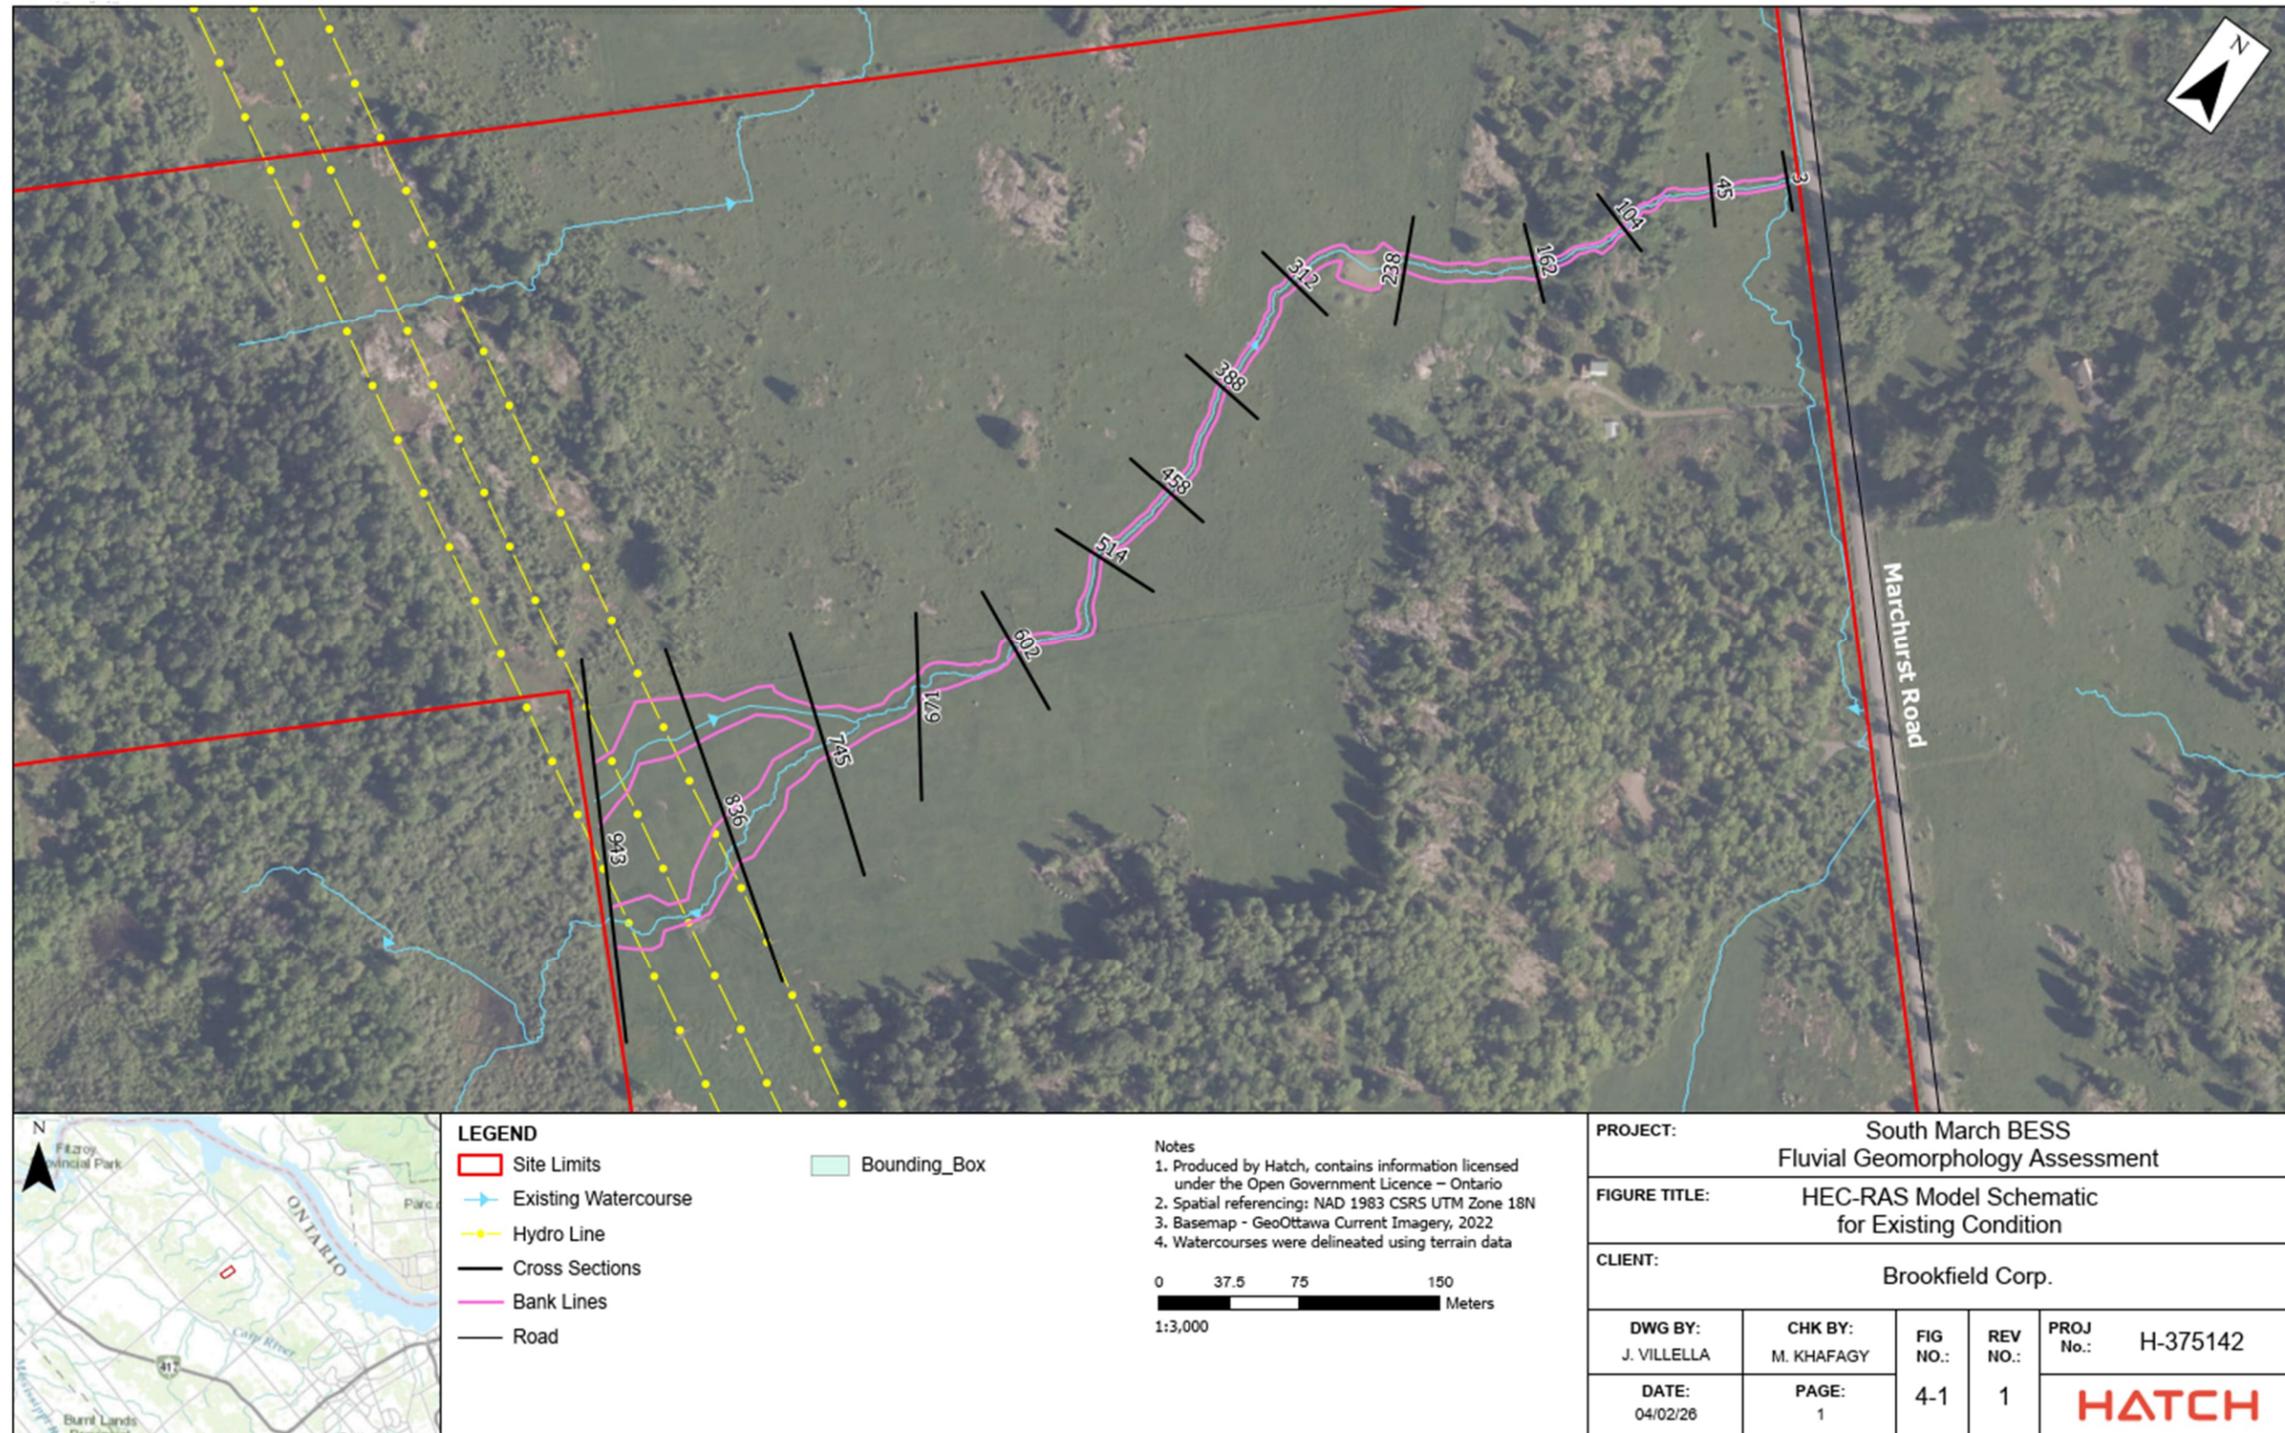
Figure 4-1: HEC-RAS Model Schematic for Existing Condition

The terrain for the existing condition was created based on the available survey and was used to create cutlines (cross-section lines) within HEC-RAS. The HEC-RAS model includes a total reach length of approximately 950 m. The cutlines are perpendicular to the direction of flow and developed using the RAS Mapper extension. The cross-sections were cut at locations with potential changes (i.e., bends, bridge structure, contraction, expansion, etc.) in the stream. In general, 14 cross-sections were constructed along the river alignment with an average spacing of 60 m. Figure 4-1 shows the HEC-RAS schematic of the cross-sections and river alignment with the terrain for the existing condition. Note that the north reach of the Creek had not appeared in the GIS delineation, however, it was observed from the aerial photographs and field photographs. The cross sections in HEC-RAS were extended to cover both reaches of the creek. It is important to note that the north reach of the creek did not appear in the GIS delineation; however, its presence was confirmed through aerial imagery and field observations. Therefore, the HEC-RAS cross-sections were extended to include both the main and north reaches of the Creek.

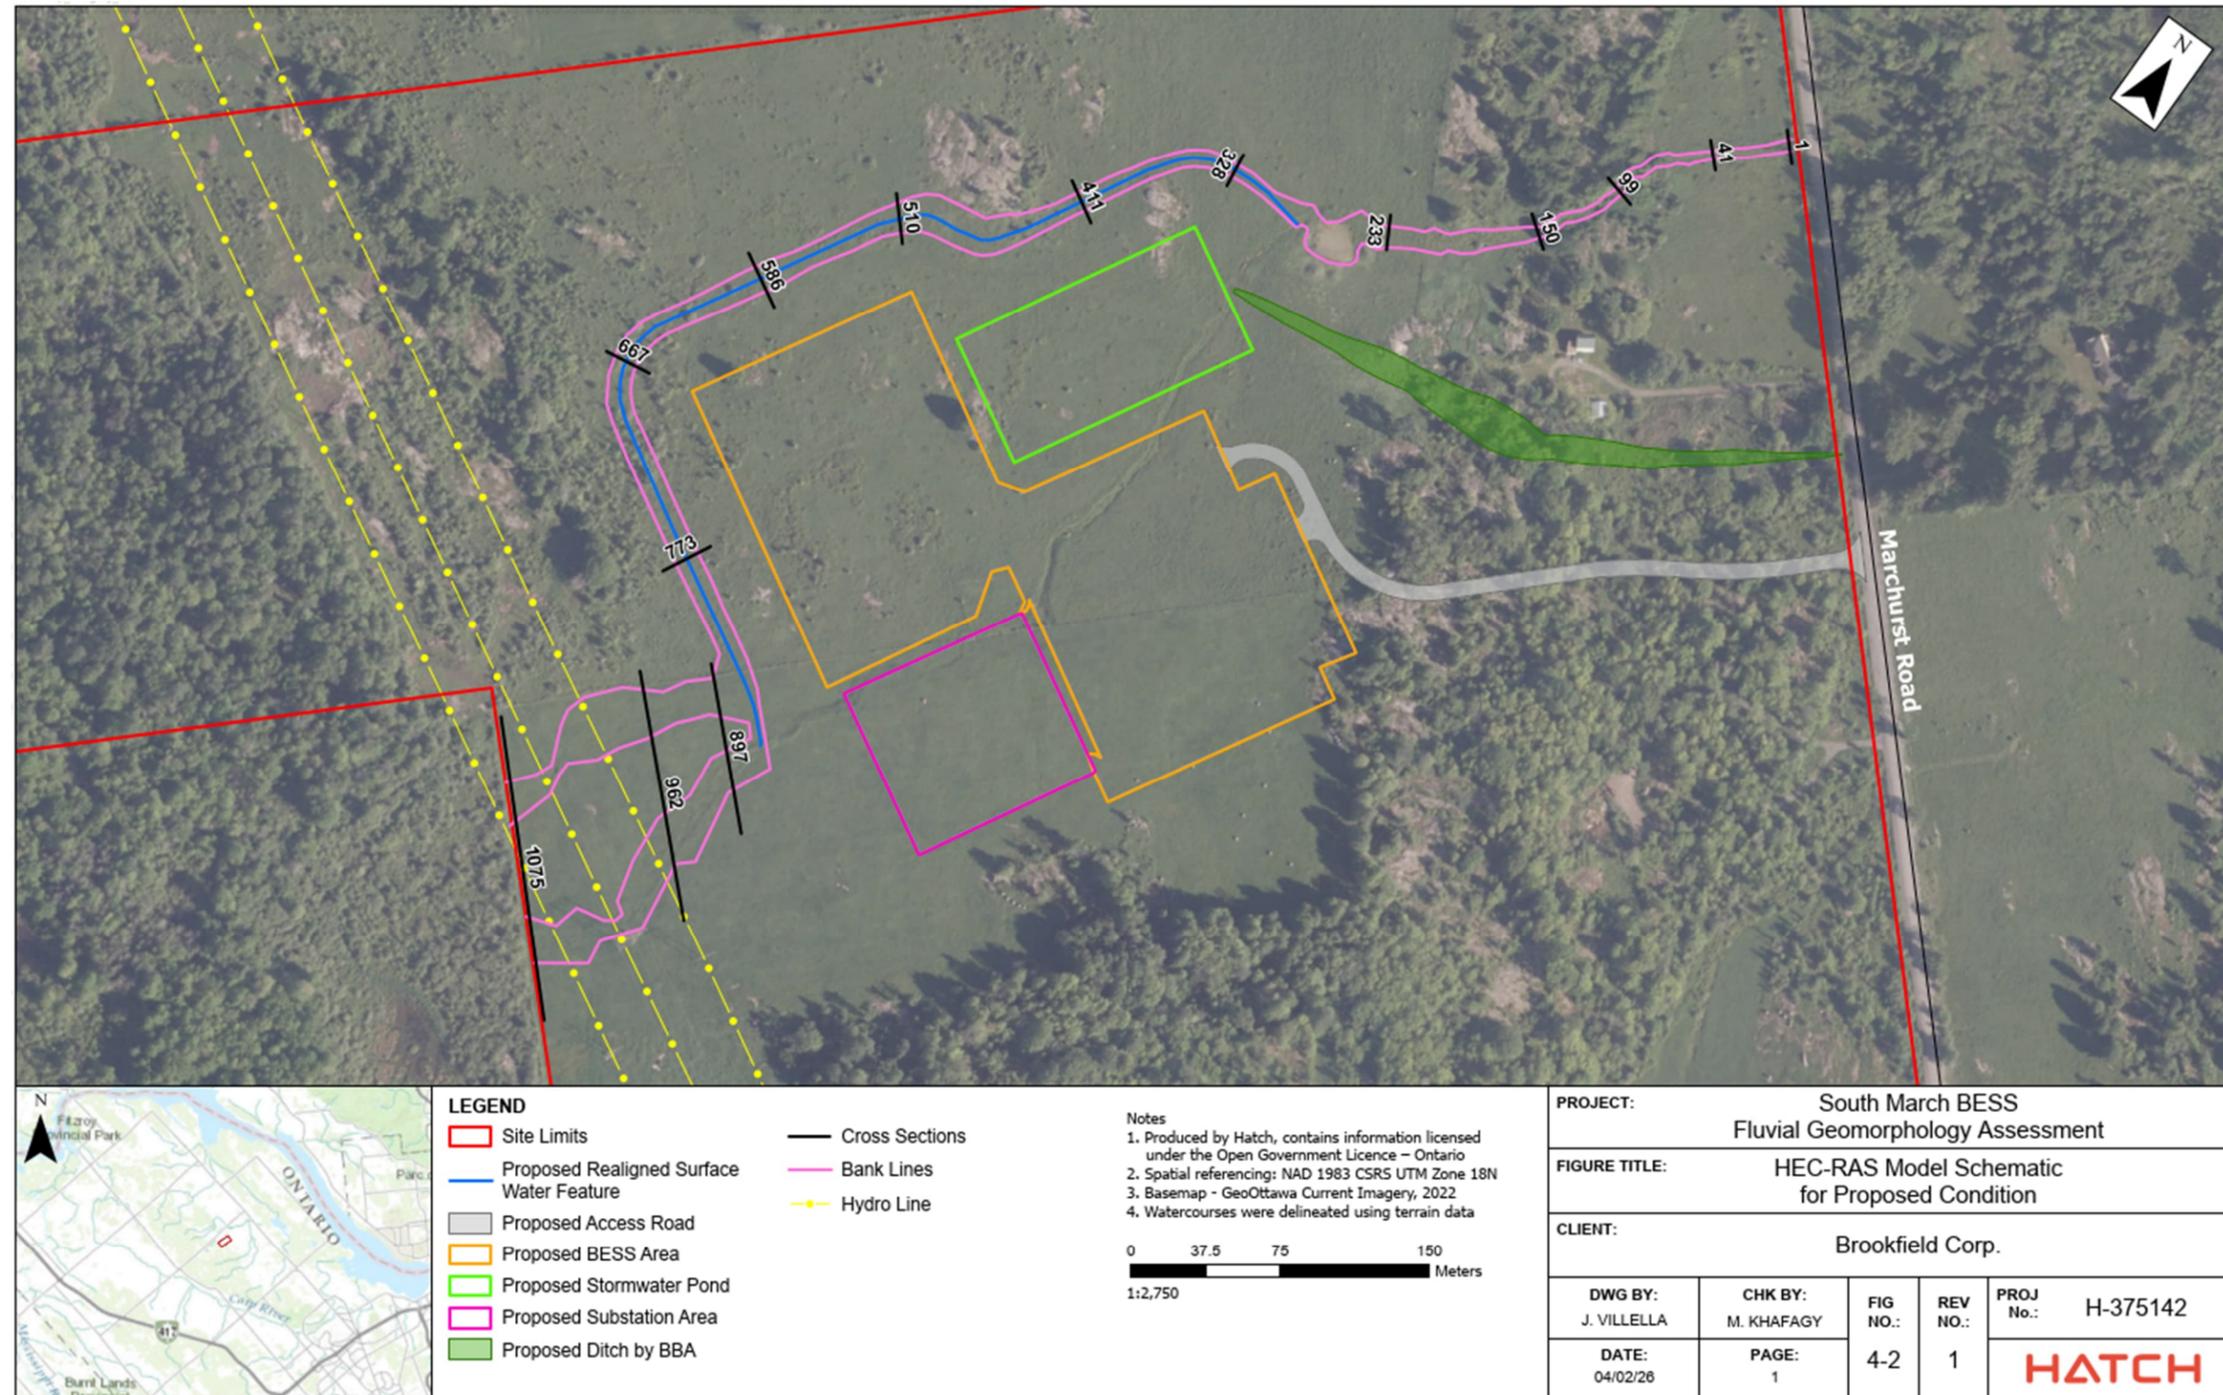
Figure 4-2: HEC-RAS Model Schematic for Proposed Condition

For the proposed condition, the terrain was modified to include the realigned surface water feature based on the Civil Drawings by BBA (Drawing no.: 7154023-100000-41-D20-0005 (Rev AE) and is provided in Appendix F) and was used to create cutlines (cross-section lines) within HEC-RAS. The HEC-RAS model includes a total reach length of approximately 1075 m. In general, 14 cross-sections were constructed along the Creek alignment with an average spacing of 70 m. Figure 4-2 shows the HEC-RAS schematic of the cross-sections and Creek alignment with the terrain for the proposed condition.

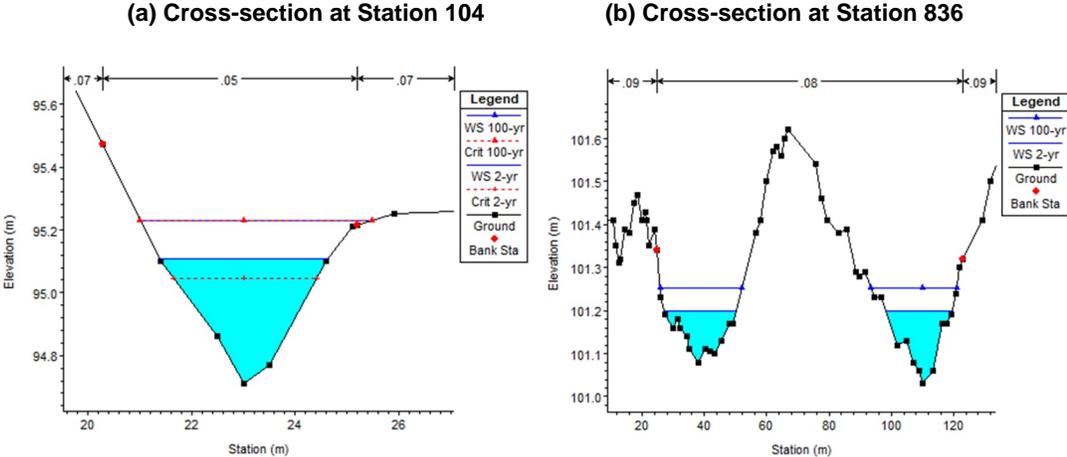
Figure 4-3: Existing Condition Cross-sections with Peak Flow for 2- and 100-year Storm Events

The flow in all cross-sections is subcritical ($F_r < 1$) for both storm events, except at station 104, where the flow is critical ($F_r = 1$) for the 5-year storm event. This location corresponds to a small waterfall with an approximate drop of 7 cm, as observed at location S15 (Photos 19, 20, and 21 in Appendix B). Figure 4-3 shows the water levels in two cross-sections for the 100-year storm event.

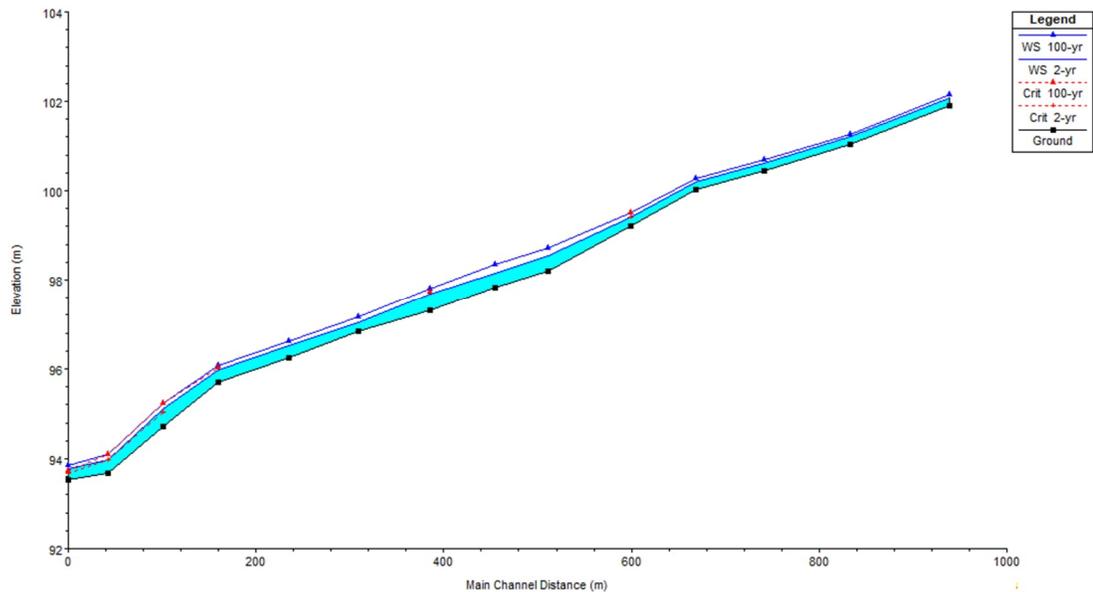
Figure 4-4: South March Creek Profile for 2- and 100-year Storm Events - Existing Condition

Figure 4-4 shows the Creek profile for 2-year and 100-year storm events.

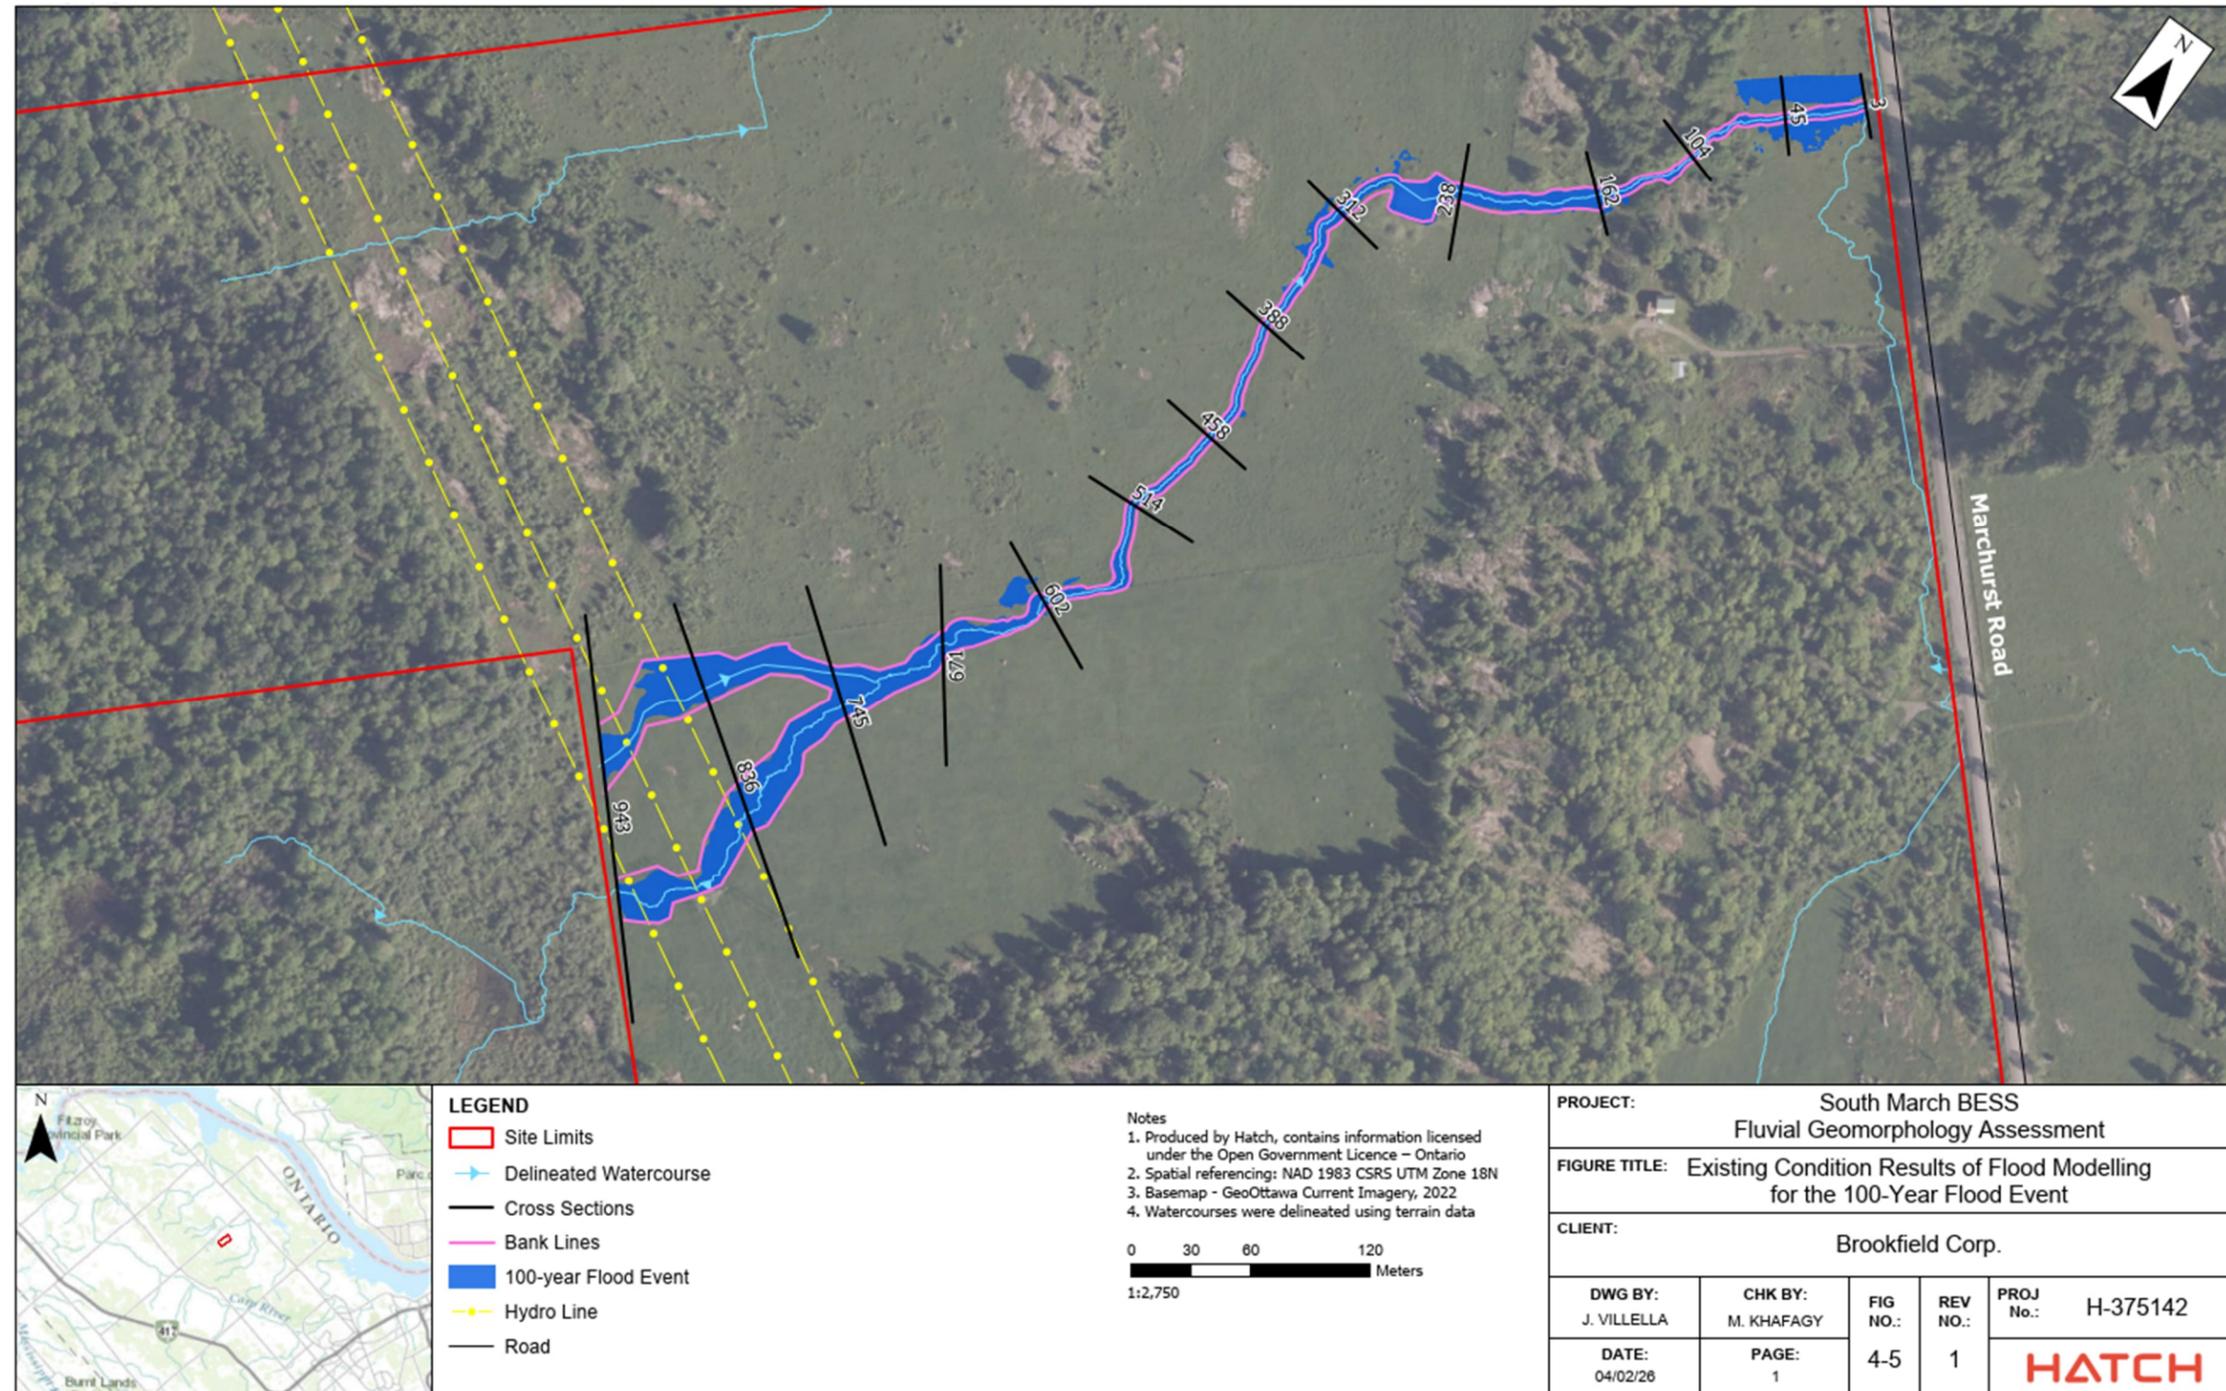
Figure 4-5: Existing Condition Results of South March Creek Floodplain Modelling for the 100-year Flood Event

The results of the 100-year flood events at the Creek are shown in Figure 4-5 below.

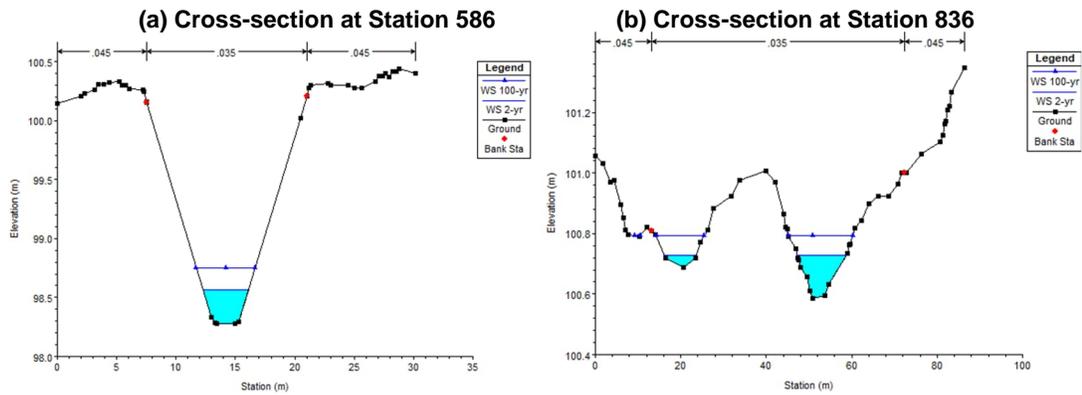
Figure 4-6: Proposed Condition Cross-sections with Peak Flow for 2- and 100-year Storm Events

The flow in all cross-sections is subcritical ($F_r < 1$) for both storm events, except at stations 99 and 1,075, where the flow is critical ($F_r = 1$) for the 100-year storm event. Figure 4-6 shows the water levels in two cross-sections for the 2- and 100-year storm events. The results of the 100-year flood events at the Creek are presented in Figure 4-8 below.

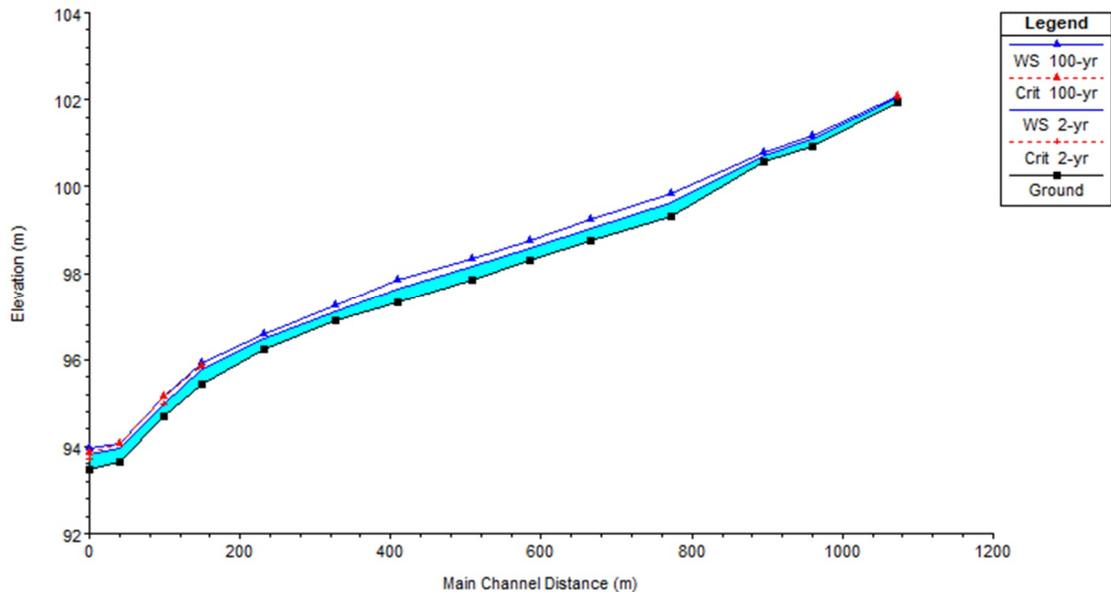
Figure 4-7: South March Creek Profile for 100-year Storm Event - Proposed Condition

Figure 4-7 shows the Creek profile for 2-year and 100-year storm events.
