South March Battery Energy Storage System (BESS) Fluvial Geomorphology Assessment

H375142-0000-2B0-066-0001

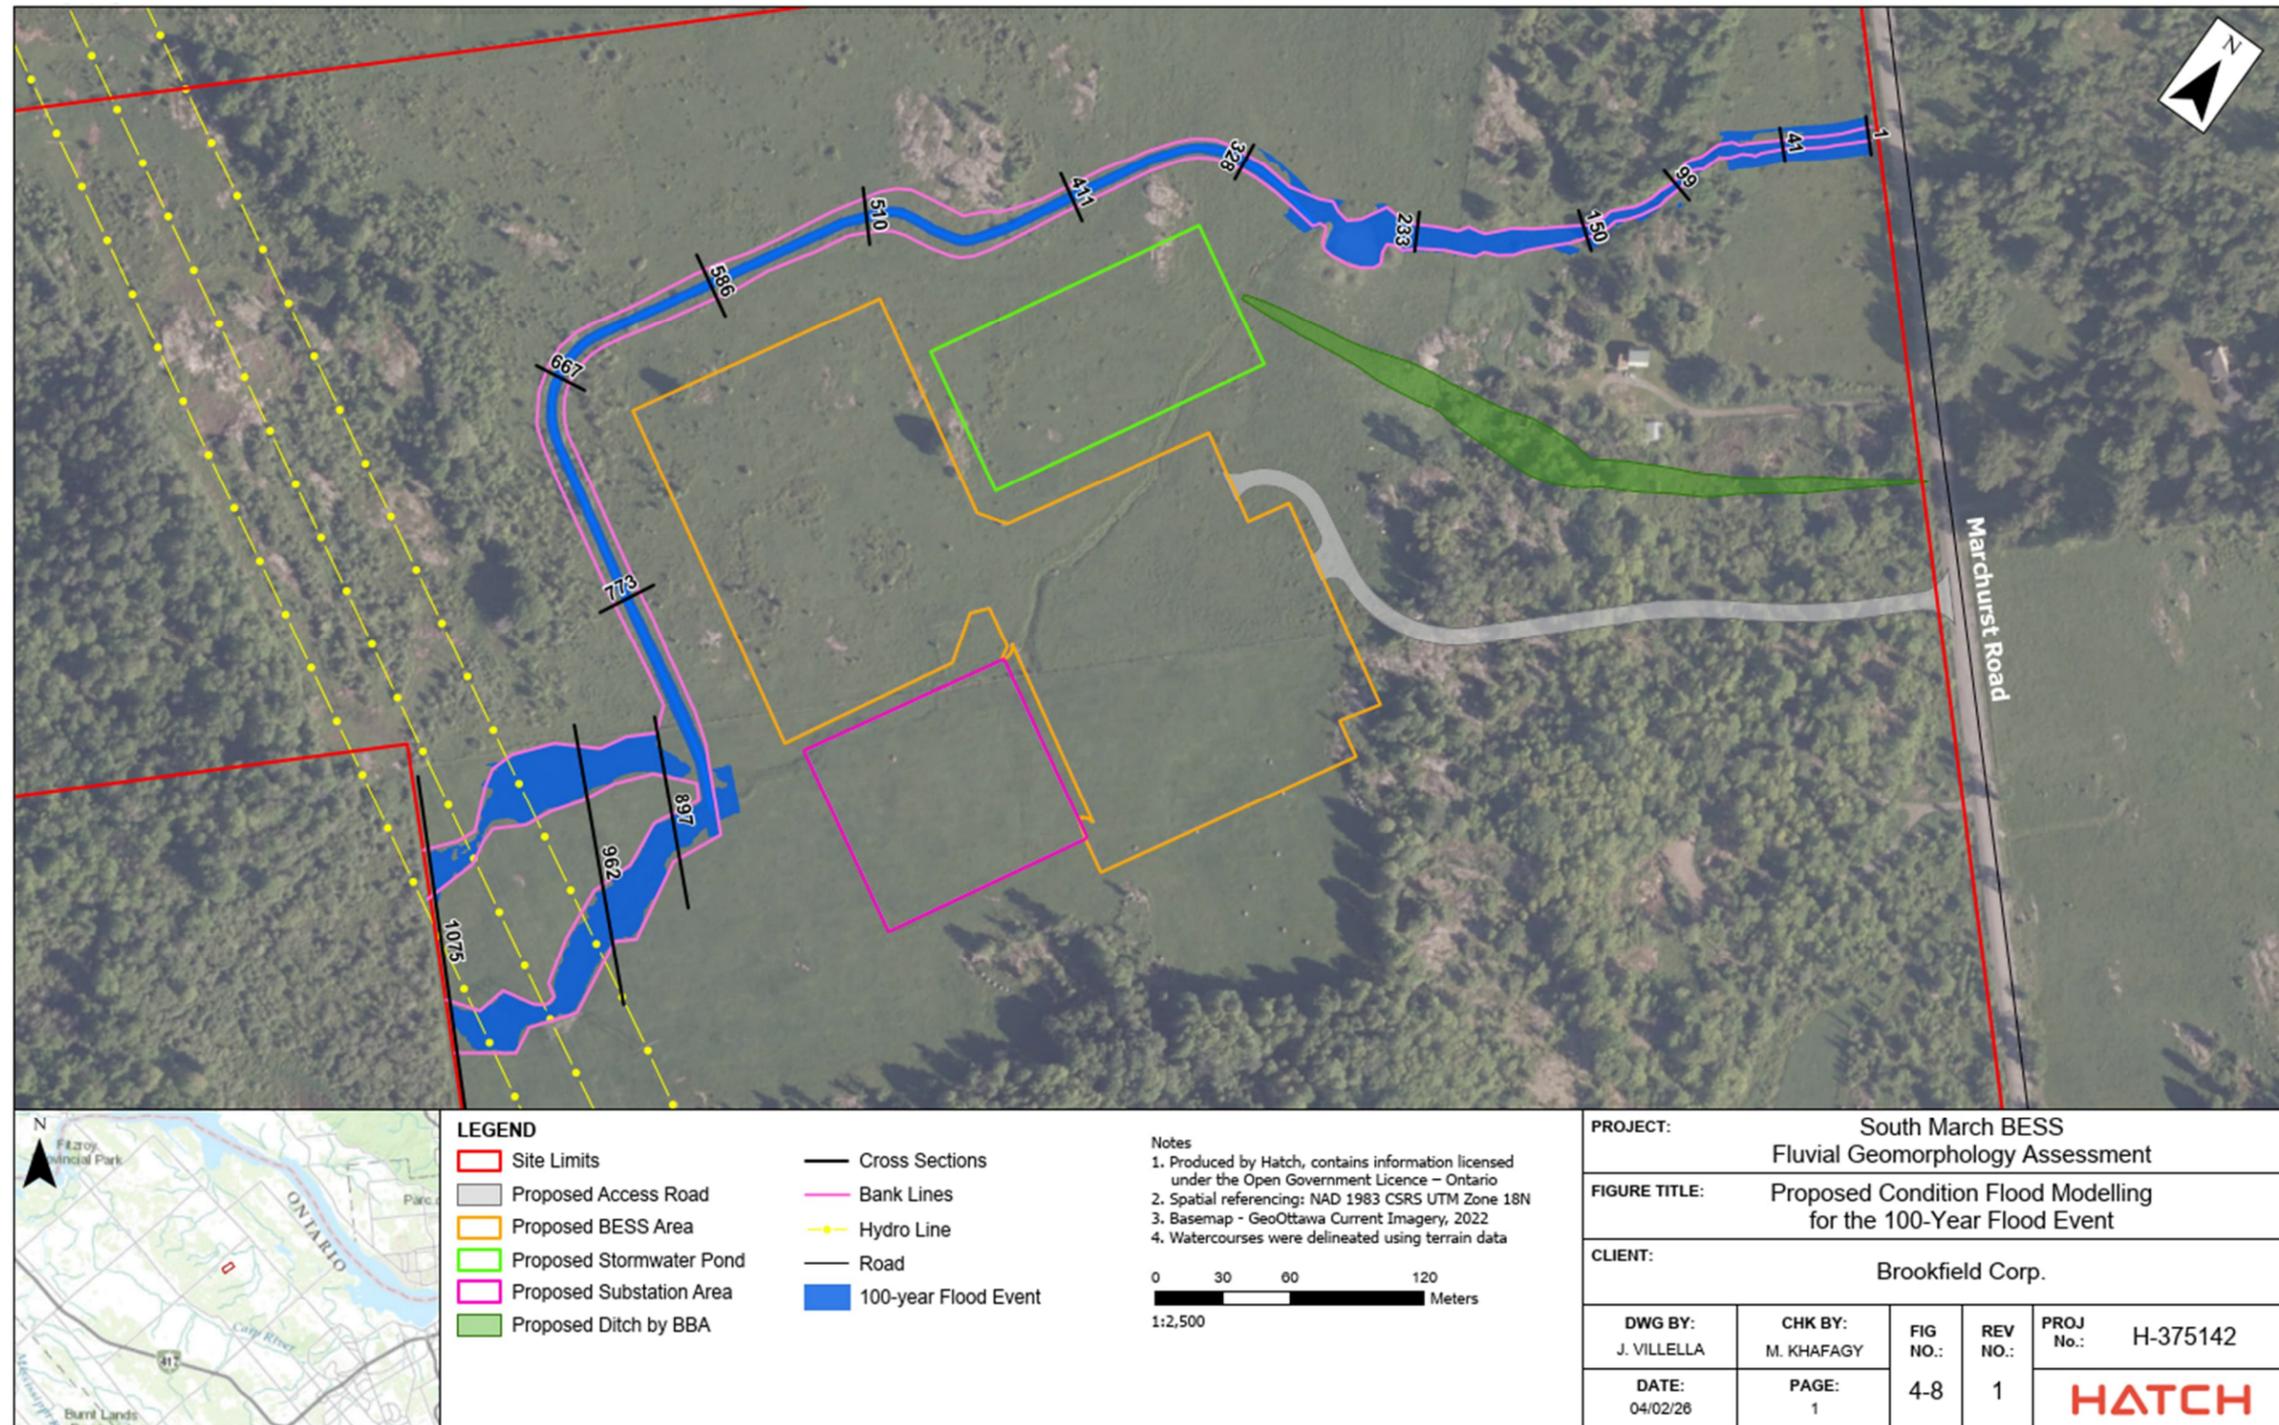
Figure 4-8: Proposed Condition Results of South March Creek Floodplain Modelling for the 100-year Flood Event

The flow in all cross-sections is subcritical ($F_r < 1$) for both storm events, except at stations 99 and 1,075, where the flow is critical ($F_r = 1$) for the 100-year storm event. Figure 4-6 shows the water levels in two cross-sections for the 2- and 100-year storm events. The results of the 100-year flood events at the Creek are presented in Figure 4-8 below.

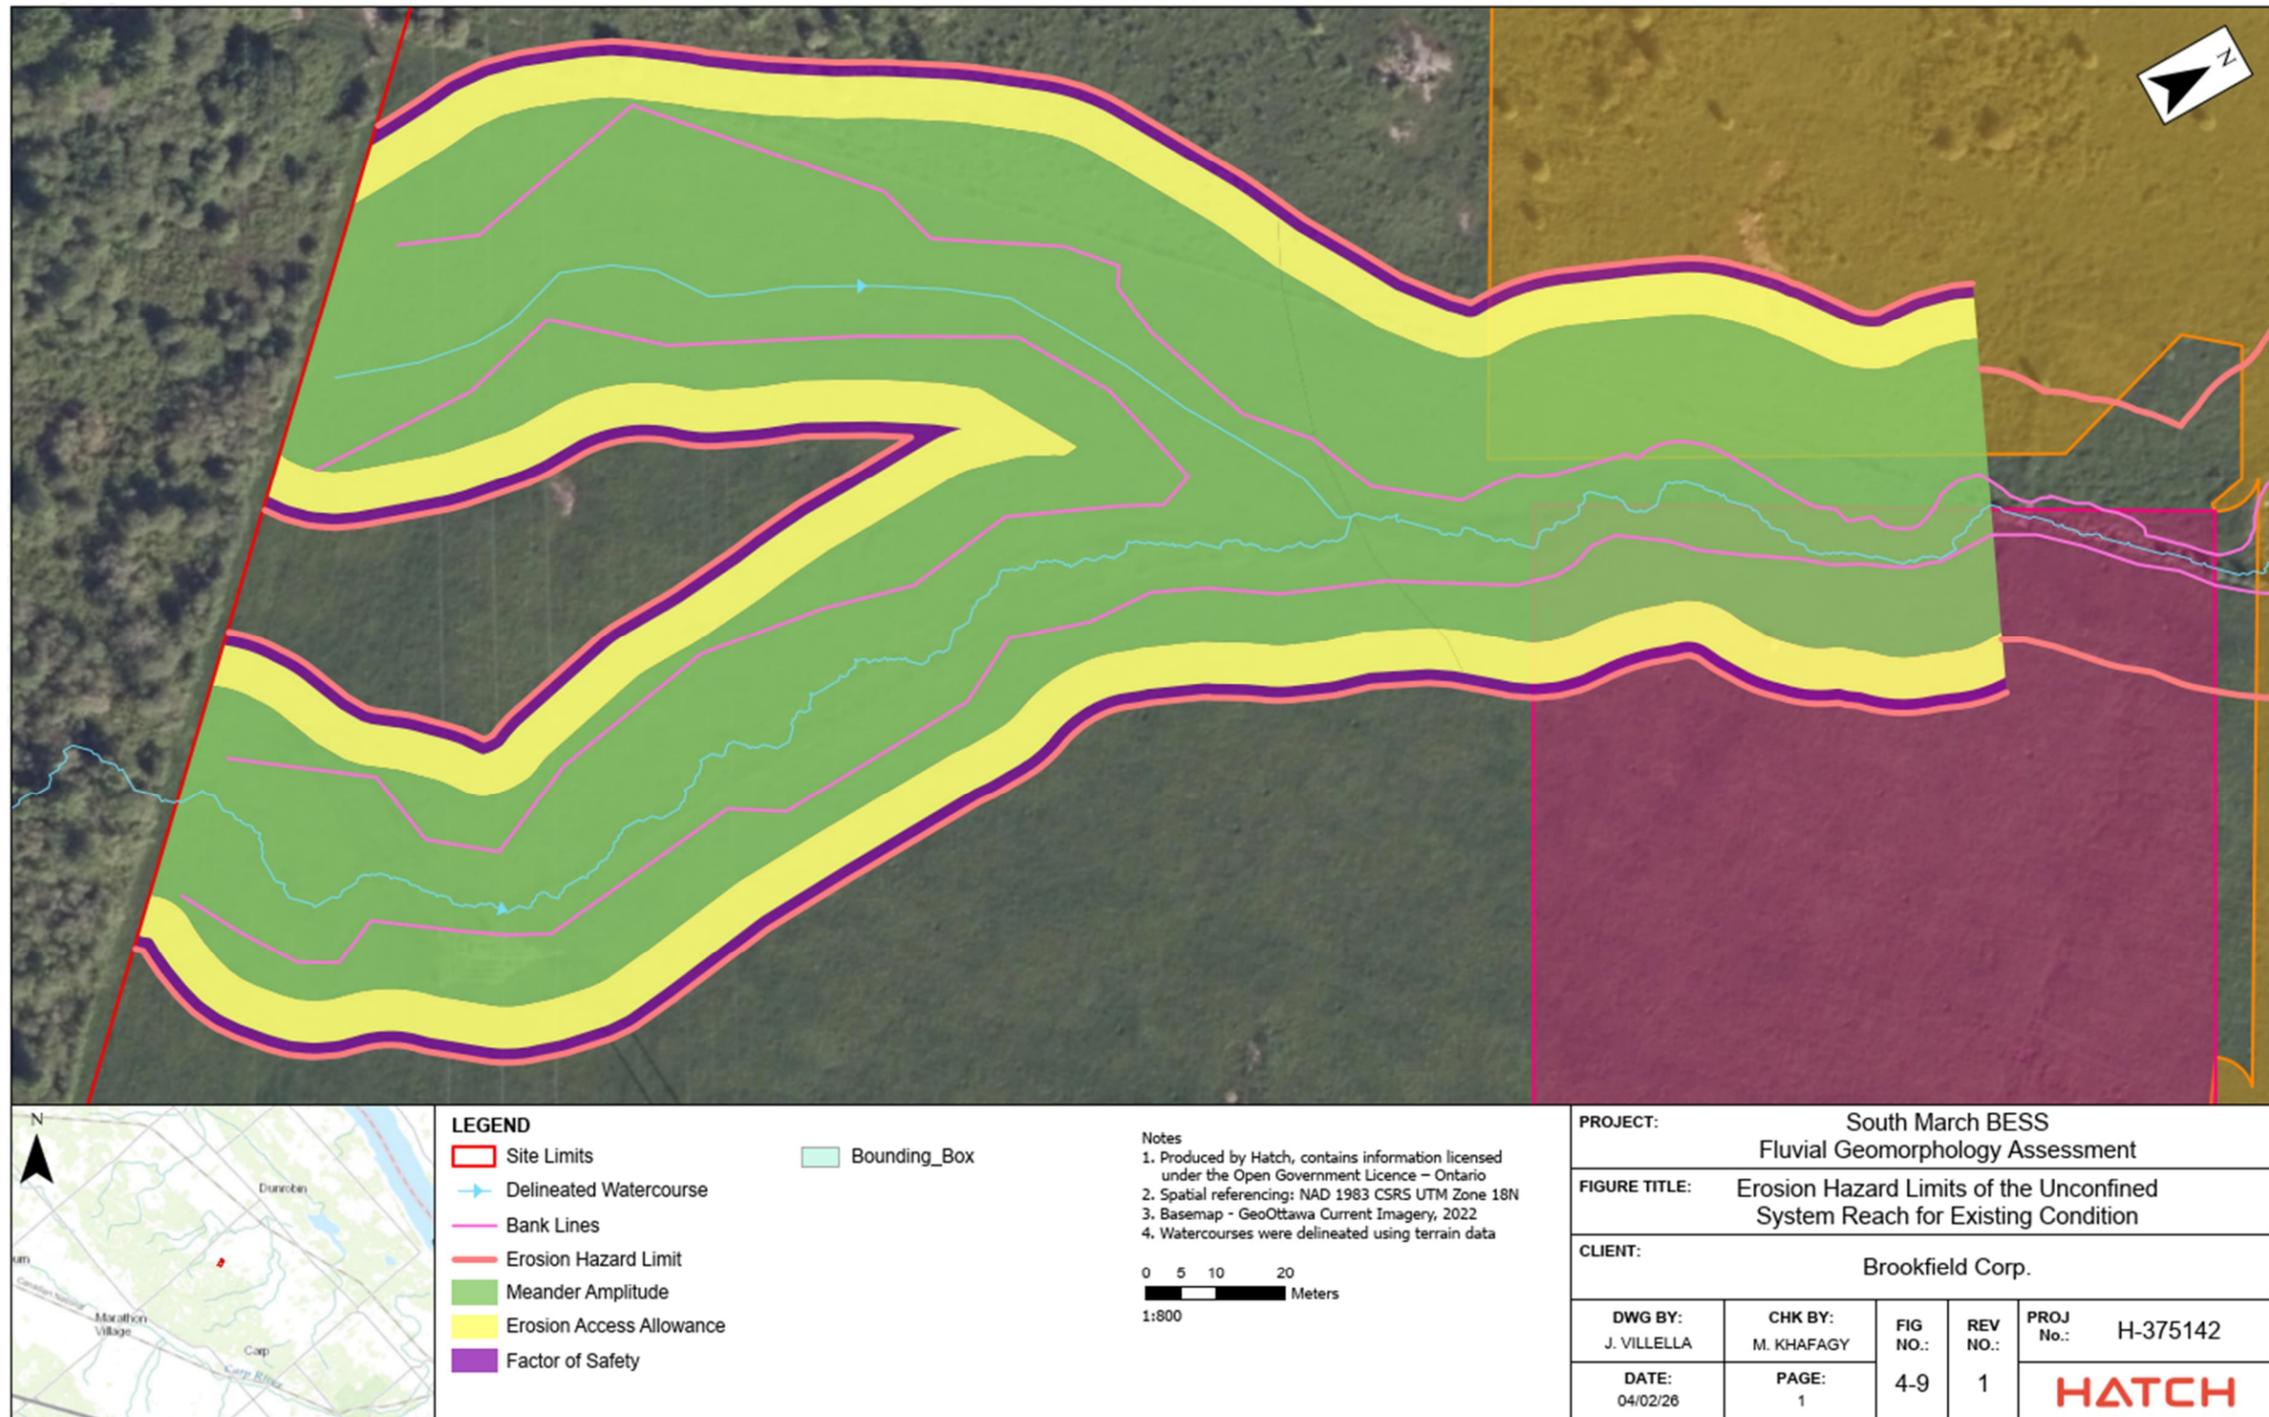
Figure 4-9: Erosion Hazard Limit of the Unconfined System Reach for Existing Condition

The upstream reach of the Creek is defined as an unconfined system. In such systems, the erosion hazard is assessed using a meander belt width approach, which reflects the maximum fixed lateral extent of historical and potential future channel migration. As per MNR Technical Guide (2002), the meander belt width is defined as the summation of meander amplitude and erosion access allowance. In this case, the historical aerial photograph analysis confirms lateral channel migration and expansion of the channel and adjacent wetland features over time. Erosion Access Allowance is a minimum access distance that is typically applied at the top of the valley slope to allow space for maintenance or future stabilization works. Regarding the erosion access allowance, MNR Technical Guide (2002) guidelines note that for stiff/hard cohesive soil (clays, clay silt) and coarse granular (gravels) tills, a 5 to 8 m erosion access is to be applied. Given the evidence of erosion along the Creek, erosion access allowance of 6 m is recommended. An appropriate safety factor can be applied to the Erosion Hazard limit as per guideline recommendations, and a 2 m safety factor has been applied. Figure 4-9 shows the erosion hazard limit for the unconfined system reach of the Creek including the Meander belt Width, erosion access allowance, and safety factor.

The proposed development area is located within the delineated erosion hazard limit associated with a portion of both the unconfined and confined system reaches of the Creek. Figure 4-9 and Figure 4-10 show the overlap between the development footprint and the defined erosion hazard components, including the meander amplitude, toe erosion allowance, and erosion access allowance. This confirms that the development, as currently planned, encroach upon areas identified as geomorphologically sensitive or at risk of fluvial erosion. A new reach of the Creek has been proposed by BBA Consultants to realign the channel around the development footprint. Appendix D shows the erosion hazard limits for the existing condition of the Creek.

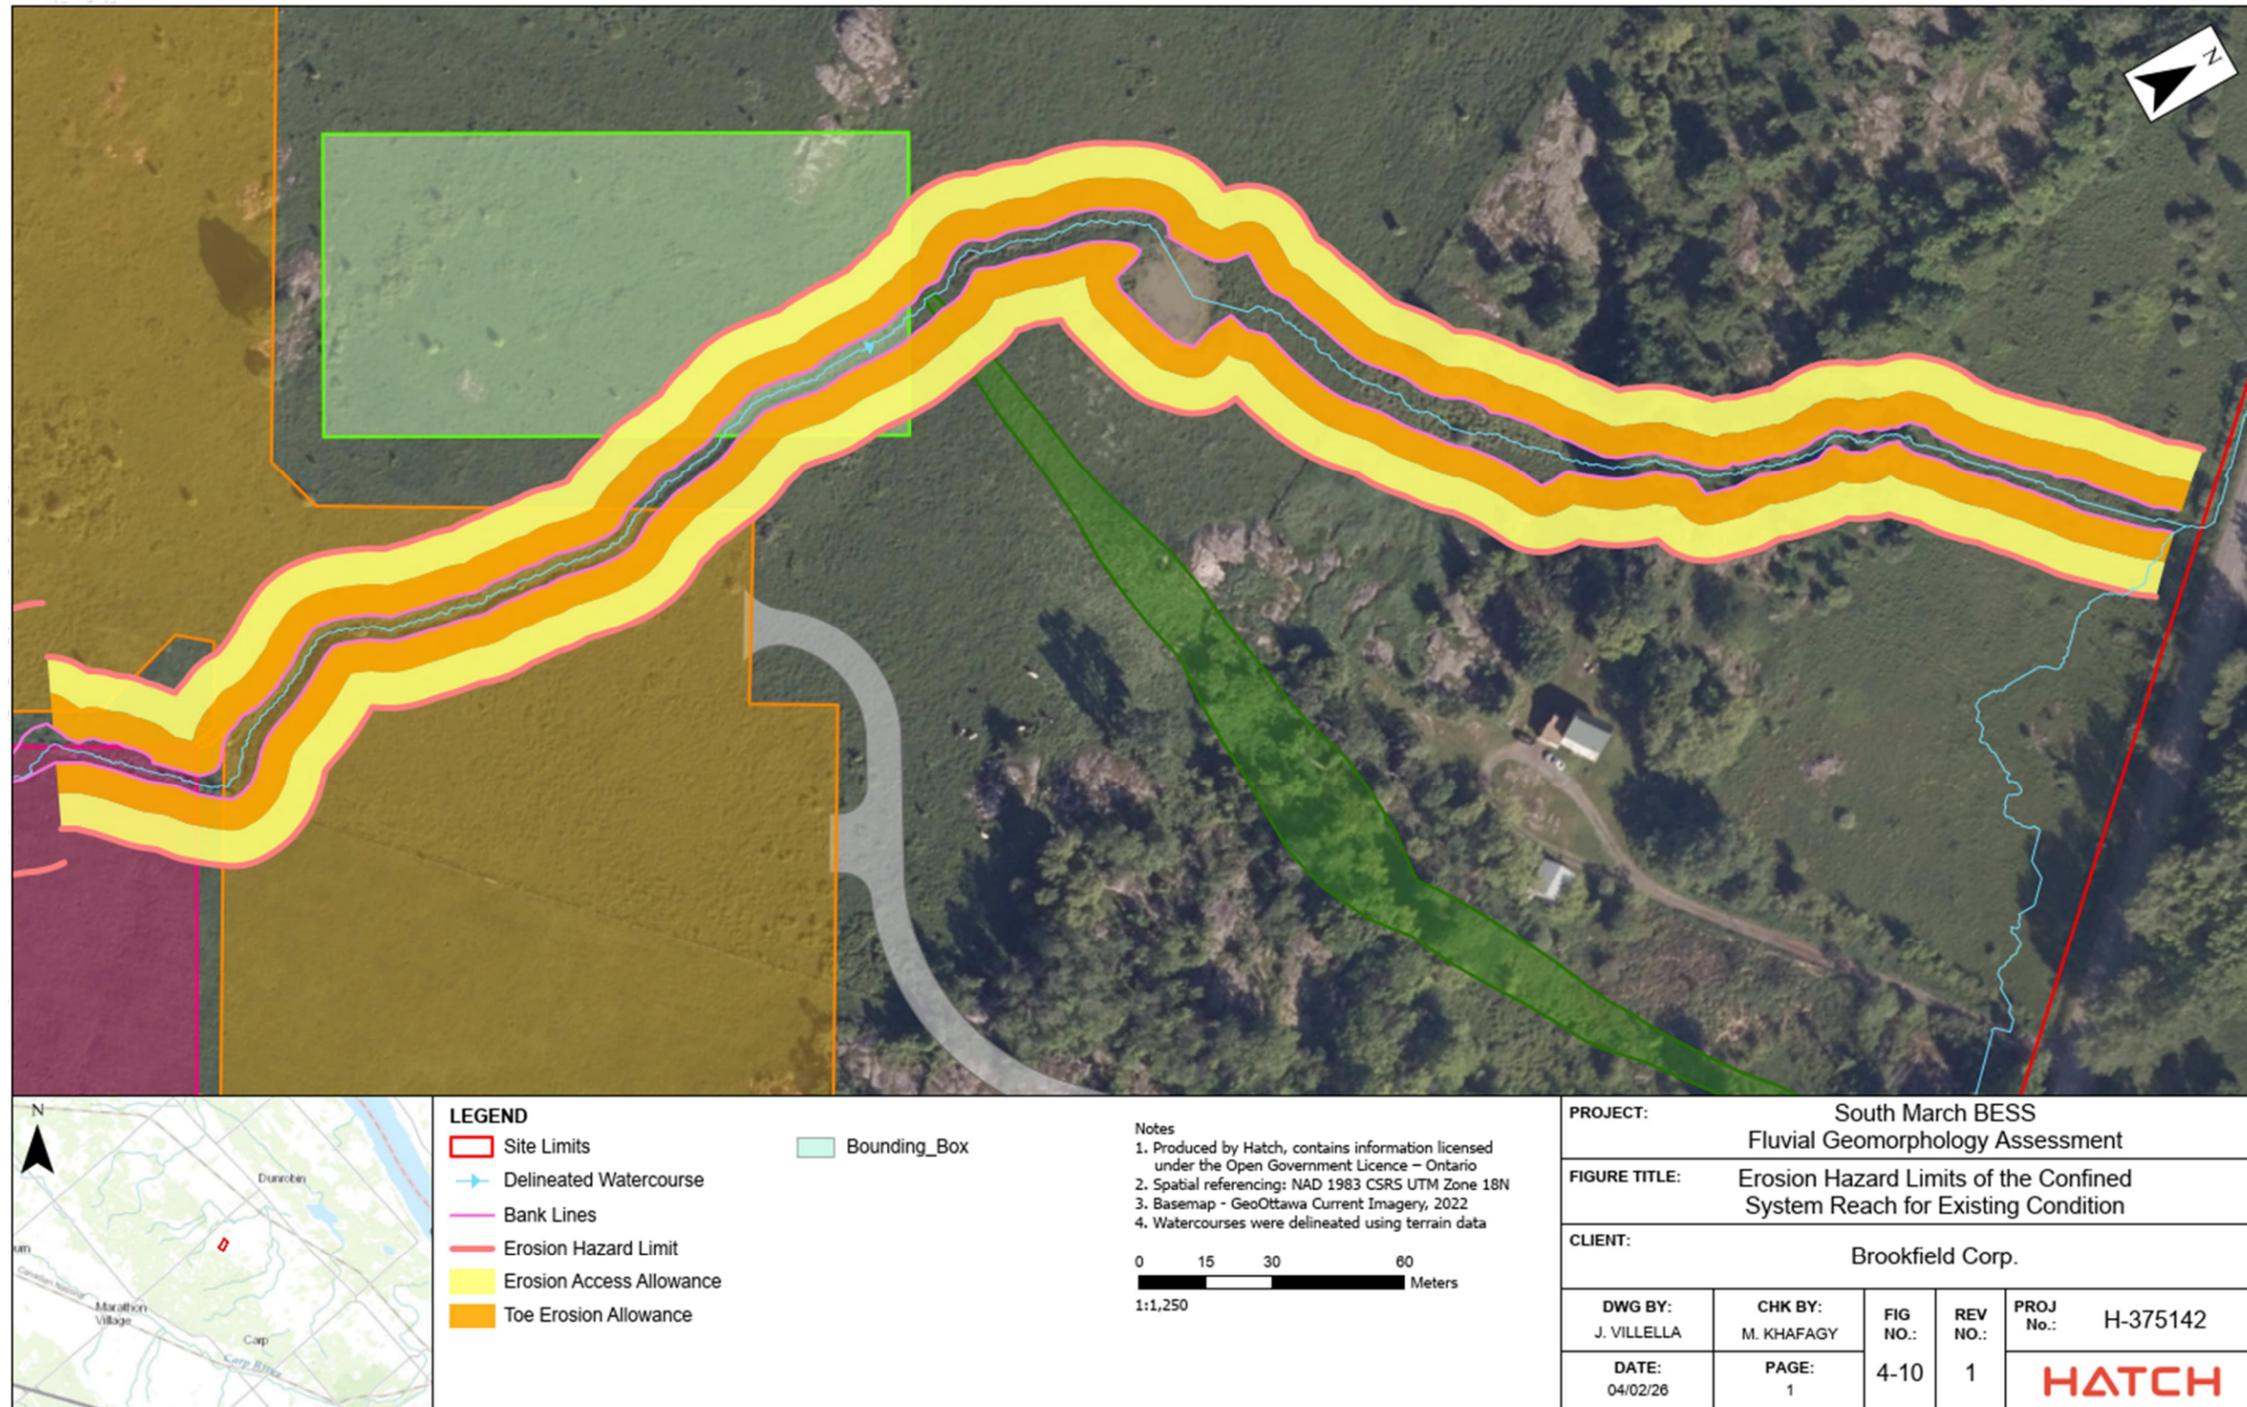
Figure 4-10: Erosion Hazard Limit of the Confined System Reach for Existing Condition

The downstream reach of the Creek transitions into a confined system. An appropriate approach is to delineate the erosion hazard for the confined systems following MNR Erosion Hazard Limit Technical Guide (2002), where the erosion hazard is comprised of three main components: 1) the toe erosion allowance; 2) the stable slope allowance; and 3) the erosion access allowance. The toe Erosion Allowance represents the potential for channel migration at the base of the valley slope. A toe erosion allowance of 7 m was applied following the MNR Technical Guide (2001). Stable Slope Allowance is to address potential long-term slope instability, where the stable slope allowance is determined based on geotechnical criteria. In accordance with the CVC Watershed Planning and Regulation Policies (2010), a stable slope allowance is required only where specific conditions apply, including: slope gradients steeper than 3:1, slope heights equal to or greater than 2 m, visible evidence of slope instability, proximity of bankfull flow to the valley toe of slope (within 15 m), or a known history of slope failure. Not all of these conditions were observed at the subject site. Therefore, a stable slope allowance is not considered necessary for this reach of the watercourse. An erosion access allowance of 8 m is recommended.

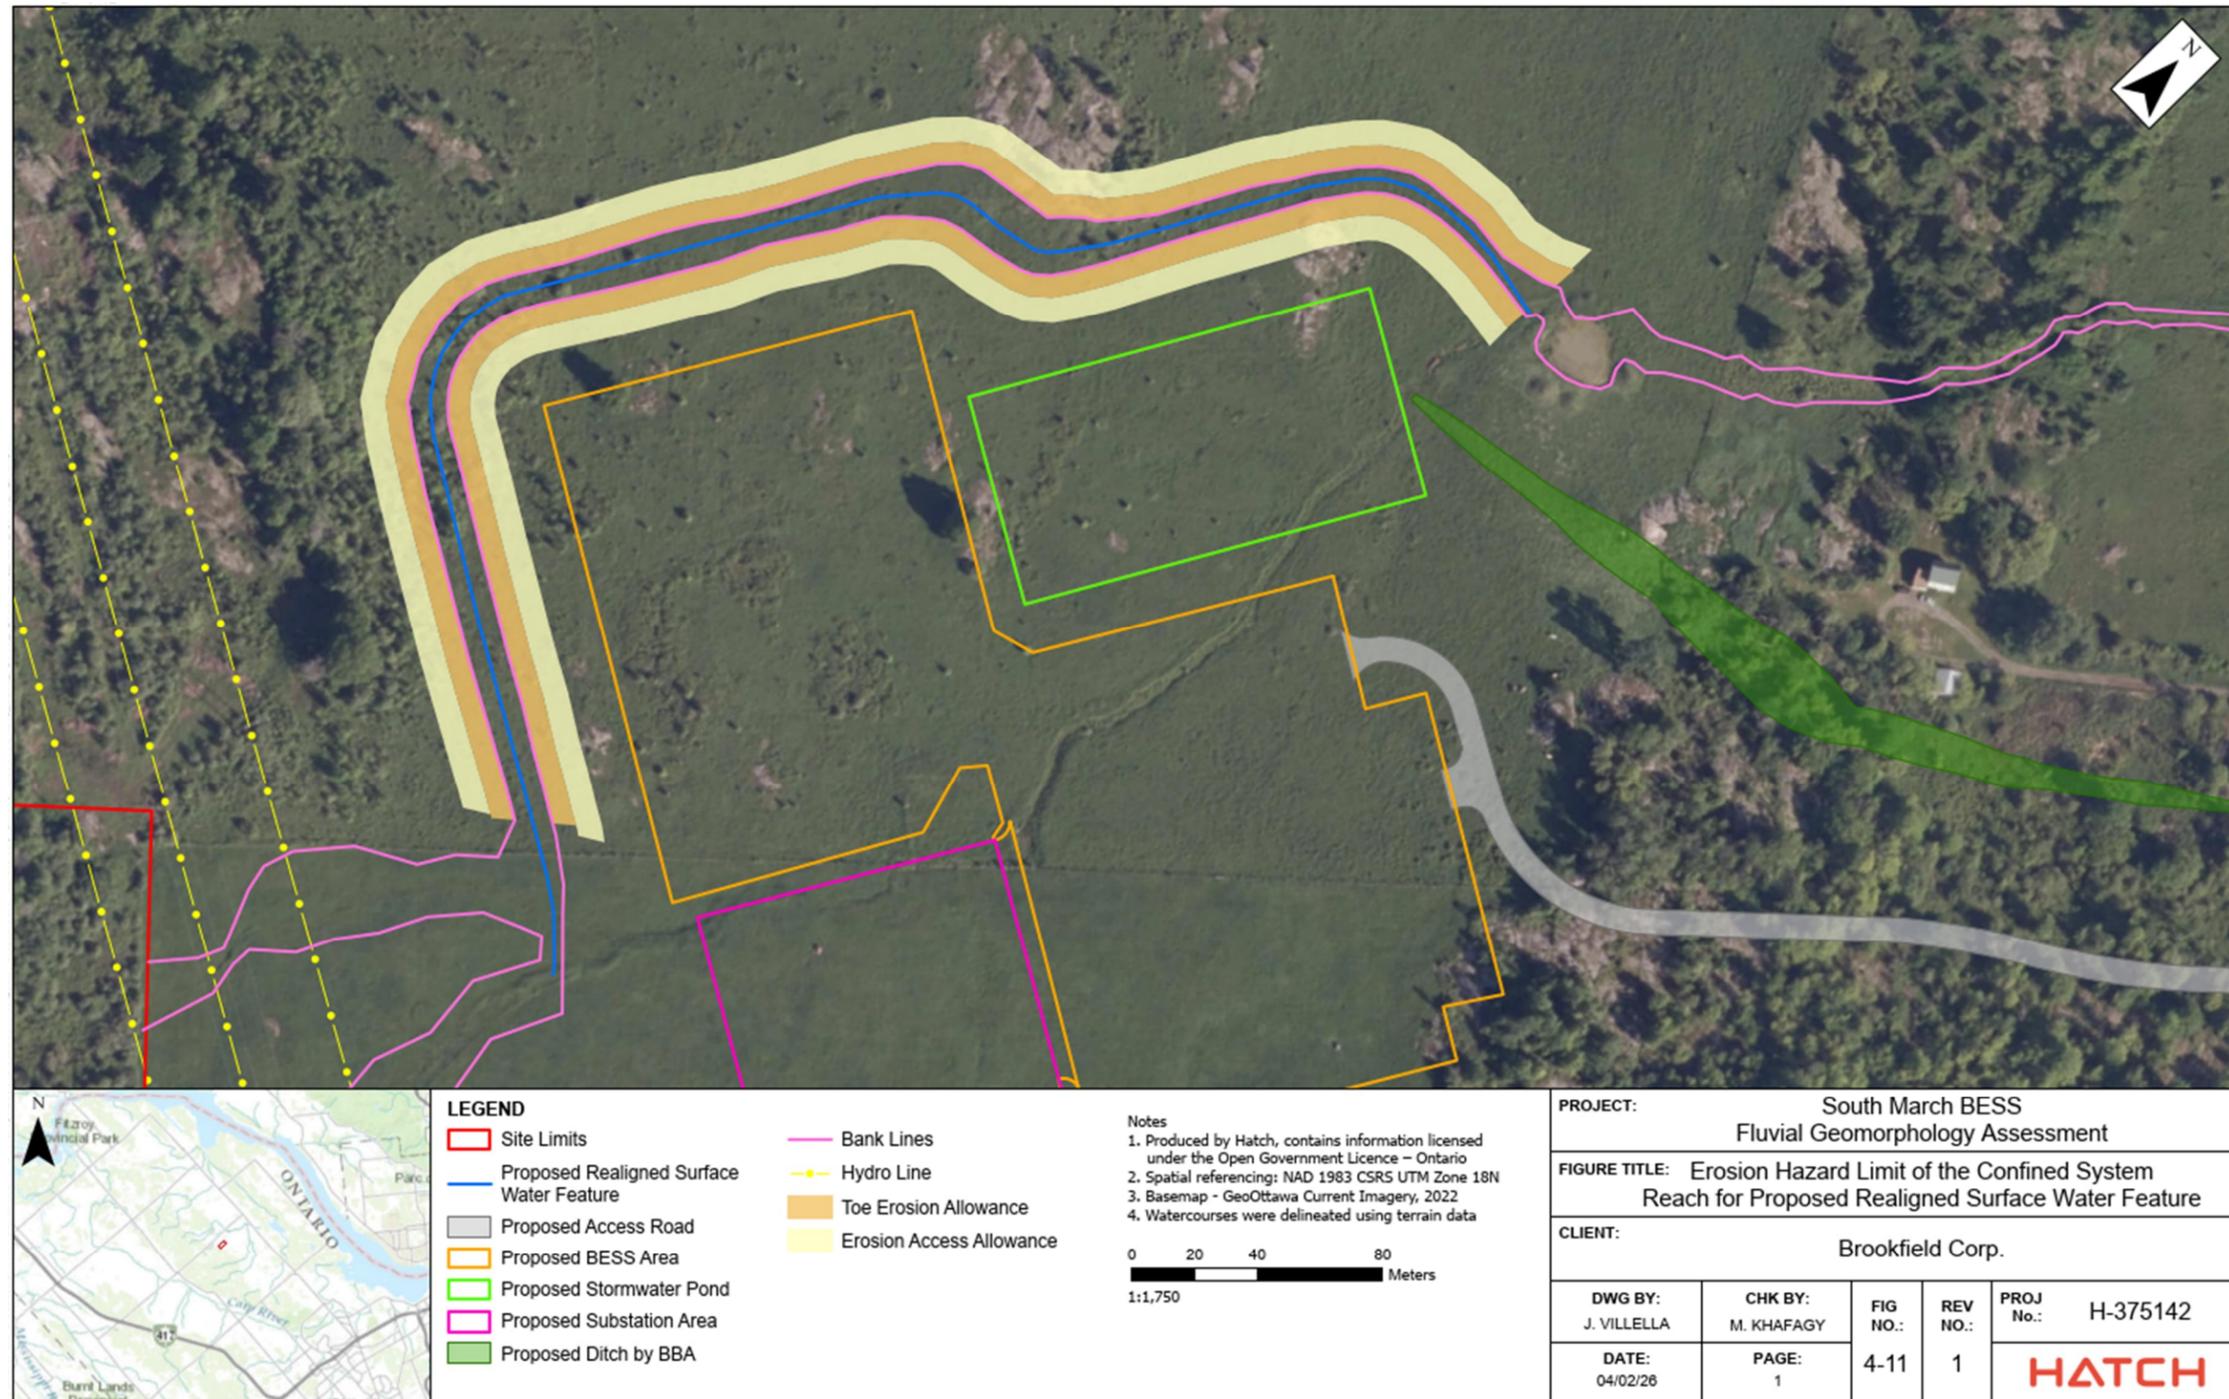
Figure 4-11: Erosion Hazard Limit of the Confined System Reach for Proposed Realigned Surface Water Feature

Figure 4-11 illustrates the erosion hazard limit for the realigned surface water feature. The hazard limits do not encroach upon any of the development area boundaries.

As per the Erosion and Sediment Control Guideline for Urban Construction (2006), diversion channels that are expected to remain in place for extended periods (e.g., 6-12 months or longer) and convey moderate flows should be lined with erosion-resistant materials such as hydroseeded vegetation to ensure stability during operation. These treatments help reduce shear stress on channel boundaries and promote vegetation establishment. Furthermore, the proposed channel should be designed using Natural Channel Design principles by ensuring appropriate sizing, planform, slope, and materials that reflect the natural characteristics to promote long-term stability, as recommended in the CVC Fluvial Geomorphologic Guidelines (2015). Appendix E shows the erosion hazard limits for the proposed condition of the Creek.

- A realignment of the Creek has been proposed and designed by BBA Consultants in the form of a realigned surface water feature that routes flow around the development area. The erosion hazard limits do not encroach upon the development area boundaries. The proposed realigned surface water feature should be lined with erosion-resistant materials such as hydroseeded vegetation to ensure stability during operation.

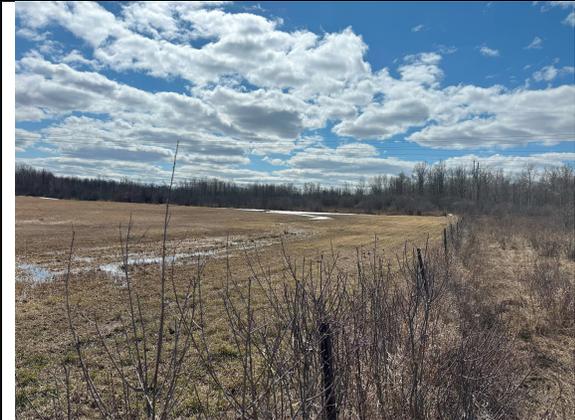
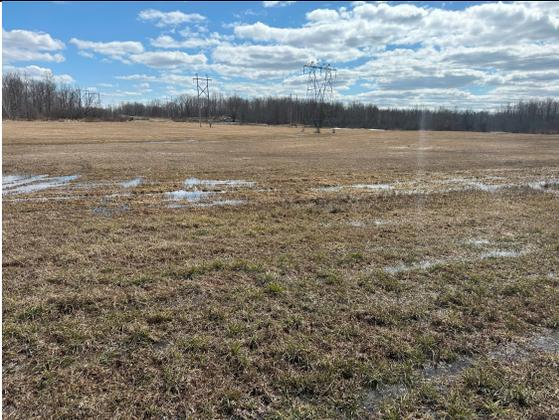
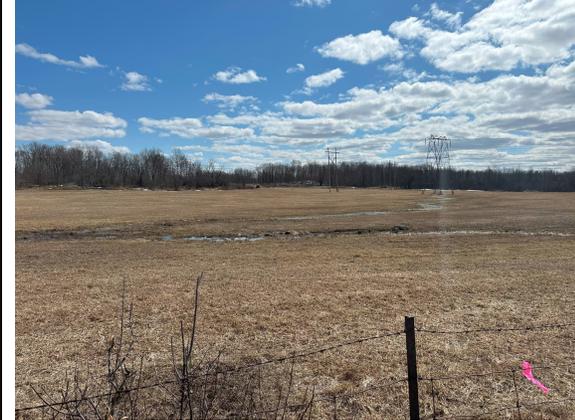
At the southeast boundary of the Project site, stagnant water was observed within two upstream branches of the Creek, as shown in Photos 1 to 4 (Appendix B) from locations S1 and S2. The presence of standing water outside the defined channel zone may suggest backwater effects during wet periods, although no well-defined channel was visible in this area. These observations are consistent with the high groundwater table identified in the borehole data from the geotechnical investigation (Hatch, 2026). The lack of defined banks suggests low channel confinement, with water dispersing laterally across the adjacent field. These conditions are characteristic of weak channelization and reduced hydraulic capacity, with potential for overland flow contributions during high-flow events.

Photo 1: View looking south (Upstream) at location S1 (Figure 3-1) on April 7, 2025.

Photo 2: View looking southeast (Upstream) at location S1 (Figure 3-1) on April 7, 2025.

Photo 3: View looking southeast (Upstream) at location S2 (Figure 3-1) on April 7, 2025.

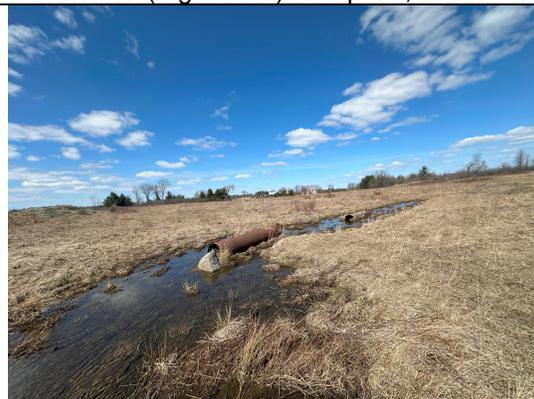
Two culverts installed in series, each is 80 cm in diameter and 3.5 m in length (Photo 12 in Appendix B) were observed along the Creek corridor. These culverts convey flow into a large wet pond located along the northern portion of the Creek, shown in Photo 13 (Appendix B). Given their placement within a wide section of the channel, where flow is also conveyed around the culverts, their influence on overall channel hydraulics and fluvial processes appears to be marginal.

Photo 12: View looking northeast (downstream) at location S9 (Figure 3-1) on April 7, 2025.

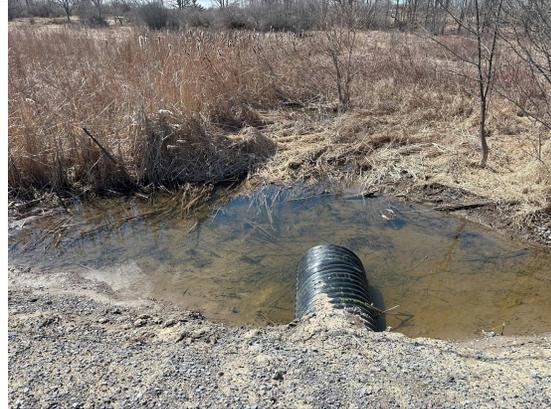
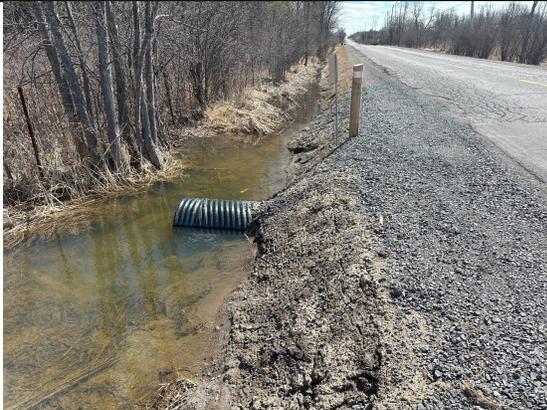
Active flow was observed during the site visit, with ponded water present within the upstream ponded/spreading water section, and continuous flow through the downstream channelized reach. At the northeast property boundary, the Creek drains through a 70 cm diameter culvert crossing Marchurst Road, discharging to the northeast (Photos 26 and 27 in Appendix B).

Photo 26: View looking southwest (Upstream) at location S18 (Figure 3-1) on April 7, 2025.

Photo 27: Side view at location S18 (Figure 3-1) on April 7, 2025.

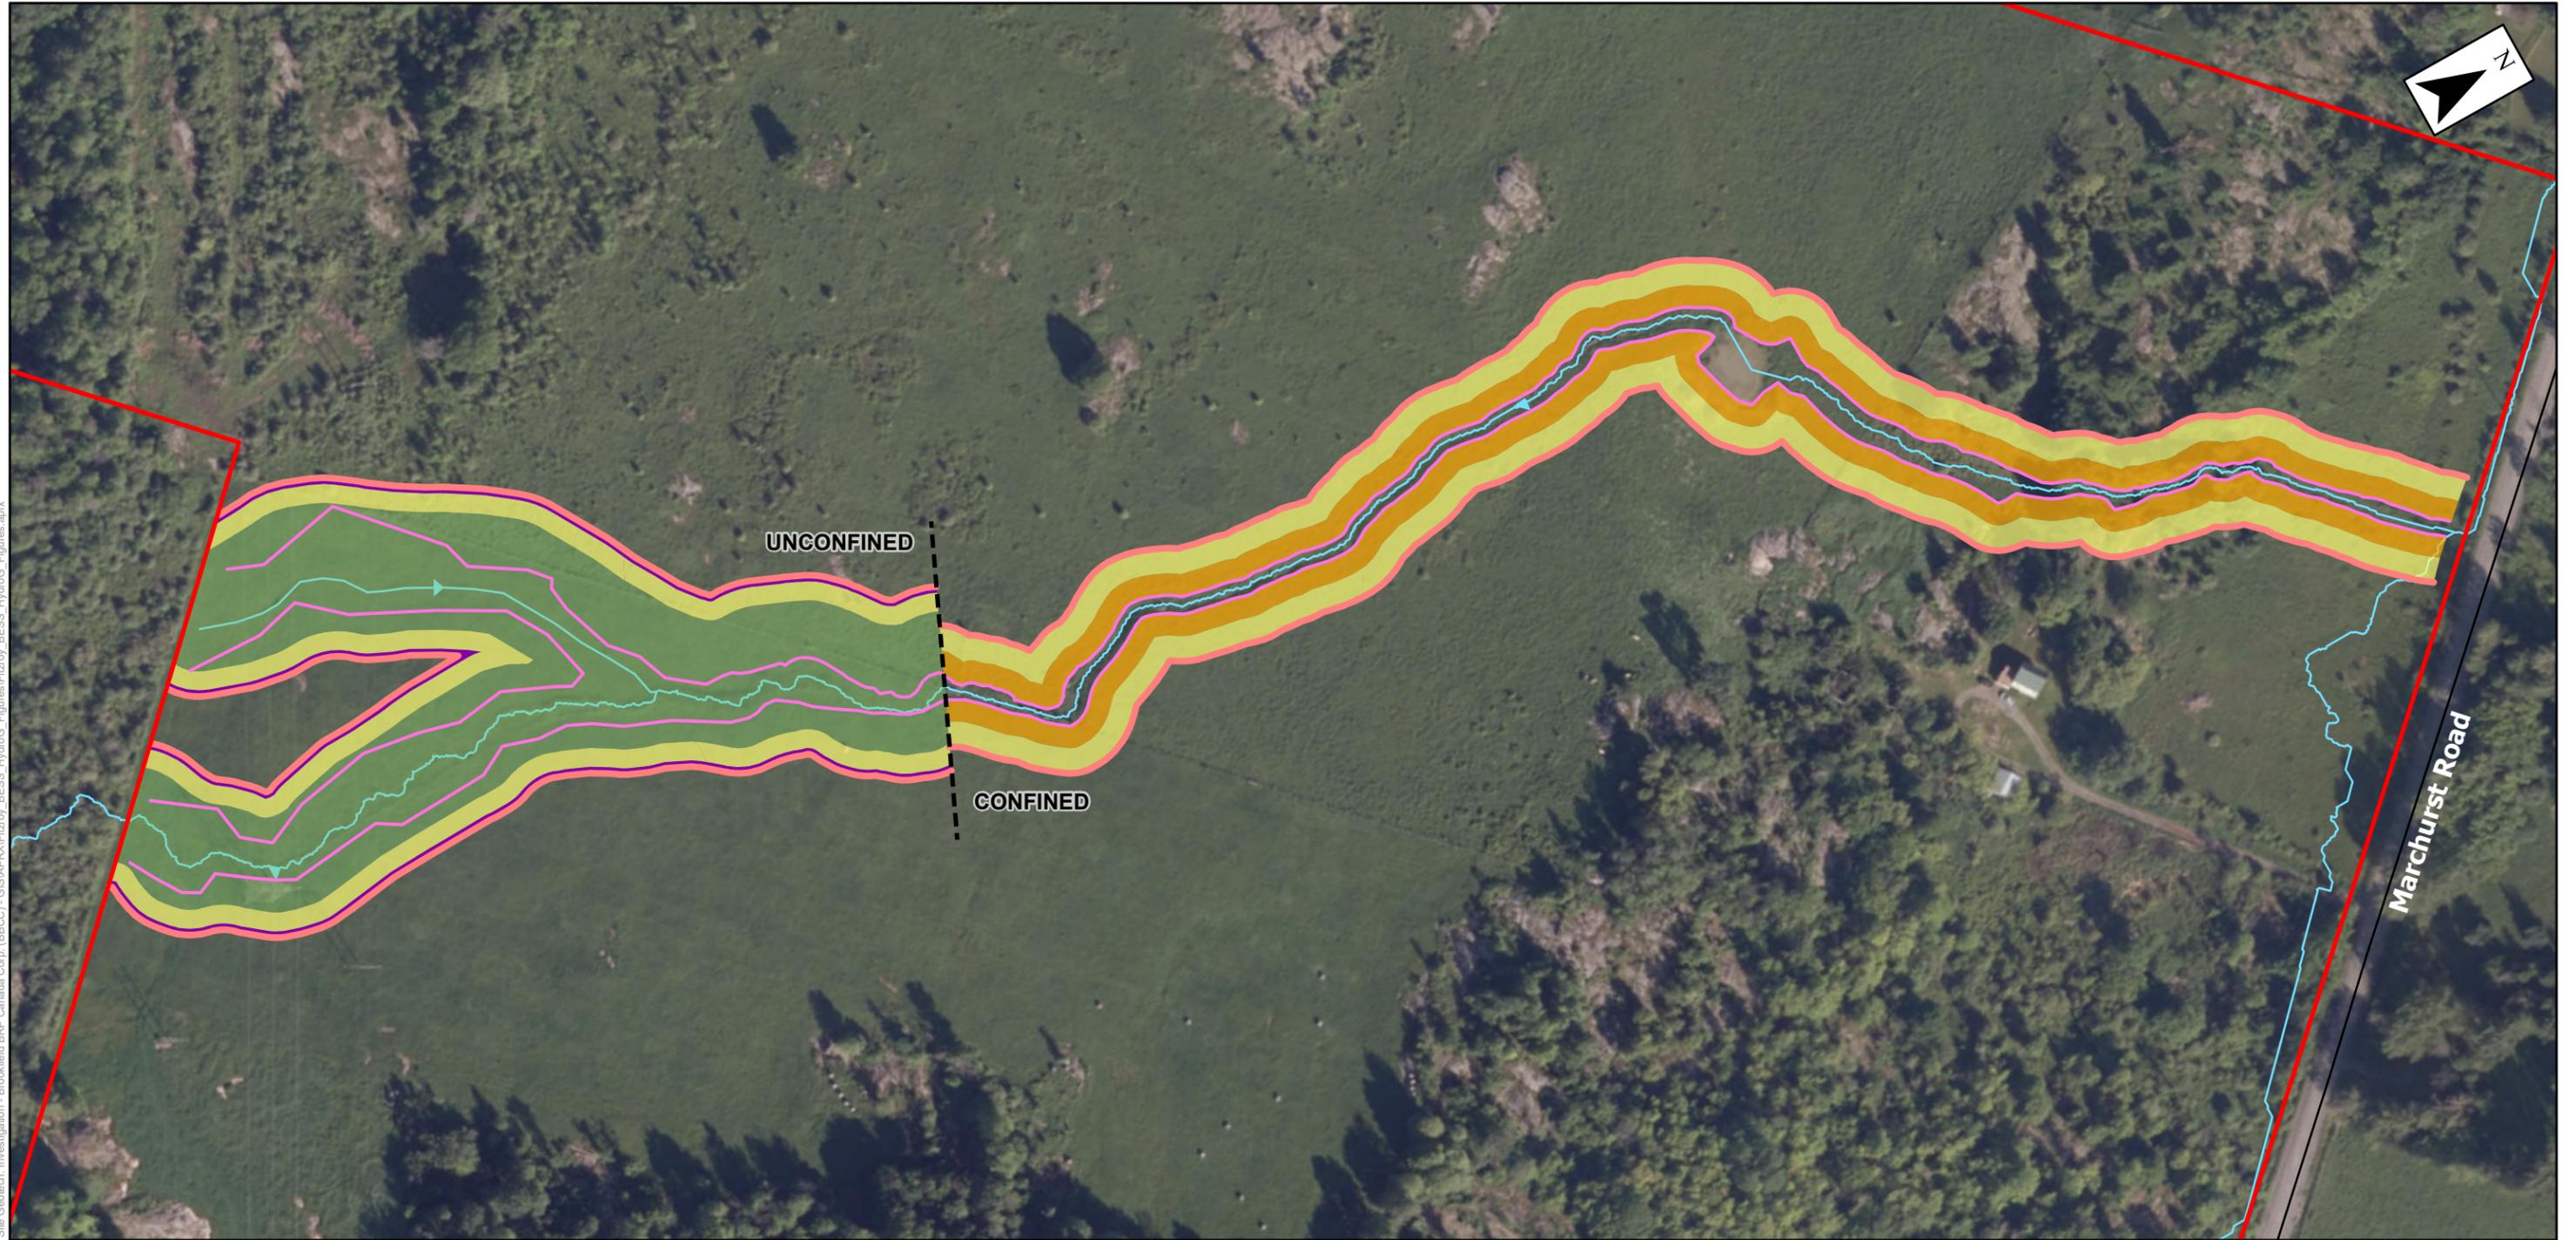
PROJECT: South March BESS Fluvial Geomorphology Assessment				
FIGURE TITLE: Erosion Hazard Limits for Existing Condition				
CLIENT: Brookfield Corp.				
DWG BY: J. VILLELLA	CHK BY: M. KHAFAQY	APP.: D	REV NO.: 1	PROJ No.: H-375142
DATE: 04/02/26	PAGE: 1	HATCH

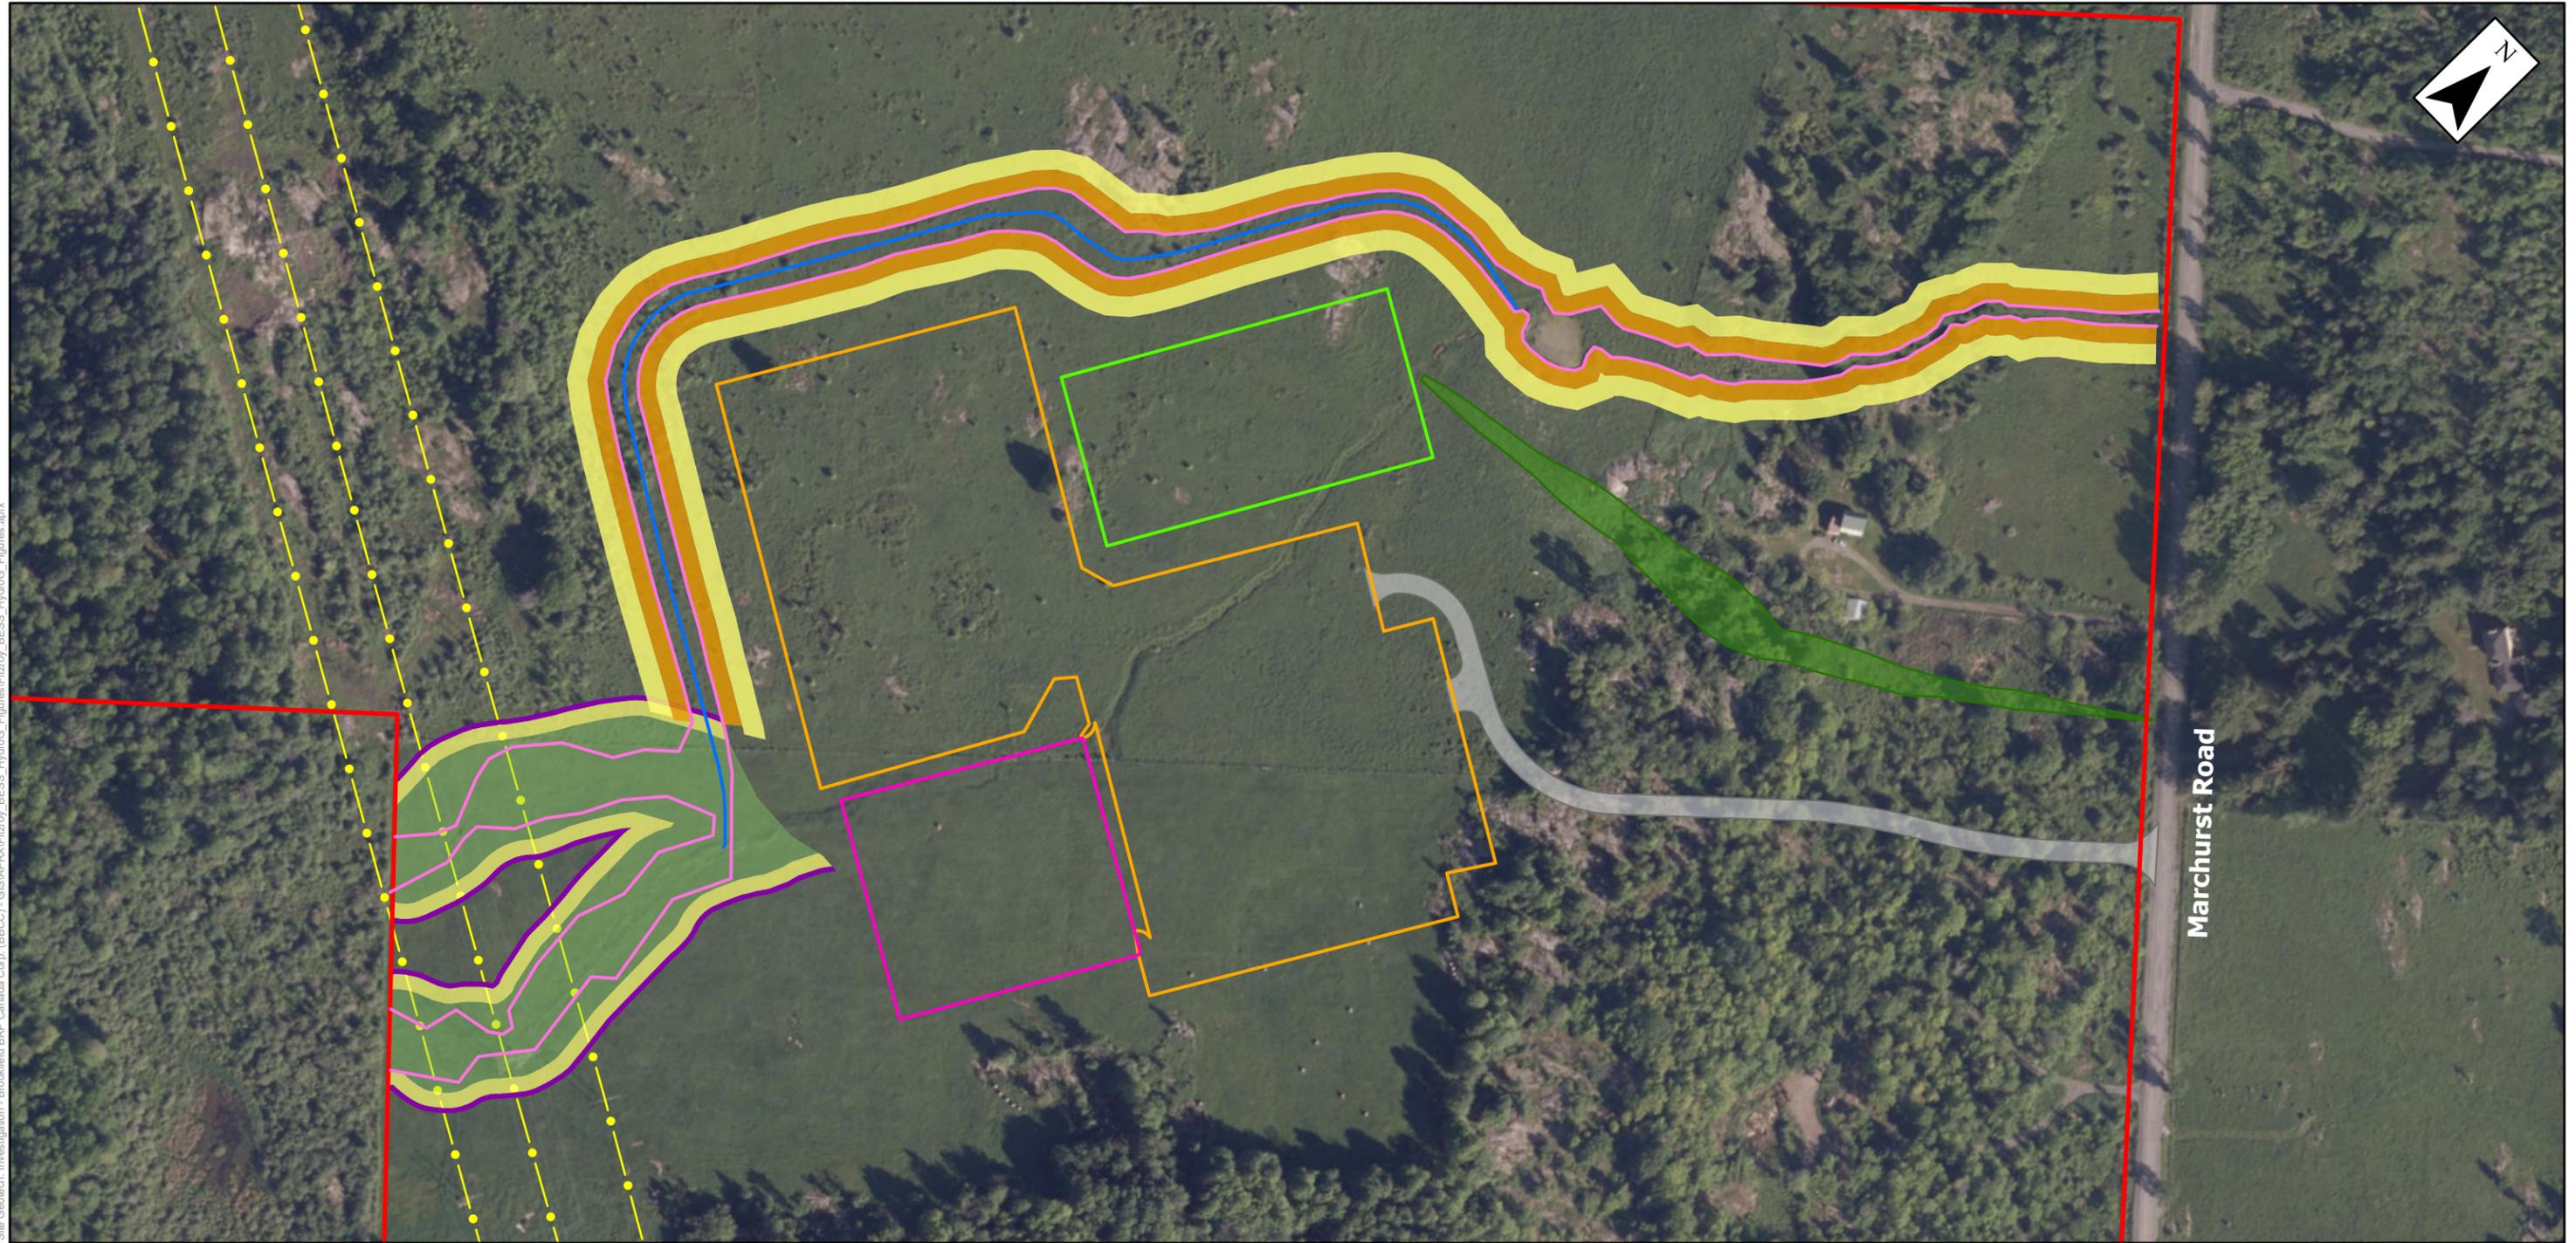
PROJECT: South March BESS Fluvial Geomorphology Assessment				
FIGURE TITLE: Erosion Hazard Limits for Proposed Condition				
CLIENT: Brookfield Corp.				
DWG BY: J. VILLELLA	CHK BY: M. KHAFAGY	APP.: E	REV NO.: 1	PROJ No.: H-375142
DATE: 04/02/26	PAGE: 1	HATCH
